The Whole Story in Woods Hole

Or How Sometimes You Need to Dig a Little Deeper Than a Traditional I/I Project to Really Fix a Collection System

NEWEA Wastewater Collection Systems
Specialty Conference & Workshop Series
September 9, 2014

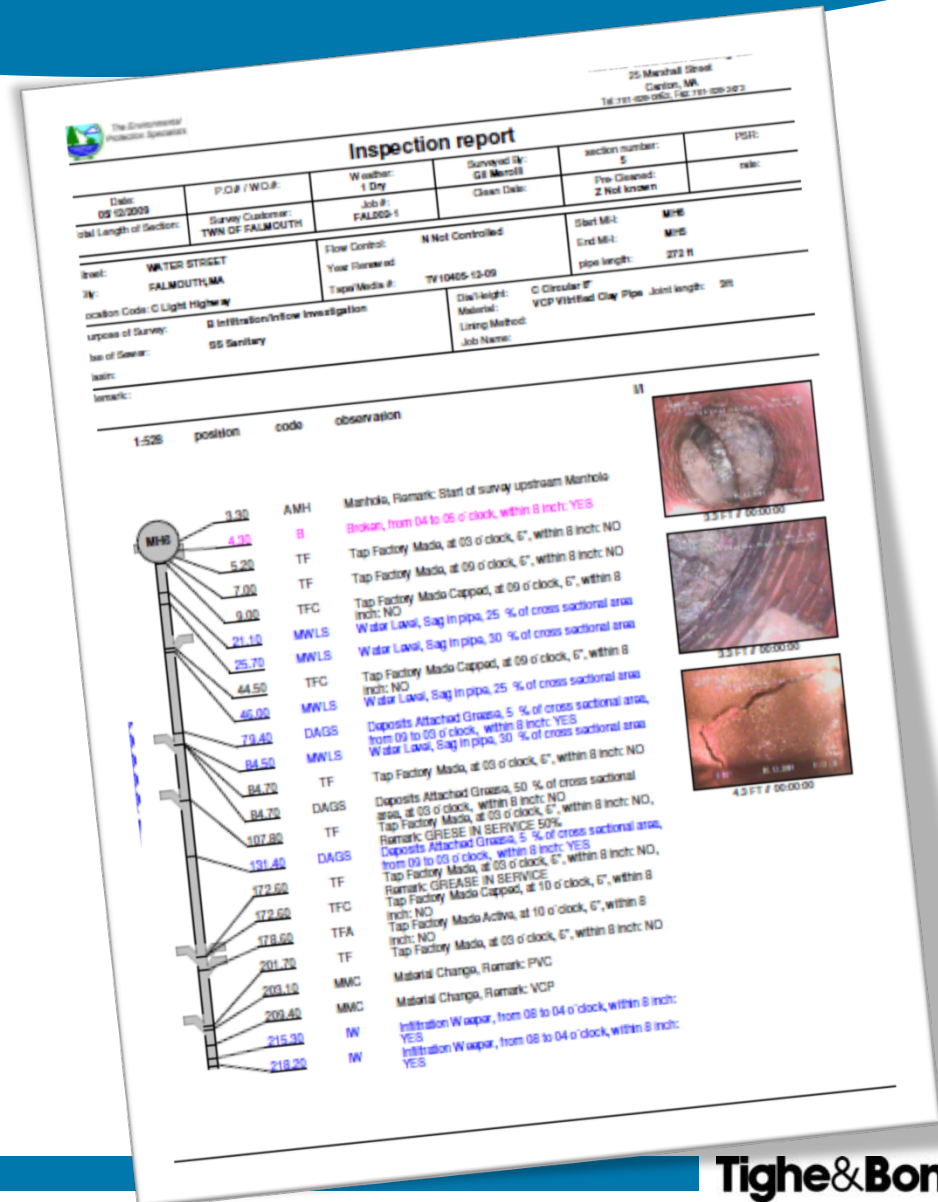
CCTV inspection results

■ 13,600 feet inspected

- Open joints
- Cracks/Fractures
- Infiltration
- Mineral Deposits
- Roots

■ Localized Grease

■ Sag, sags, sags

Recommendations

- Cured in place lining (5,900')
- Tee-liners (100)
- Seal service connections (19)
- Rehabilitate Man Holes (365 v.f.)

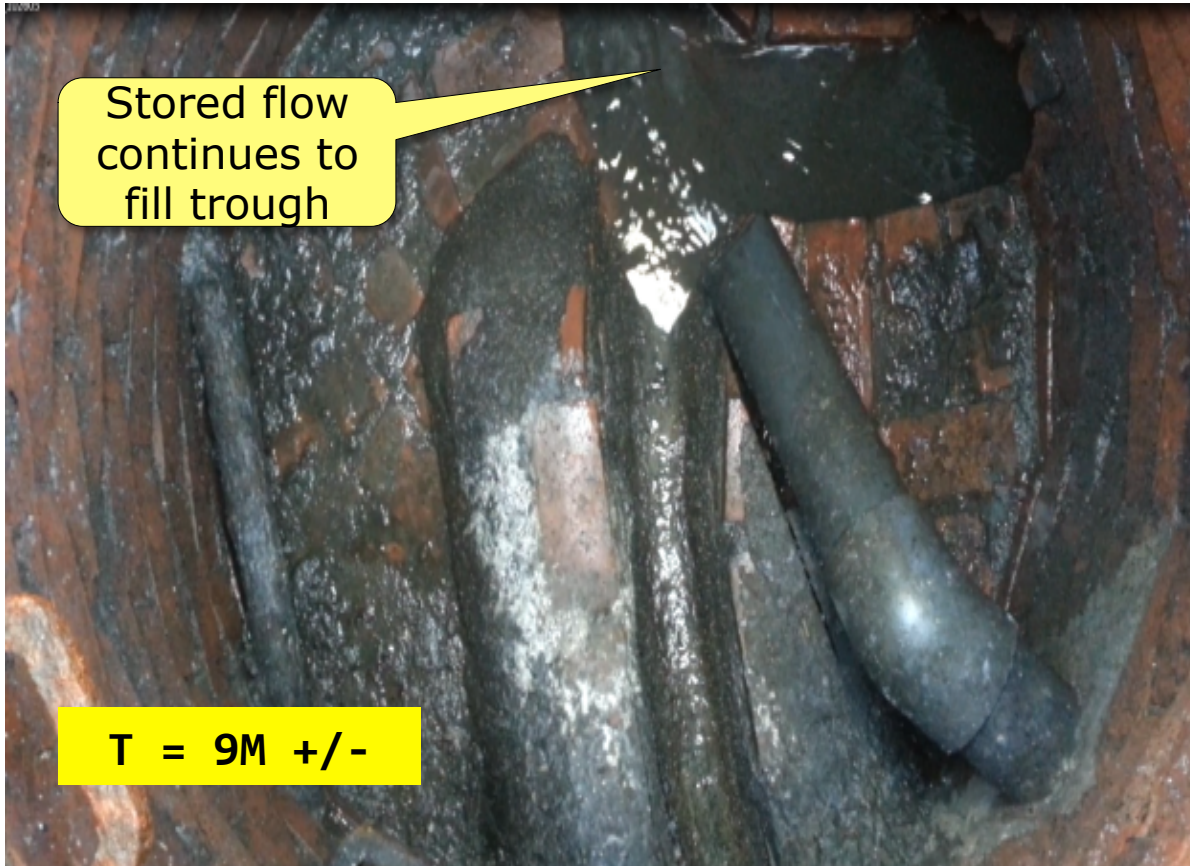
Flow =
250-300 GPM

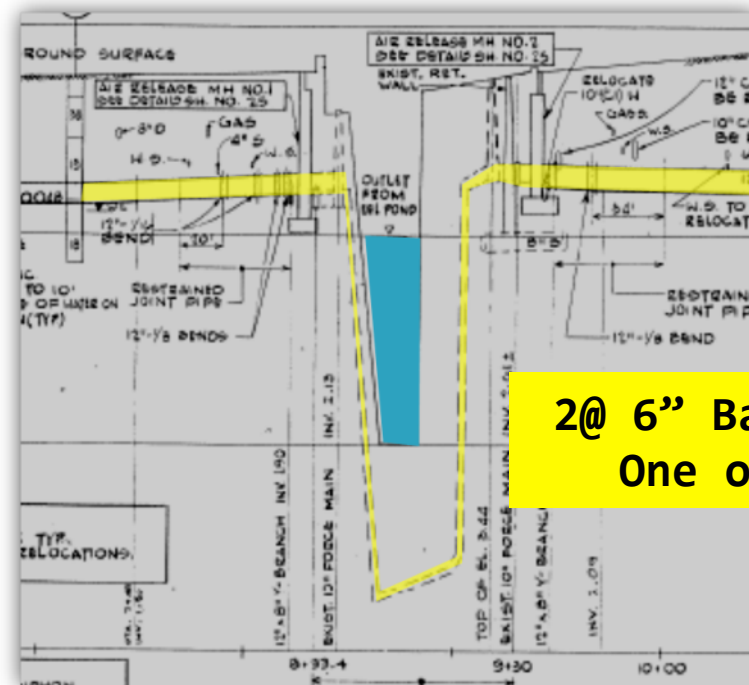
Capacity Conclusion

■ Siphon is limiting factor

2@ 6" Barrels
One open

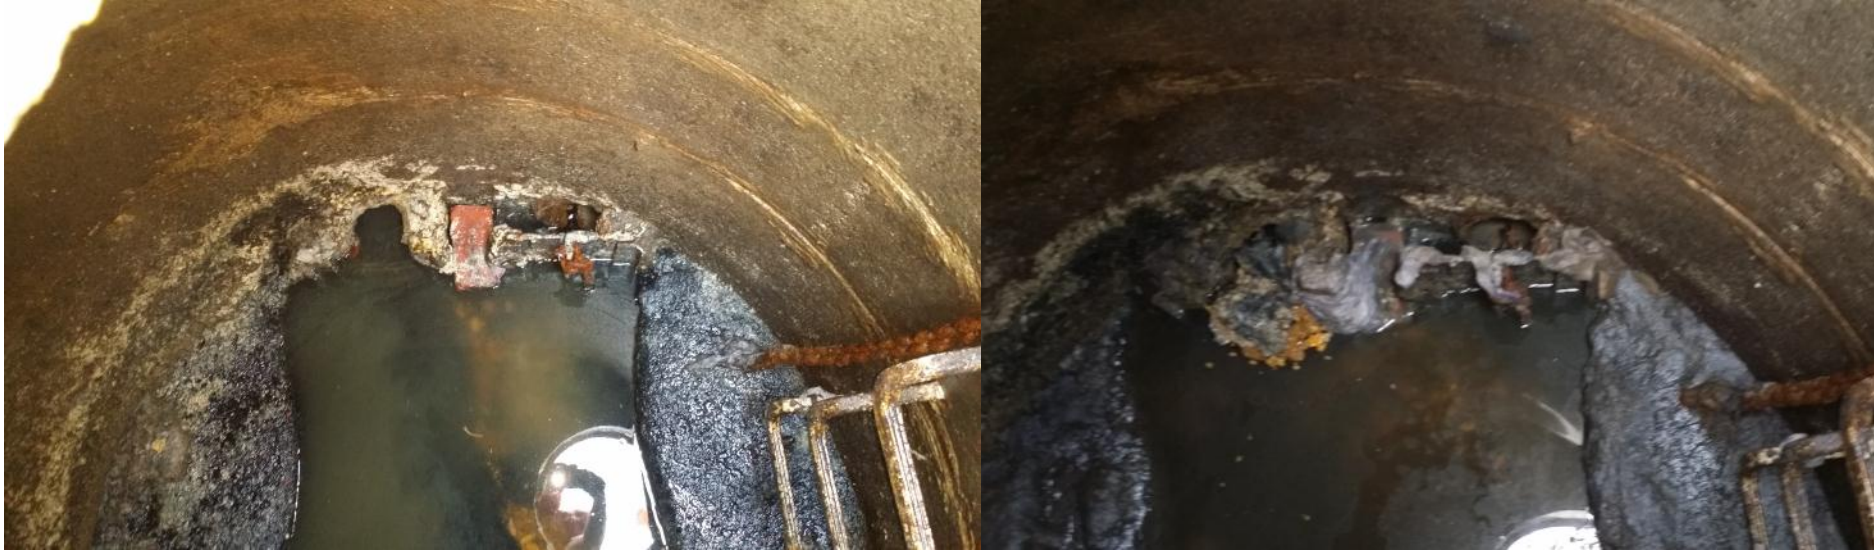
Siphon Issues

- **Surcharges**
- **Fouls with grease**
- **Difficult to maintain**

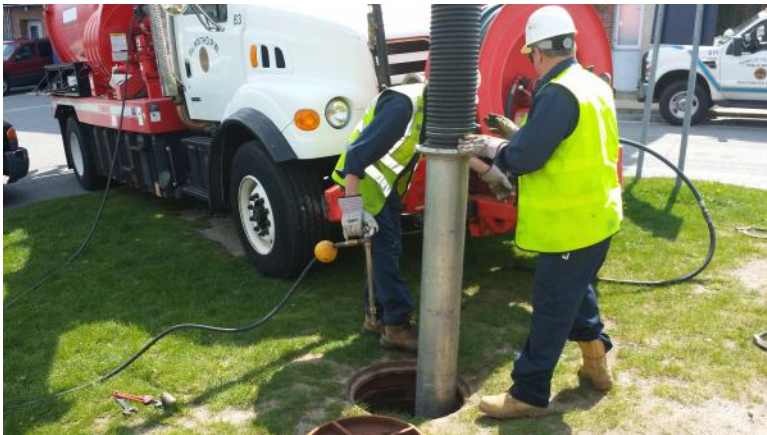
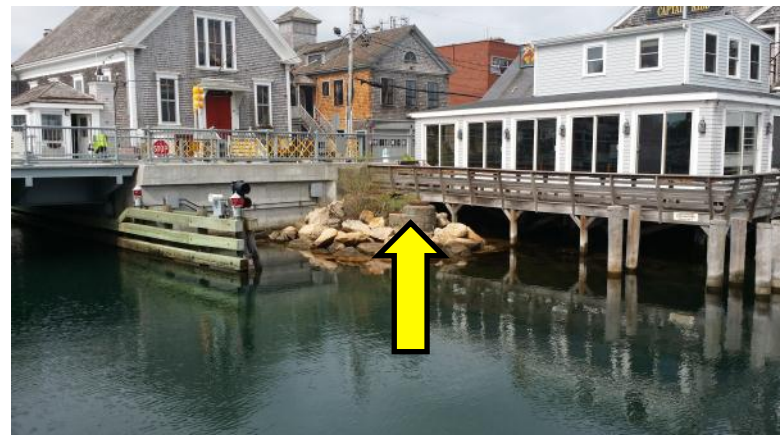
Siphon Issues

- **Surcharges**
- **Fouls with grease**
- **Difficult to maintain**

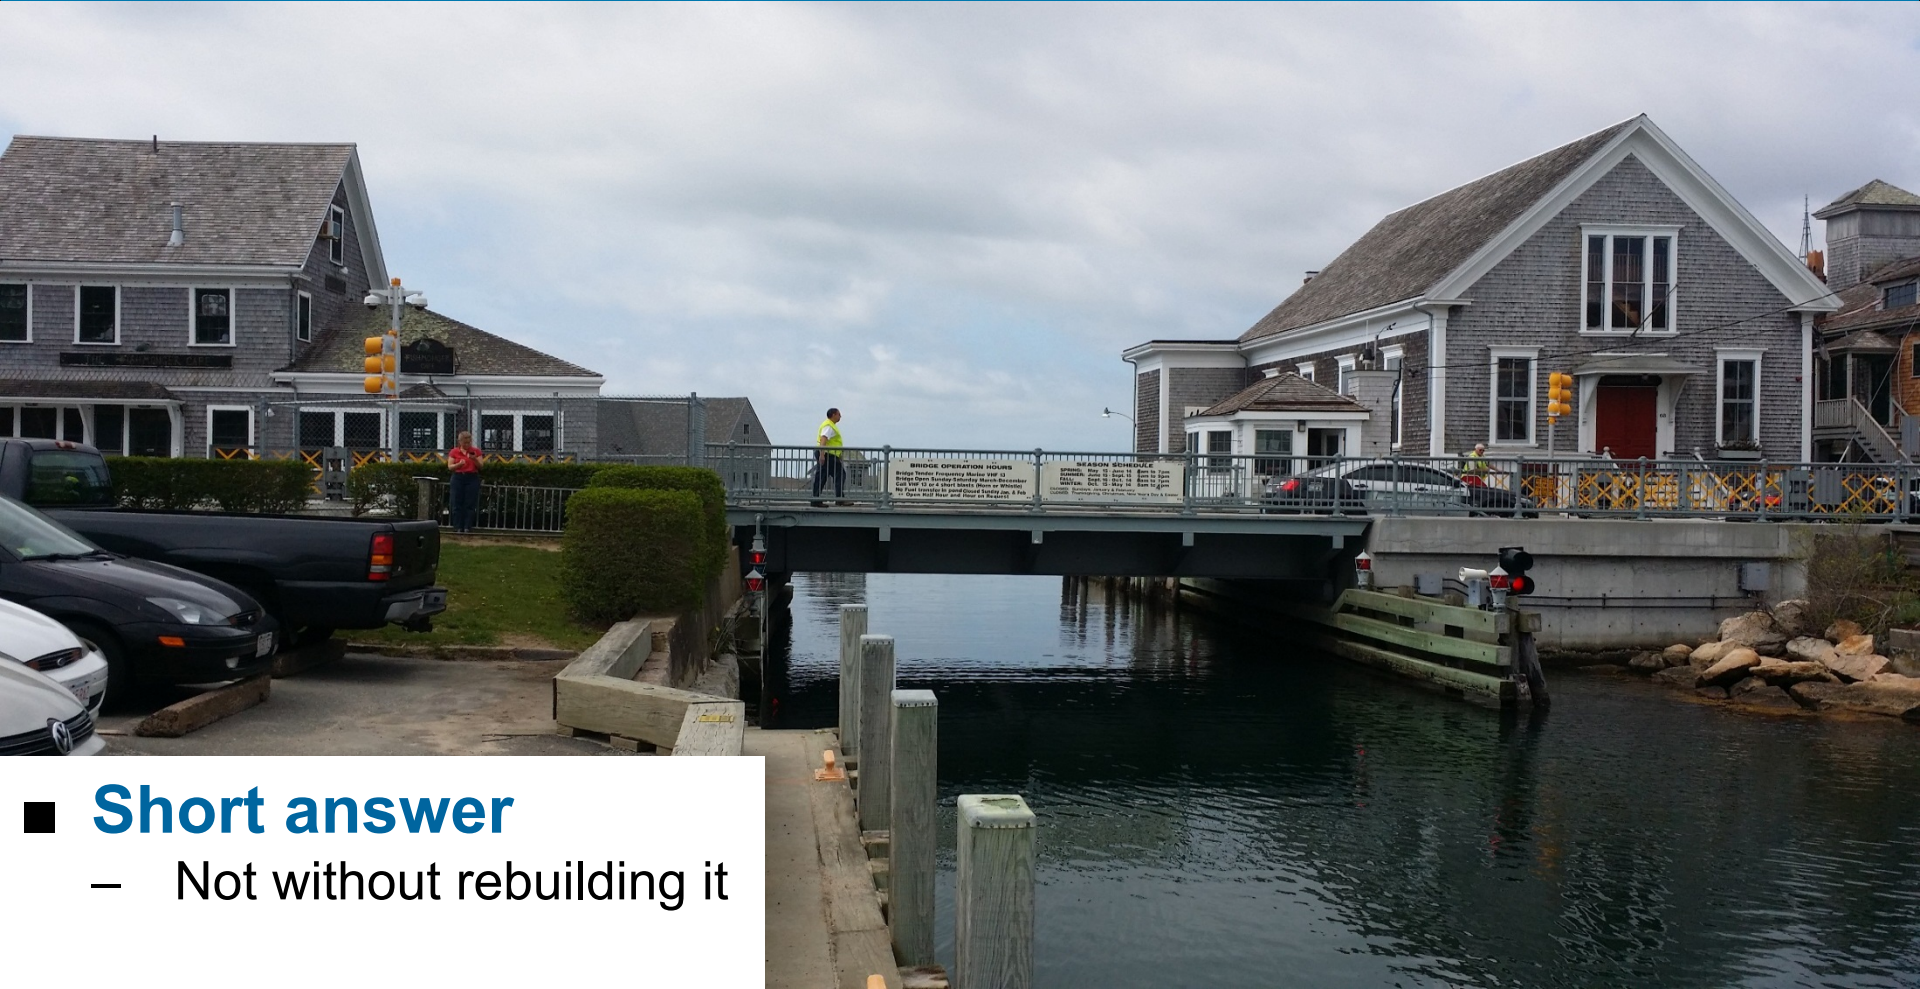
Can we fix the siphon?

■ Short answer

- Not without rebuilding it

■ Longer answer

- Improve entrance
- Improve flow
- Will go a long way

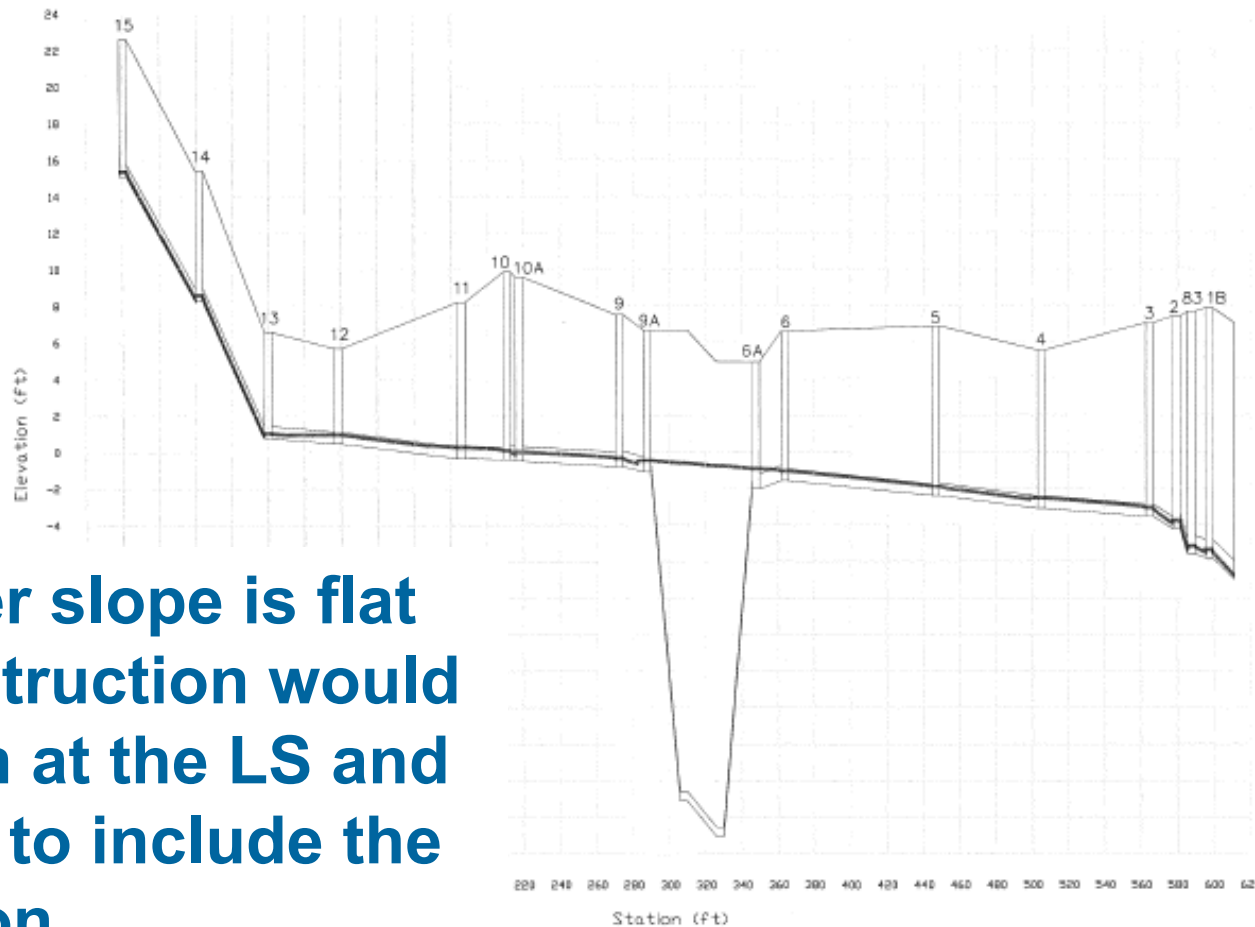
Hydraulic Profile (Various Alternatives)

Pipes with negative slope

- Sewer slope is flat
- Construction would begin at the LS and need to include the siphon

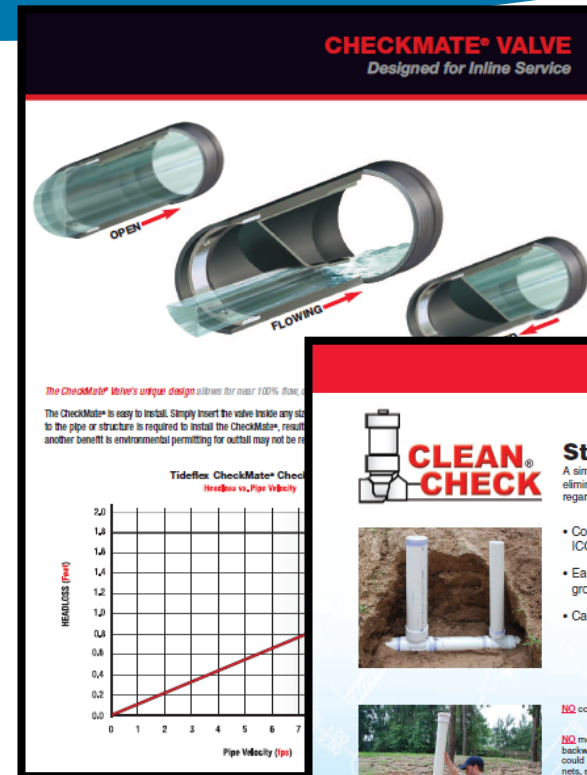
Flat slope laterals

- Mainline sewer is flat
- Lateral comes in at 9 o'clock
- Not much can be done
- Installation of check valves?
- Grinder pump?
