# Model Forensics: Validating the Performance of a Hydraulic Model against a Design Storm that Actually Occurred

David Bedoya, MWH

# Background: Cambridge's Area 13

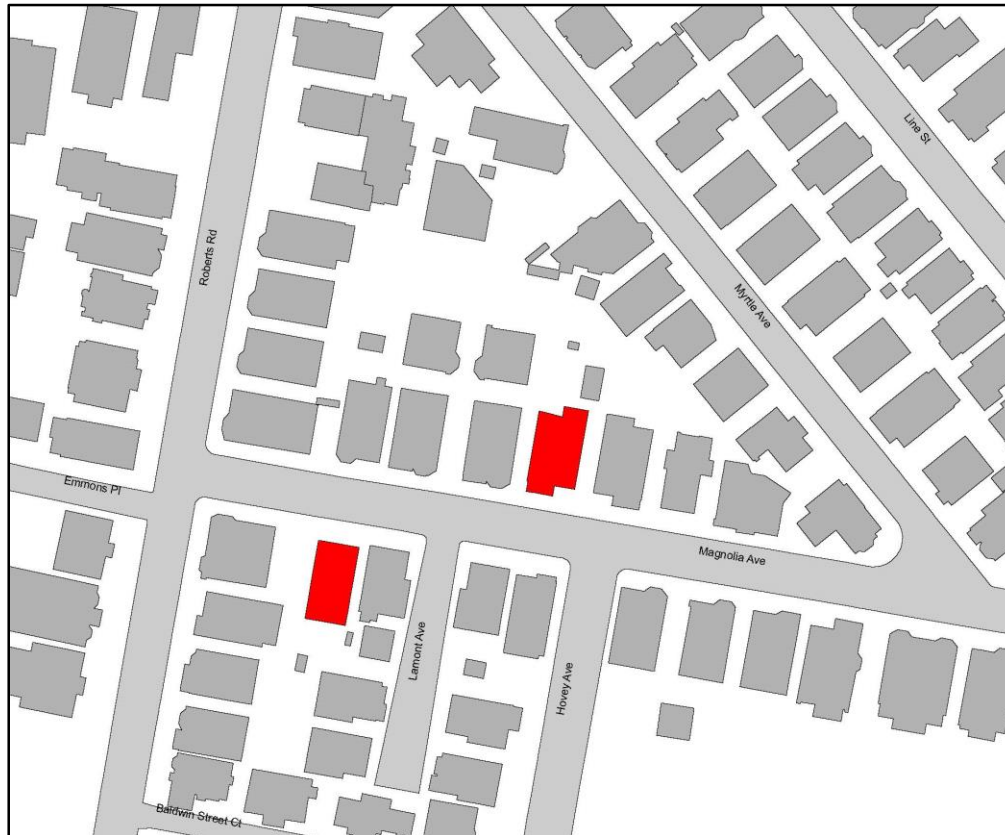
Sanitary sewer backups were reported at #9 and #20-22 Magnolia Avenue

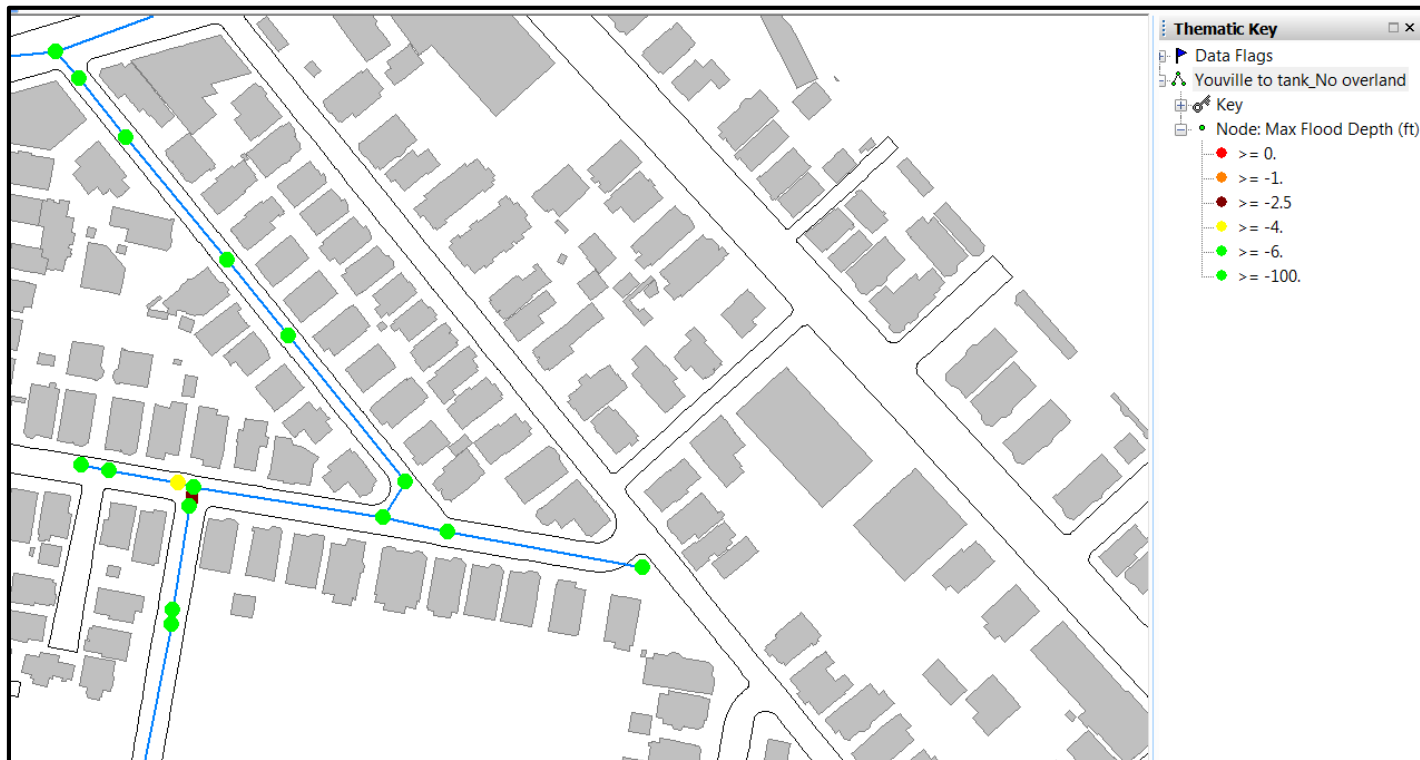
The conveyance system performed well with freeboards of 4' or more below ground

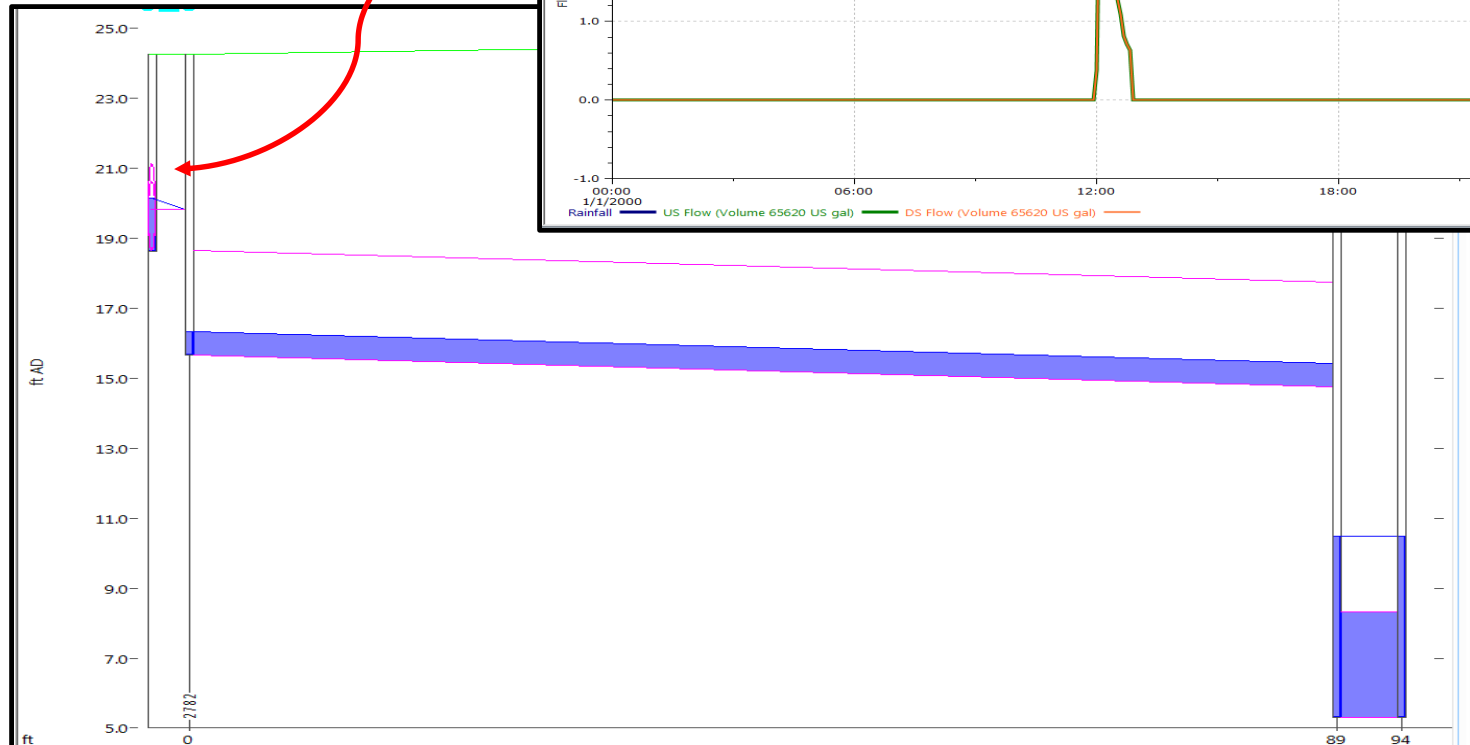
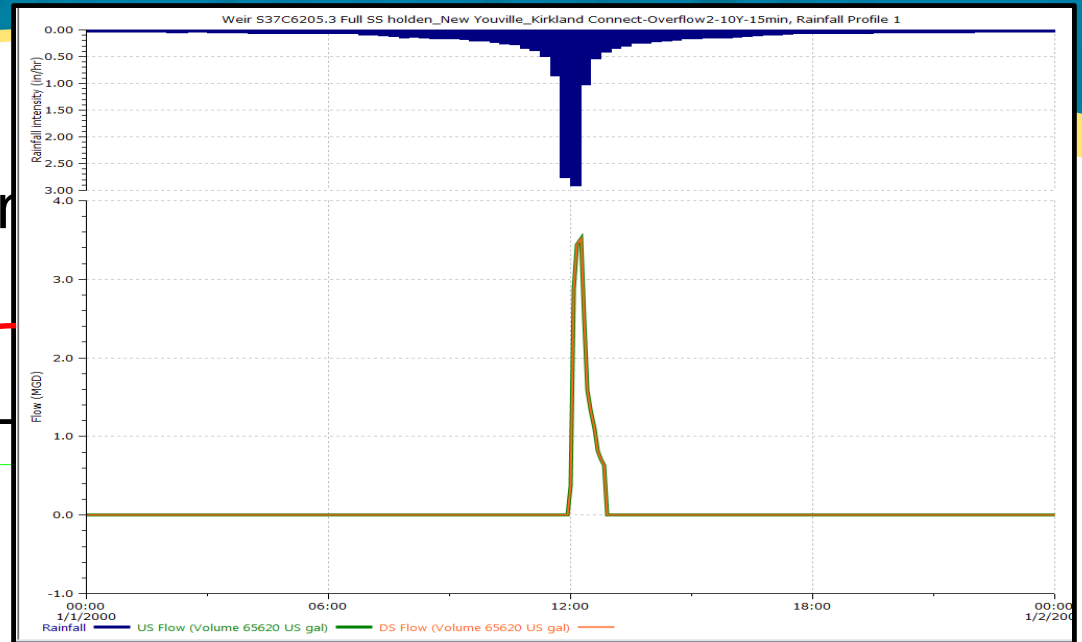
- The Hovey Ave stormwater tank had 68,000 gallons of storm water post storm
- Stormwater system doesn't seem to have enough capacity? (surface flooding)

The Hovey Ave Tar  
stormwater

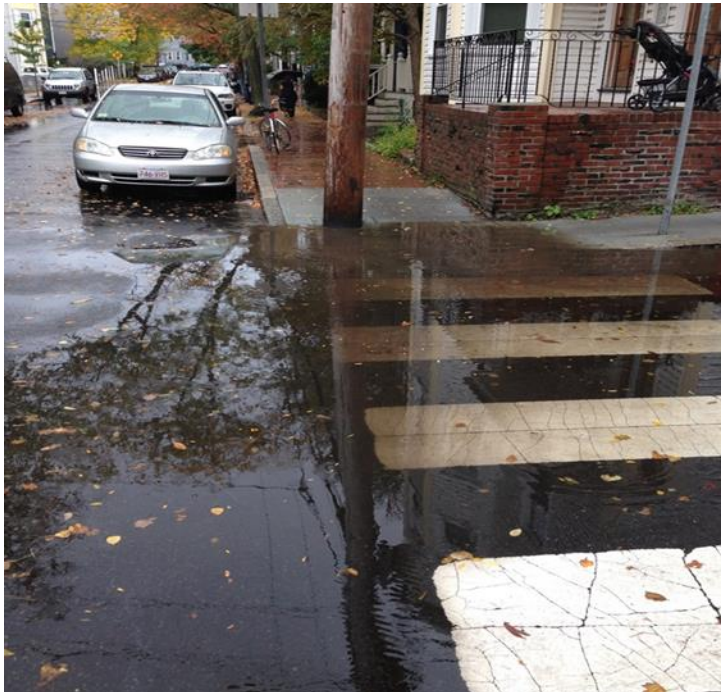
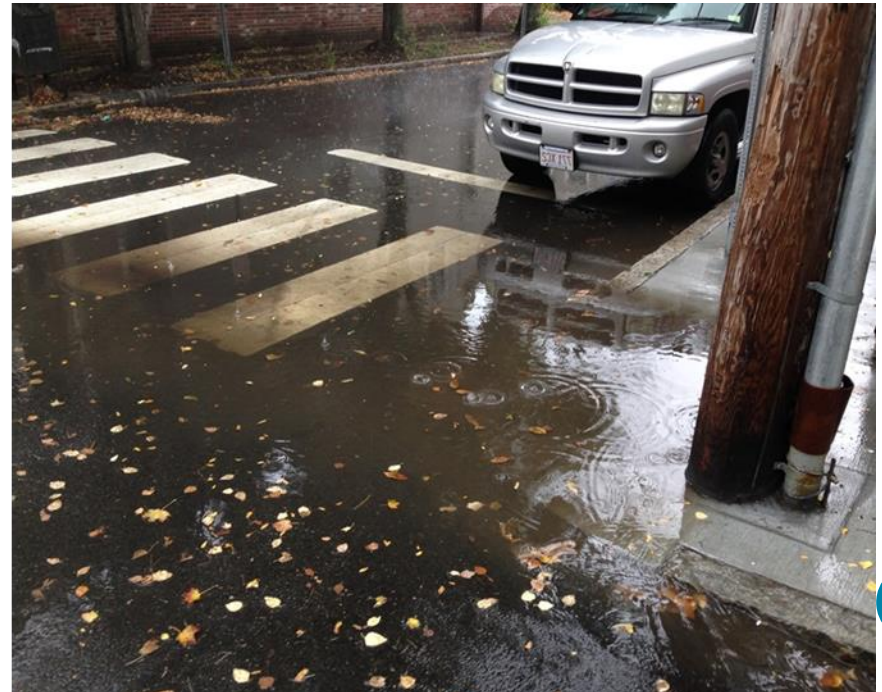
- Several inches of ponding in the public ROW were observed at the Hovey Ave and Magnolia Ave intersections
- The model indicated there is enough conveyance capacity

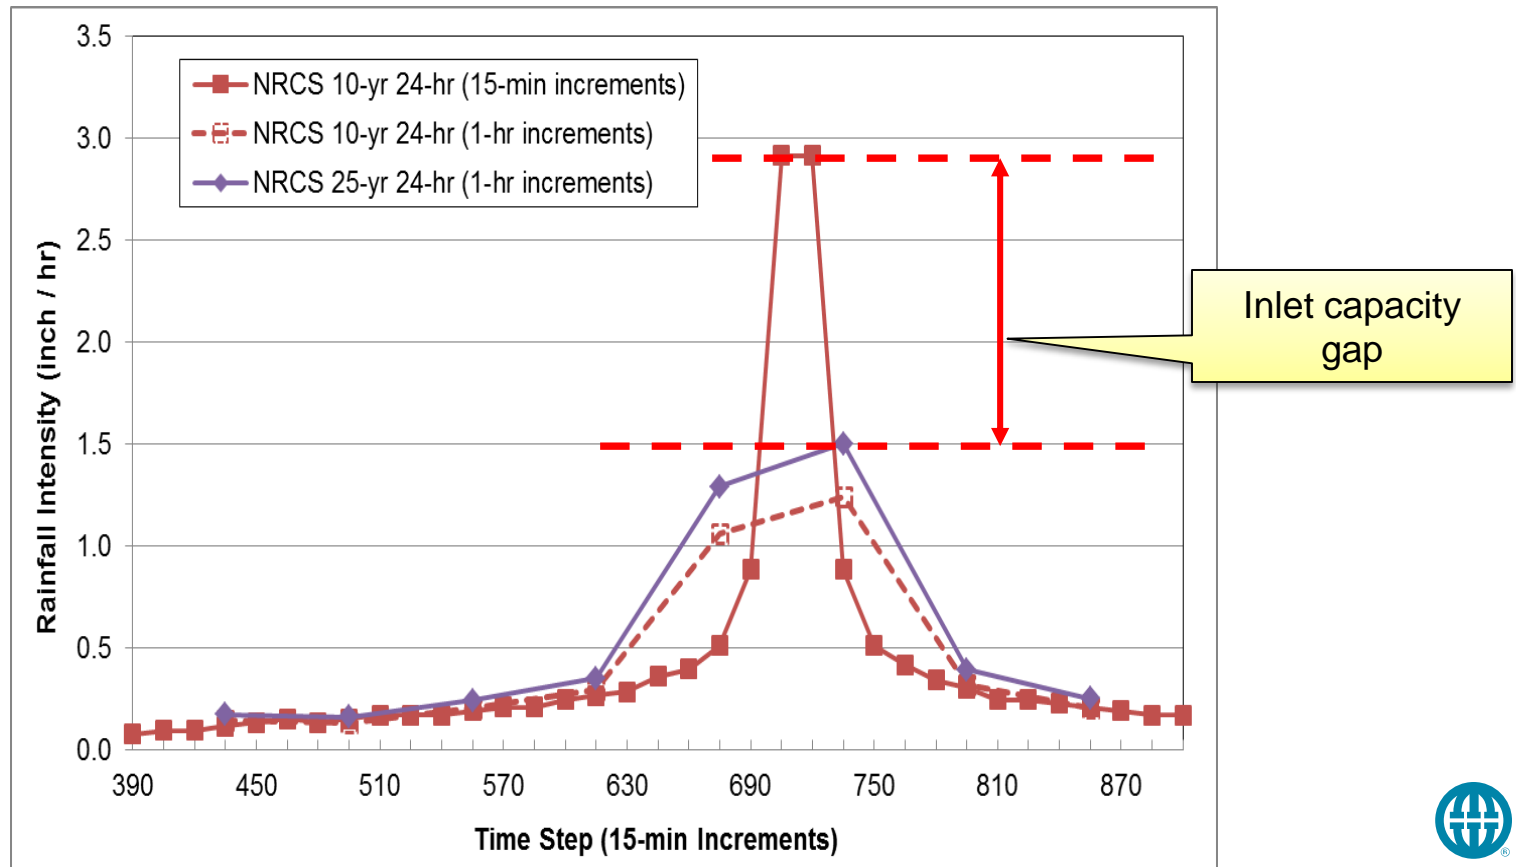
- Peak intensity criteria for inlet design was 1.50in/h (peak of the 25y, 24hr storm with 1-hour increments)
