Recovering from H₂S Attack: Greenwich, CT – Shore Road Area Sewer Rehabilitation Project

January 26, 2016

Shore Road Area Sewer Rehabilitation Project

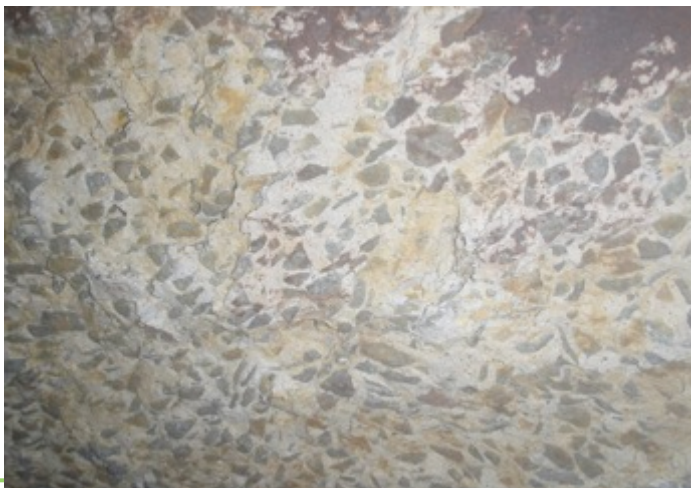
Transition Chamber Wall

- Petrographic Analysis
- Sulfate Content & pH:
 - Roof Slab: 0-1", 1-2" & 6"
 - Walls: 0-1" & 1-2"
- Results:
 - Petrographic confirmed chemical attack
 - Reinforcing steel in relatively good condition
 - 0.4 to 0.8 inches of remaining concrete surface integrity compromised
 - High amount of sulfate content in all samples to a maximum depth of 2 inches
 - pH of concrete samples ranged between 8.5 – 11.5
