A Proactive Approach to Assessing and Managing The Wastewater Collection System, and a UV Cured CIPP Rehabilitation

Stamford, CT WPCA

Presented by:
Joe Hausmann, PE – Wright-Pierce

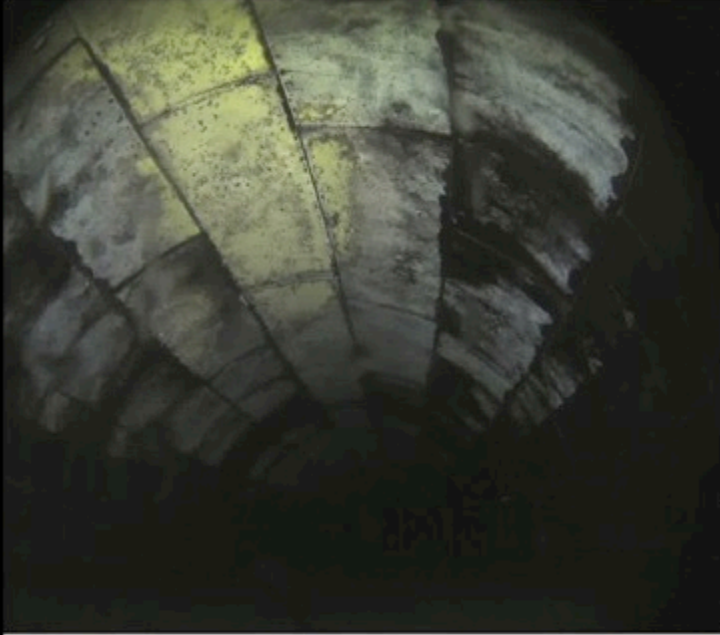
Jefferson Line No: JHA4-JHA3

Size: 60in, Clay Tile Distance: 7.20ft

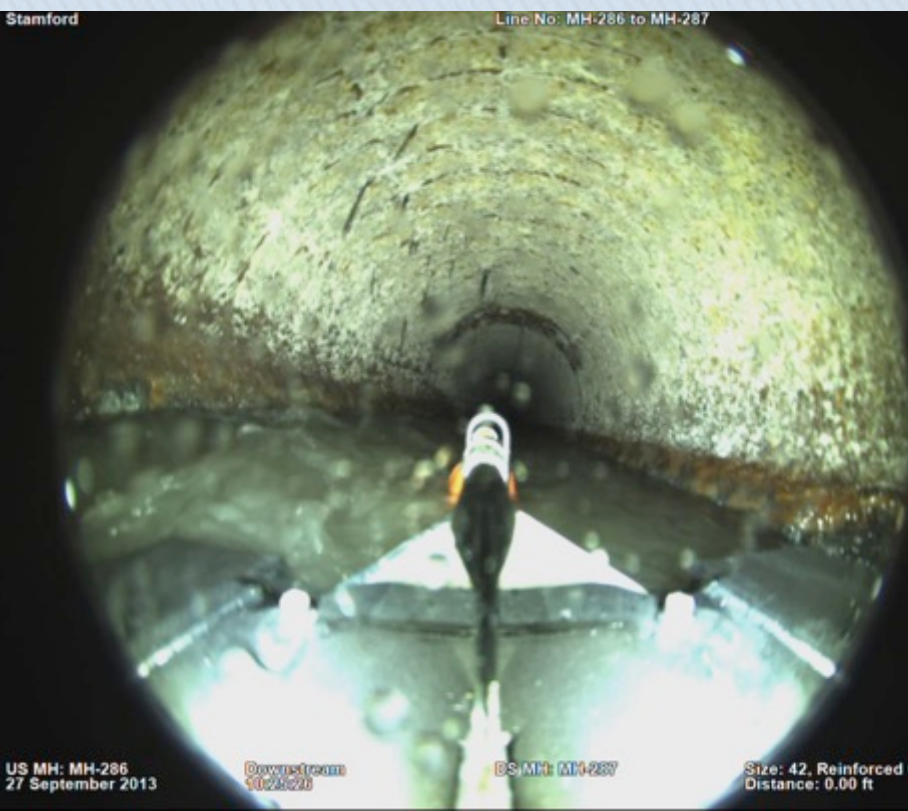
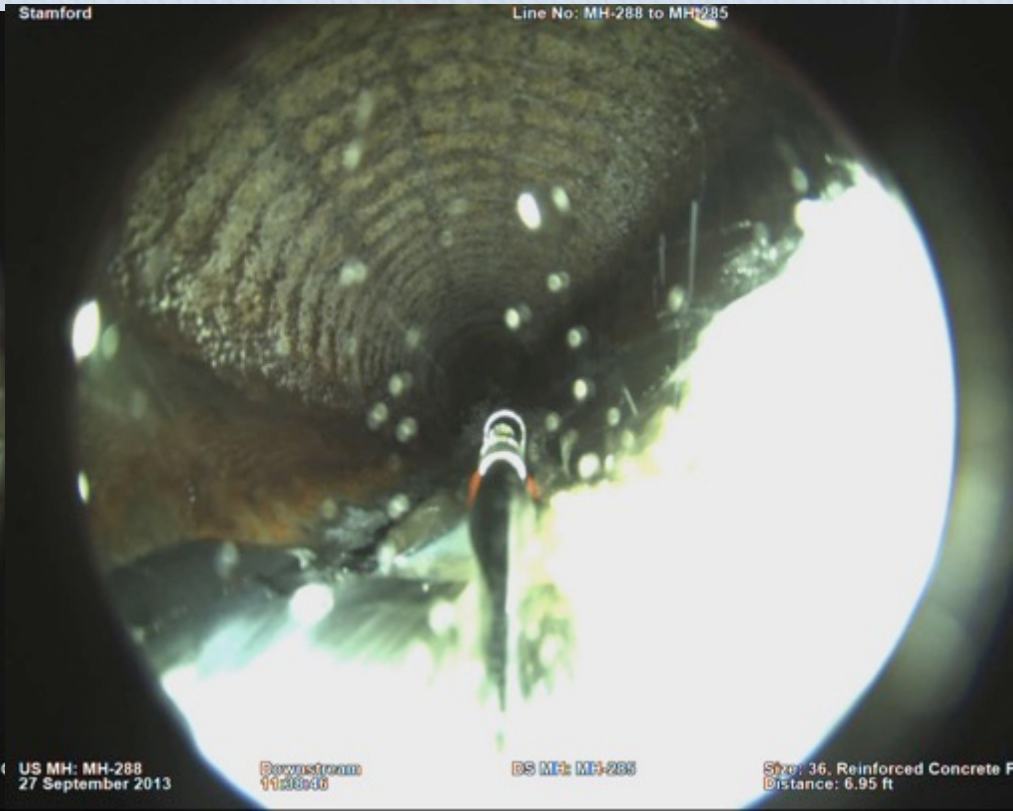
Soundview Avenue

- 36" and 42" RCP Interceptor
- Rebar visible during inspection
- ~3,000LF of sewer in danger of collapse

- WPCA and W-P initiated design immediately
- Lining was preferred method:
 - Too deep for open cut (Road Closures)
 - Laterals reduced sliplining's viability
 - Linestop on upstream forcemains for bypass
- Precision Industrial Maintenance
 - Selected as contractor - very competitive bid
 - UV cured CIPP liner

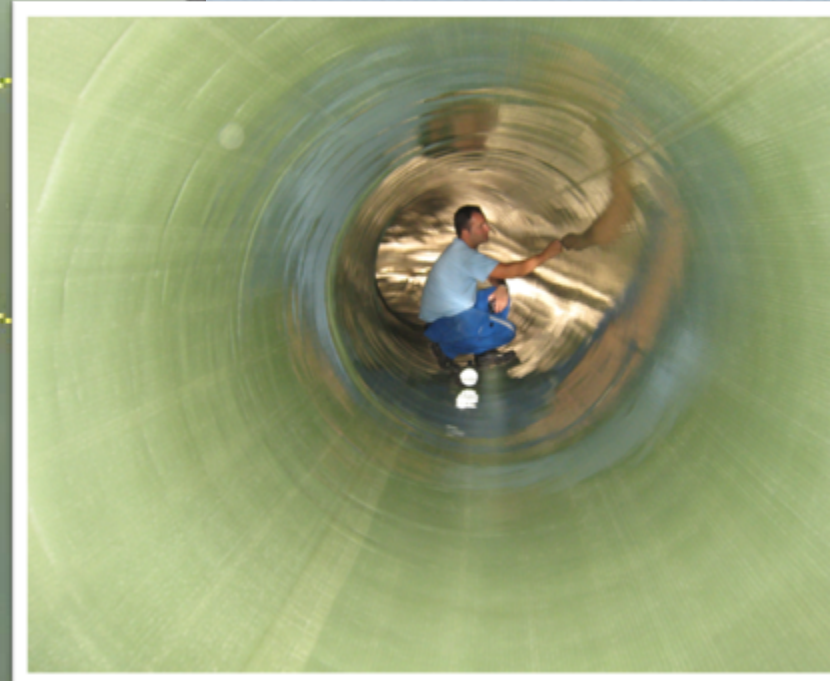
Industrial Maintenance, Inc.
Stamford CT, Soundview Ave Lining
95 post tv|

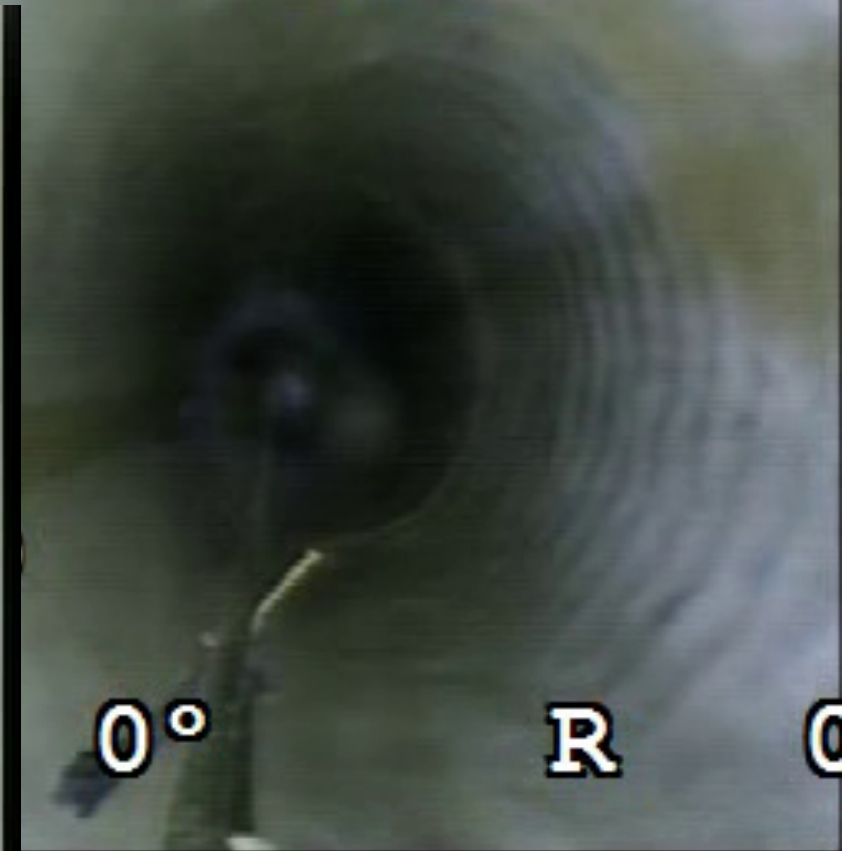
Industrial Maintenance, Inc.
Danford CT, Soundview Ave Lining
post tvl
