Groton, CT Pump Station Evaluation

NEWEA 2016 Annual Conference

Asset Management II – Case Studies

Jen Zoppo
Project Manager
CH2M

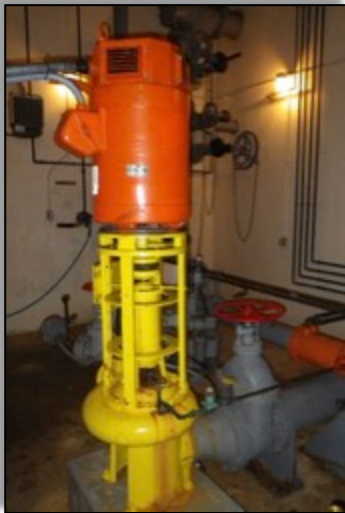
Gravel Street
Chicago

- Each Pump Station has three or four sewage pumps with average score 2.1

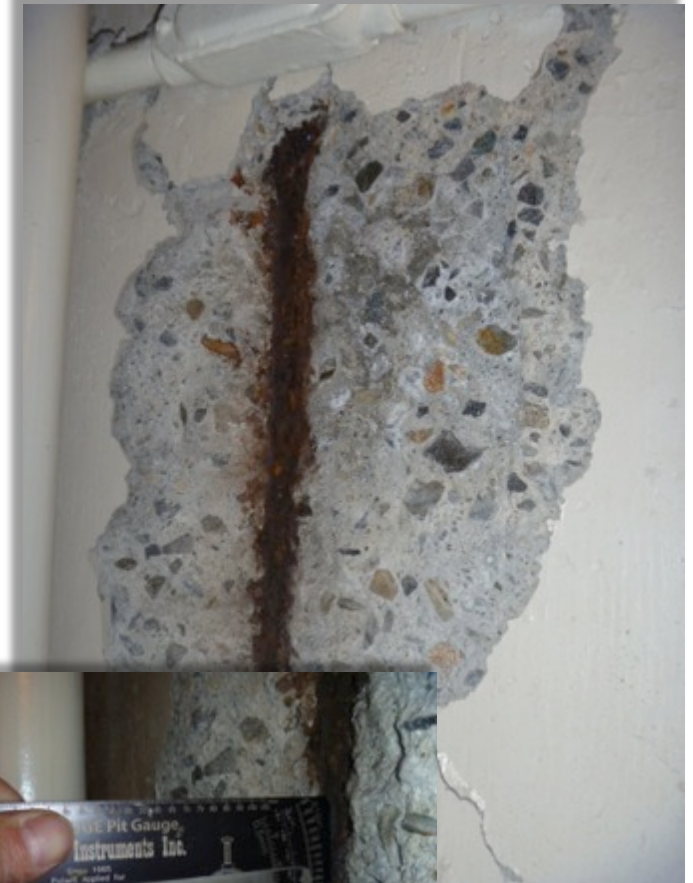
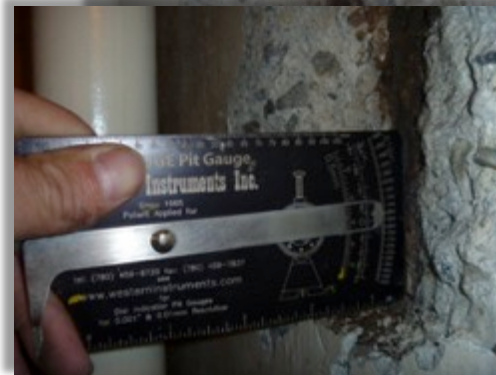
- Issues common to all pump stations
 - Failure of protective wall and ceiling coatings
 - Failure of metal coatings
 - Cement paste loss/exposed aggregate in wastewater channels
- Goss Cove: Condition score 4
 - Wet well rehabilitation is required to protect from further damage
- Little Gibraltar: Condition score 5
 - Salt water intrusion has compromised structural integrity of lower level walls
 - Suspect same condition on wet well side
