PIPE FAILURE SPURS ACTION

MARBLEHEAD PIPELINES REPLACEMENT PROJECT

EXISTING PIPELINES CONDITION ASSESSMENT PROGRAM

*Marblehead Force Main Condition Assessment and Repair Project
Phase A*

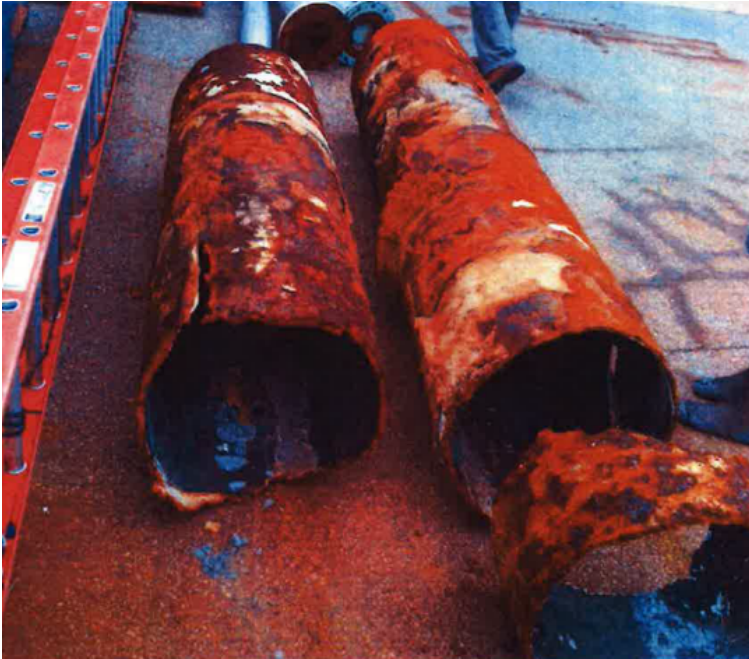
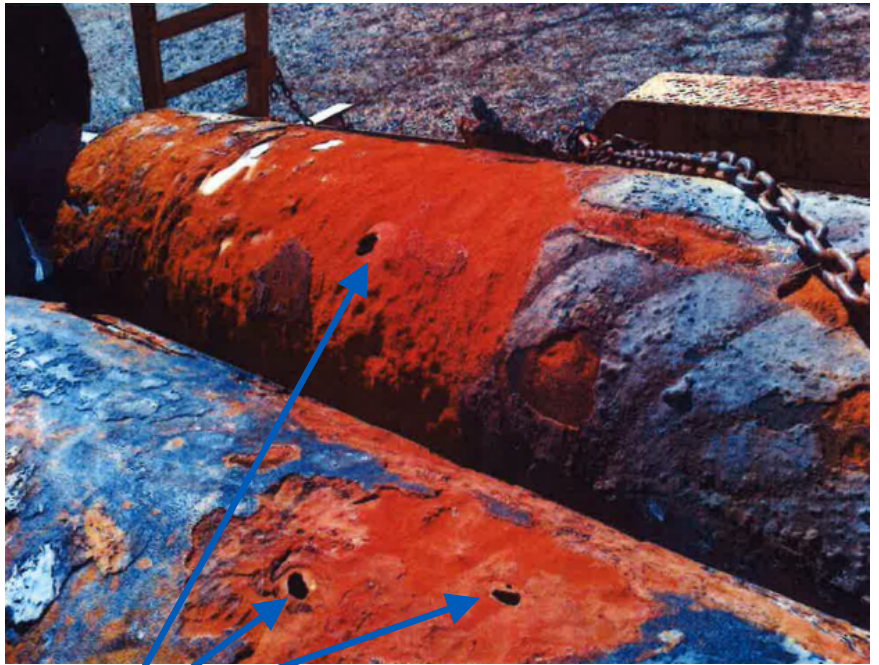
Perforation through DI pipe wall
