POINT BREAK

How a Thriving Beach Community Handled a Coastal Sewer Force Main Failure

SETTING: Hampton Beach, NH

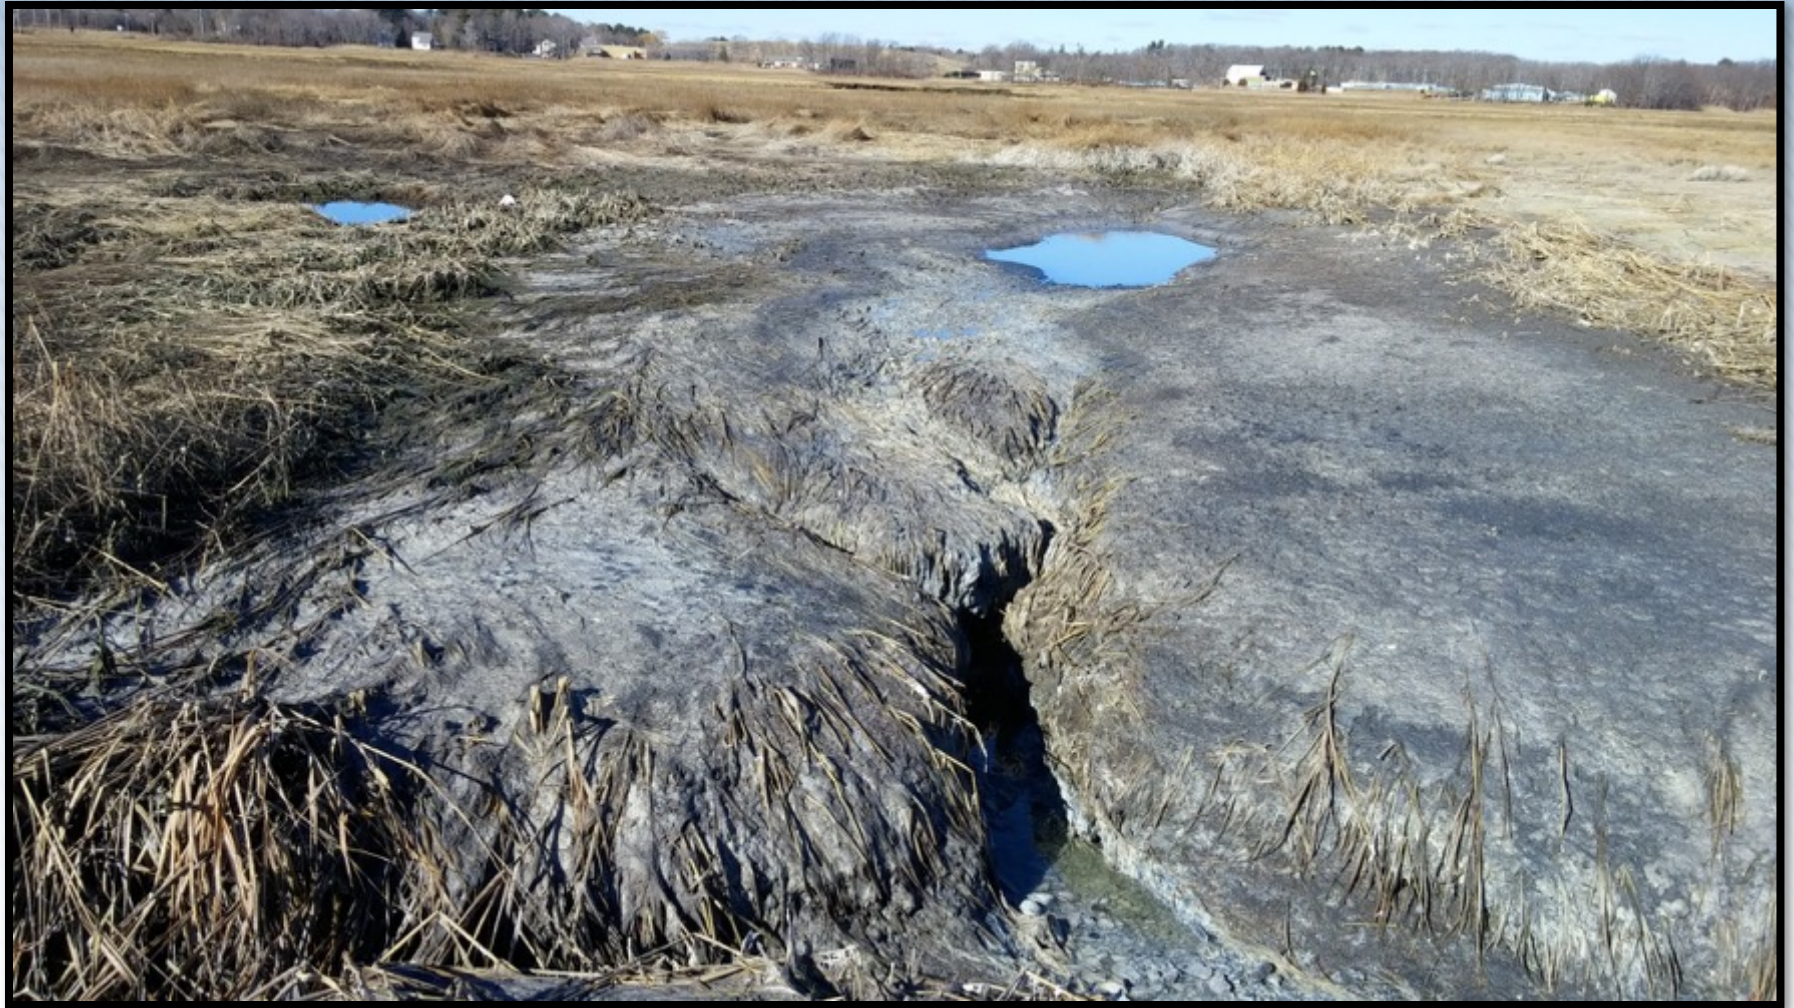
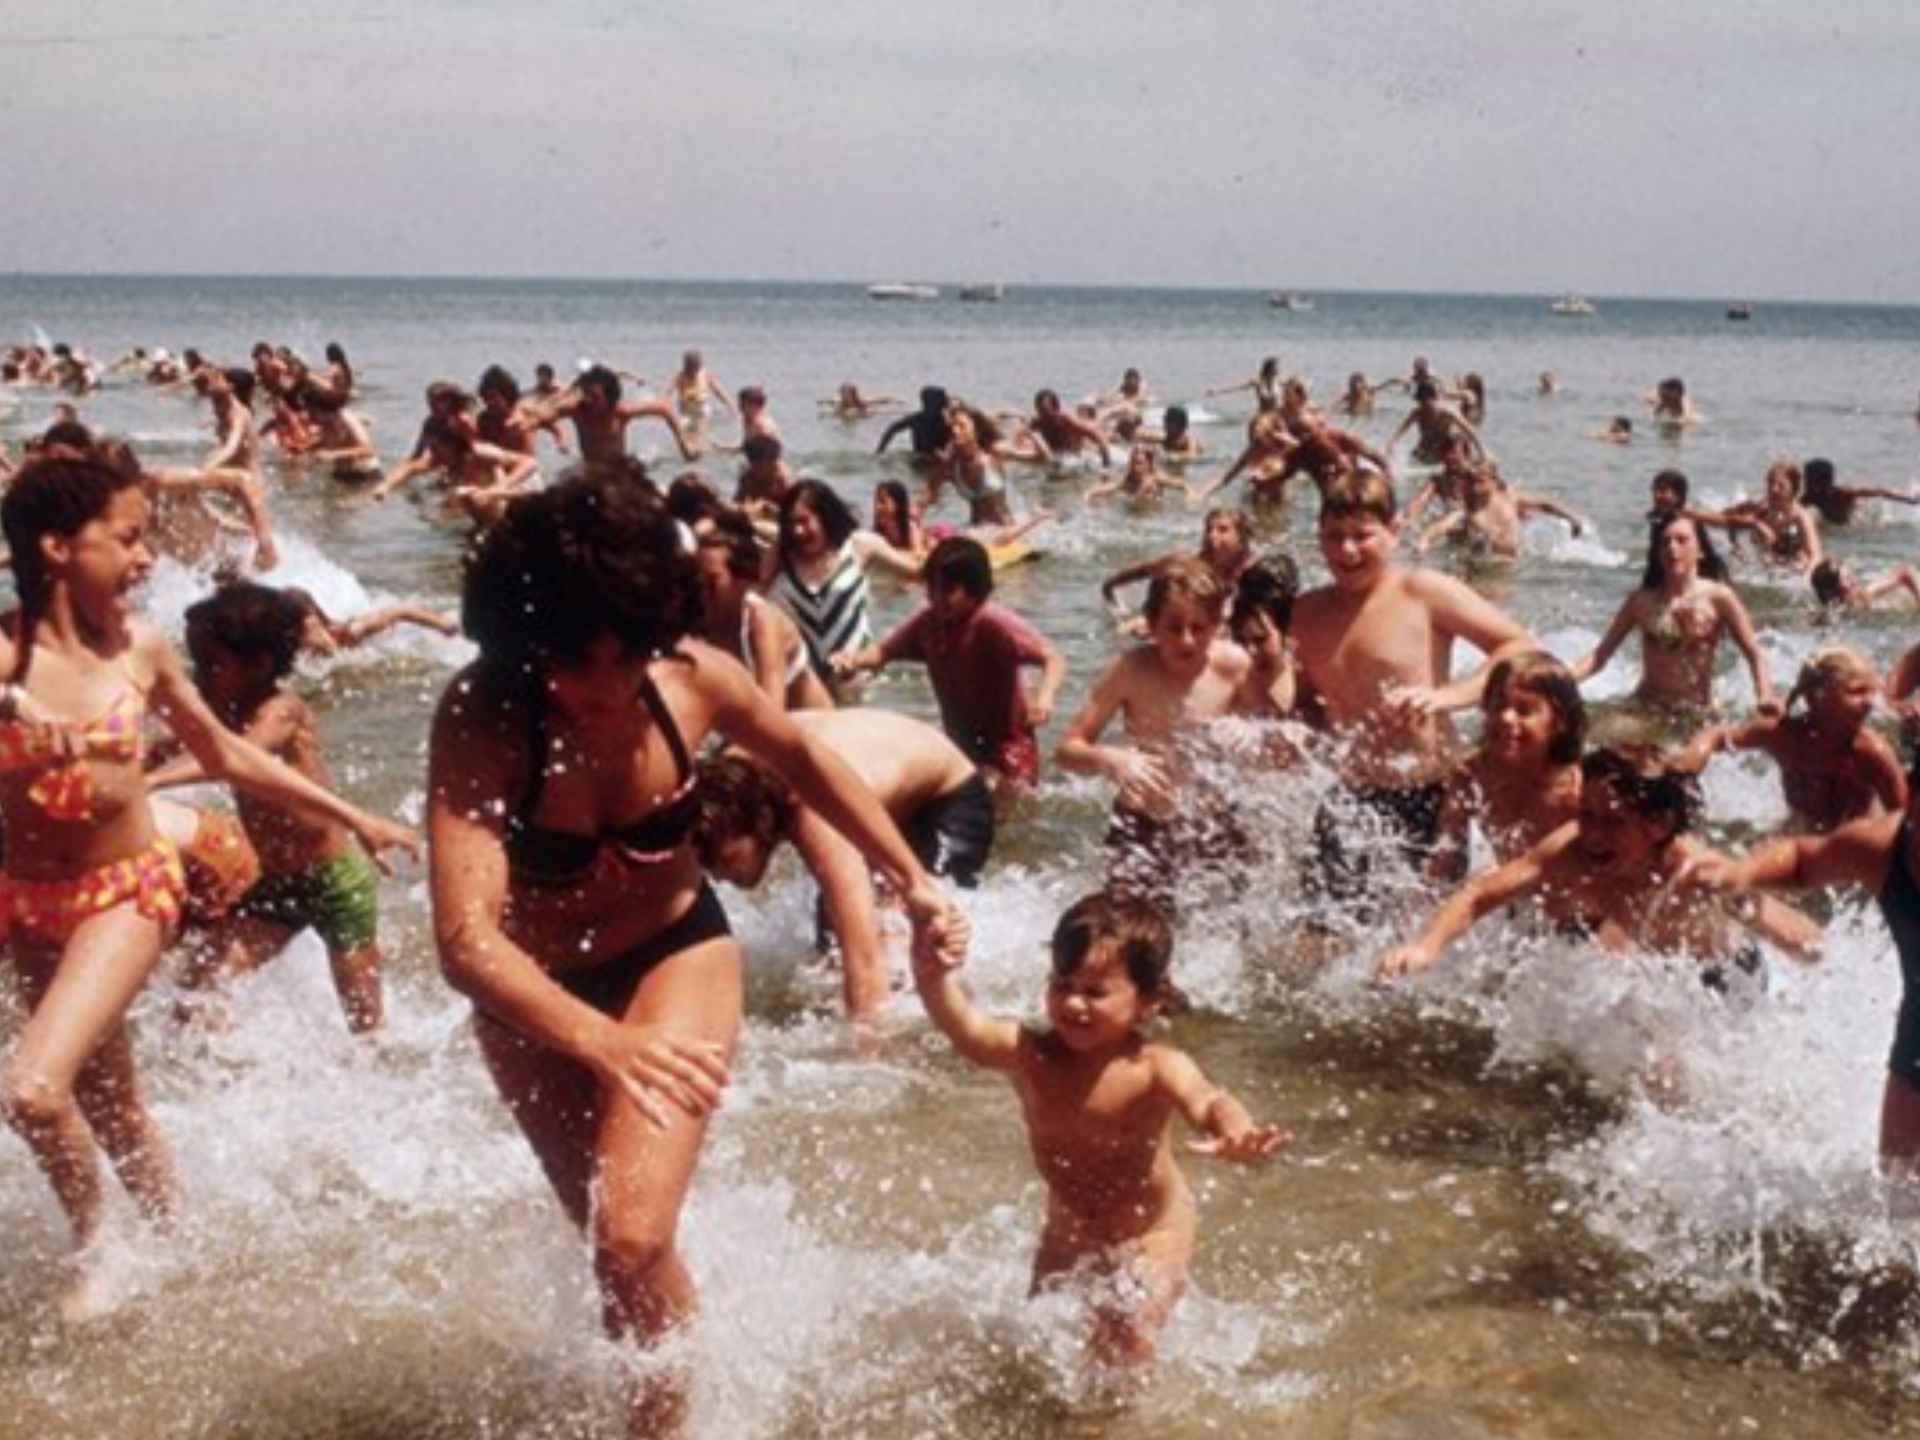
THE DISCOVERY

TWO Sewer Force Mains

- Asbestos Cement (1967)
- Ductile Iron (1987)

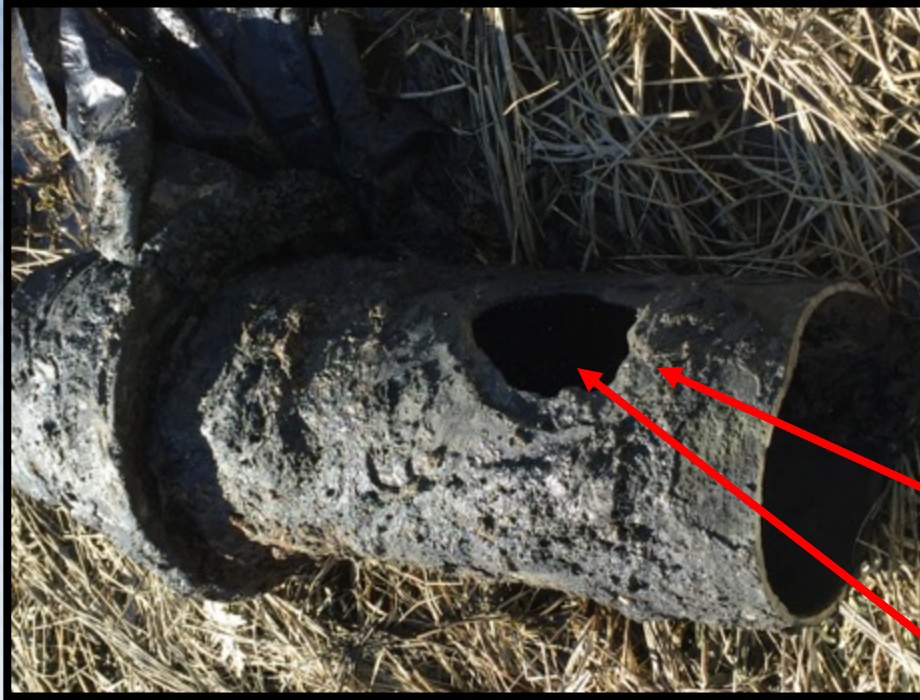
DISCOVERY

DI Pipe Locating and Excavation

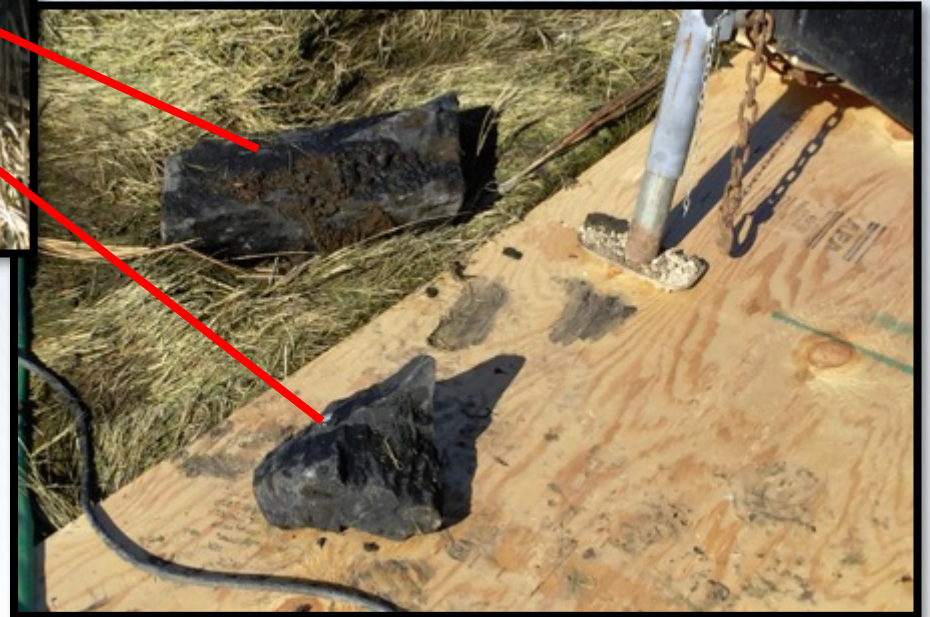
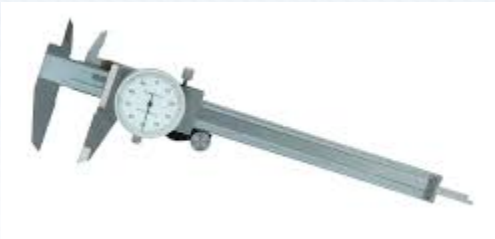
CONDITION ASSESSMENT

- Interior (abrasion)
- Exterior condition (abrasion)

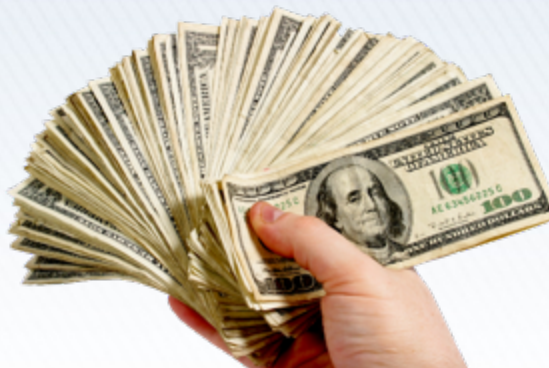
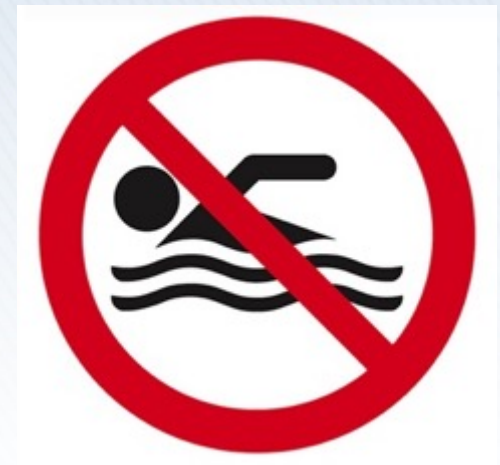
PIPE FAILURE EVALUATION

- Cause of failure: Improper pipe bedding
- Potential for similar future failure in marsh?
 - 3,500-ft of ductile iron force main (1987)
 - 3,500-ft of asbestos cement force main (1967)
- Consequence of failure
 - Hampton Beach restrictions
 - Shellfish/Fishing
 - Bypass pumping
