The Main Interceptor Project: An Engineered Approach to Innovative Pipeline Rehabilitation

Springfield Water and Sewer Commission
Springfield, Massachusetts

NEWEA Annual Conference January 25, 2017

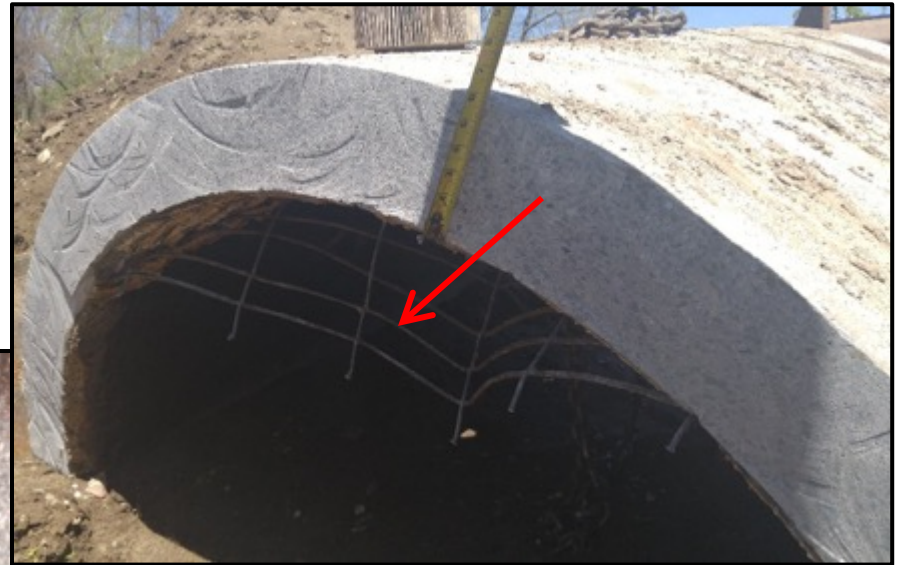
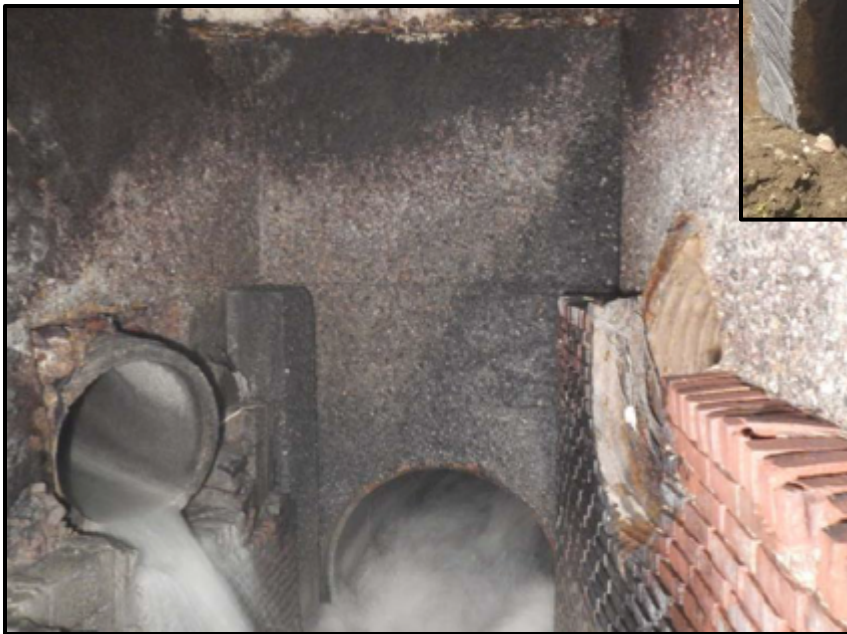
Exposed wire mesh cage from removed section of 60" RCP

Corrosion/Deterioration experienced throughout MIS pipeline MHs as well

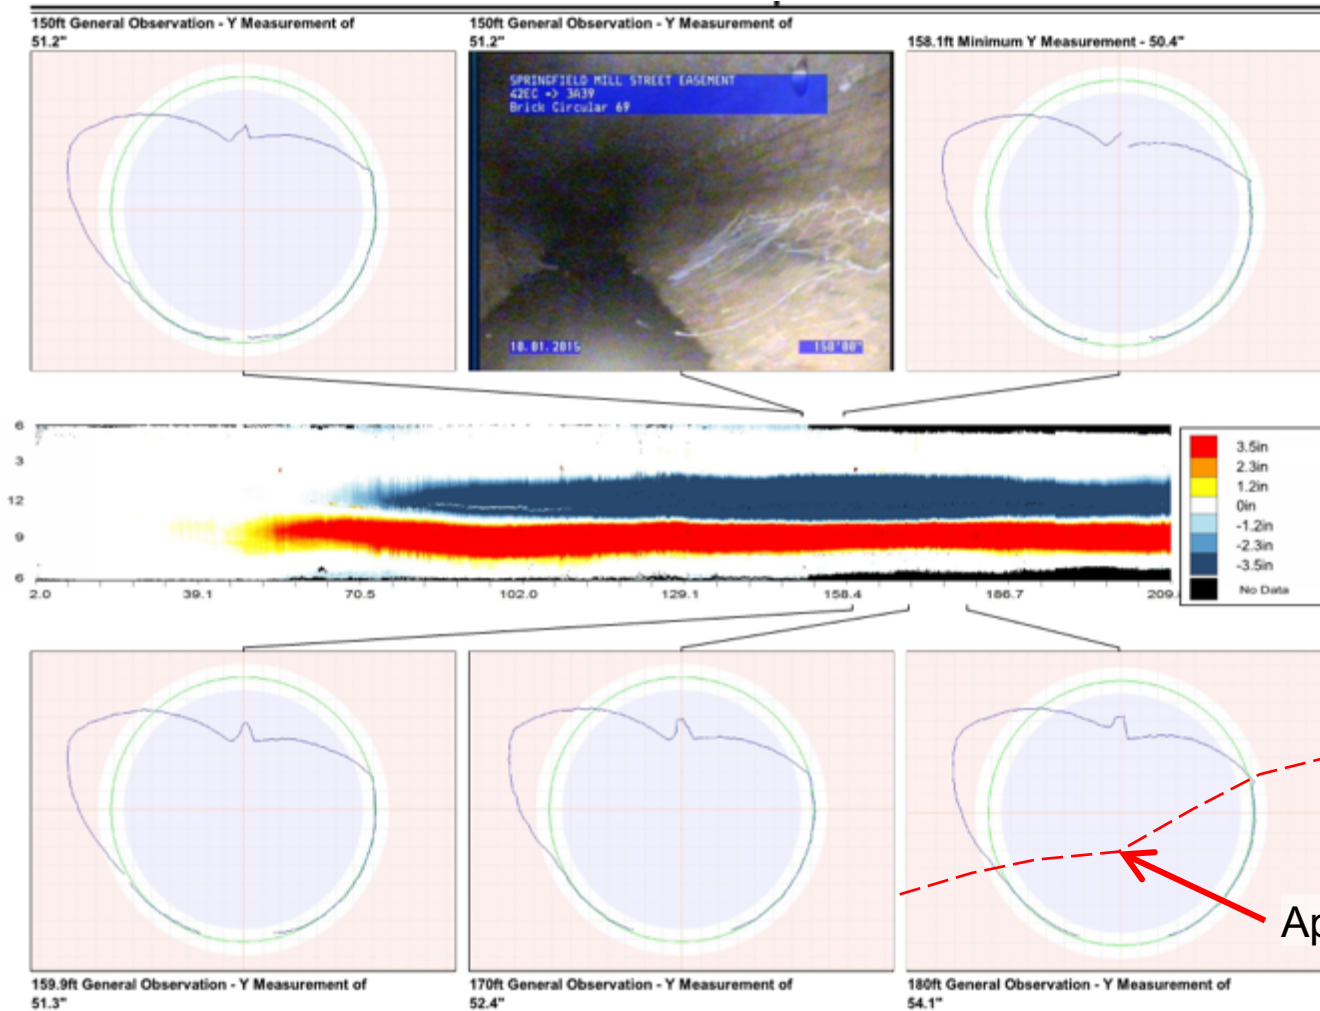
“High Point” 69-in Brick Deformation

- Laser Inspection
- Vertical change: 69" down to 51"
- Excess vertical loading
- Rock Profile may have restrained deformation
- Unsafe for manned entry

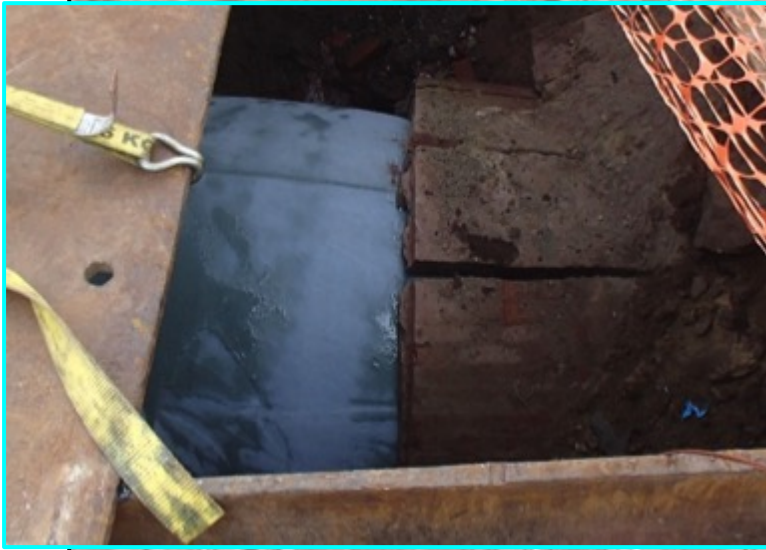
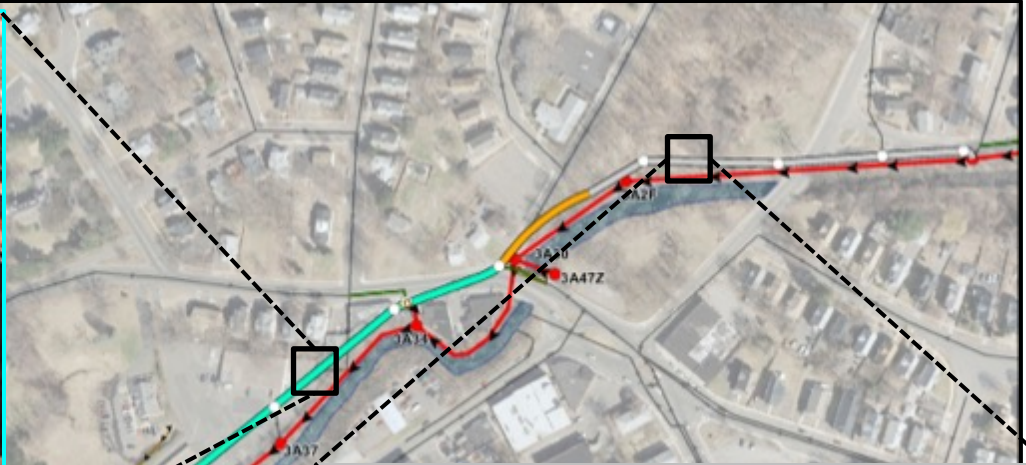
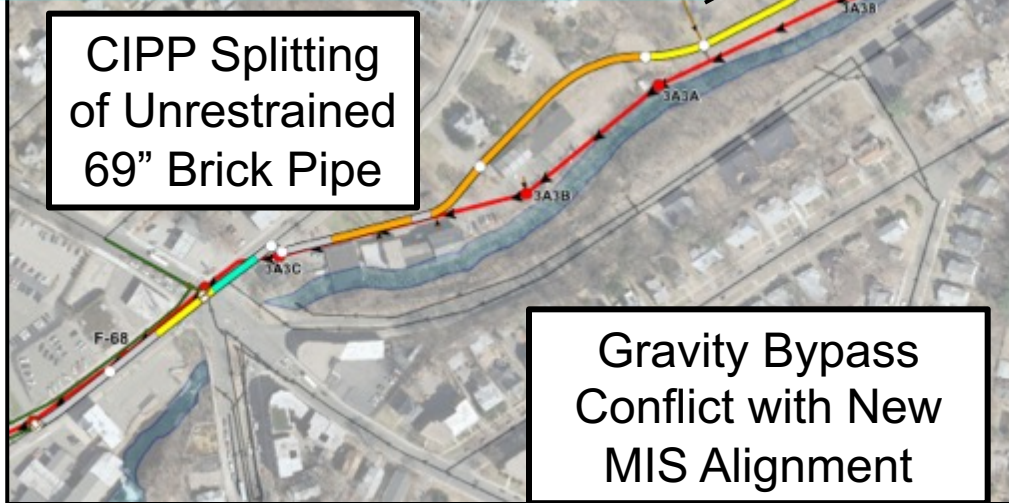
CIPP Splitting
of Unrestrained
69" Brick Pipe

- May want to perform test pits to confirm records
- Pipes CIPP lined from within open excavations should be restrained
- Take care excavating around existing brick; be prepared to chase the pipe

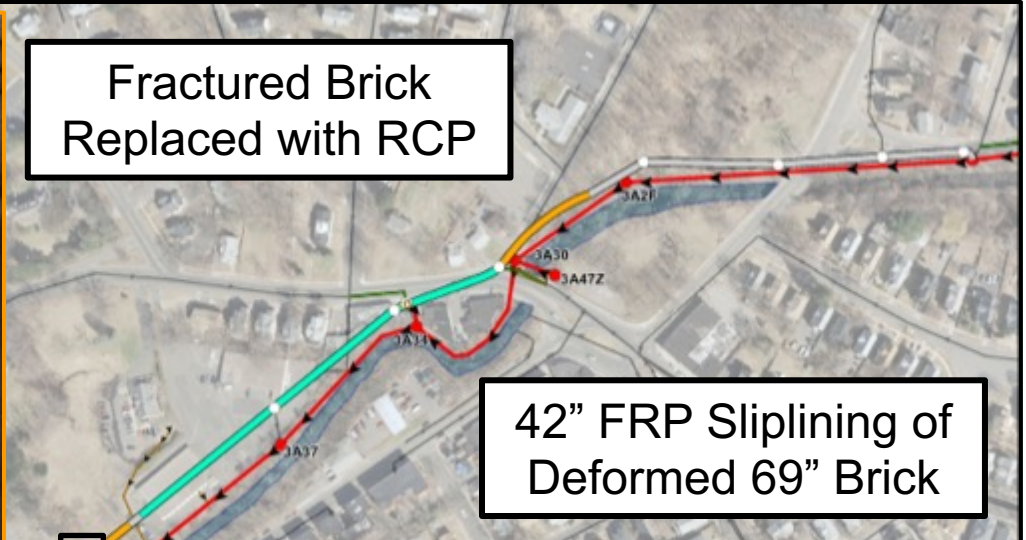
Fractured Brick
Replaced with RCP

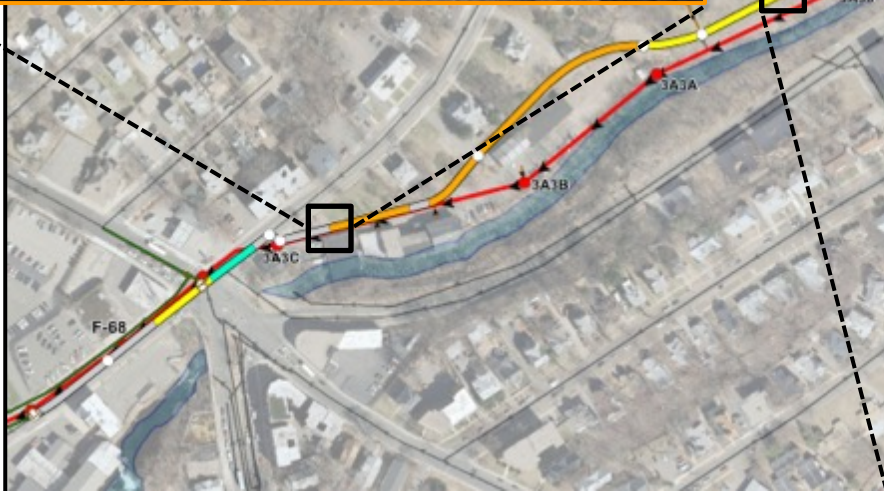
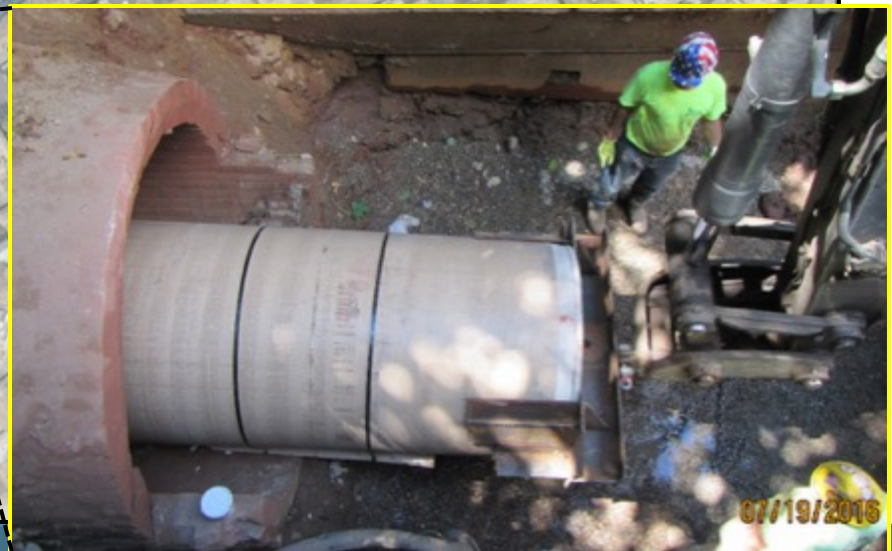
42" FRP Sliplining of
Deformed 69" Brick

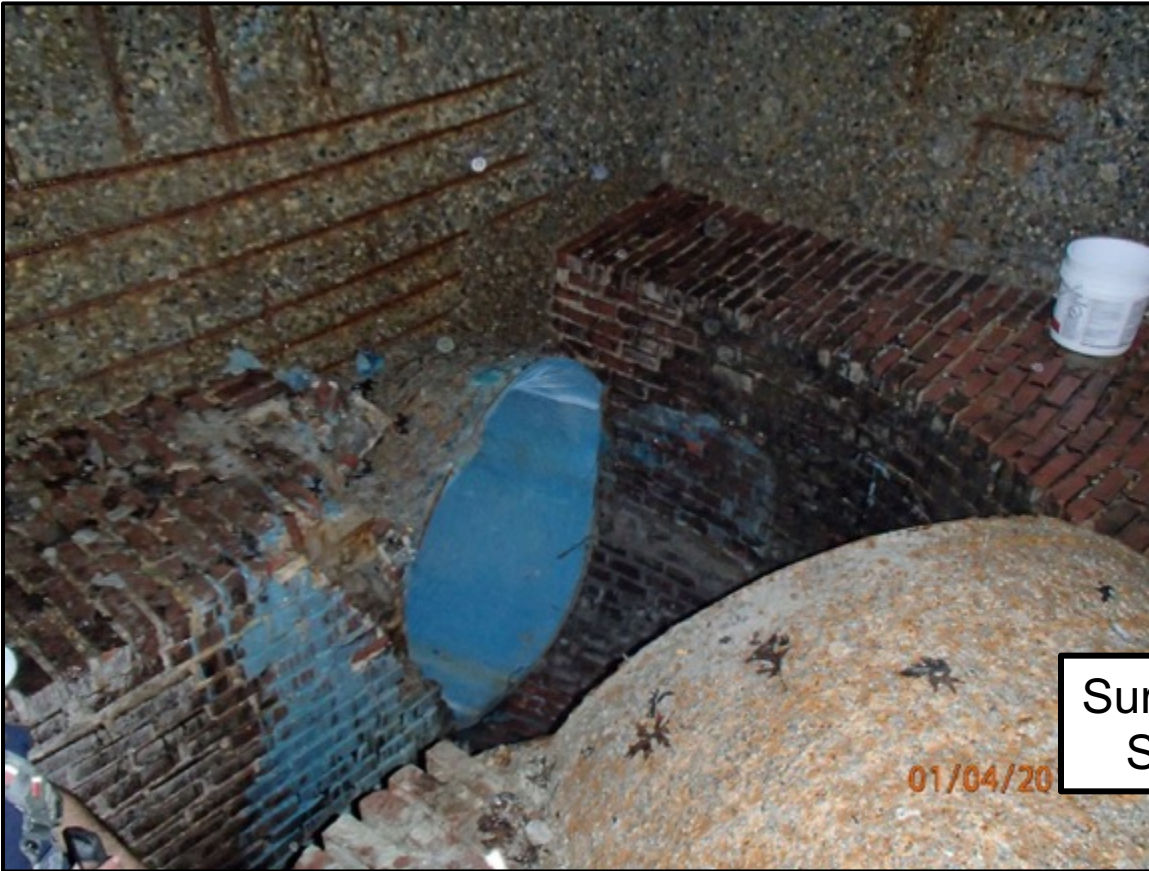
- Up to 2" of punky concrete removed
- Rebar exposed and wash of corrosion
- MH rehab scheduled around CIPP installations

Surface Prep for MH
Structure Rehab
