# *Utilizing two trenchless rehabilitation technologies to reduce wet weather flows in the Bear Brook Watershed*

**Matt Timberlake-Ted Berry Company, Inc.**

**NEWEA Sustainability & Collection Systems Specialty Conference  
& Exhibit**

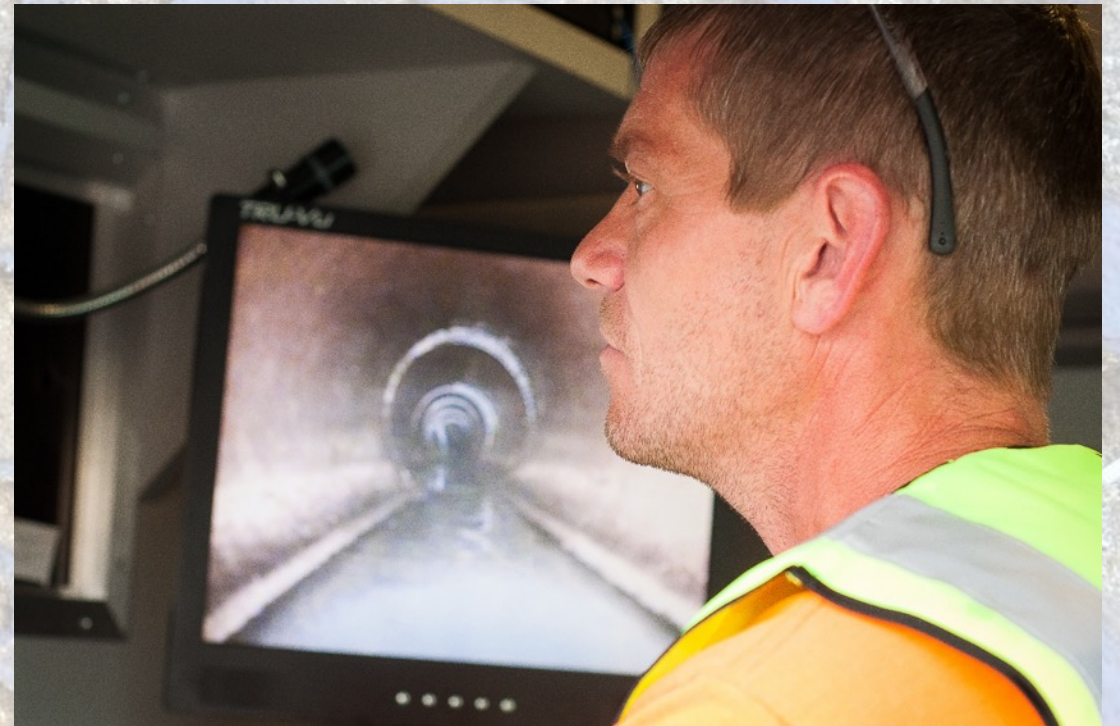
# CCTV Inspection and cleaning

- Pipe inspected to confirm condition and geometry
- Pre-cleaning performed prior to lining

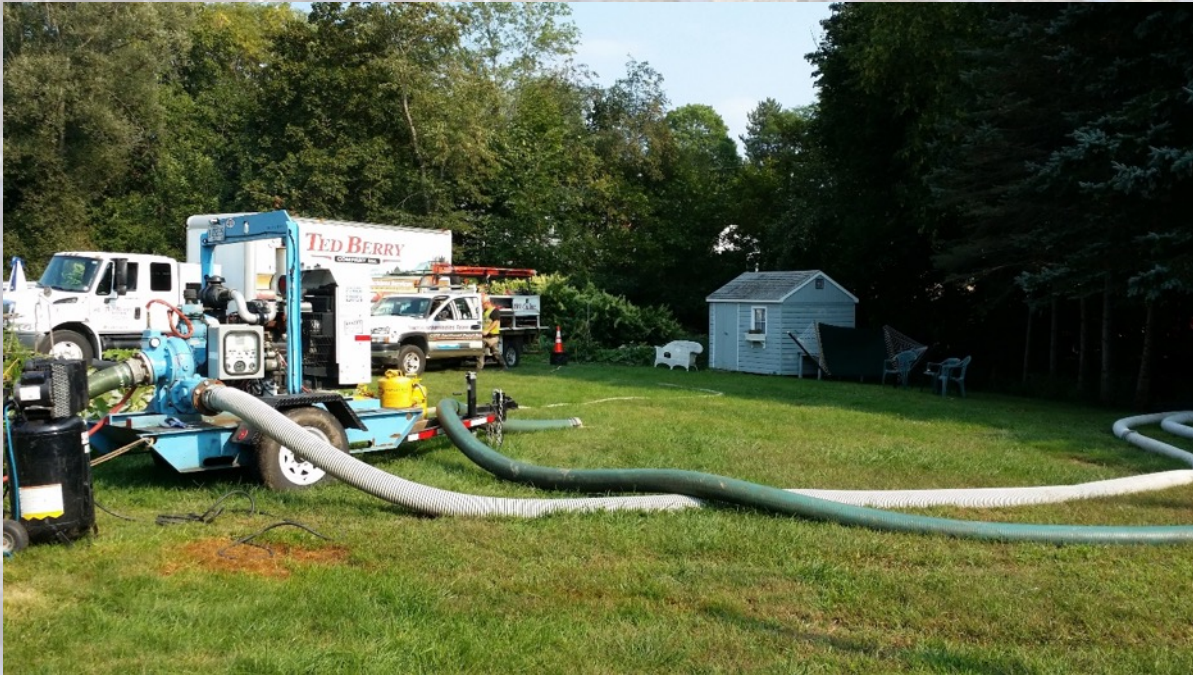
- Remote bypass
- (2) 6" self priming trash pumps
- HDPE fused discharge main
- Isolation daily using pneumatic pipe plugs and overseen by dedicated technician

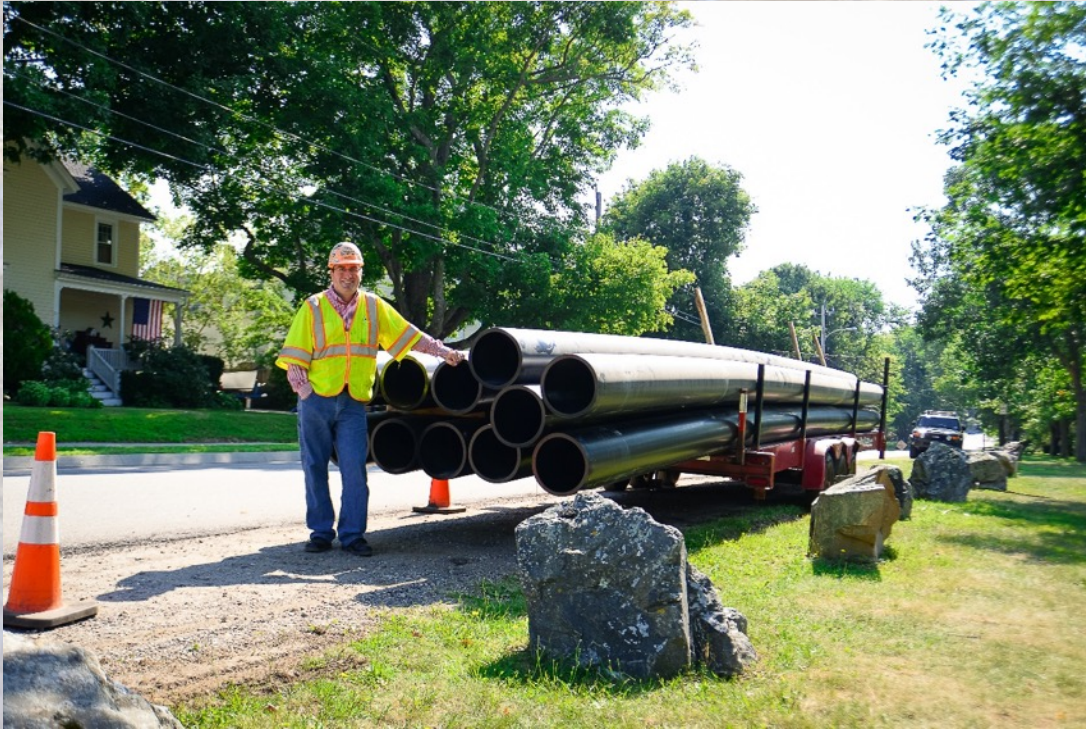
- Use McElroy “Polyhorse” fusion racks
- 16-inch IPS DR 17 HDPE
- Pull into woods and easement using winches, pulleys, and Yankee ingenuity

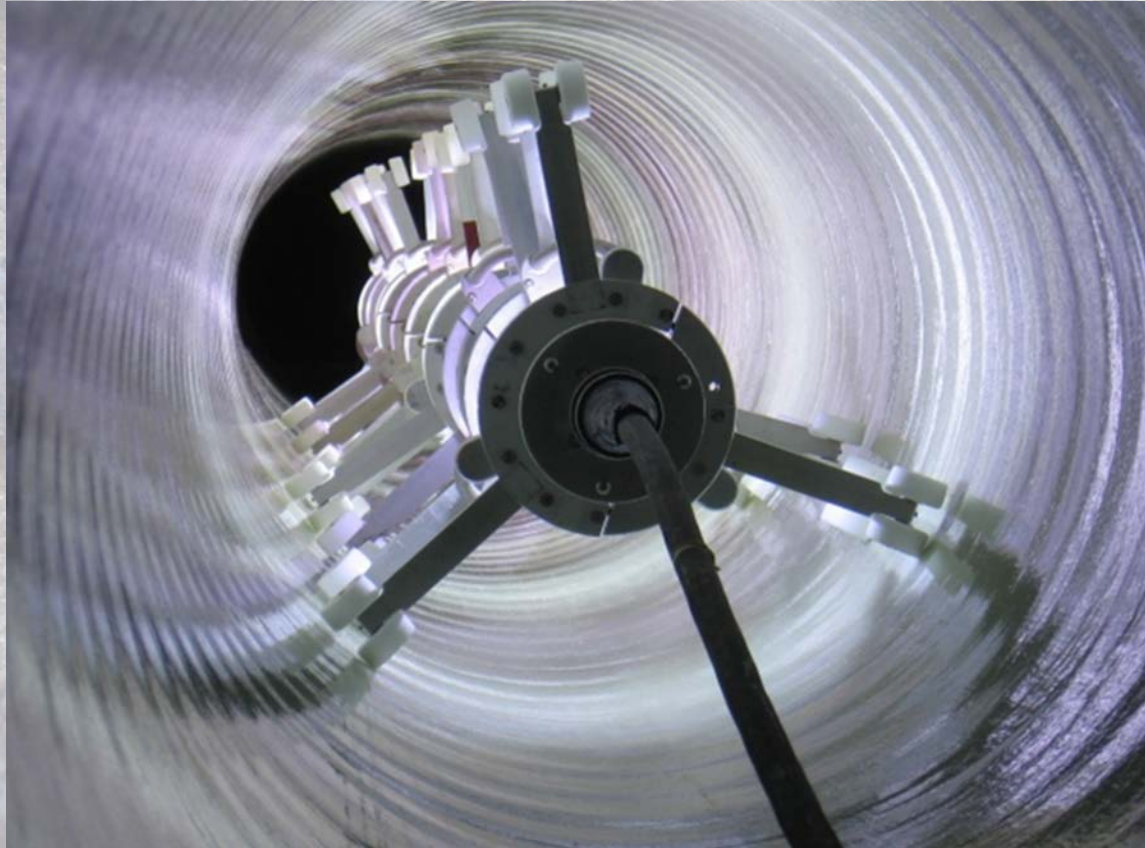
- Use pull in place method for (2) runs
  1. MH 1183.114 and 1183.106 (Estimated 133') 16" pipe
  2. MH 1203.108 and 1203.101 (57') 16" pipe
- CIPP material design
  - Multiple spiral wound layers of composite
  - Woven pulling bands
  - Inner film (Styrene barrier)
  - Outer film (preliner) (Styrene barrier)
- CCTV prior to curing
