# NASHUA REDUCES CSOs WITH GREEN INFRASTRUCTURE AND TRENCHLESS TECHNOLOGY

Nicholas Ellis, P.E.  
Hazen and Sawyer  
Joe Mendola, P.E.  
City of Nashua

June 6, 2017

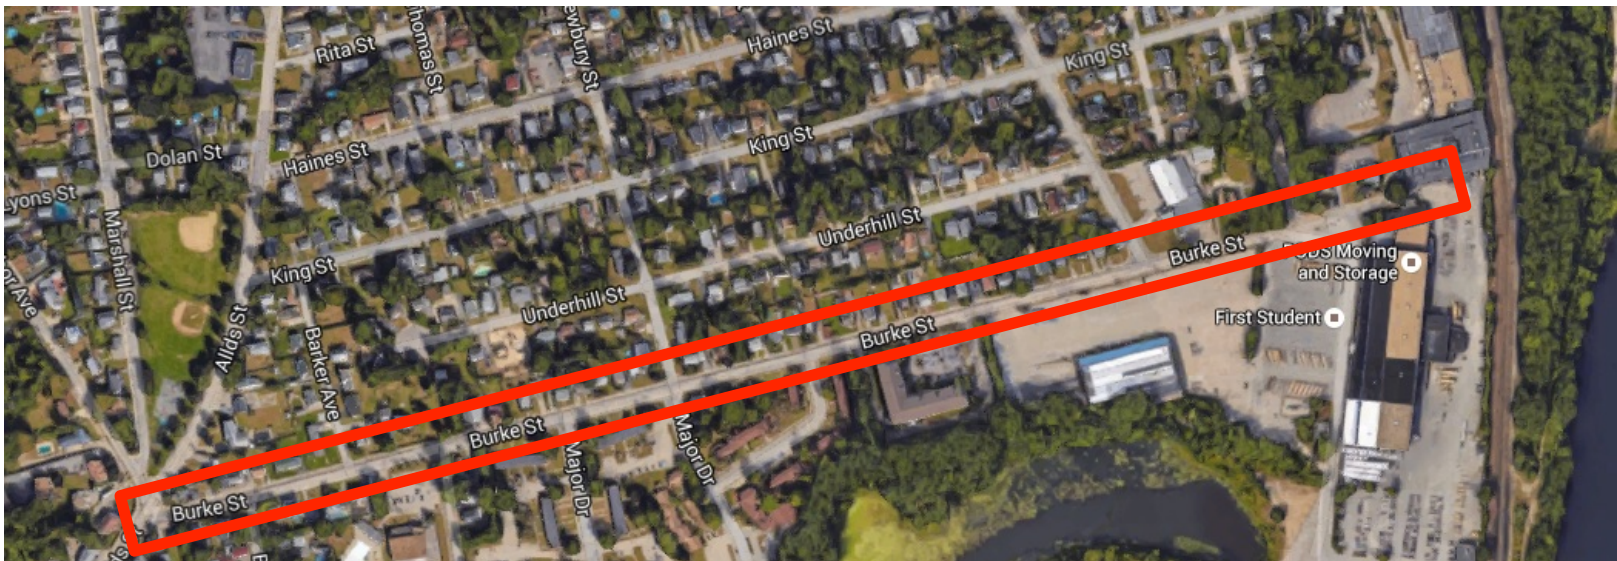
# Burke Street

- ~3,500 feet long
- 24-inch diameter clay interceptor (installed in early 1900's)
- Largely clay chimney type lateral connections
- Significant issues with sinkholes and failing laterals
- Residential, commercial and industrial use

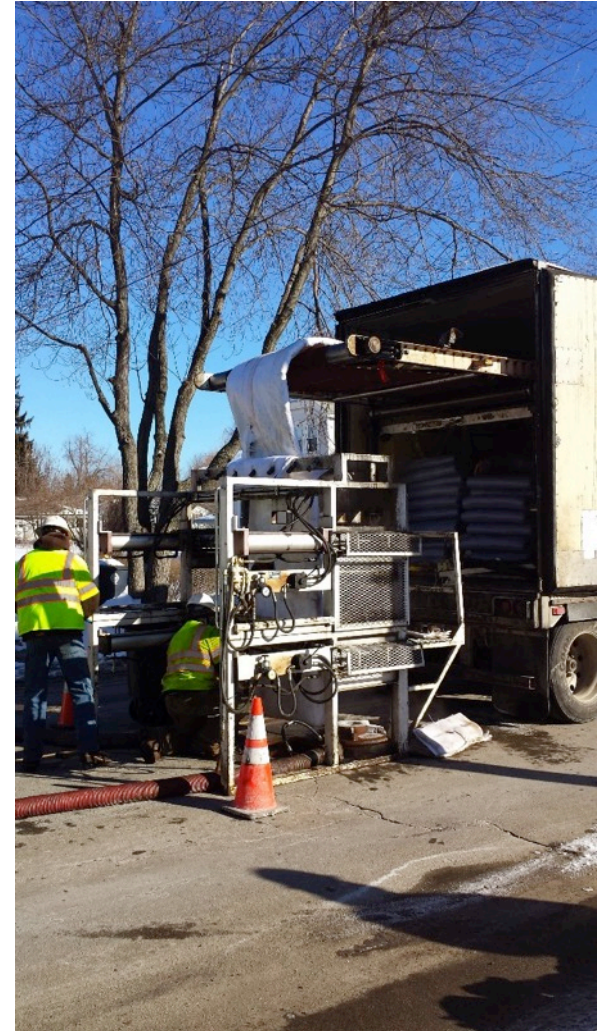
- CIPP Lining of the Interceptor
  - Approximately 3500 feet of 100+ year old 24-inch diameter clay combined sewer lined
- Why lining?
  - Deep, old interceptor piping
  - Significant utility conflicts
  - Busy road – Commercial vehicles, trucks and school buses

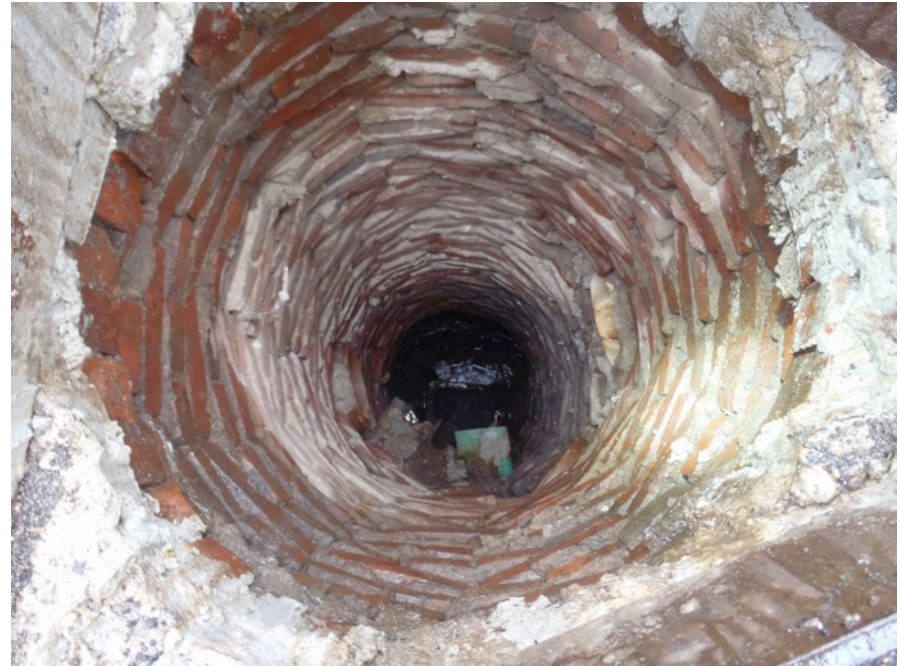
- Existing “Maholes”
  - Brick manholes with triangular covers
- Install additional manholes on exist. interceptor
- Significant stretches with no access to interceptor

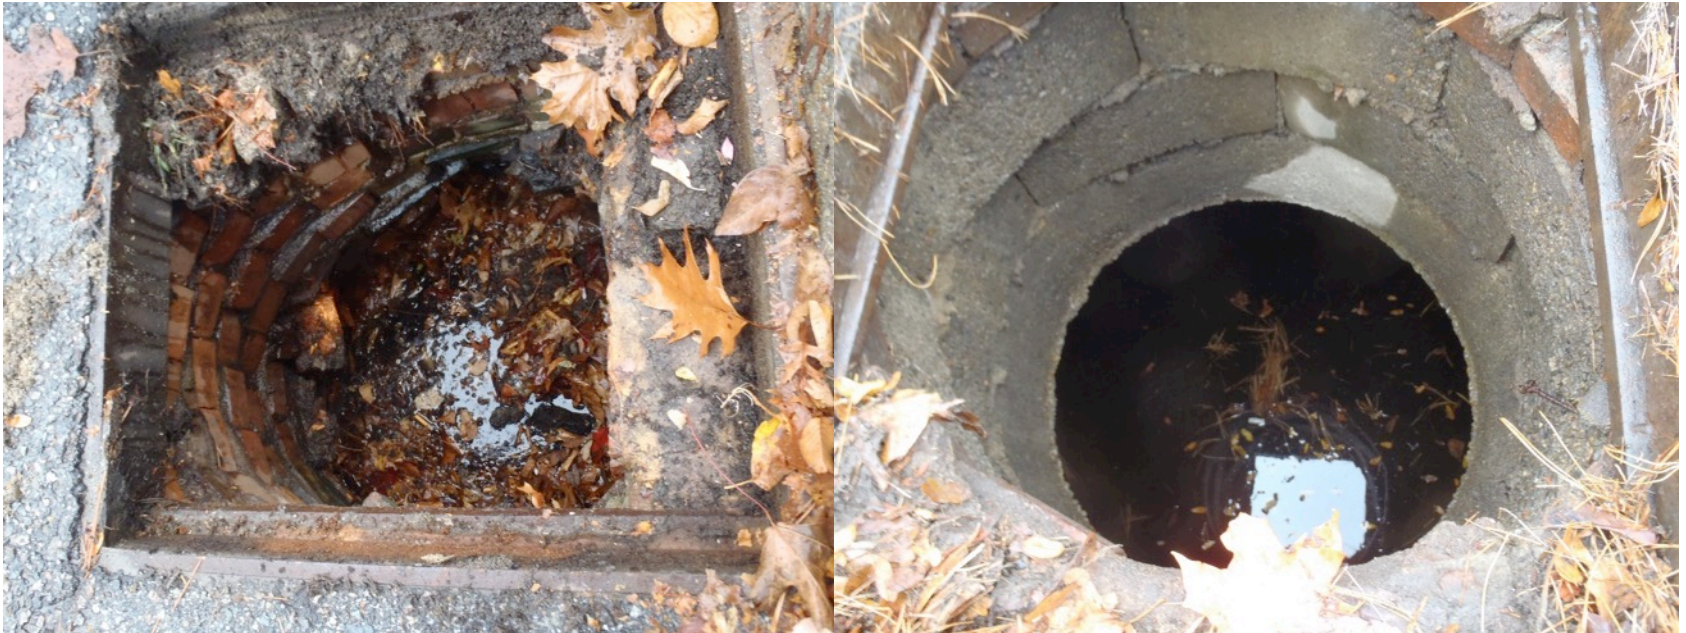
- Line some catch basins, replace others
  - Brick and concrete catch basins in various states of disrepair
- Install hoods on all existing catch basins, replace grates

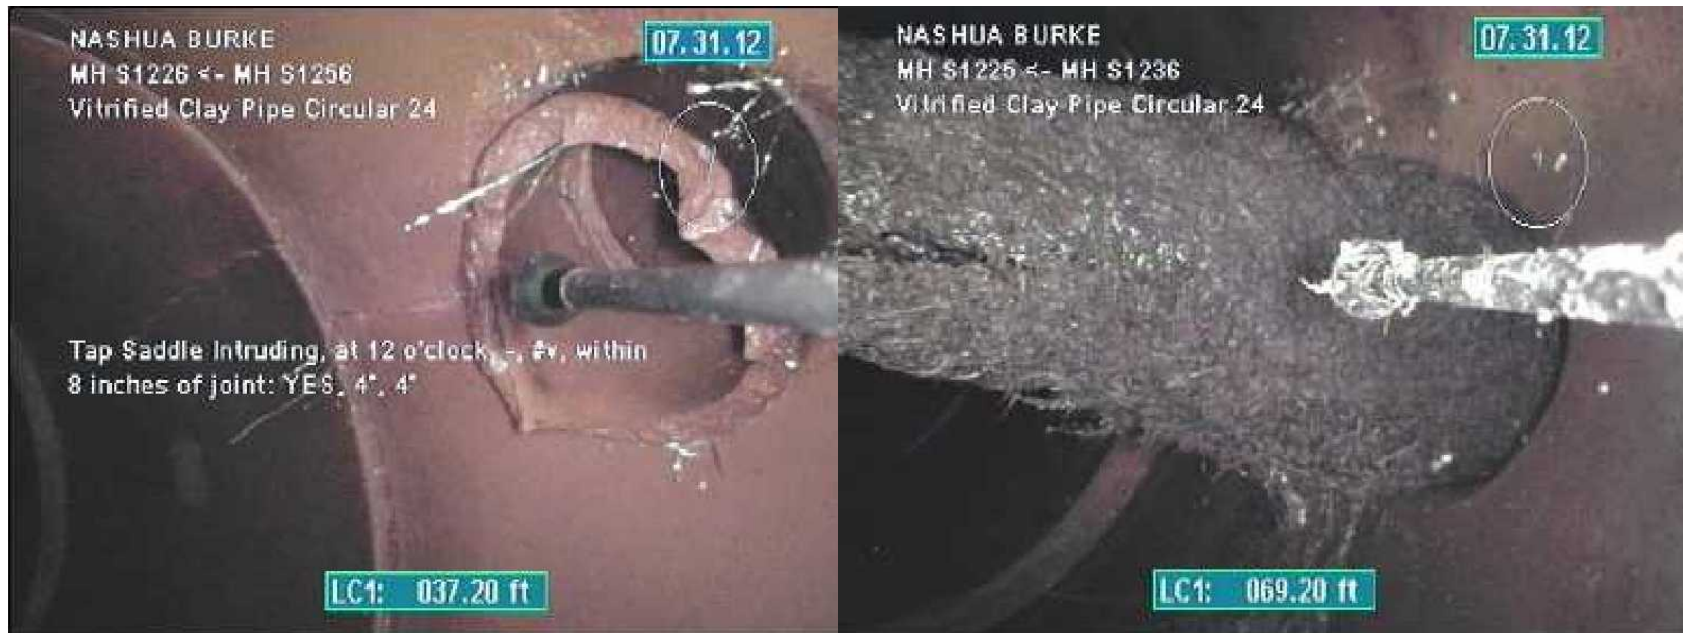
- Many service laterals were as old as the clay interceptor (100+ years)
- Significant issues with lateral collapses and sinkholes
- Significant root issues

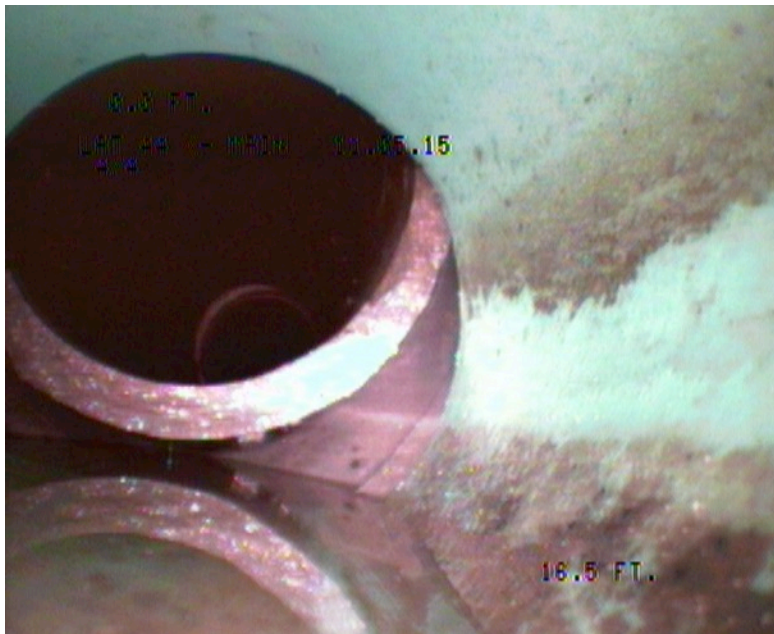
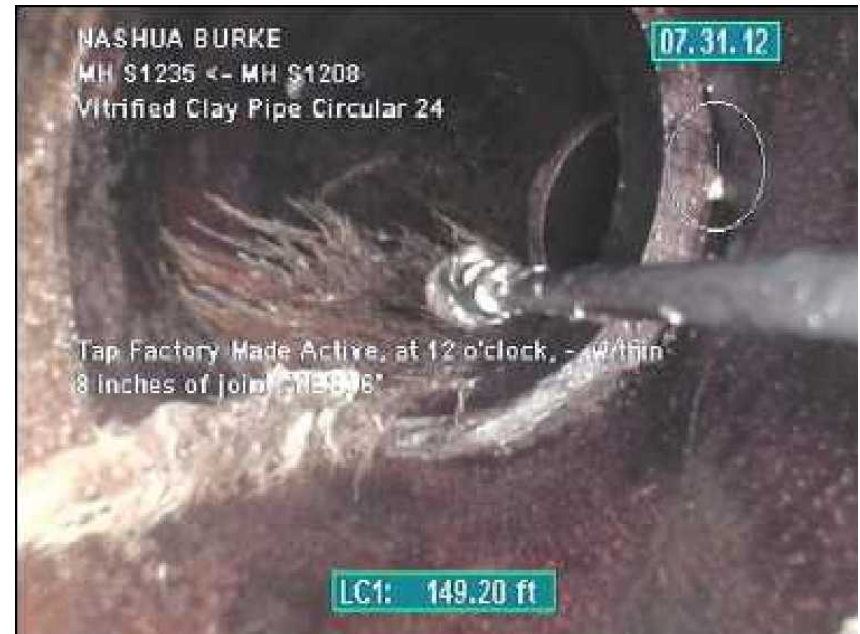
- Service laterals are chimney connections, generally 6-inch diameter clay
- CCTV Lateral inspection
  - Significant joint offsets
  - Many laterals had wyes with one or both connections capped
  - CCTV inspection of laterals was incomplete

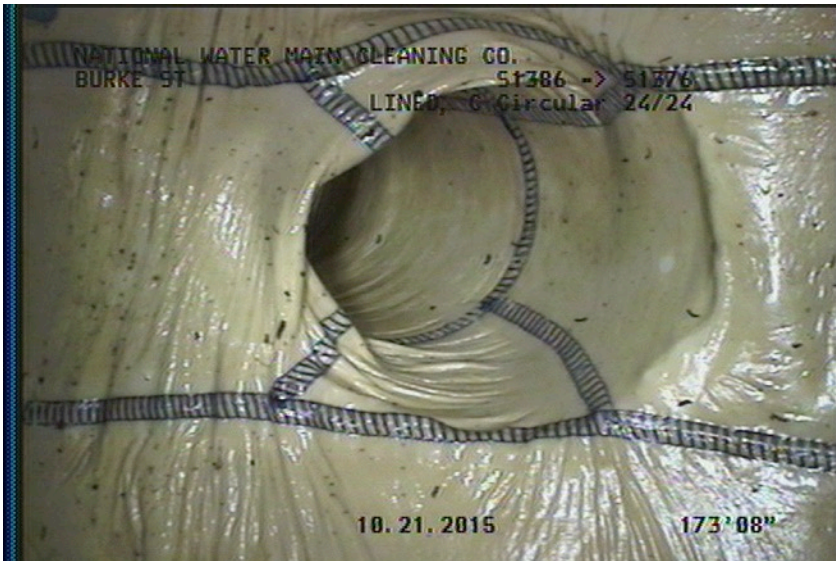
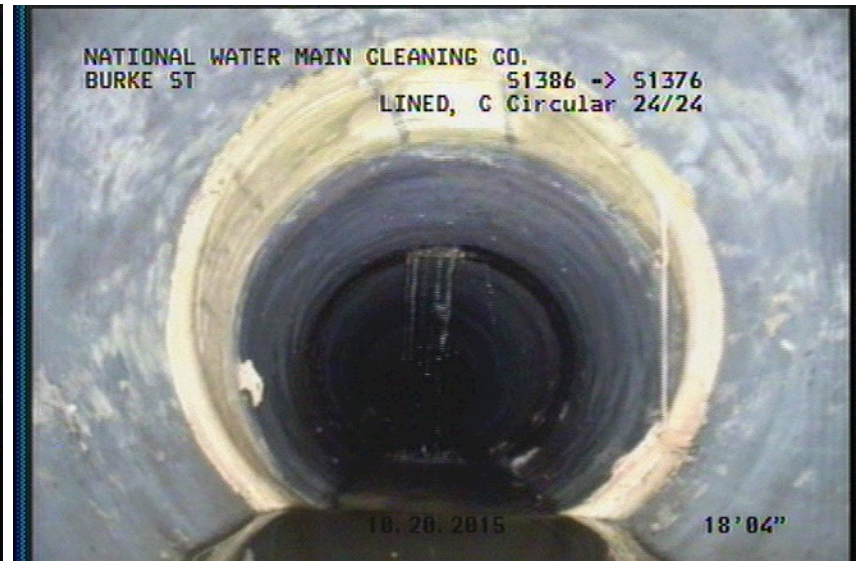
- CIPP Lining of Service Laterals
  - Many laterals had poor connections, cracking, or small joint separation
  - Lining means no excavation!
- Removal and Replacement of Service Laterals
  - Some laterals were in a condition not conducive to lining

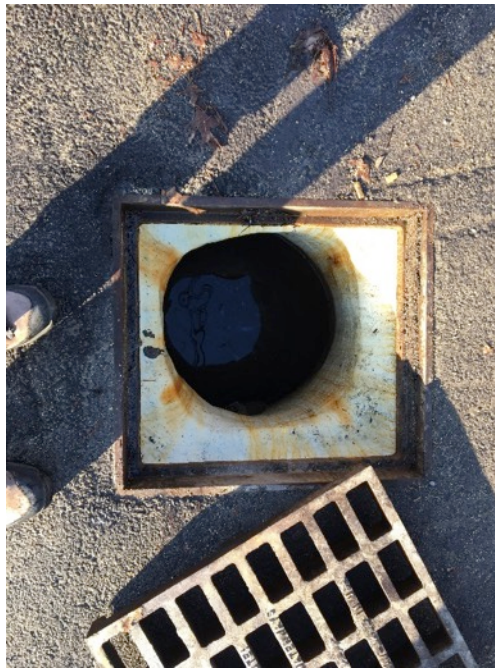
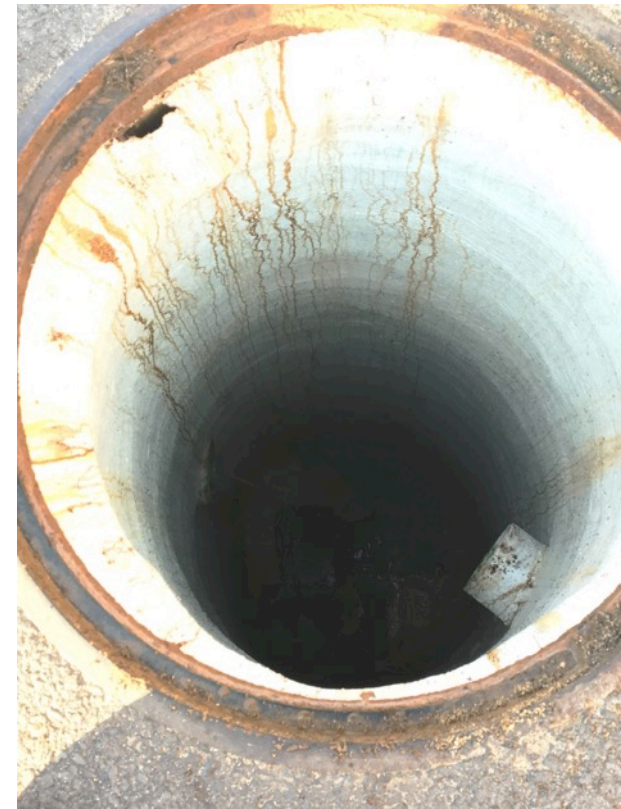
- Line existing “Maholes”
  - Brick manholes with triangular covers (all covers replaced)
- Line or Replace Existing Catch Basins
  - Install CB hoods
  - New cast iron CB grates

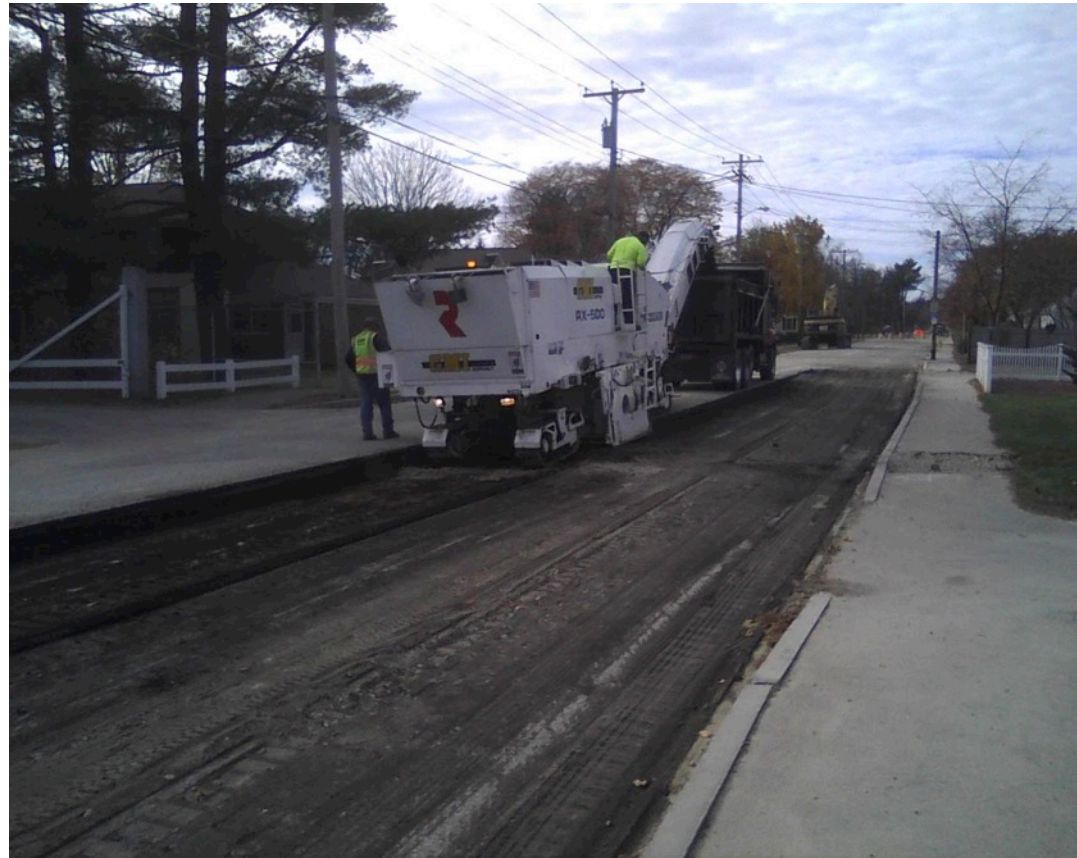
- New Paving
- Paving Challenges
  - No discernable subbase
  - Iron slag present below paving
  - Existing pavement depth varied from 5-10 inches
  - Grind and overlay was not feasible
  - Additional subbase would cause issues with grading and drainage
- Full depth removal, shimming and repaving
