Marc R. Moccio, PE

# Not Just Another Leak in the Pipe City of Haverhill, Massachusetts

Presented at the 2018  
NEWEA Annual Conference

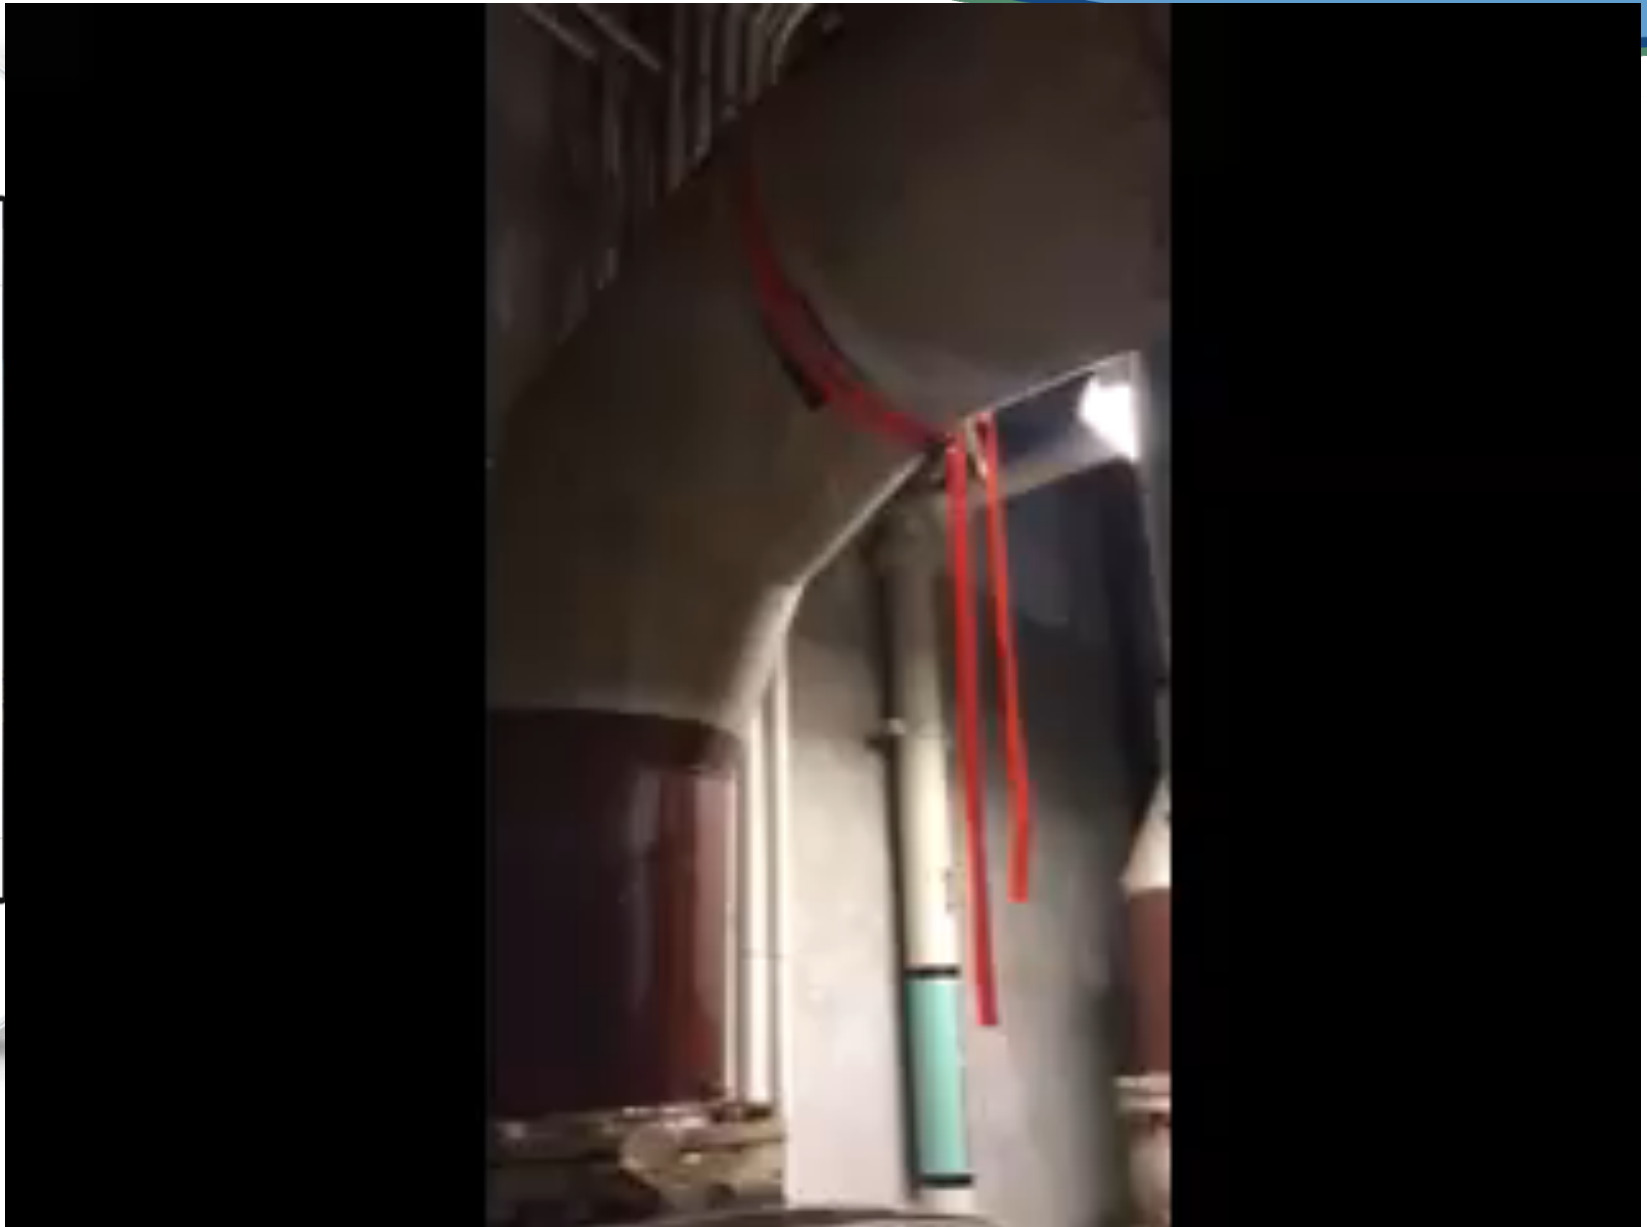
- Leak located on a mitered elbow joint
- No way to isolate
- Fix needed to be done quickly
  - Weld a patch?
  - Epoxy, rubber patch, ratchet strap?
- How extensive was the corrosion?

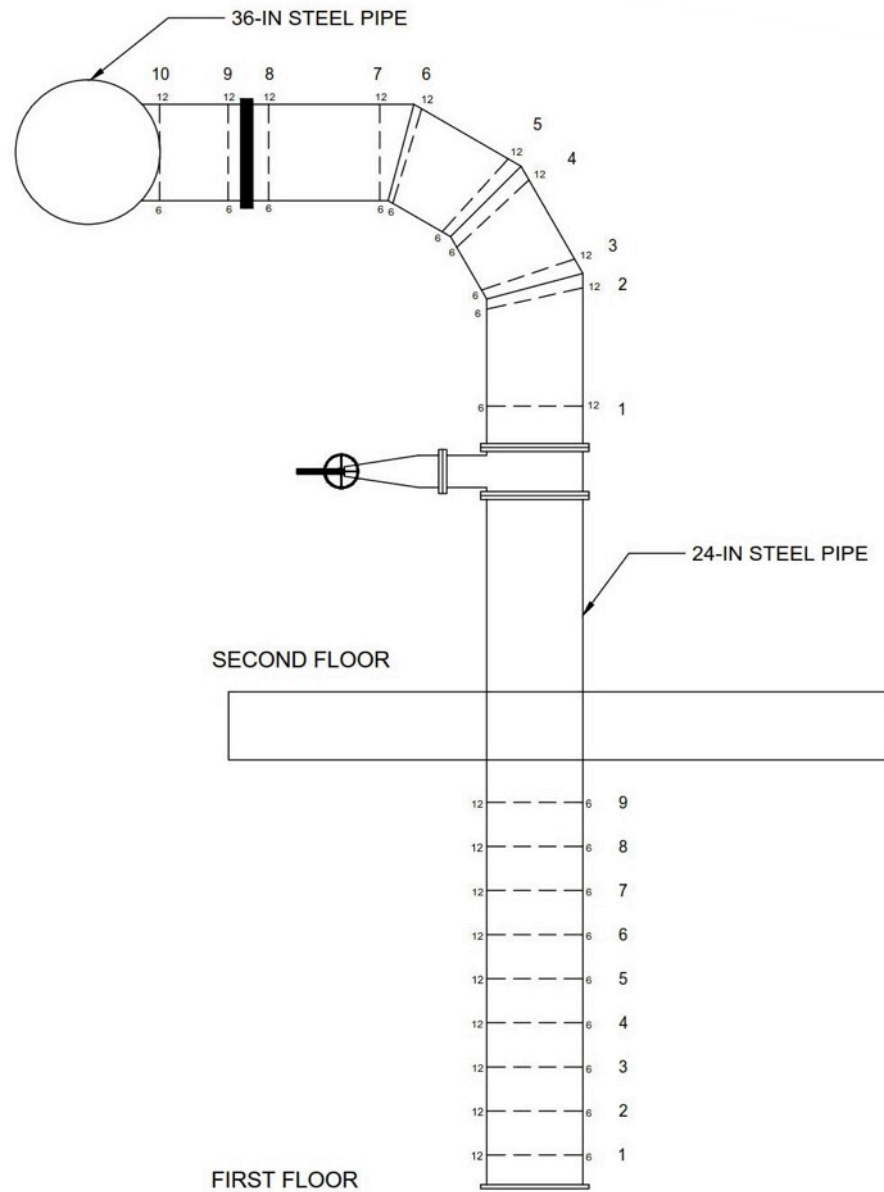
24" Piping Testing Locations

- Ultrasonic Testing Results
  - Extensive Corrosion Throughout Steel Piping System
  - Cement Lining Essentially Gone
  - Exposed Steel Throughout
- Increased Urgency

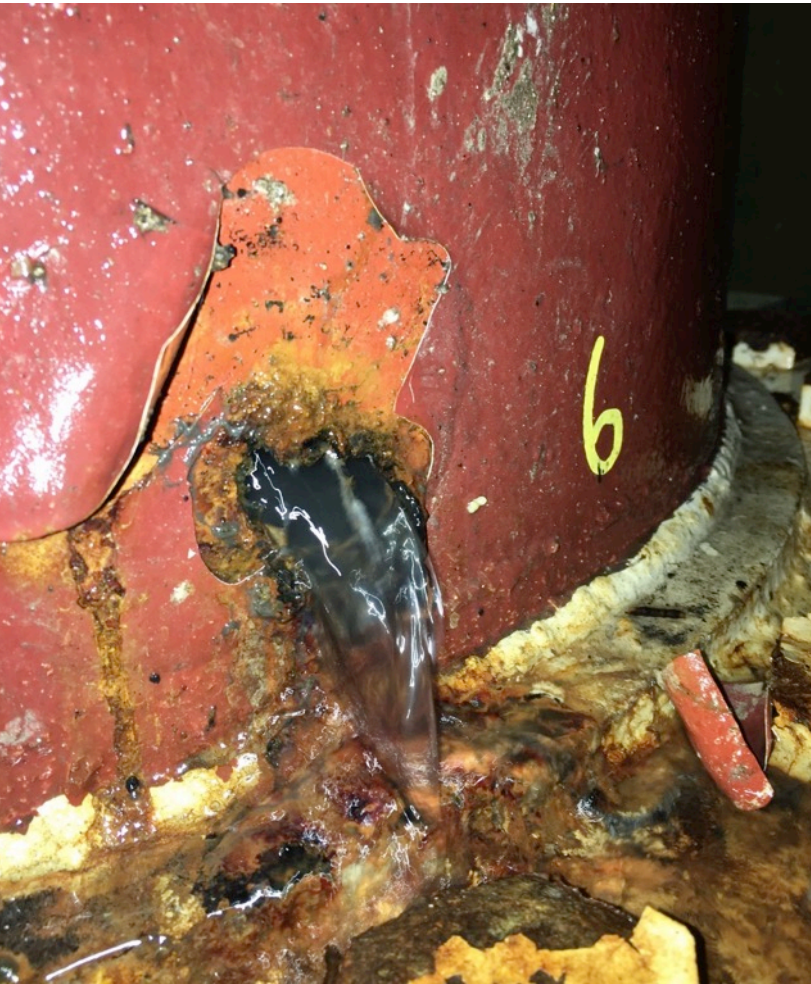
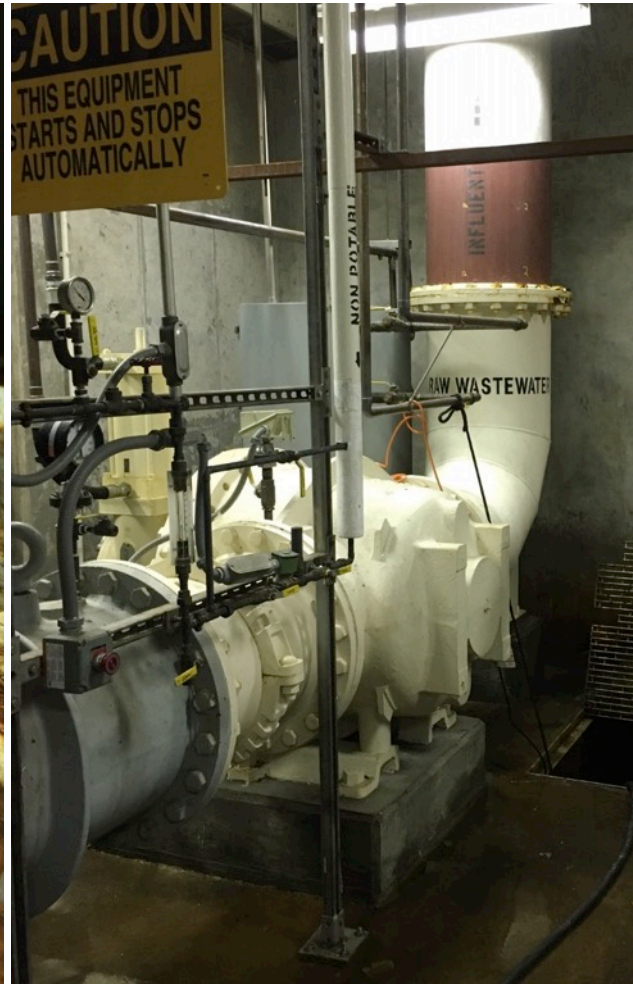
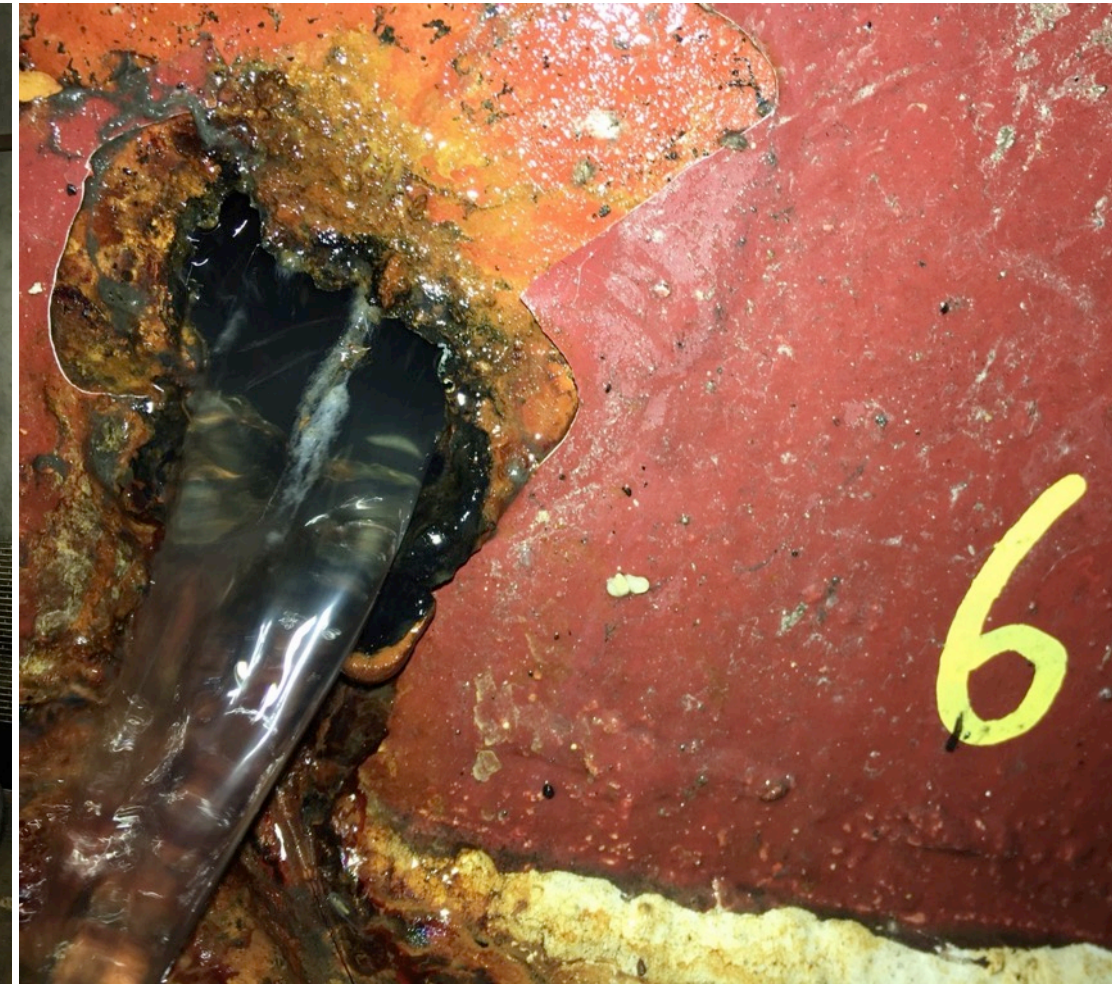
## Pump No. 2 develops a second leak!

- Pumps No. 2 and 4 Discharge Piping
- Ability to Isolate (Below 24" Gate Valve)
- Type of Pipe?
  - Ductile Iron
  - Carbon Steel
- Type of Lining?
  - Cement
  - Glass
  - Ceramic Epoxy

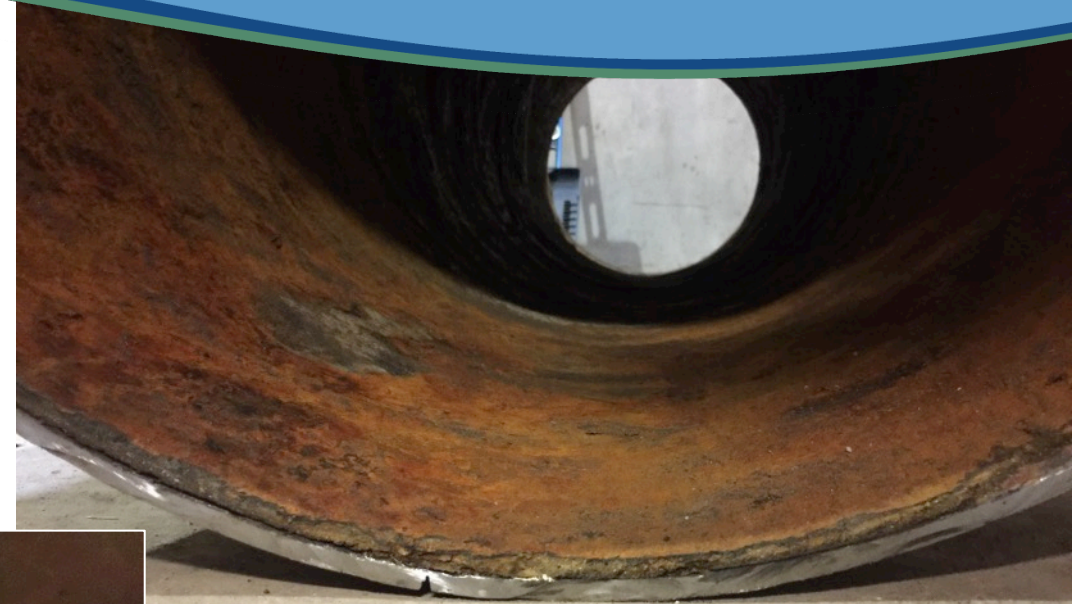
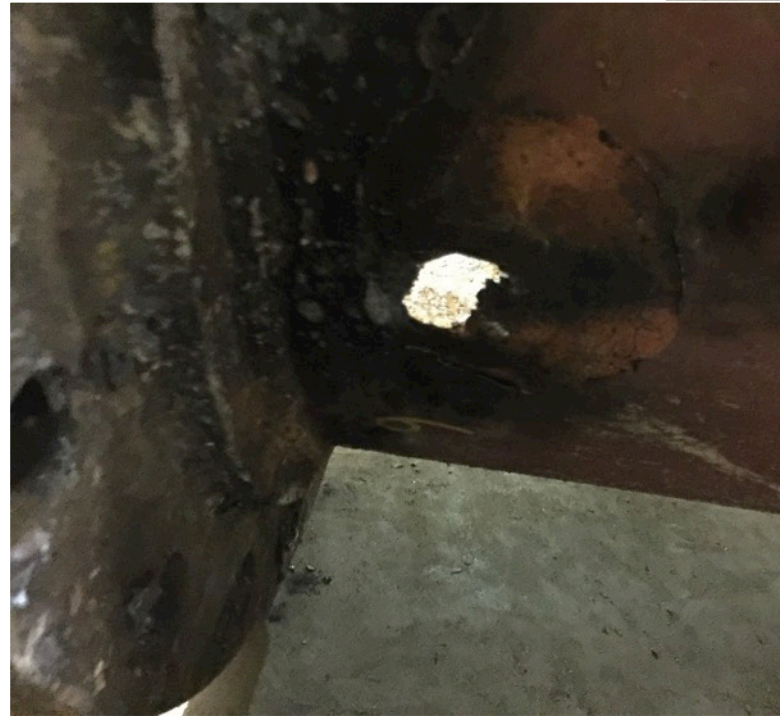
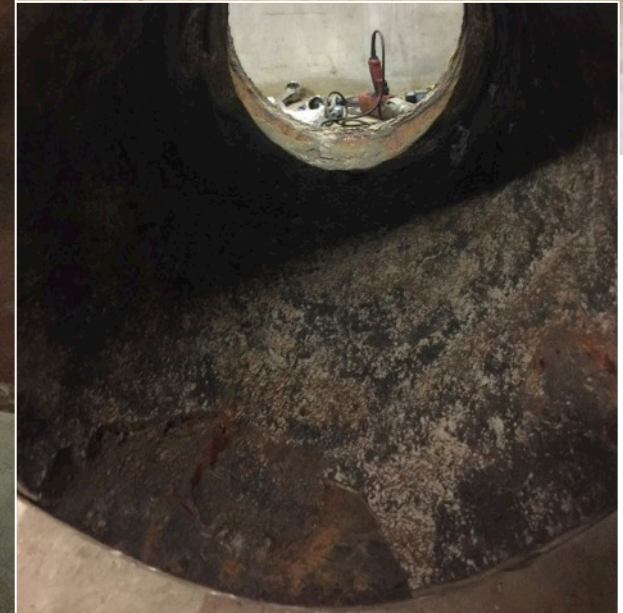
- Discovery: 24" Pipe is actually Schedule 10 NOT Schedule 20
- 0.25" vs. 0.375"
