# TOWN OF MONTAGUE

## TURNERS FALLS MAIN DRAIN AND SIPHON REHABILITATION

January 22<sup>nd</sup>, 2018

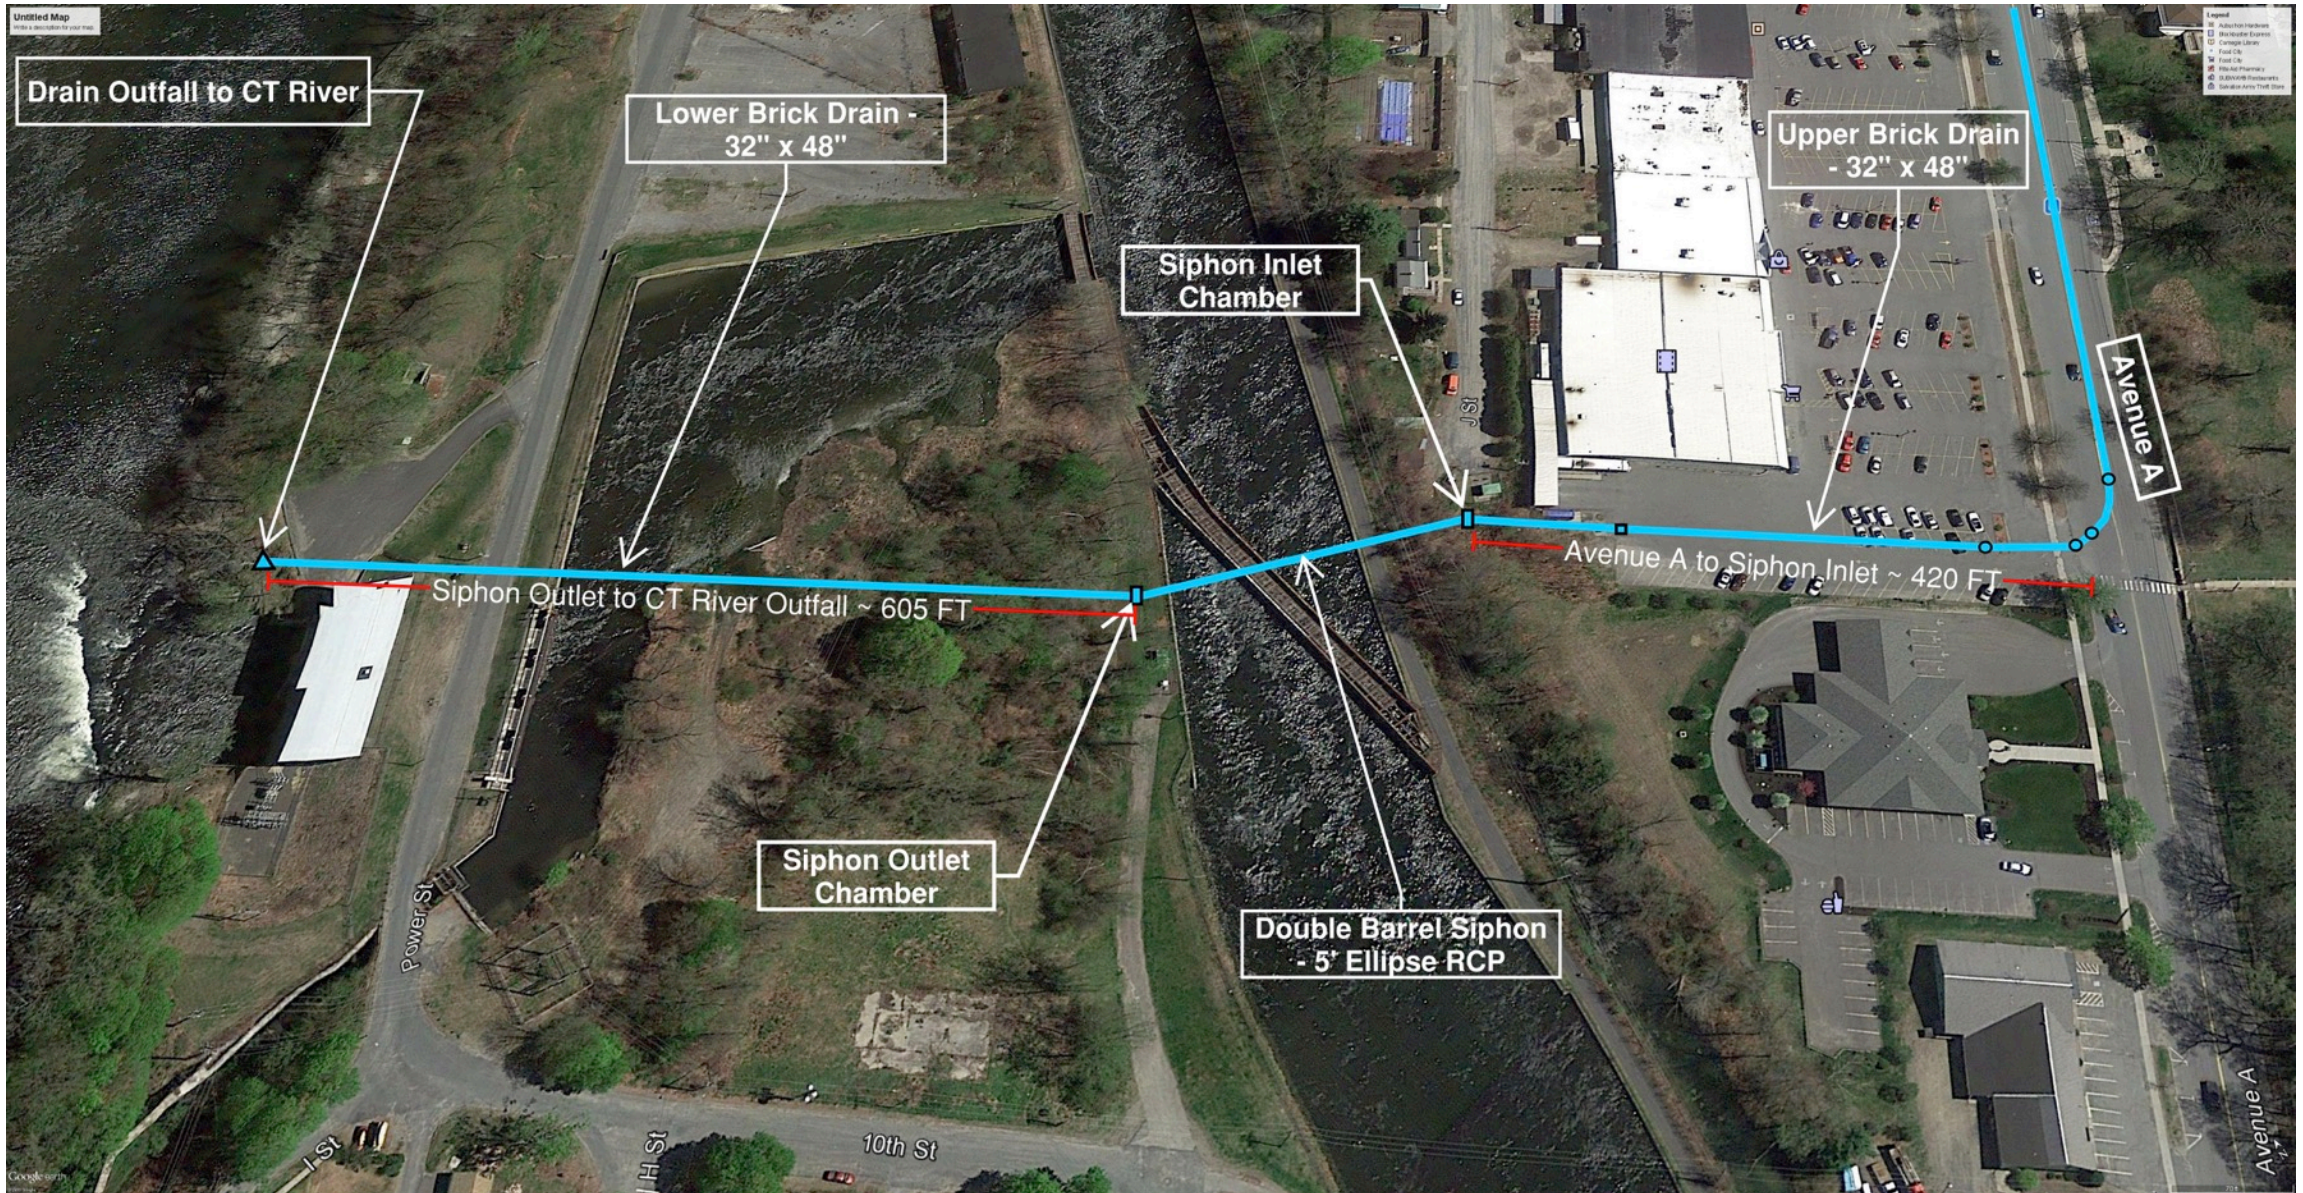
# Main Drain – Imminent Failure of Lower Drain Beneath Spur Canal!

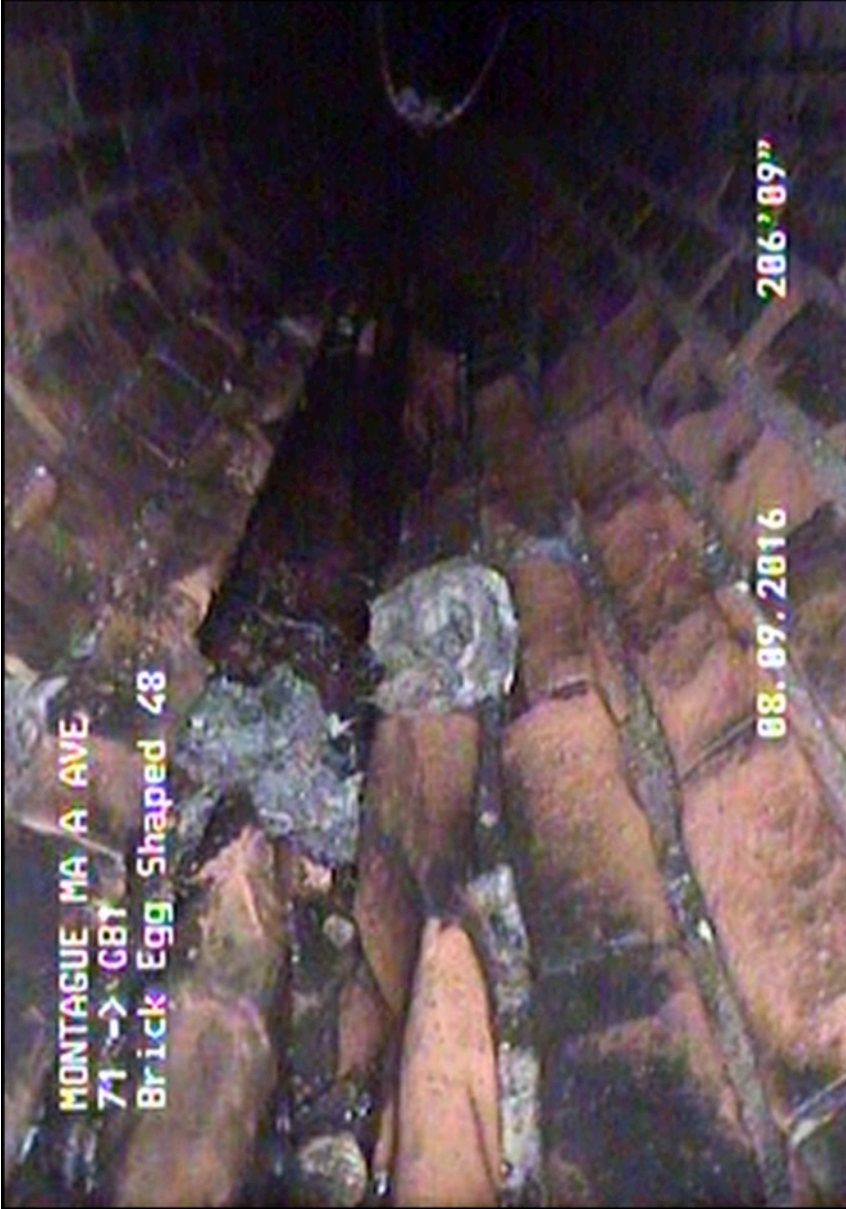
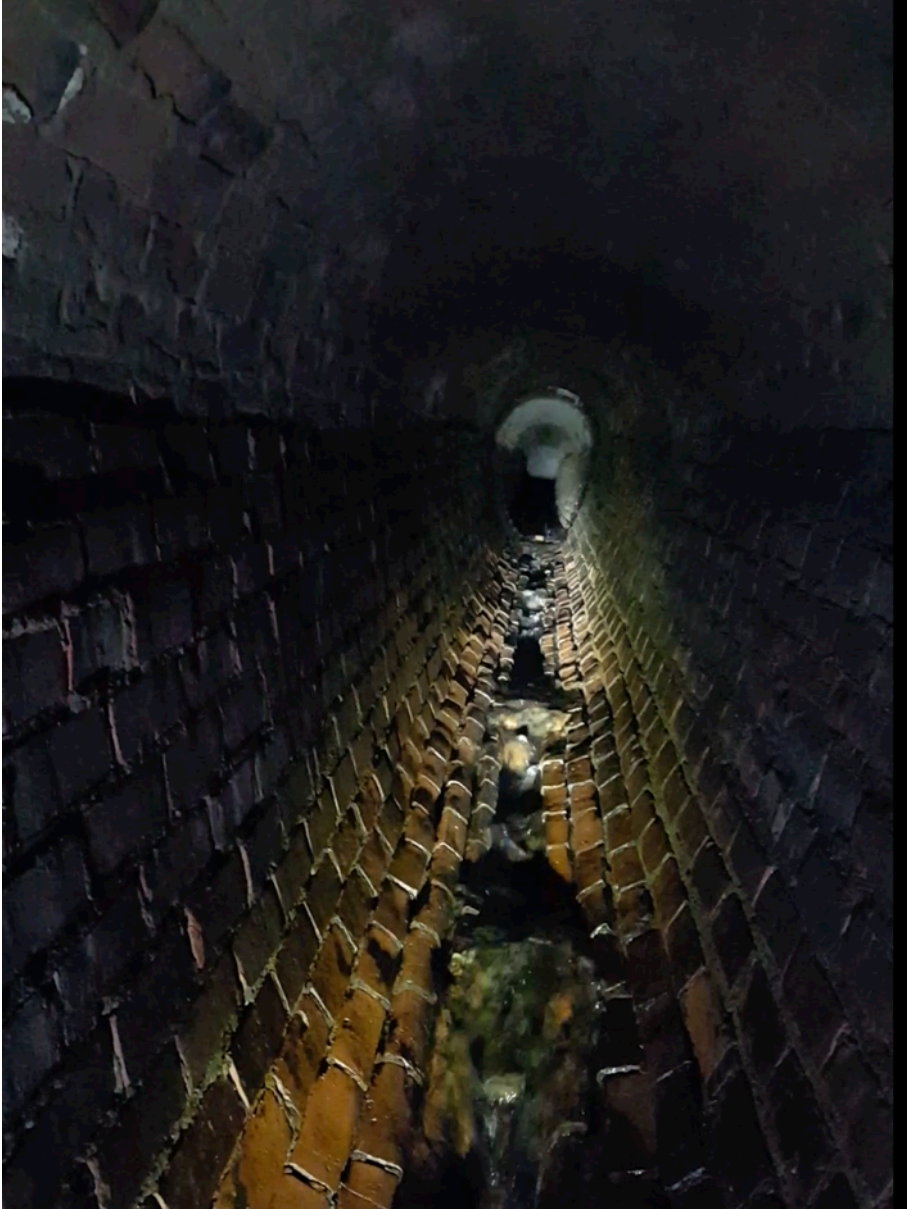
# Upper Drain Invert Deterioration

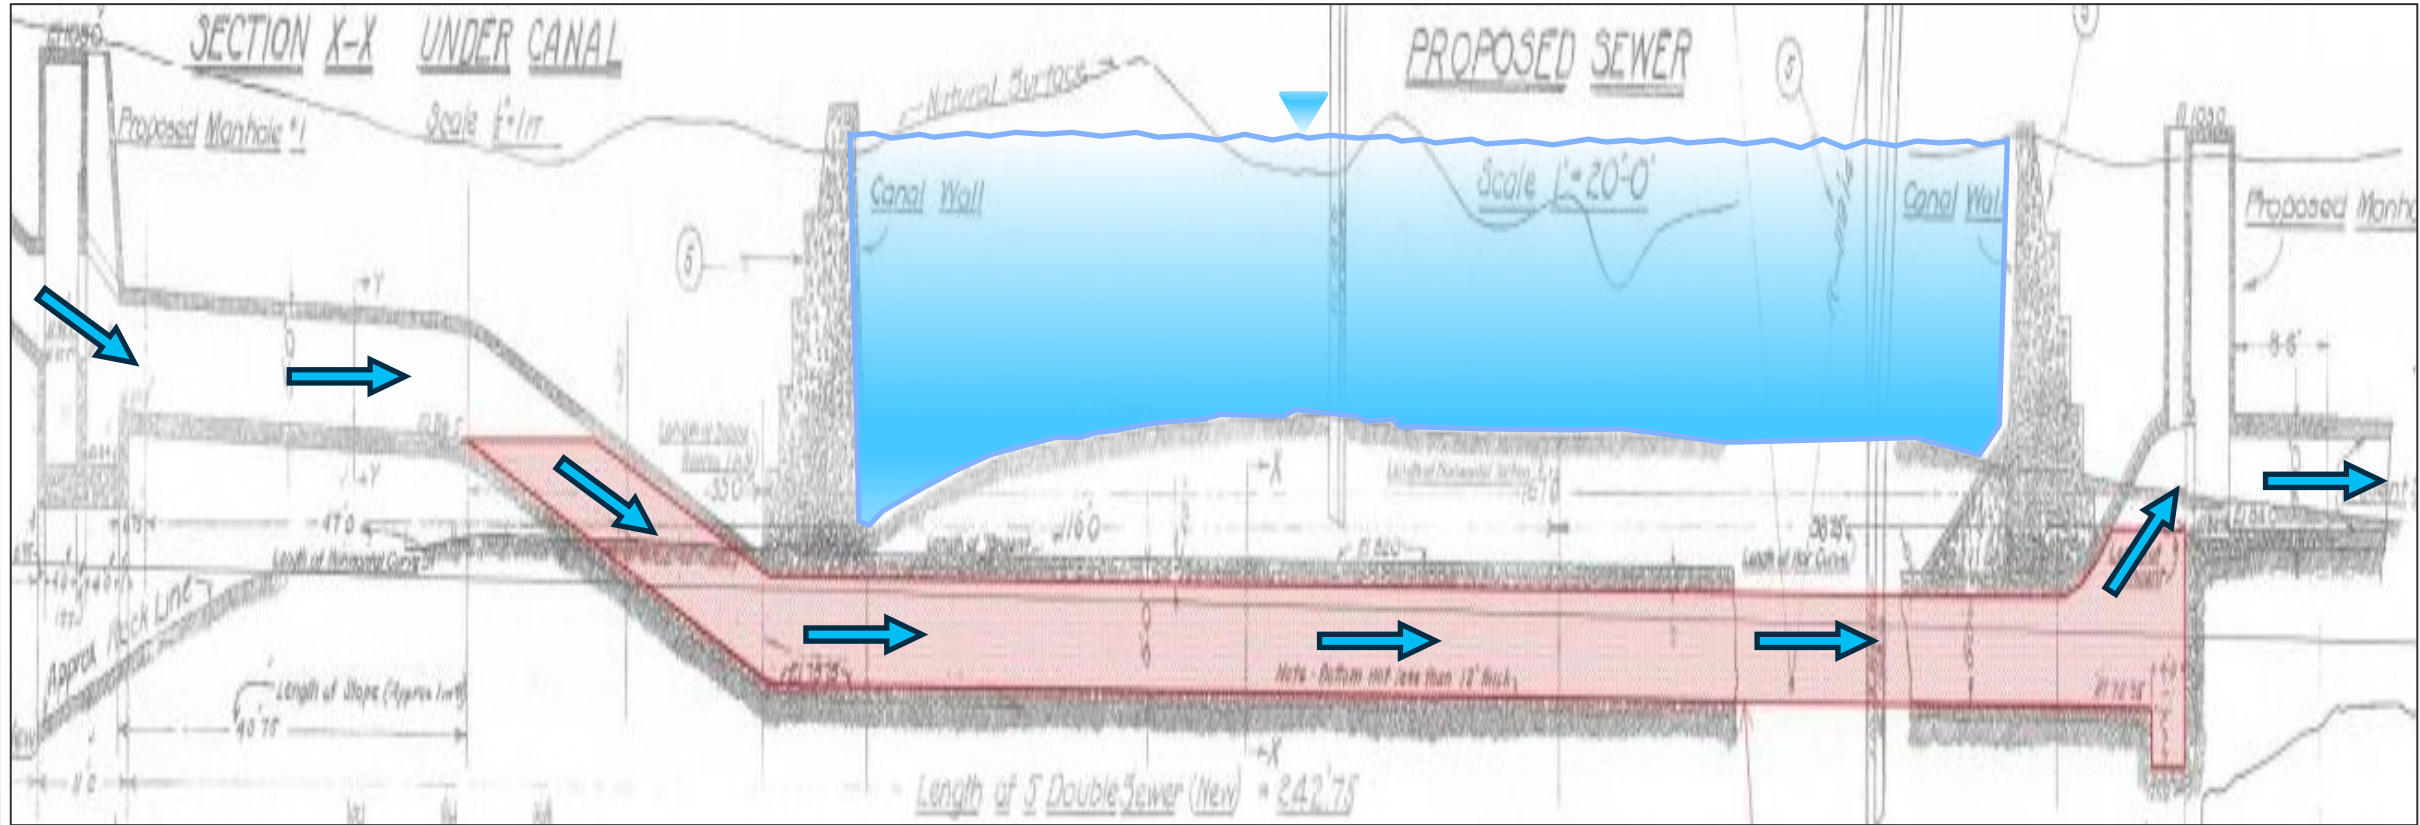
# Profile of Double Barrel Siphon – Extent of Debris

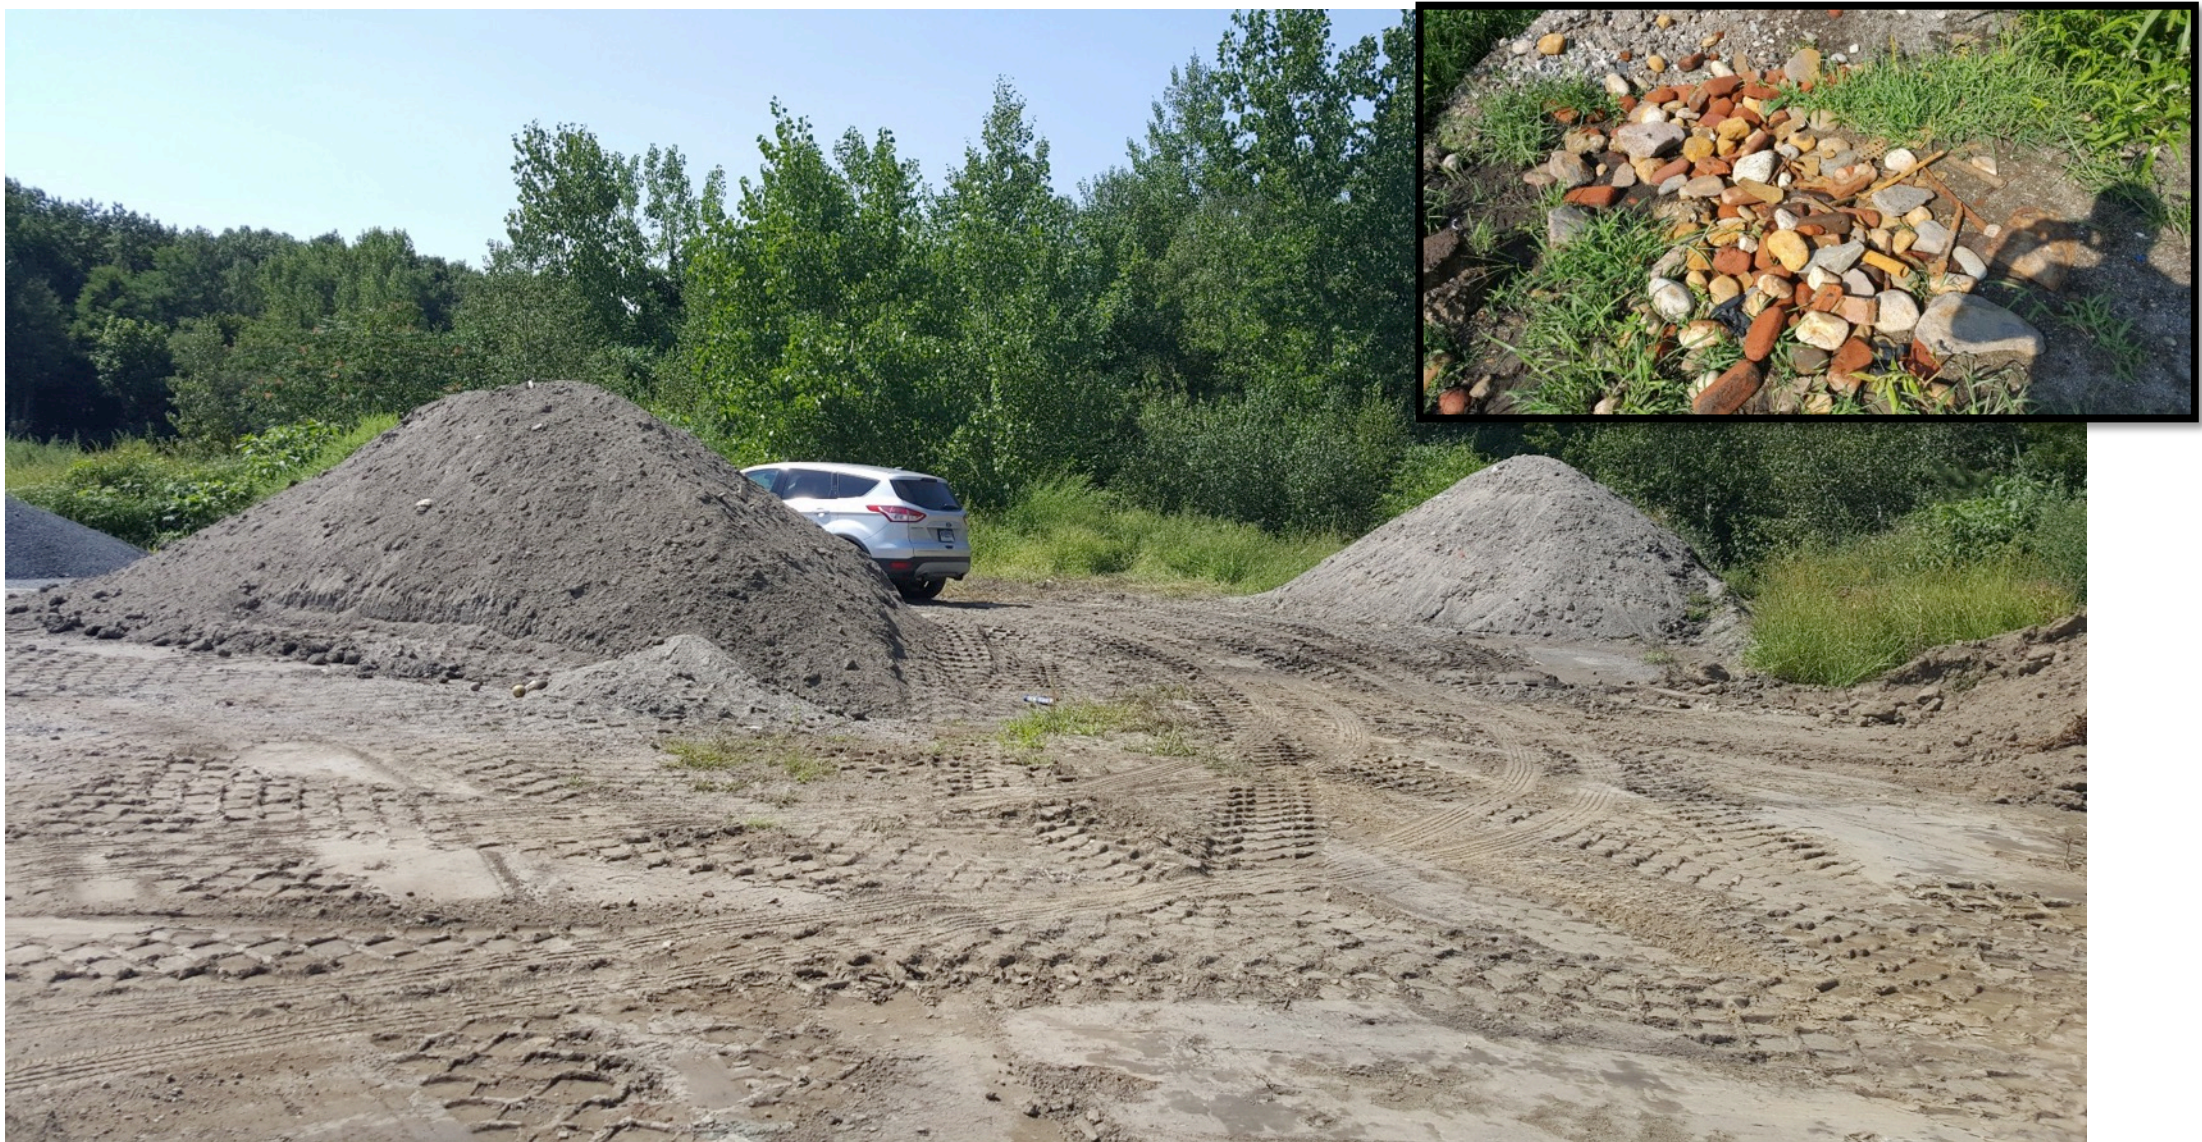
# Siphon Cleaning – Extent of Debris Removed (~ 83 Cubic Yards)

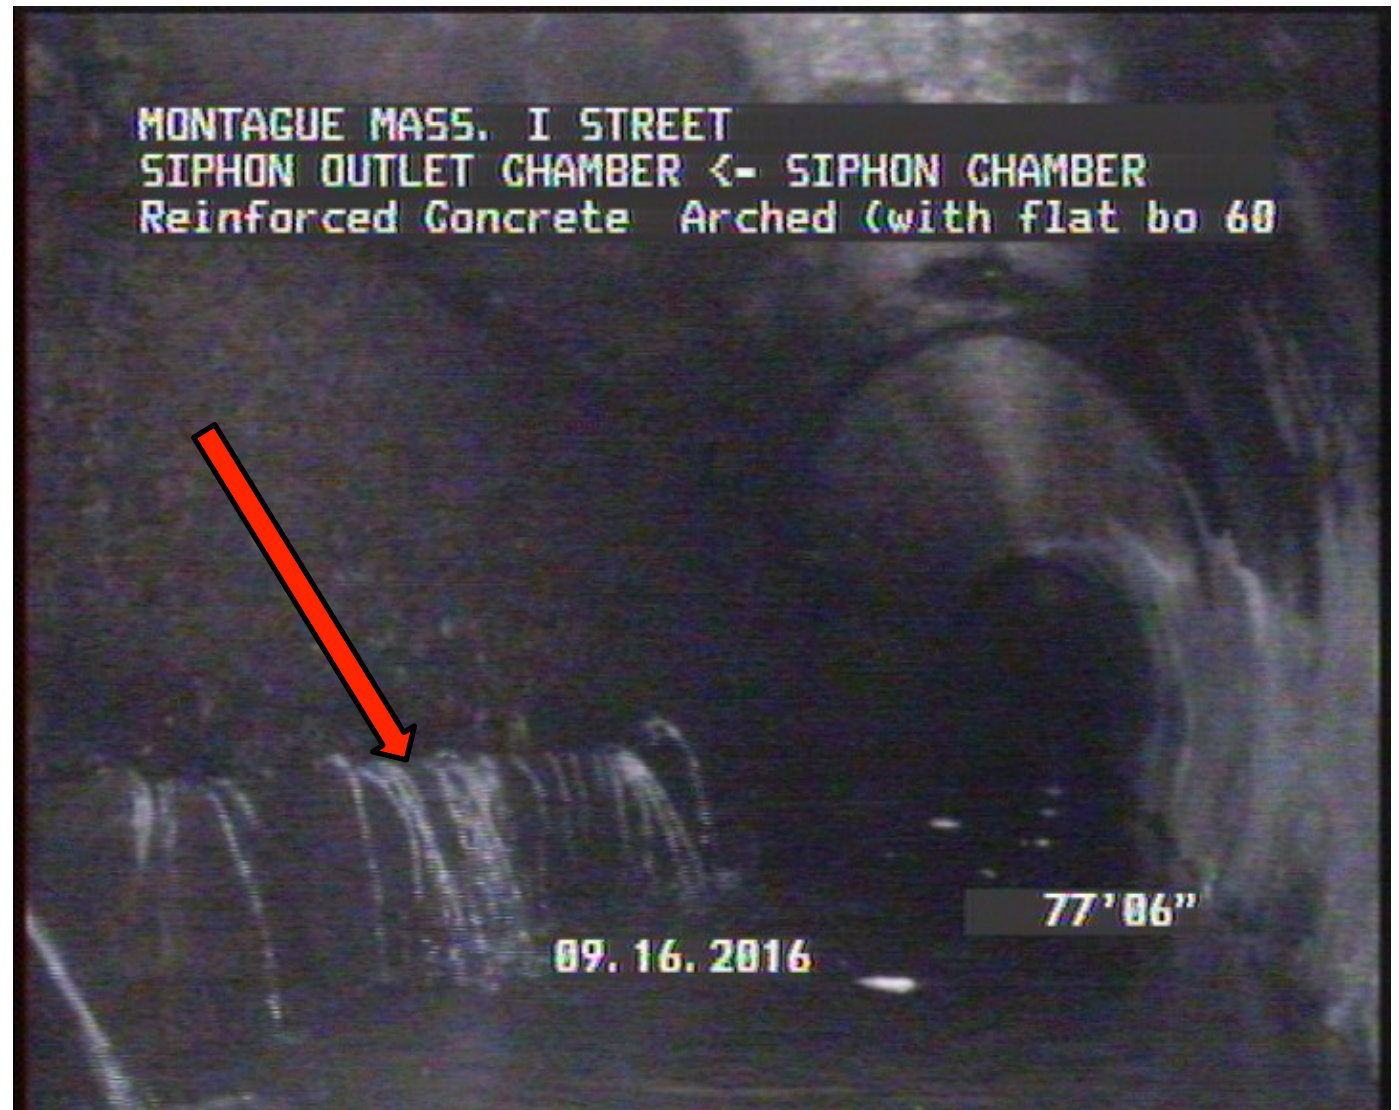
## South Barrel Condition

- 60 foot longitudinal crack from cold/construction joints discovered in South Barrel.
- Significant running/gushing infiltration via crack.
- Concrete encasement for 6" AC force main from G-St Pumping Station considerably eroded.

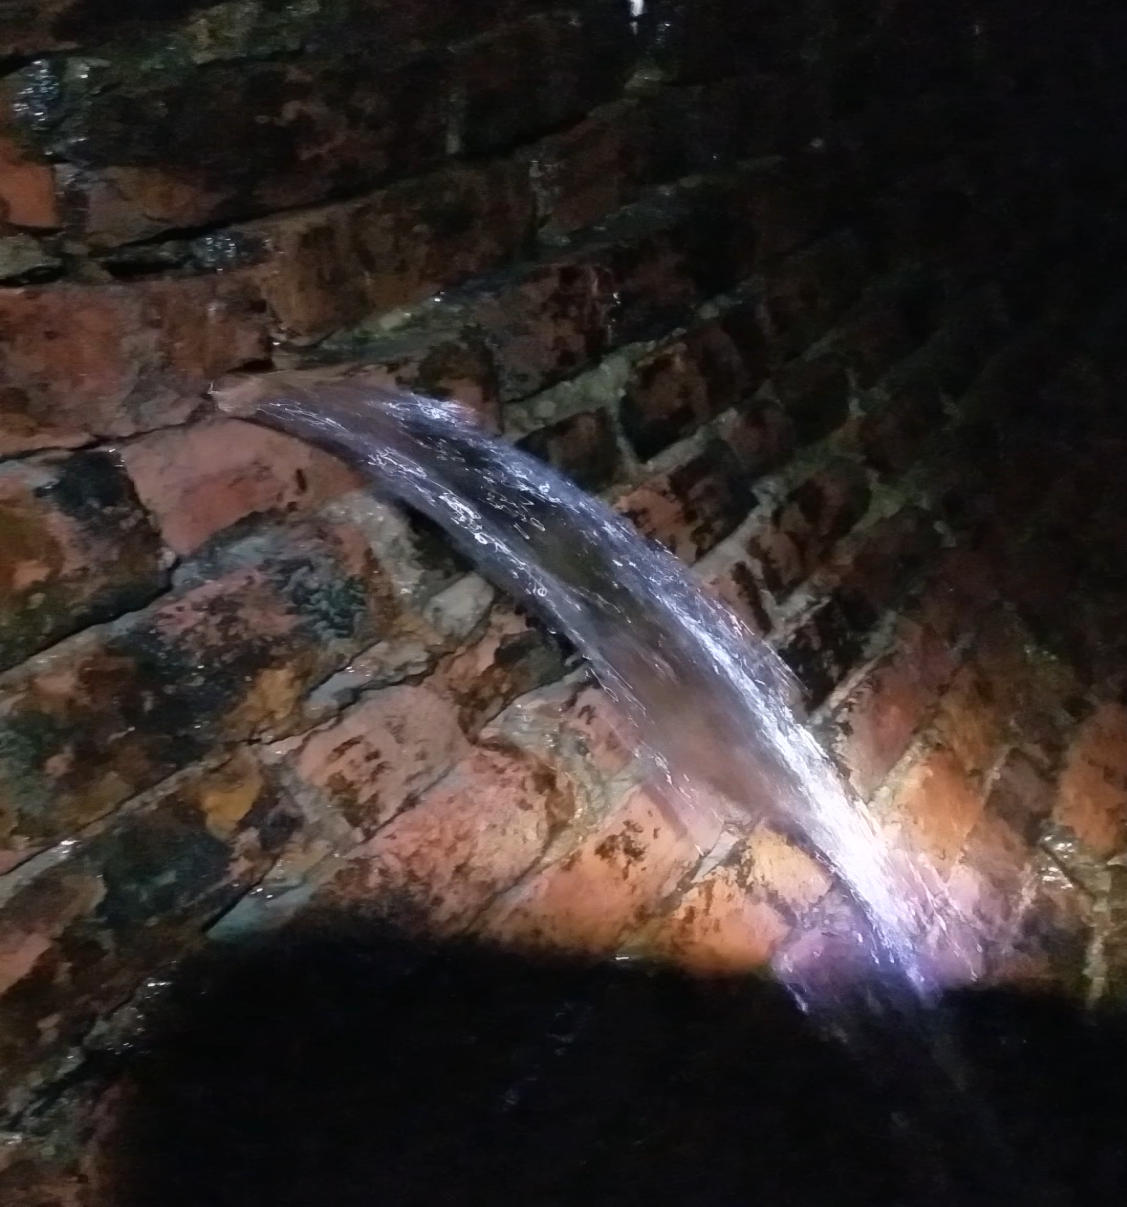
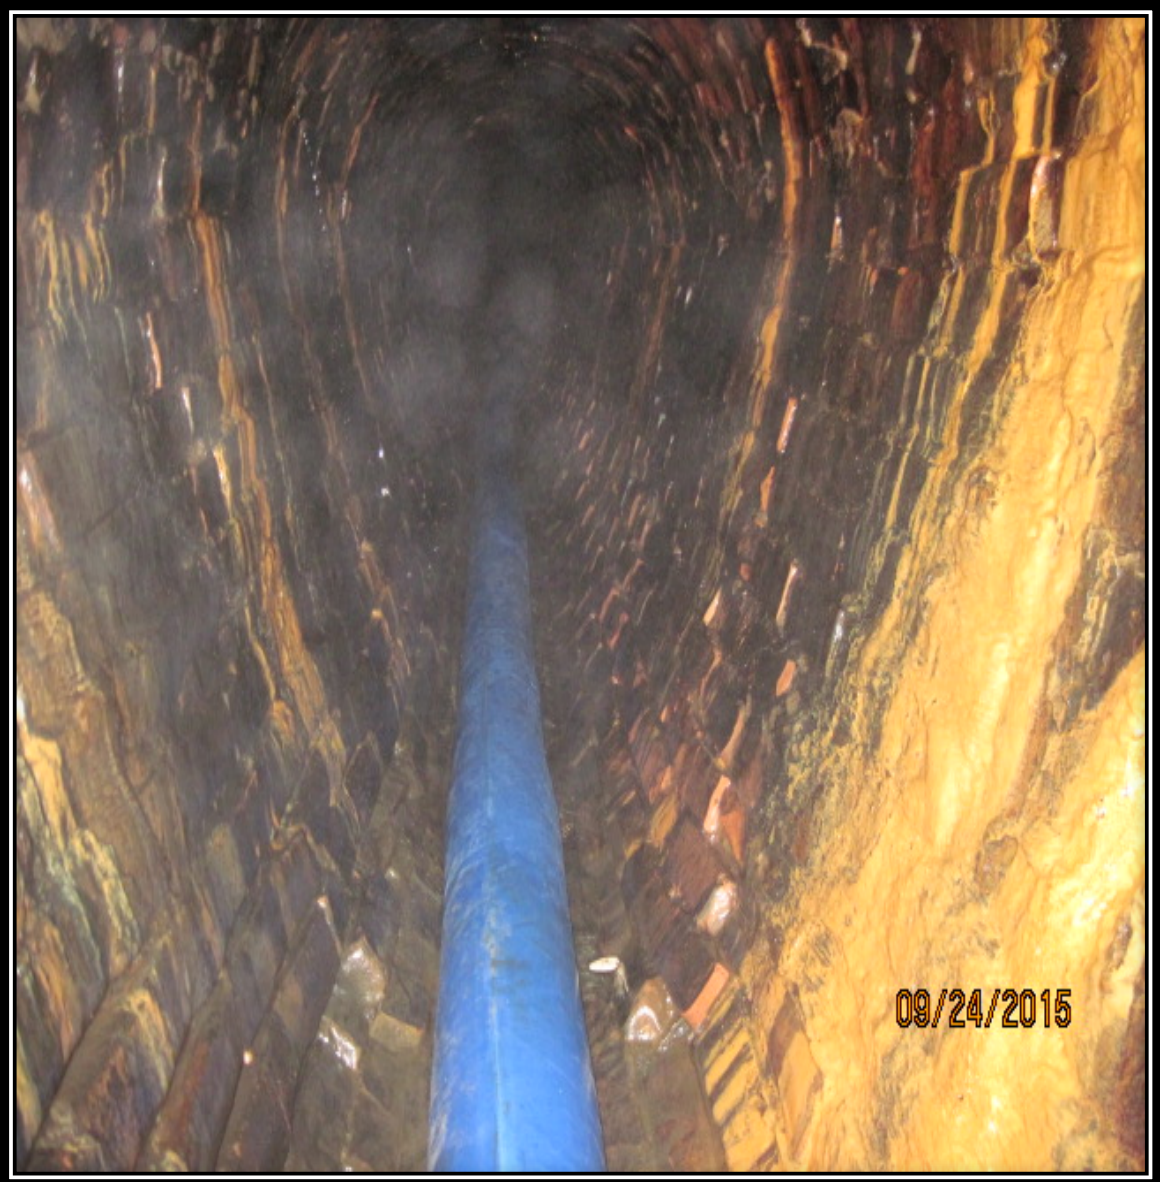
# Lower Drain – Pre-Rehabilitation Condition
