# Identification and Removal of Tidal Intrusion Sources in Manchester-by-the-Sea's Wastewater Collection System

**2019 NEWEA Annual Conference**  
Allison Shivers, PE

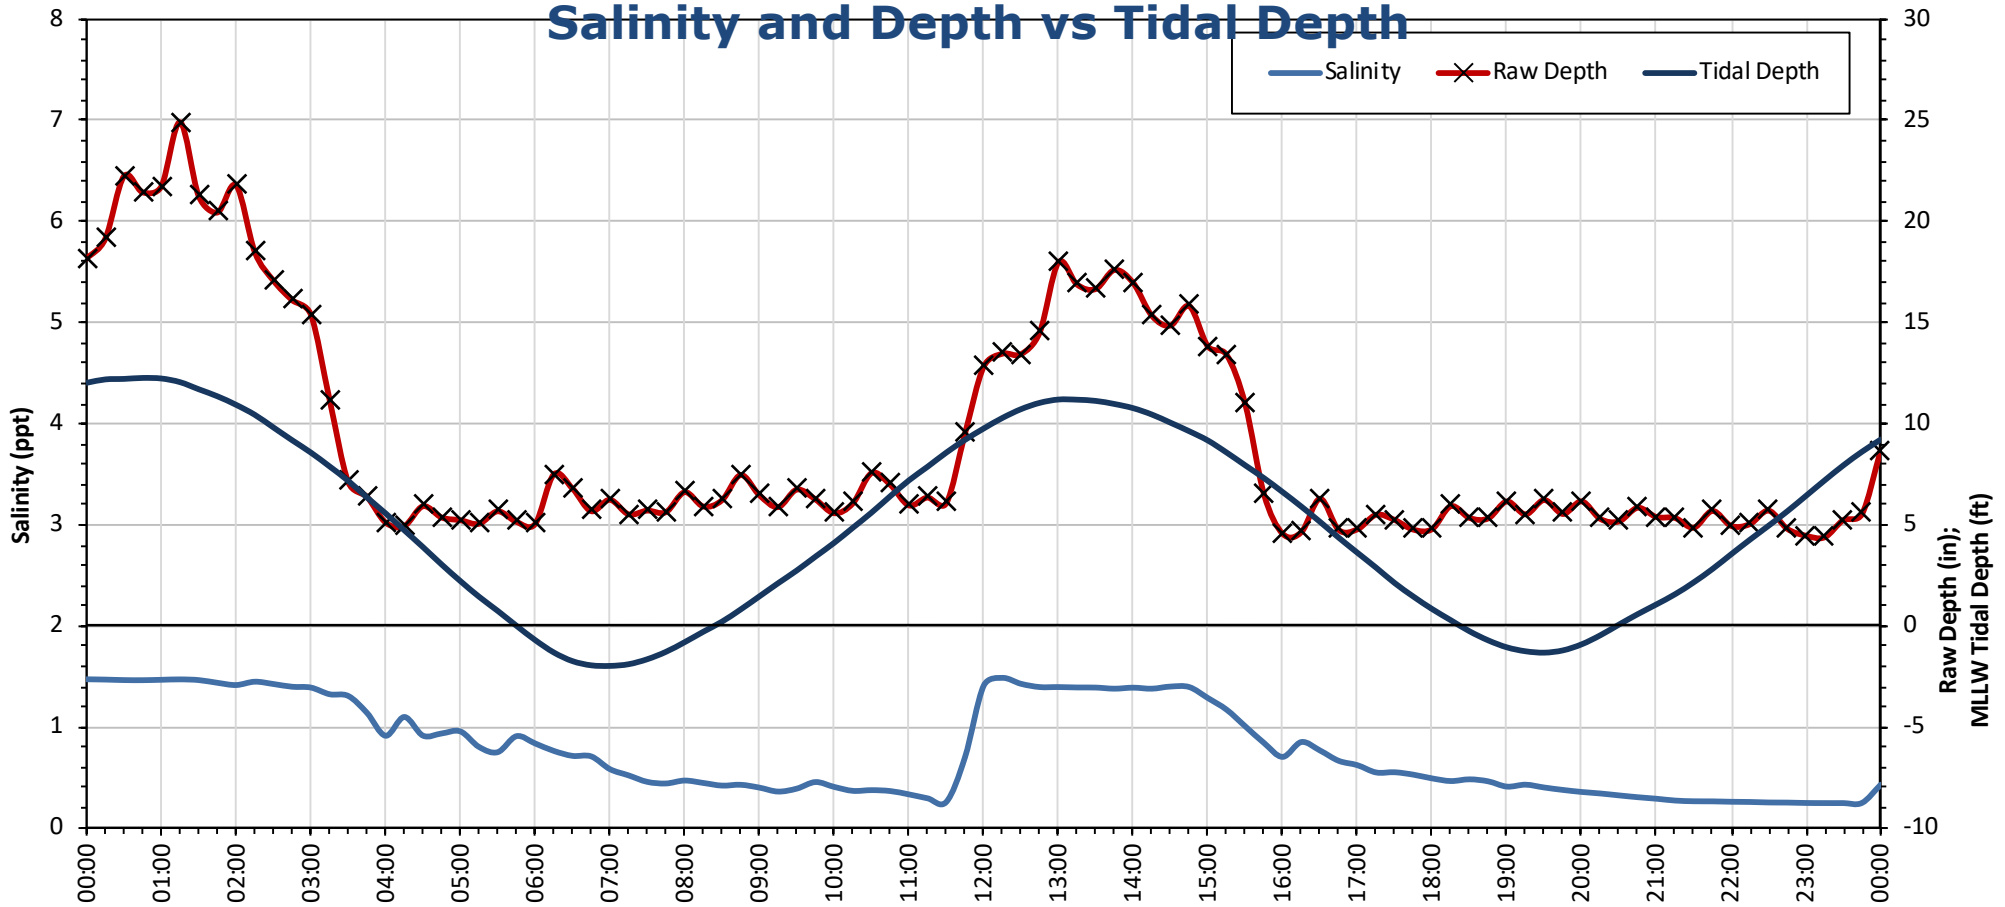
# MH 119 (Harbor Loop) April 10, 2016 – Spring Tide

## Salinity and Depth vs Tidal Depth

- Harbor Loop
  - Flow Depth increases as tidal height increases
  - Impact seen at approximately 8.5 ft tidal height
  - > Suspected Tidal Inflow Source
- Beach Street
  - Salinity increases as tidal height increases
  - Salinity increase generally lags tidal height increase
  - Impact greater when tidal height reaches approximately 10 ft
  - > Suspected Tidal Infiltration Source

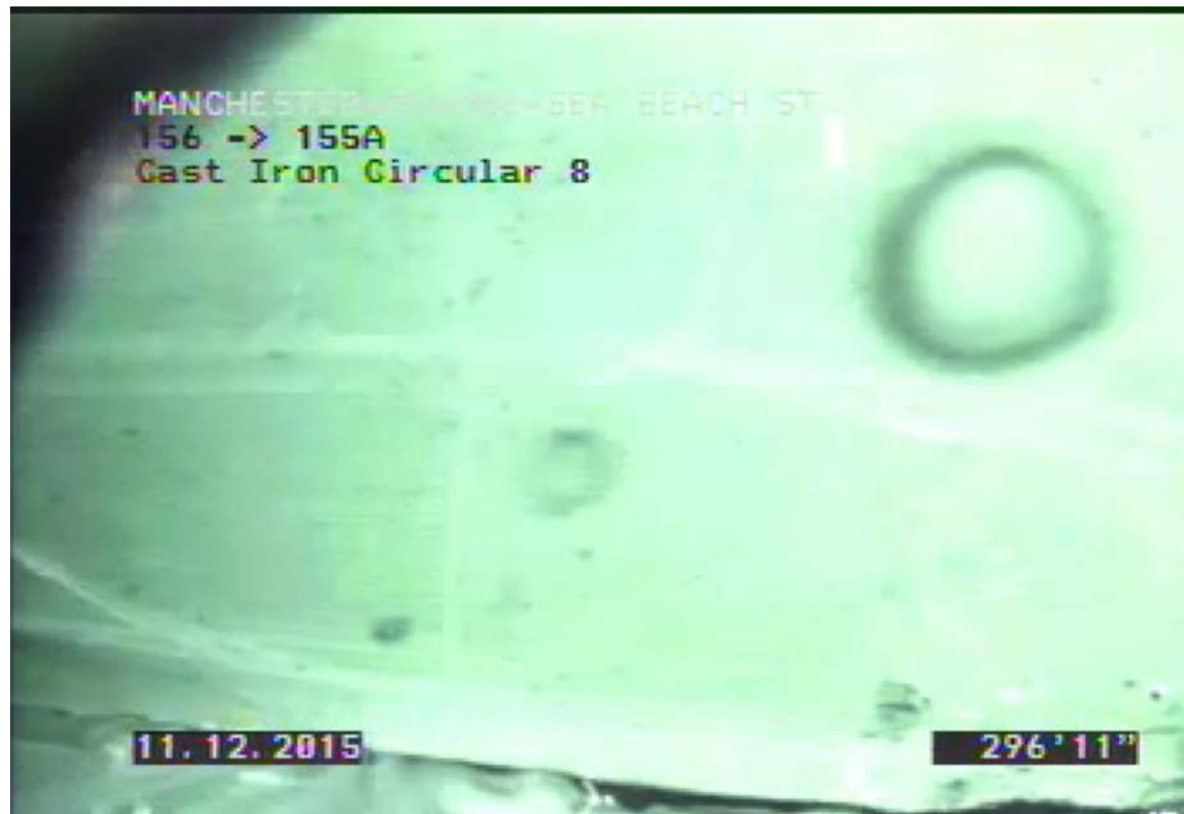
# Beach Street CCTV Investigation Results

November 2015

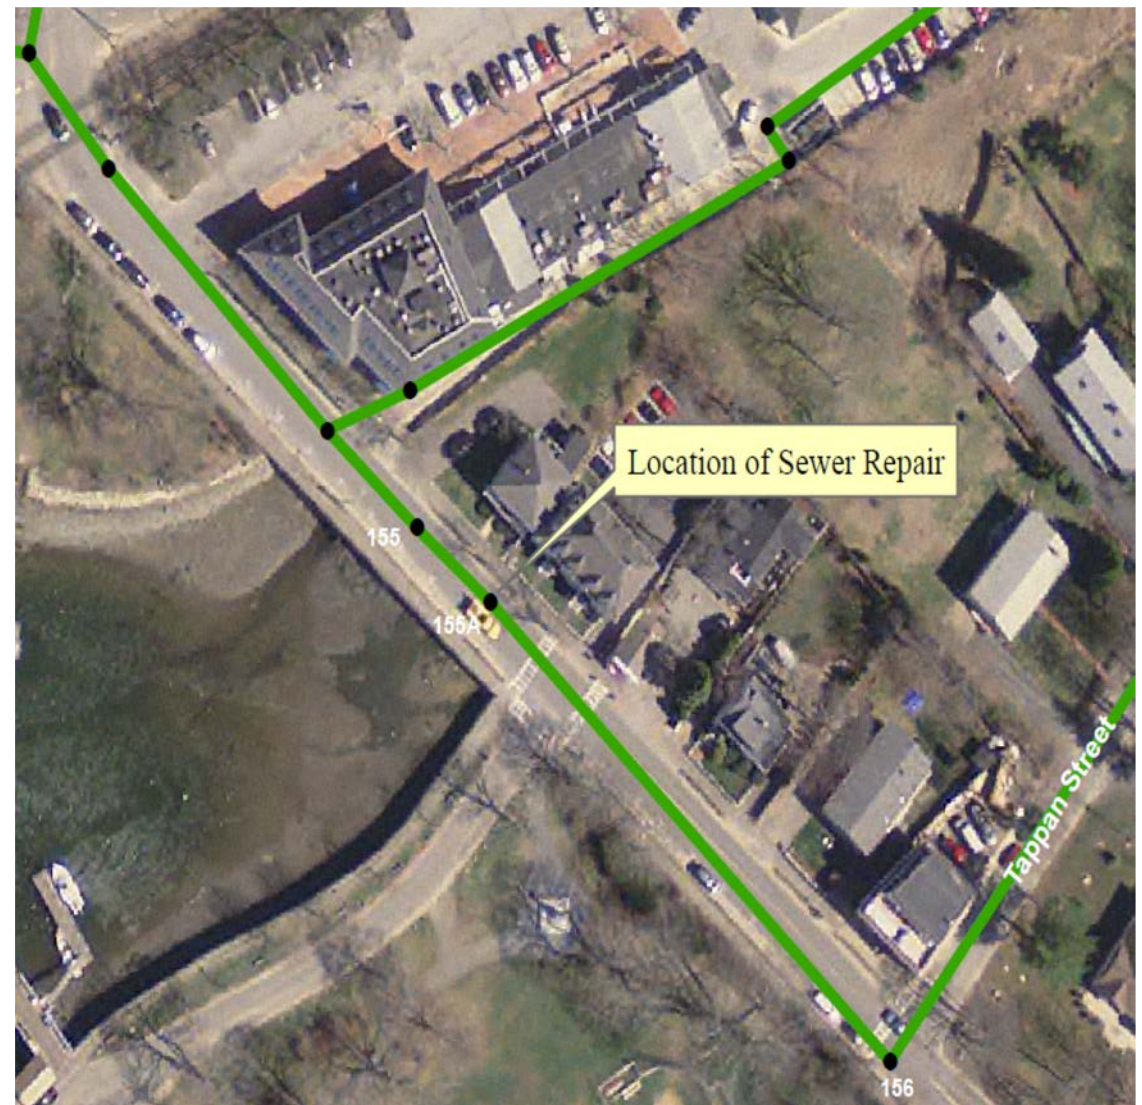
# Beach Street Tidal Infiltration Source

- Downstream of MH 155A
- Estimated Flow: 2,900 gpd
- Repaired in March 2017.

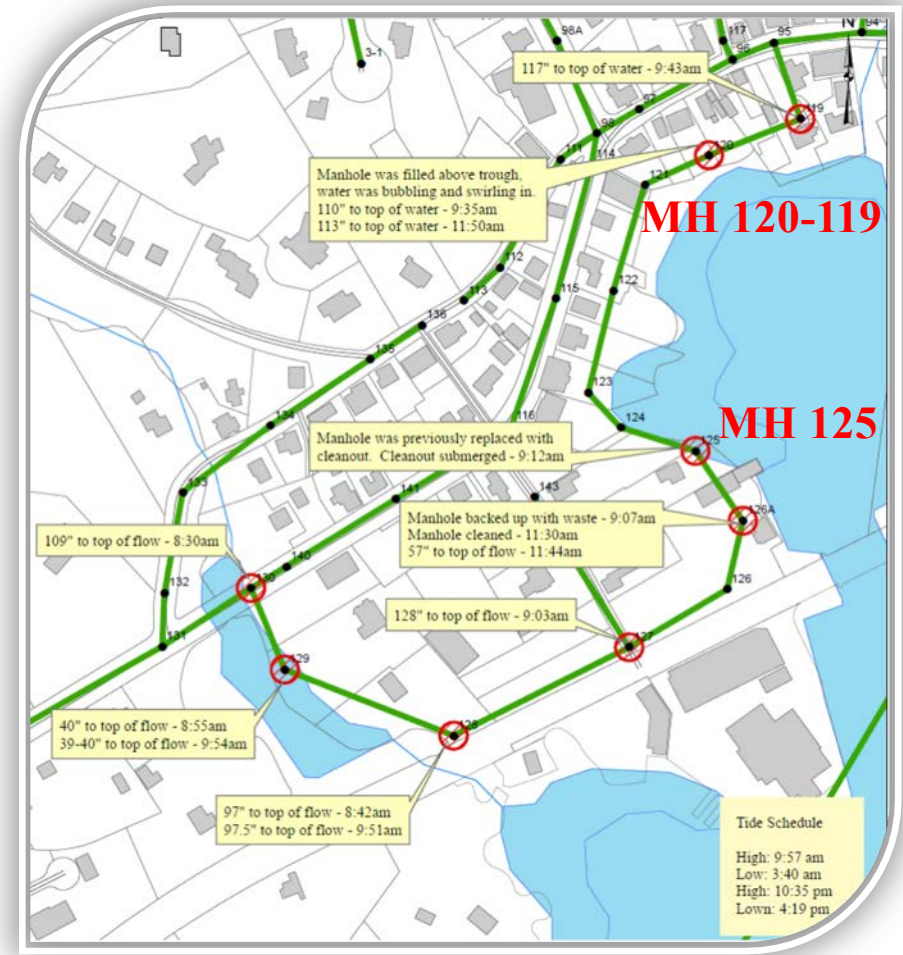
# Harbor Loop Tidal Source Investigations

Visual and depth measurements taken before, during, after high tide.

- Results
  - Depth of flow observed to increase during high tide MH's 119-120
  - No significant change in depth of flow upstream of MH 125.
- Recommended CCTV – Low Tide

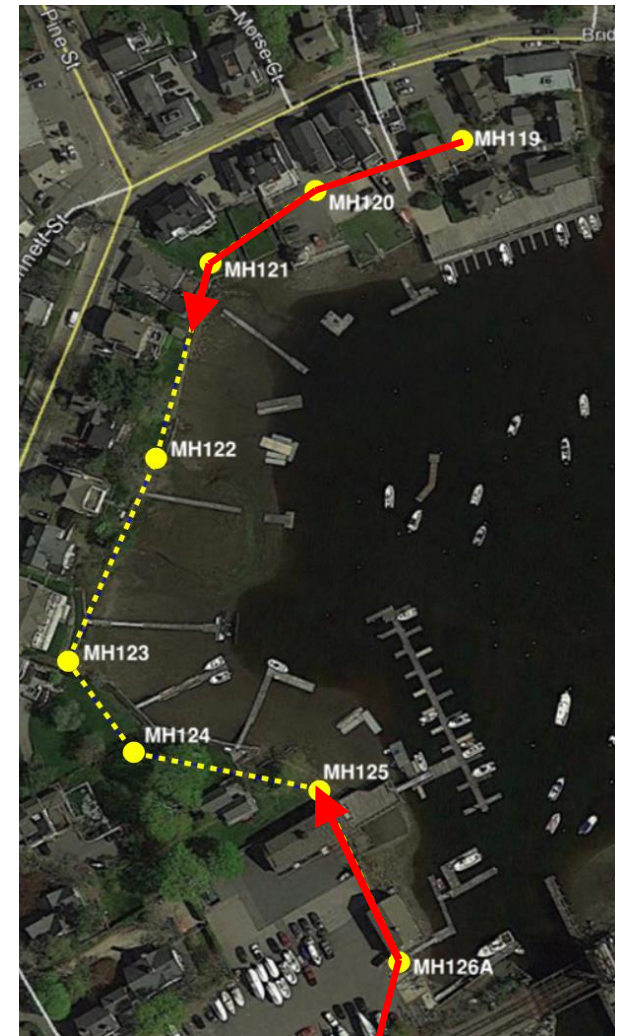
# Harbor Loop CCTV Investigations

- CCTV work unable to be completed
  - Heavy build-up in sewer between MH 121 and 122.
  - No access to MH 125 to guide CCTV through MH
- New Custom Manhole Installation

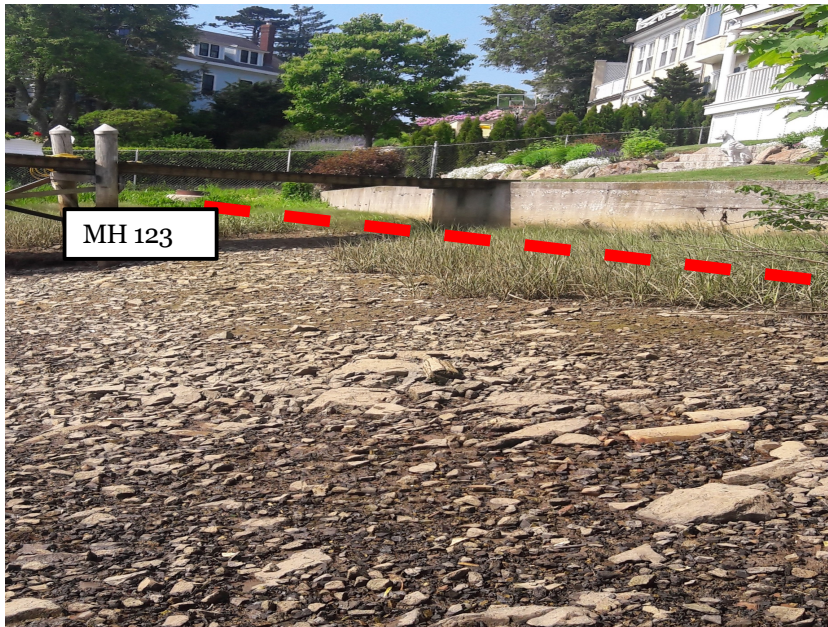
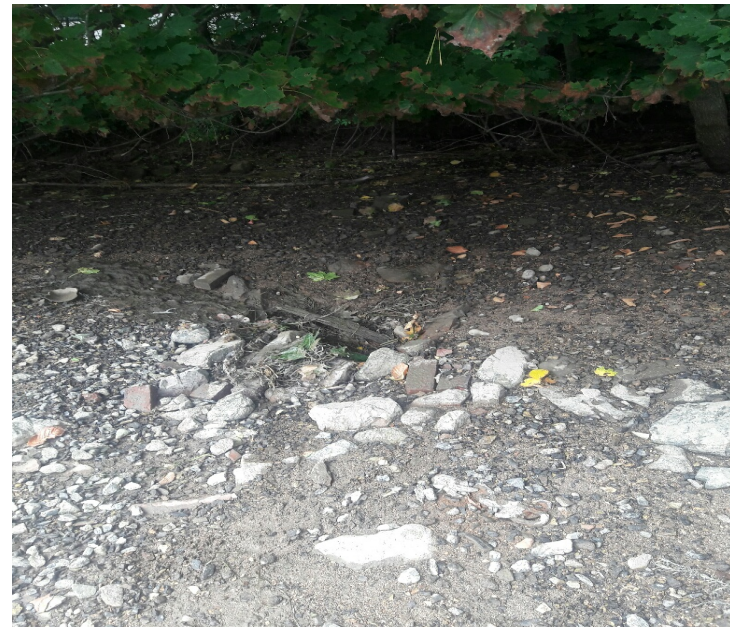
# CCTV Identified Pipe Break

- 8" CI Pipe Located between MH 122 and 123 @ 112'
- Seaweed visible

- Meeting with Town – 9/26/17
  - Emergency Permit 9/27/17
- Emergency Repair – 9/28/17
  - Hand dug about 2' below surface
  - 6' DI pipe with cast fittings on each side
  - Cast Iron Pipe broken upon installation-downstream end
    - 2 Stainless Steel wraps used for temporary fix
      - Pipe condition, materials available, limited time - tide

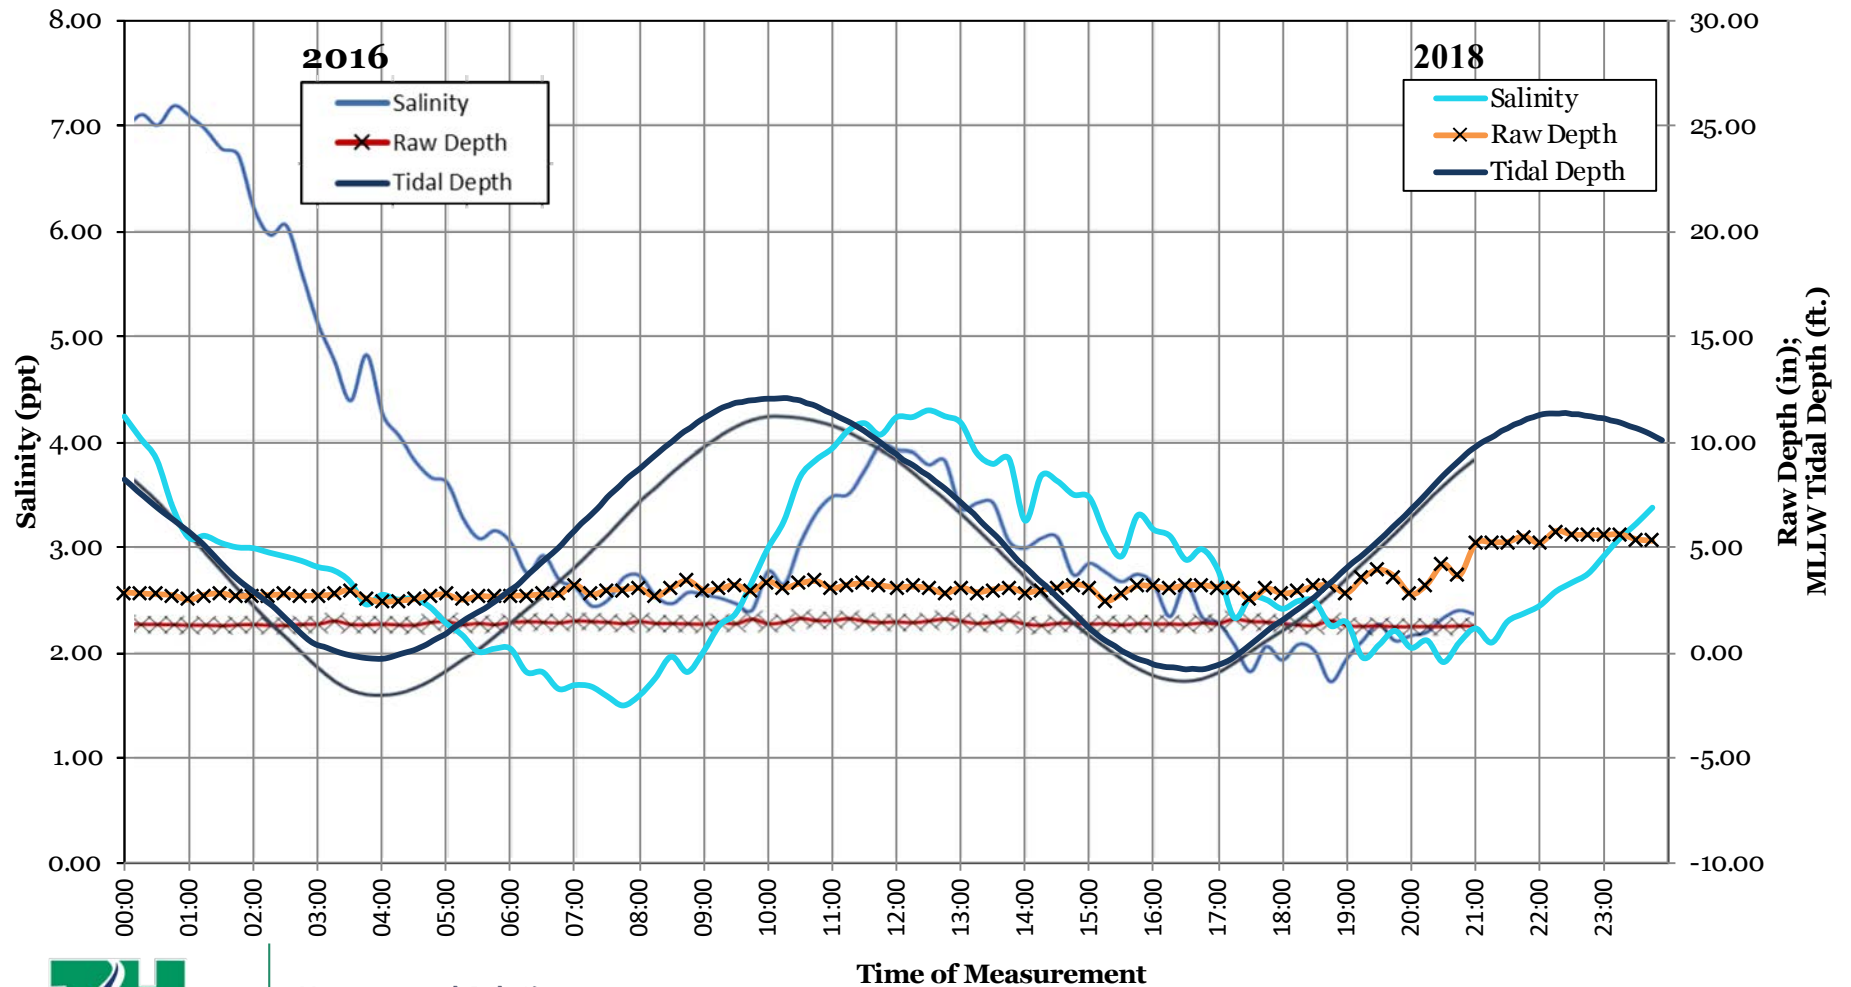
# 2016 vs. 2018 Spring Tide MH 151 (Beach Street)

- Continuous Salinity Metering program was very useful in characterizing tidal intrusion.
- Locating and identifying tidal intrusion sources proved to be challenging.
- Repair of broken pipe in Harbor Loop was successful, confirmed by post-repair Salinity Metering.
- Town of Manchester-by-the-Sea continues to address and correct deficiencies in their collection system.

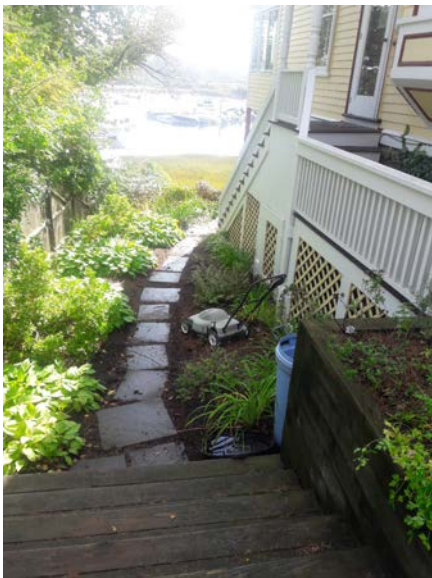
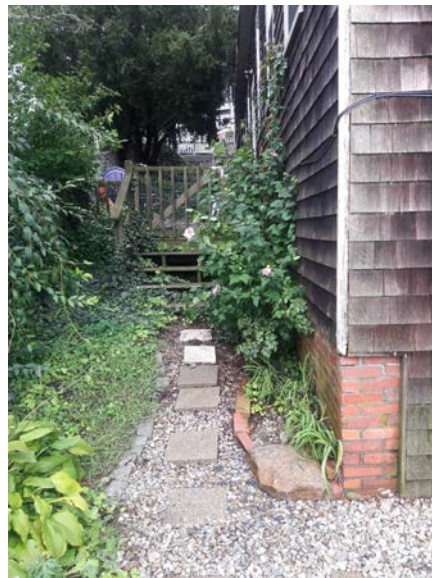
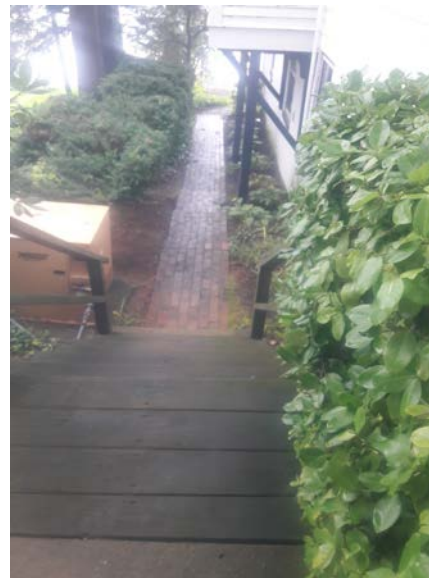
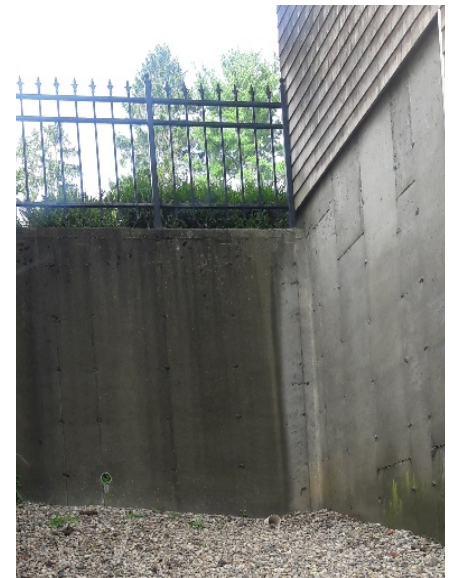
# Grinder Pump Issues

- 7 to 10 foot retaining walls to connect to Bridge Street
  - Possibility of encountering ledge
- Repair to homes/structures/landscaping
- Significant added costs compared to typical grinder installation

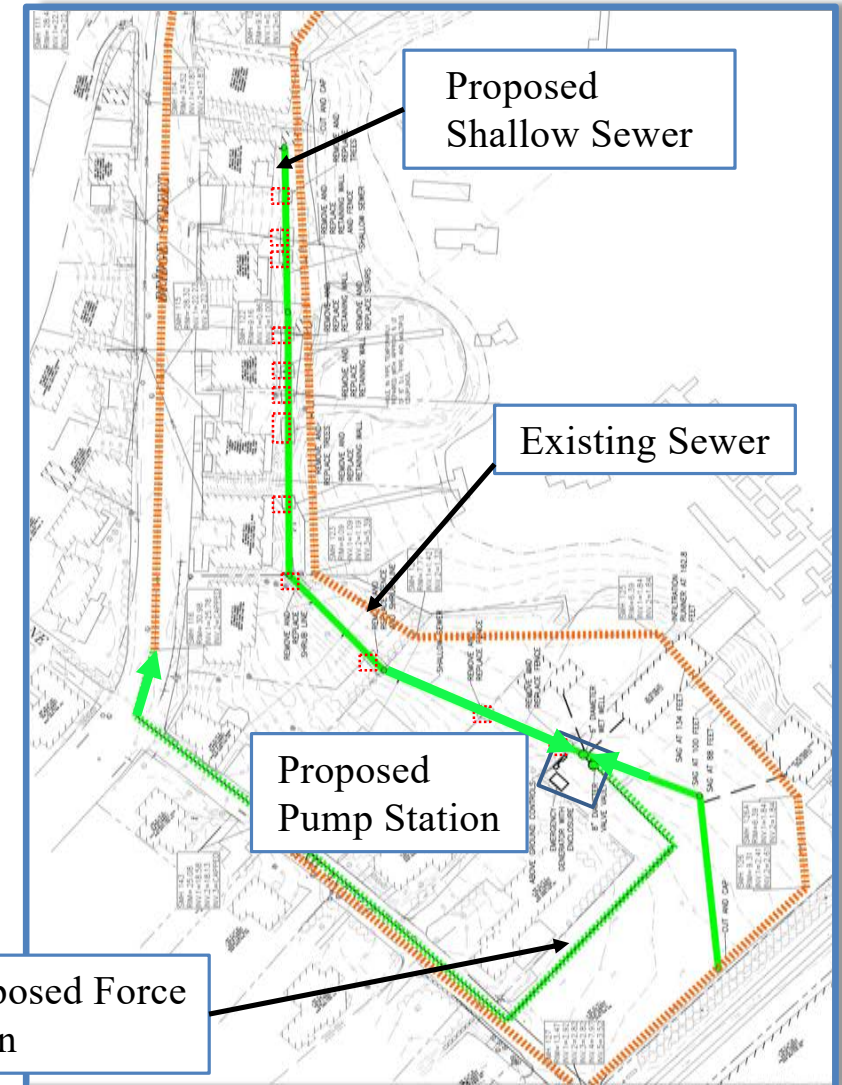
# Pump Station Shallow Sewer Alternative

- Shallow sewer through backyards
  - Sewer ~ 4 ft above existing
  - Existing Sewer MH 121 - MH 119 to remain
- Numerous Property impacts
  - fencing, decks, retaining walls, and landscaping
- Significant Disruption to Homeowners
- Pump Station
  - Boat Yard property
  - Land Acquisition, Easements
- More costly than lining

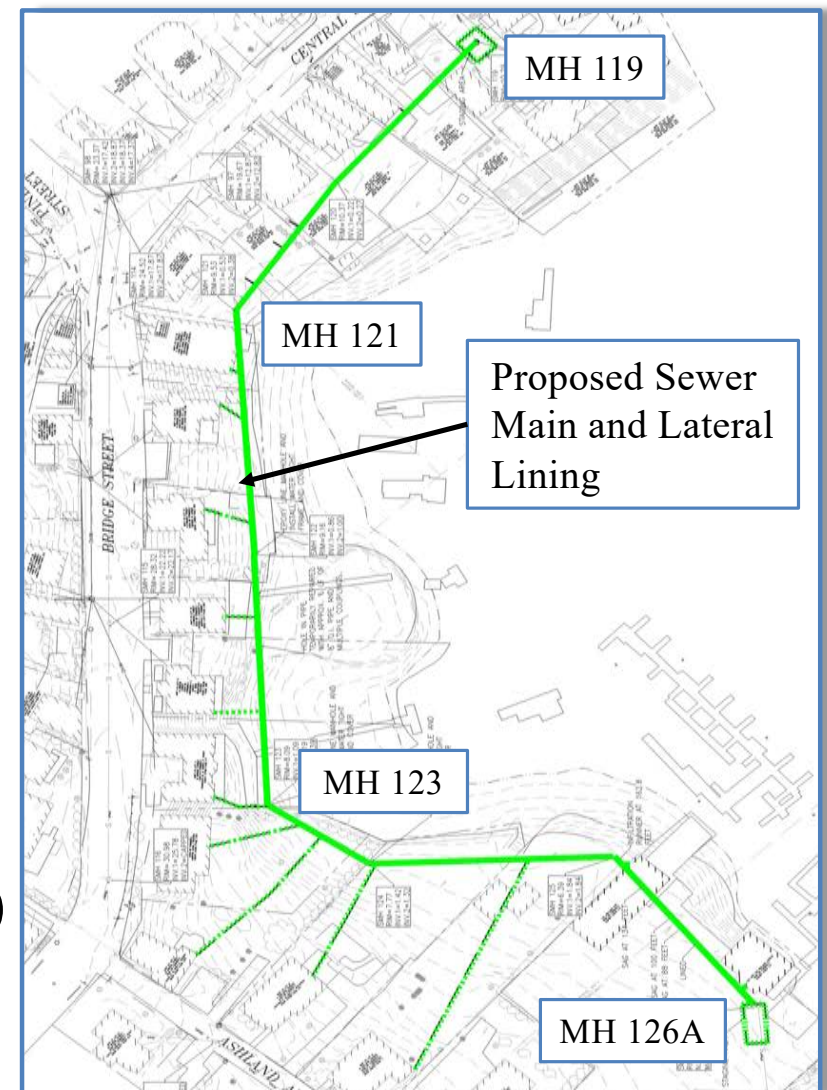
# Sewer Lining

- Access Issues MH121 to MH123
  - Extend Lining to MH 126A
- Pipe Condition
  - Light Cleaning
  - Water inversion, Hot water cure
    - Less Efficient, longer cure
- Concerns
  - Finished pipe takes shape of existing pipes (sags, imperfections)
