North Metropolitan Sewer Sections 4, 5, 6, and 186 Study

LiDAR Scanning and Strategies to Guide Rehabilitation Planning

January 28, 2019

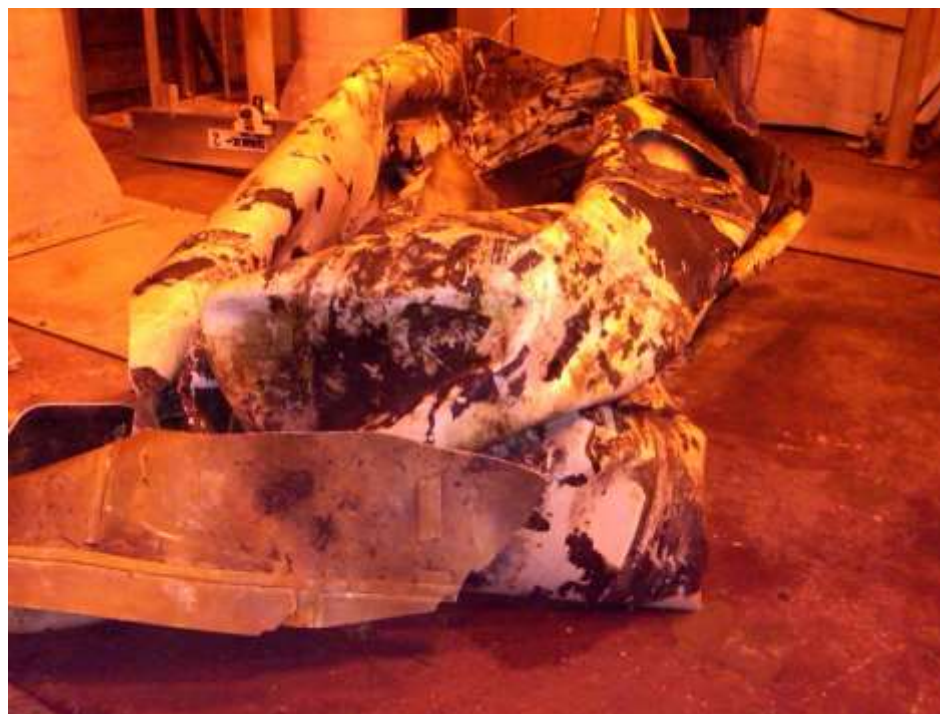
- Videos showed peeling epoxy liner
- Contractor noted shotcrete was soft in places
- The only way to understand extent of the issue was a manned inspection and internal scan
- RFQP issued

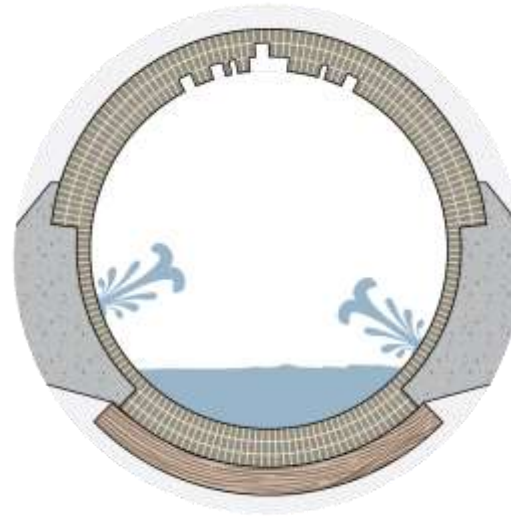
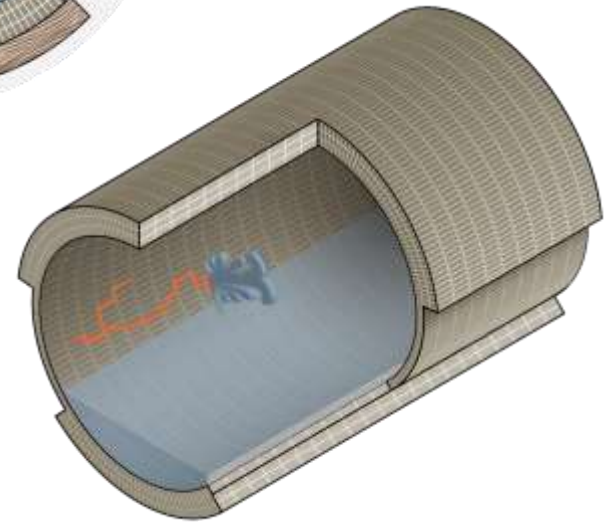
1980s – CCTV Inspection

- Sewer constructed in 1890s
- Bricks missing
- Infiltration
- Deteriorating mortar

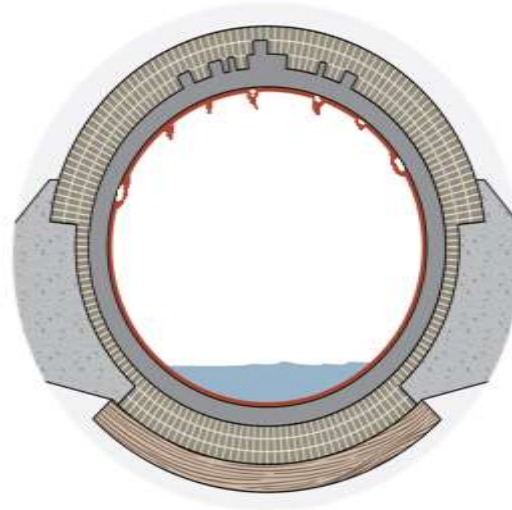
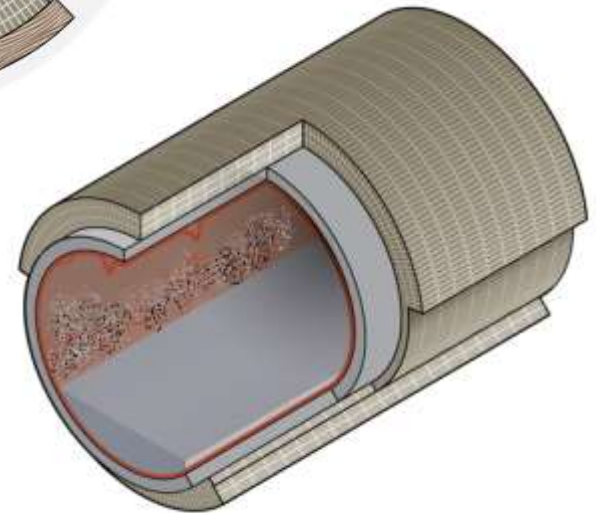
Epoxy delamination

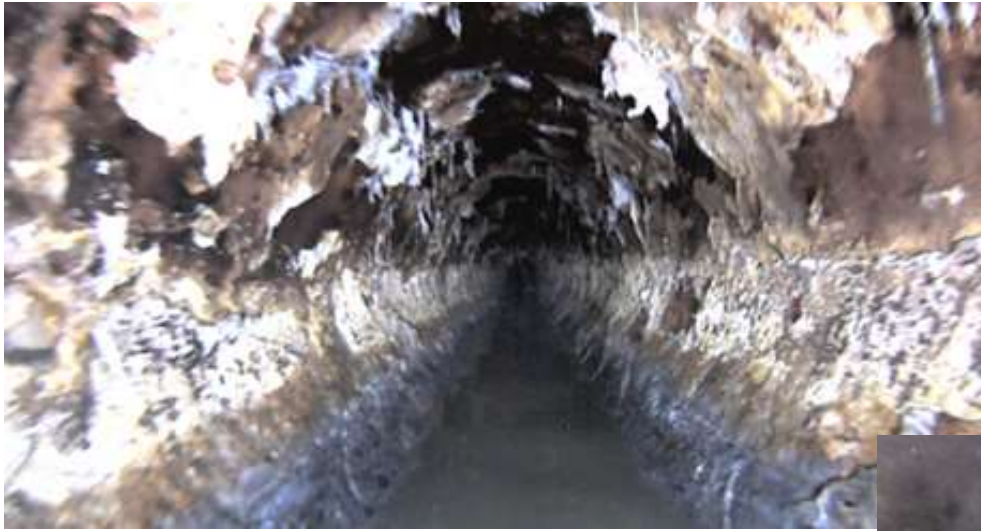
Liner delamination

Condition of shotcrete?

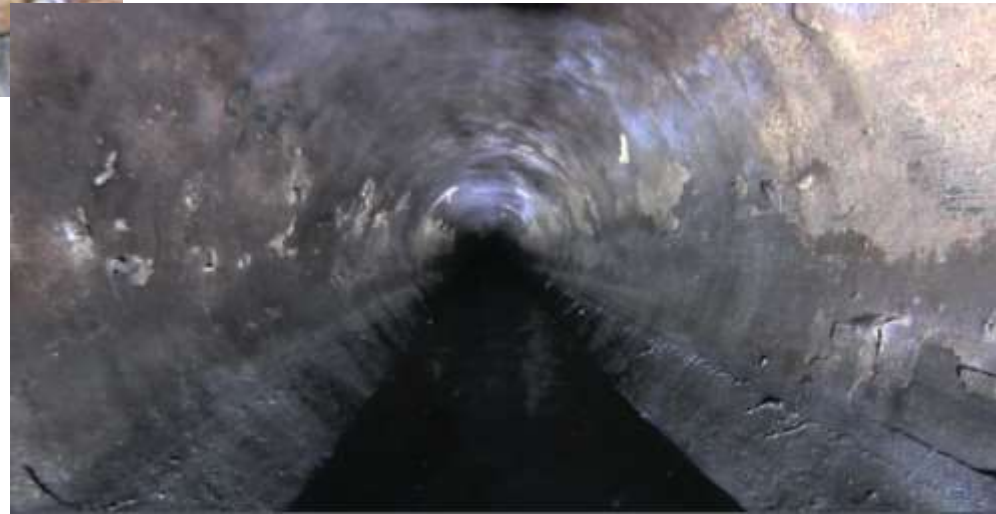
Surface spalling

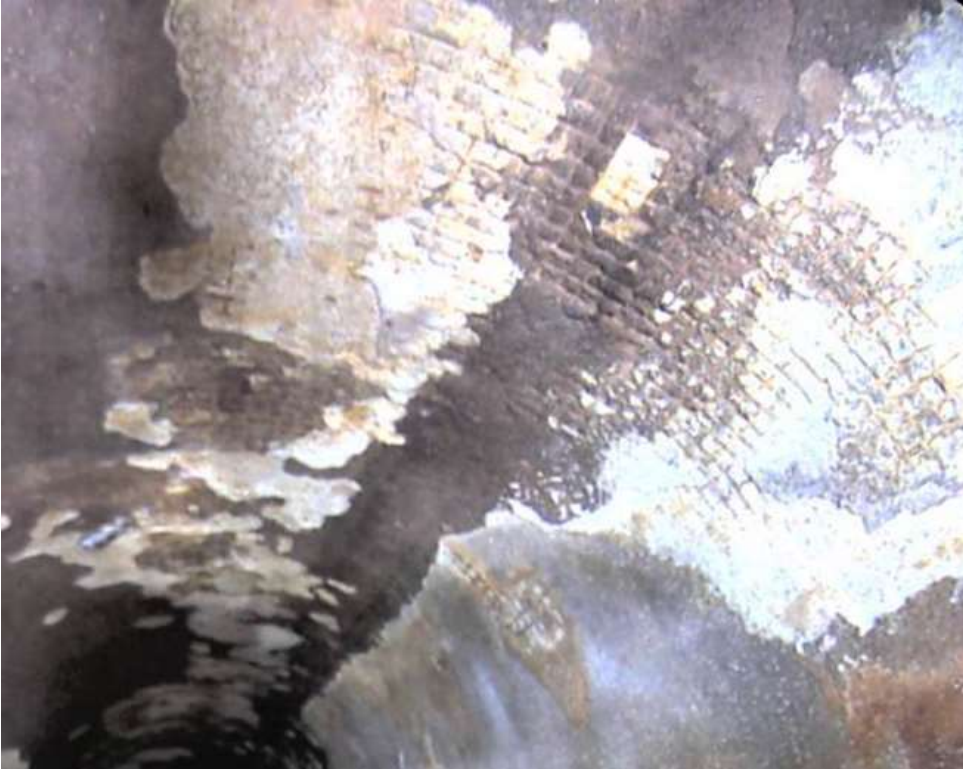
~35 LF of exposed rebar

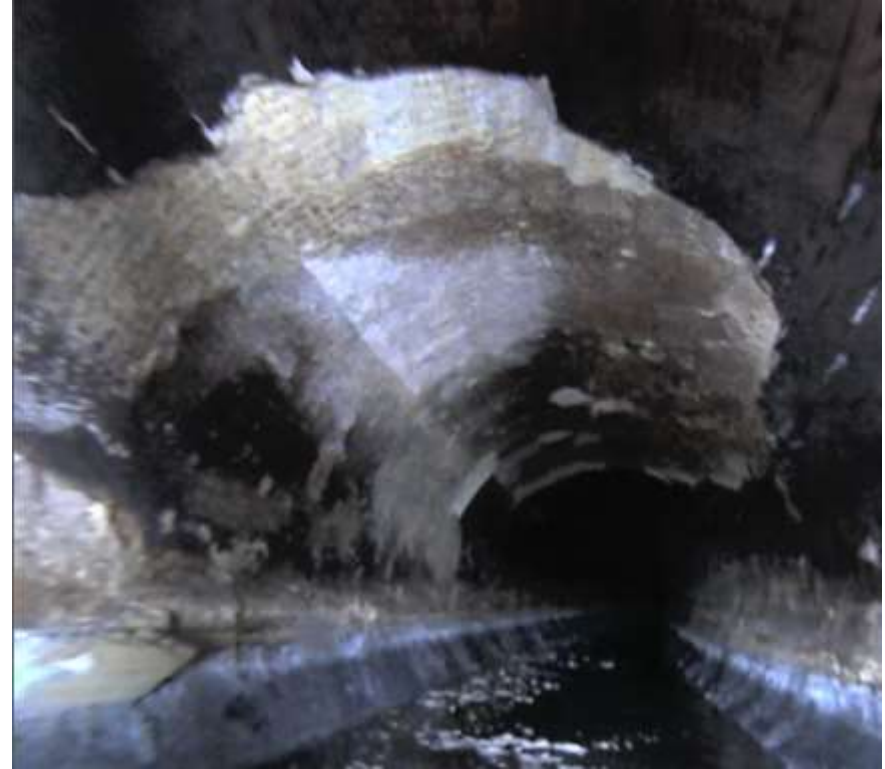
~25 LF of exposed rebar

Technology	Reasons			
Slip-lining	<i>Bypass pumping not needed</i>	<i>Fully structural</i>	<i>Corrosion resistant pipe</i>	<i>Many straight runs lends itself to slip-lining</i>
Segmental lining (25' of exposed rebar)	<i>Structural repair (wire mesh is likely already compromised)</i>	<i>Prevent further corrosion</i>		
Spray-on (over exposed steel)	<i>Prevent corrosion / rust of exposed steel</i>	<i>Shotcrete with MS has been proven within the NMS</i>	<i>Potentially improve flow hydraulics</i>	
Chemical grout	<i>Infiltration should be stopped to prevent sinkholes</i>		<i>Infiltration must be stopped before spray-on lining of steel pipe</i>	
Internal Joint Seal	<i>Infiltration in sand catcher chamber might be too heavy for chemical grouting</i>

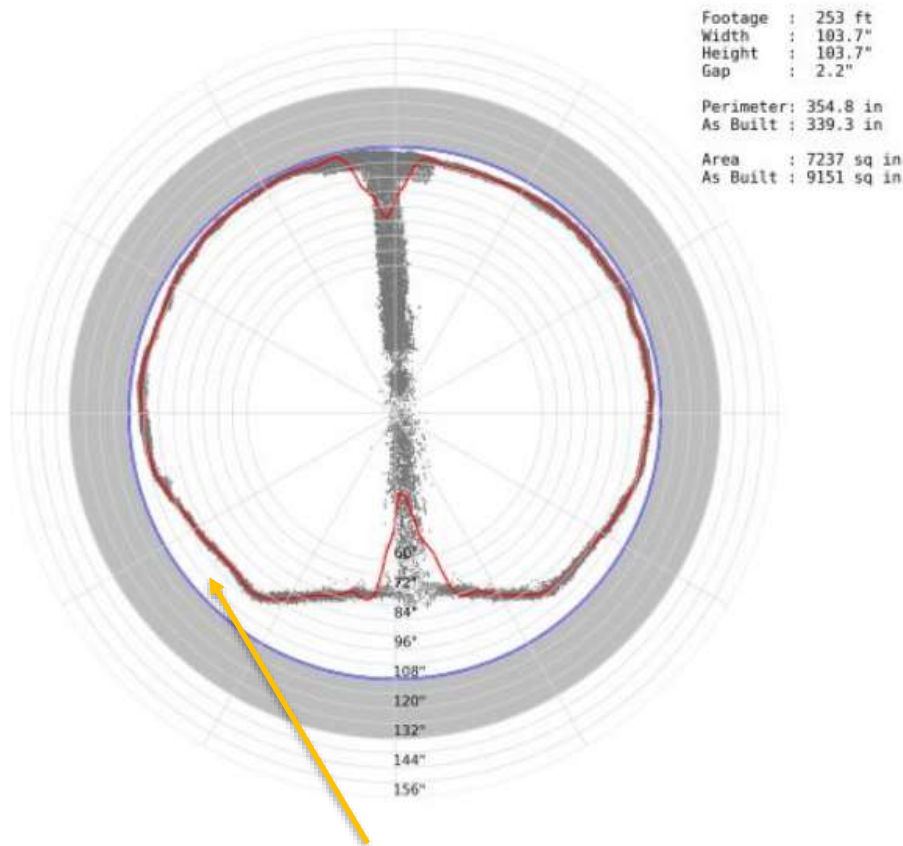
Careful QC is required

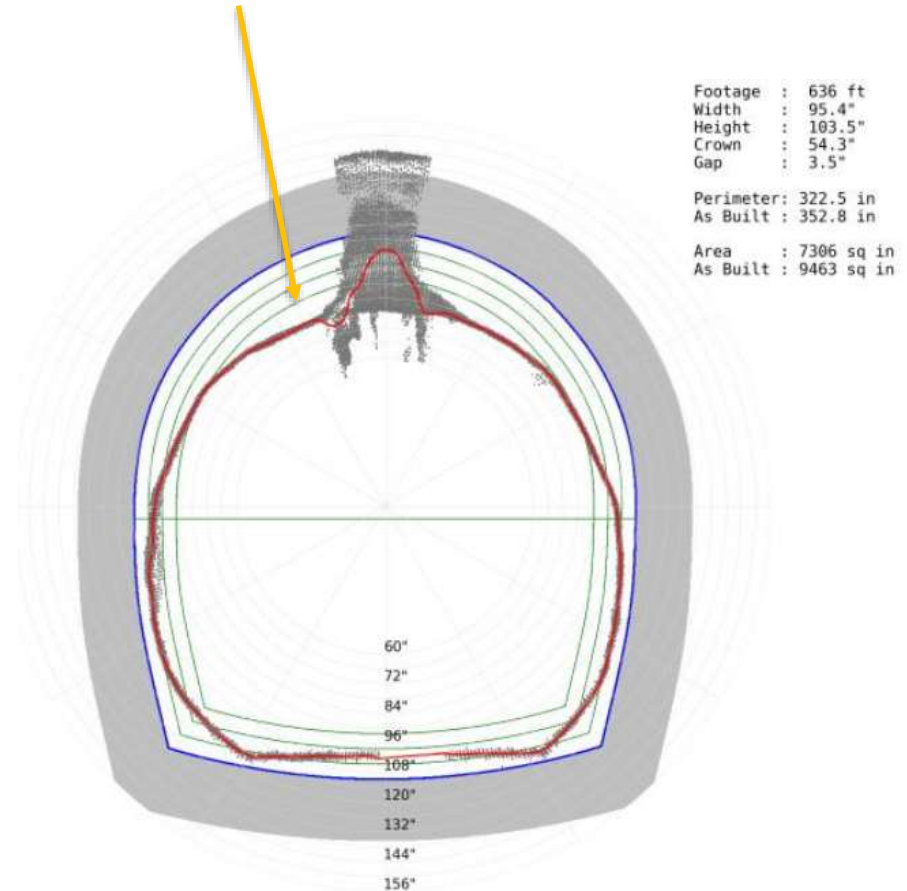
Several feet of shotcrete?

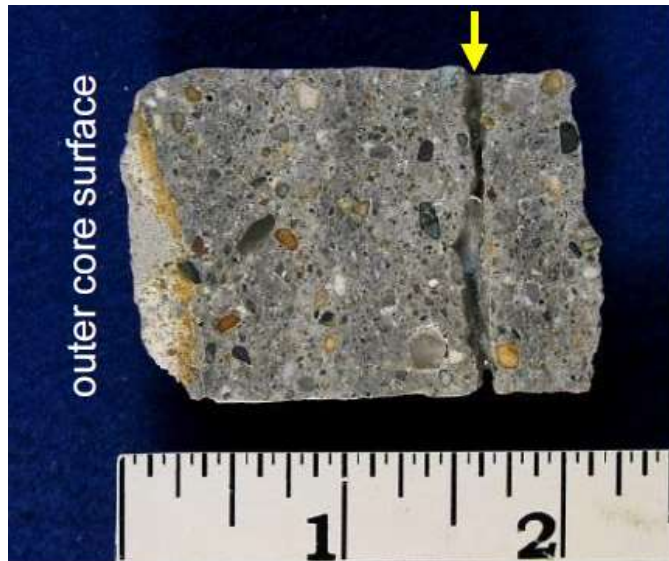
Core at STA S004 0002+62 (spec'd at 6")

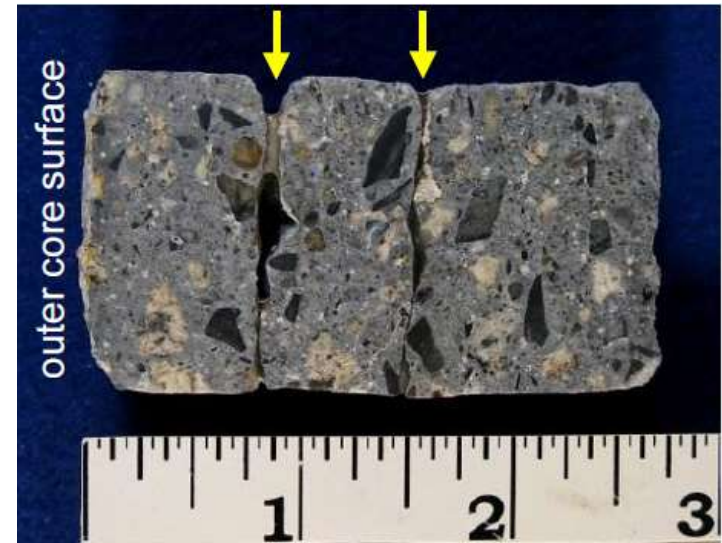
Core at STA S004 0048+32 (spec'd at 3")
