Condition Assessment Of FRP Assets Case Histories: Where and How to Look

Randy Nixon

Corrosion Probe Inc.

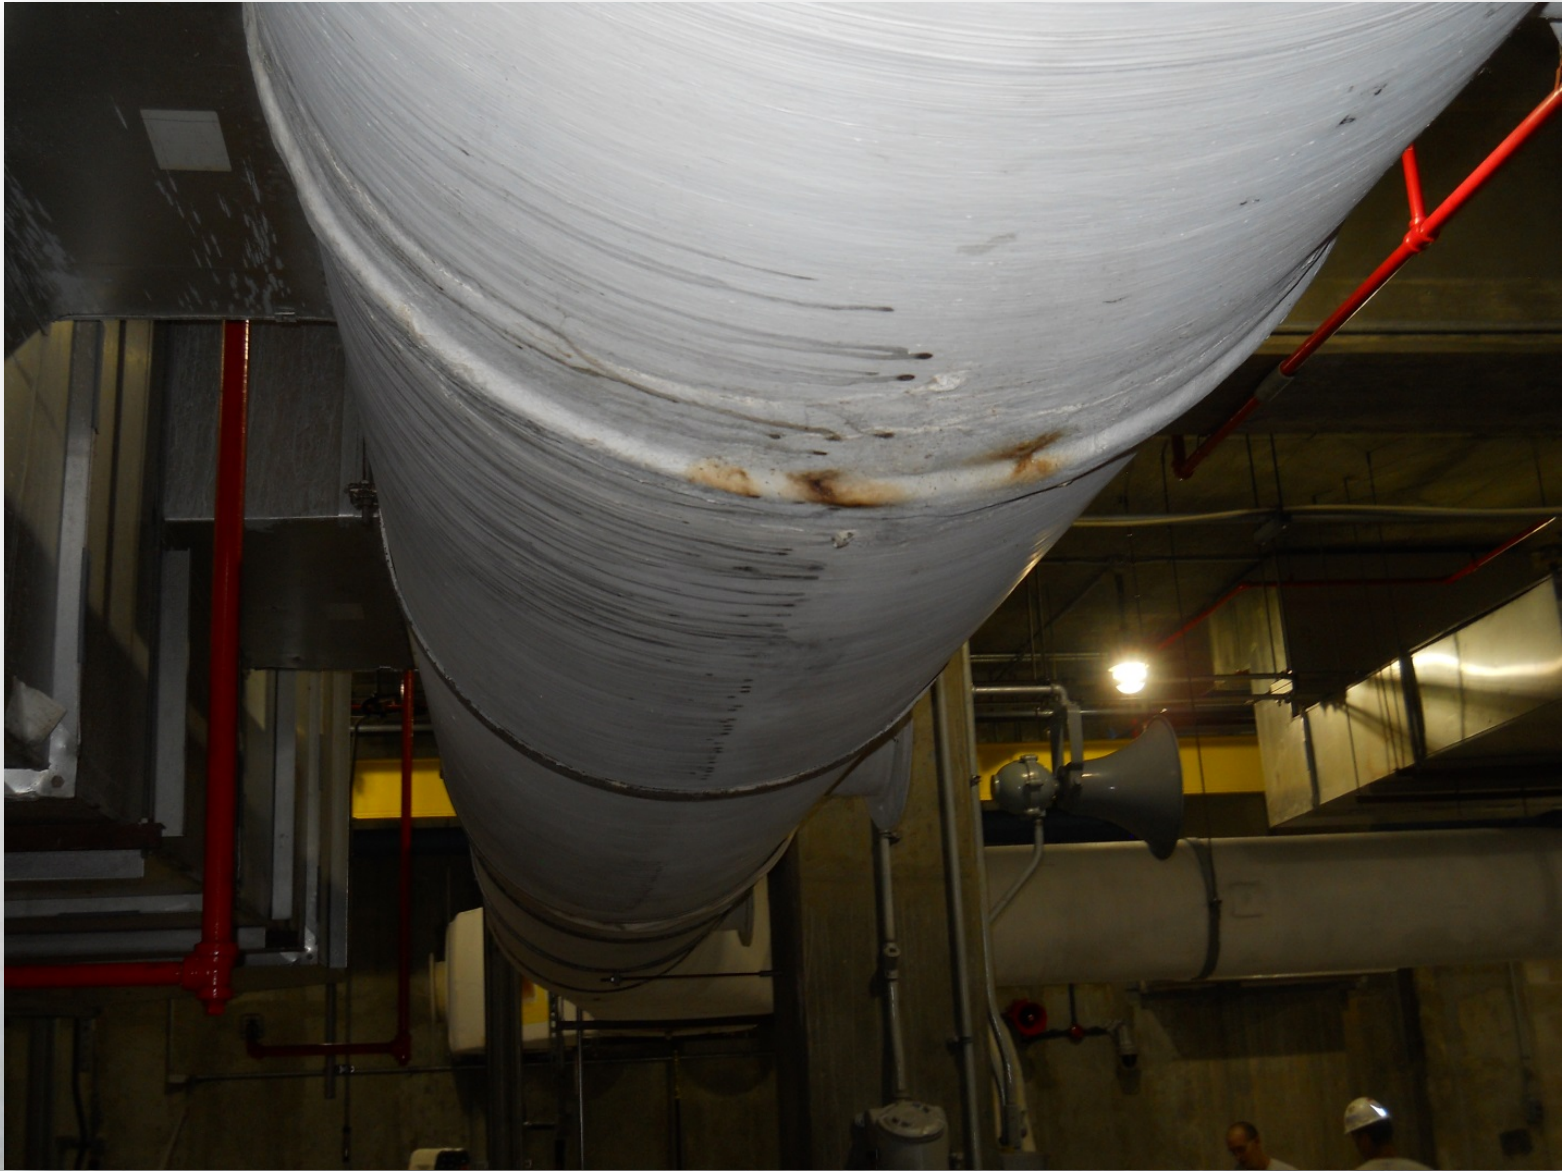
View of round ductwork on Grit Level – note leakage

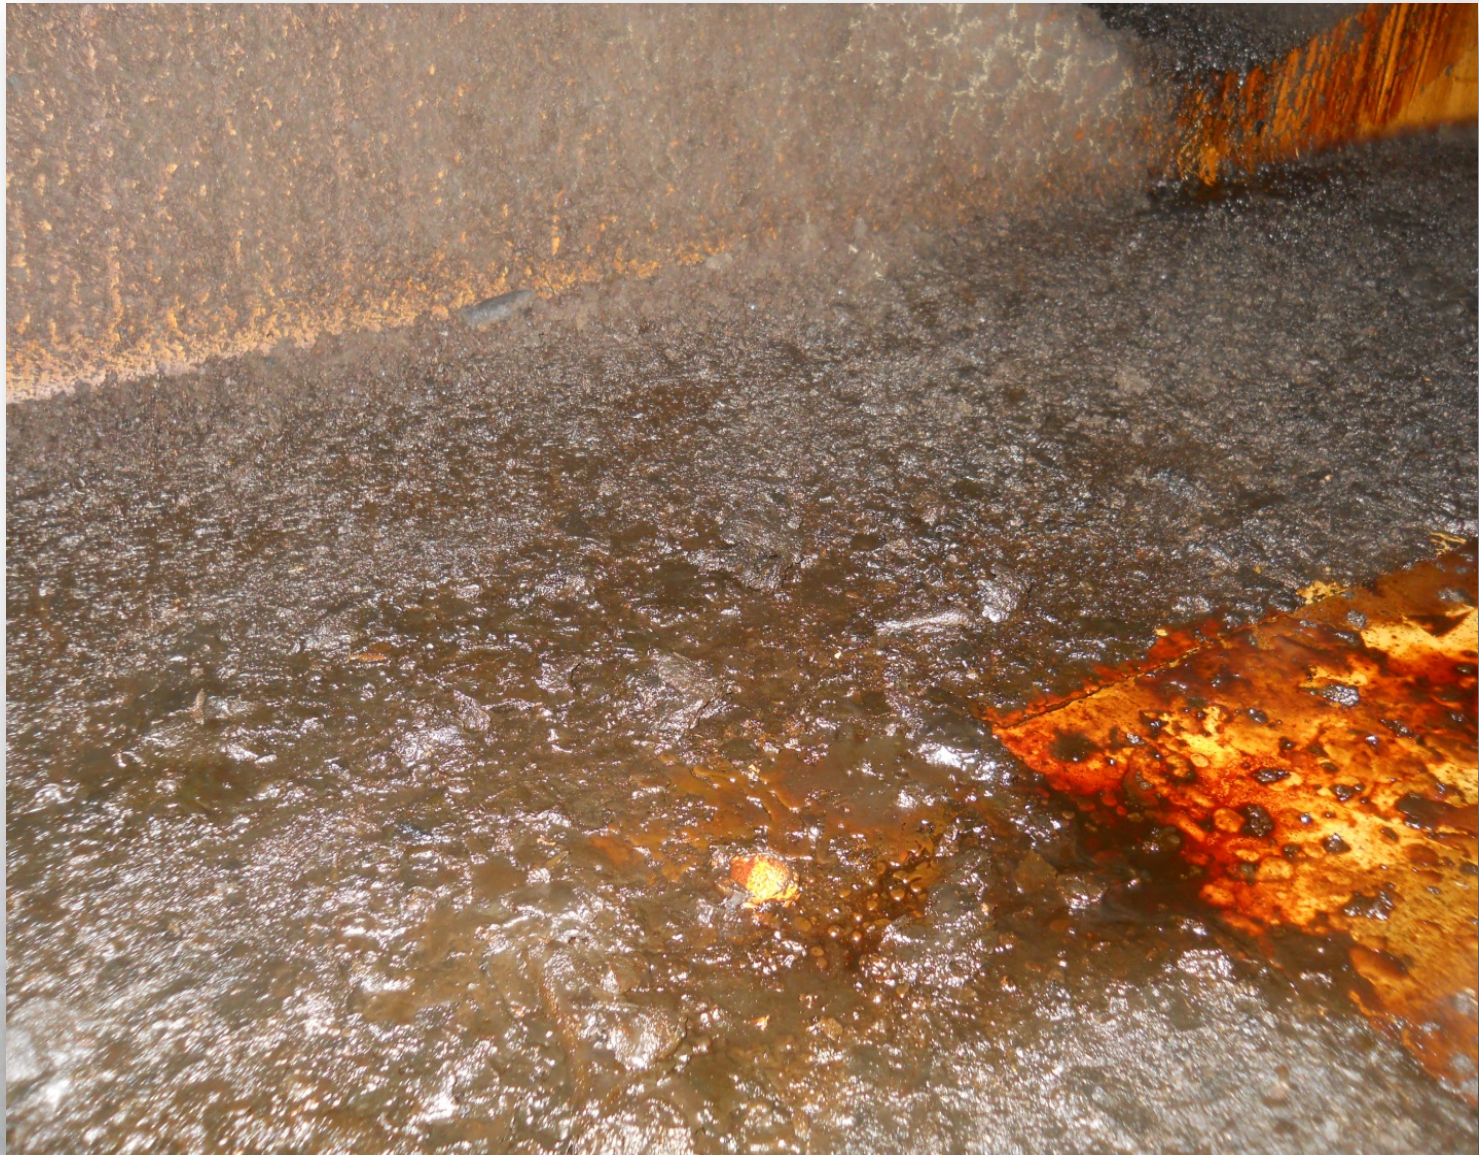
Abrasion damage to corrosion barrier

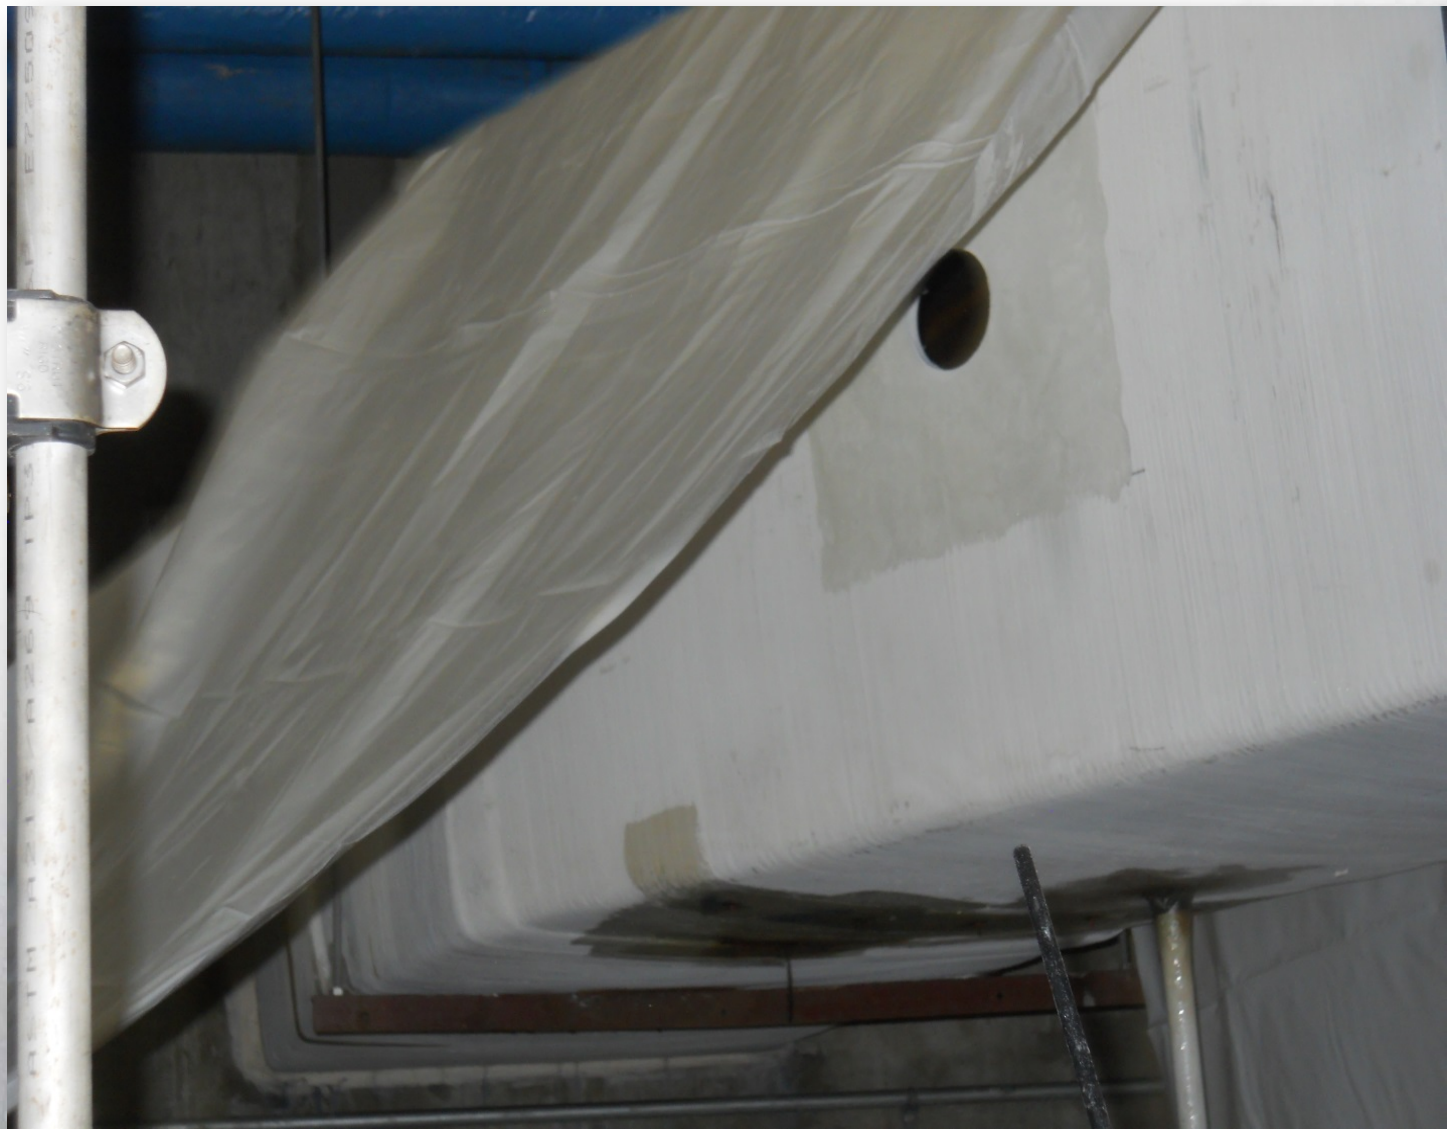
Shows the core hole in the duct – sample area

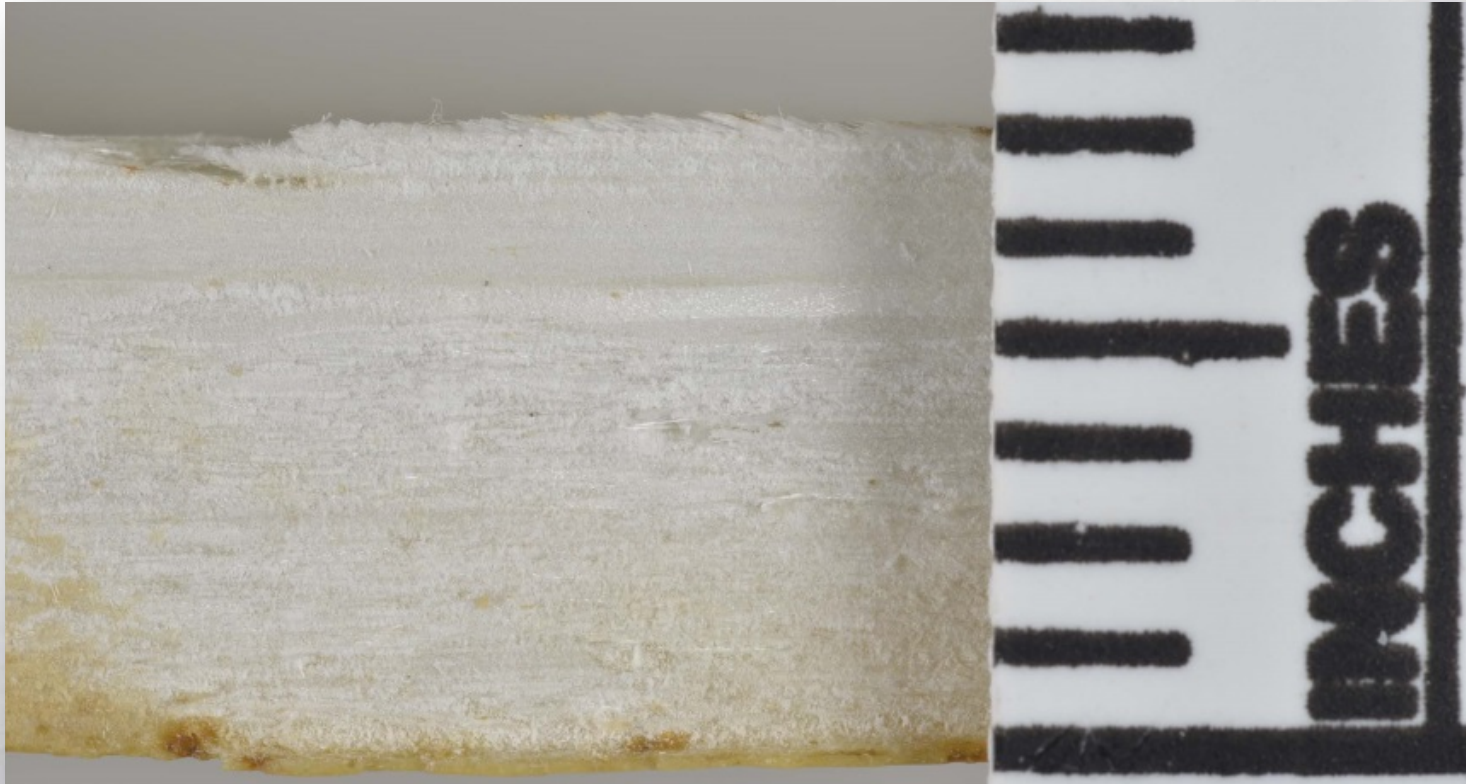
Area "A" FRP core sample: typical appearance of cross-section showing no apparent degradation

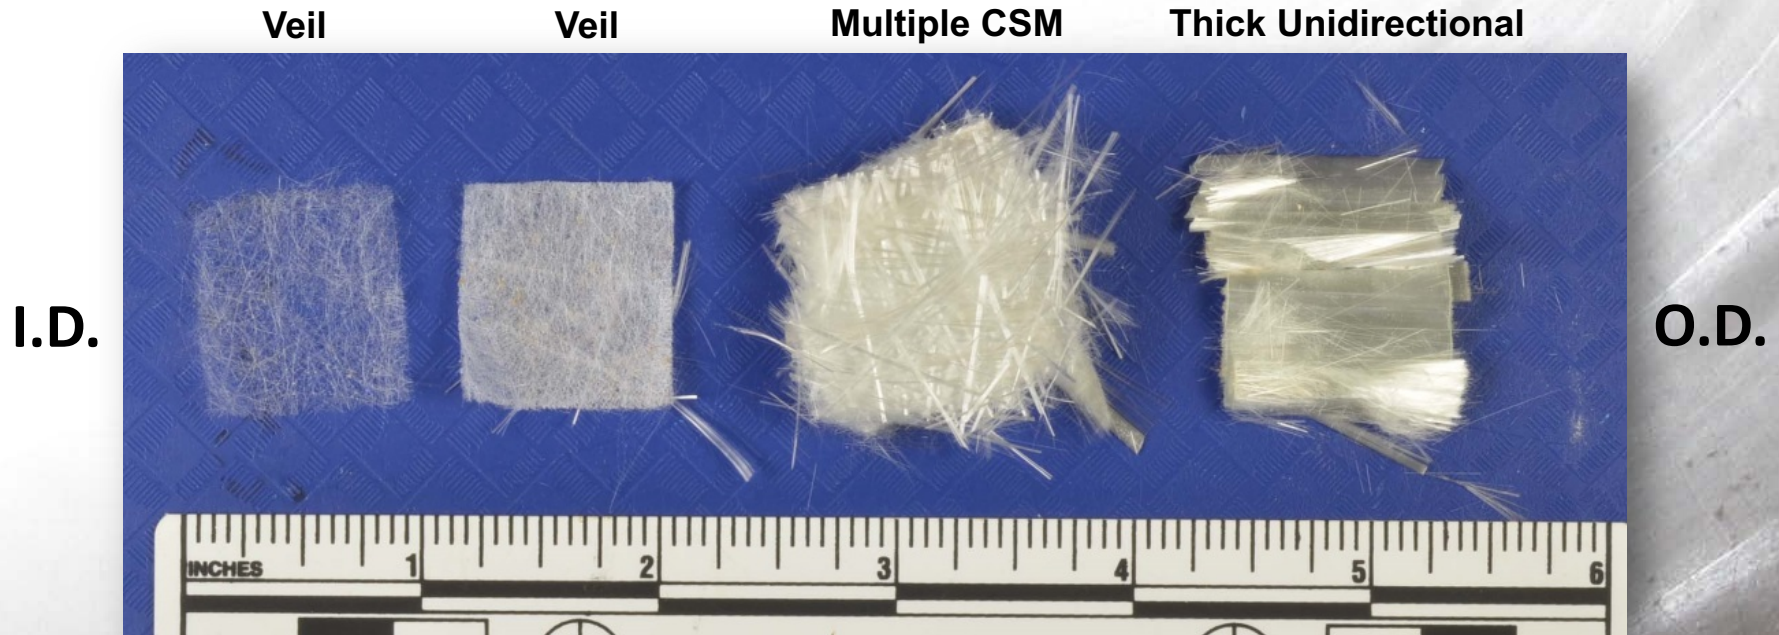
Laminate sequence from Area “A” FRP core (Test specification #1)

This laminate sequence analyses reveals double resin rich veils which exceeded the 20 mil minimum thickness requested by the MWRA performance specifications (Section 15680, 2.07 D.)

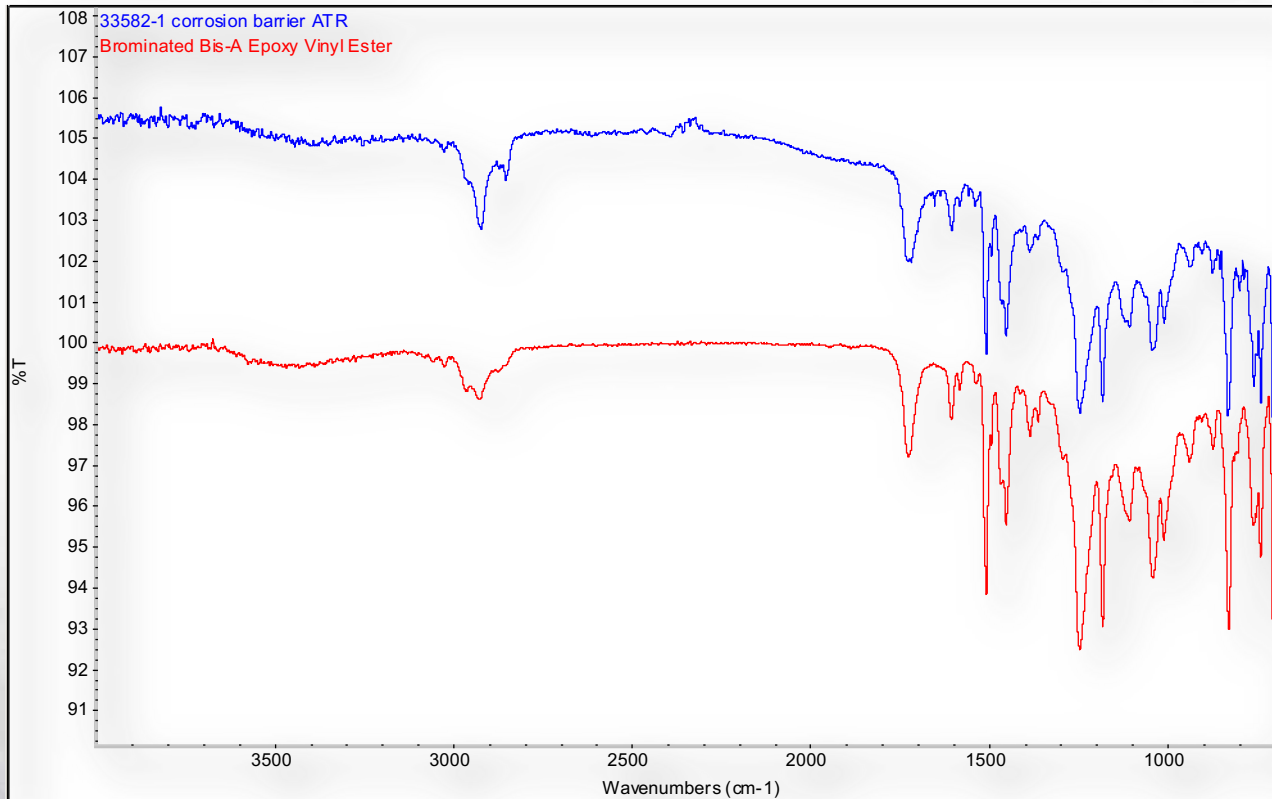
FTIR-ATR spectra of Area A FRP core inside surface (blue) and for reference sample of brominated bisphenol A epoxy vinyl ester resin (red).

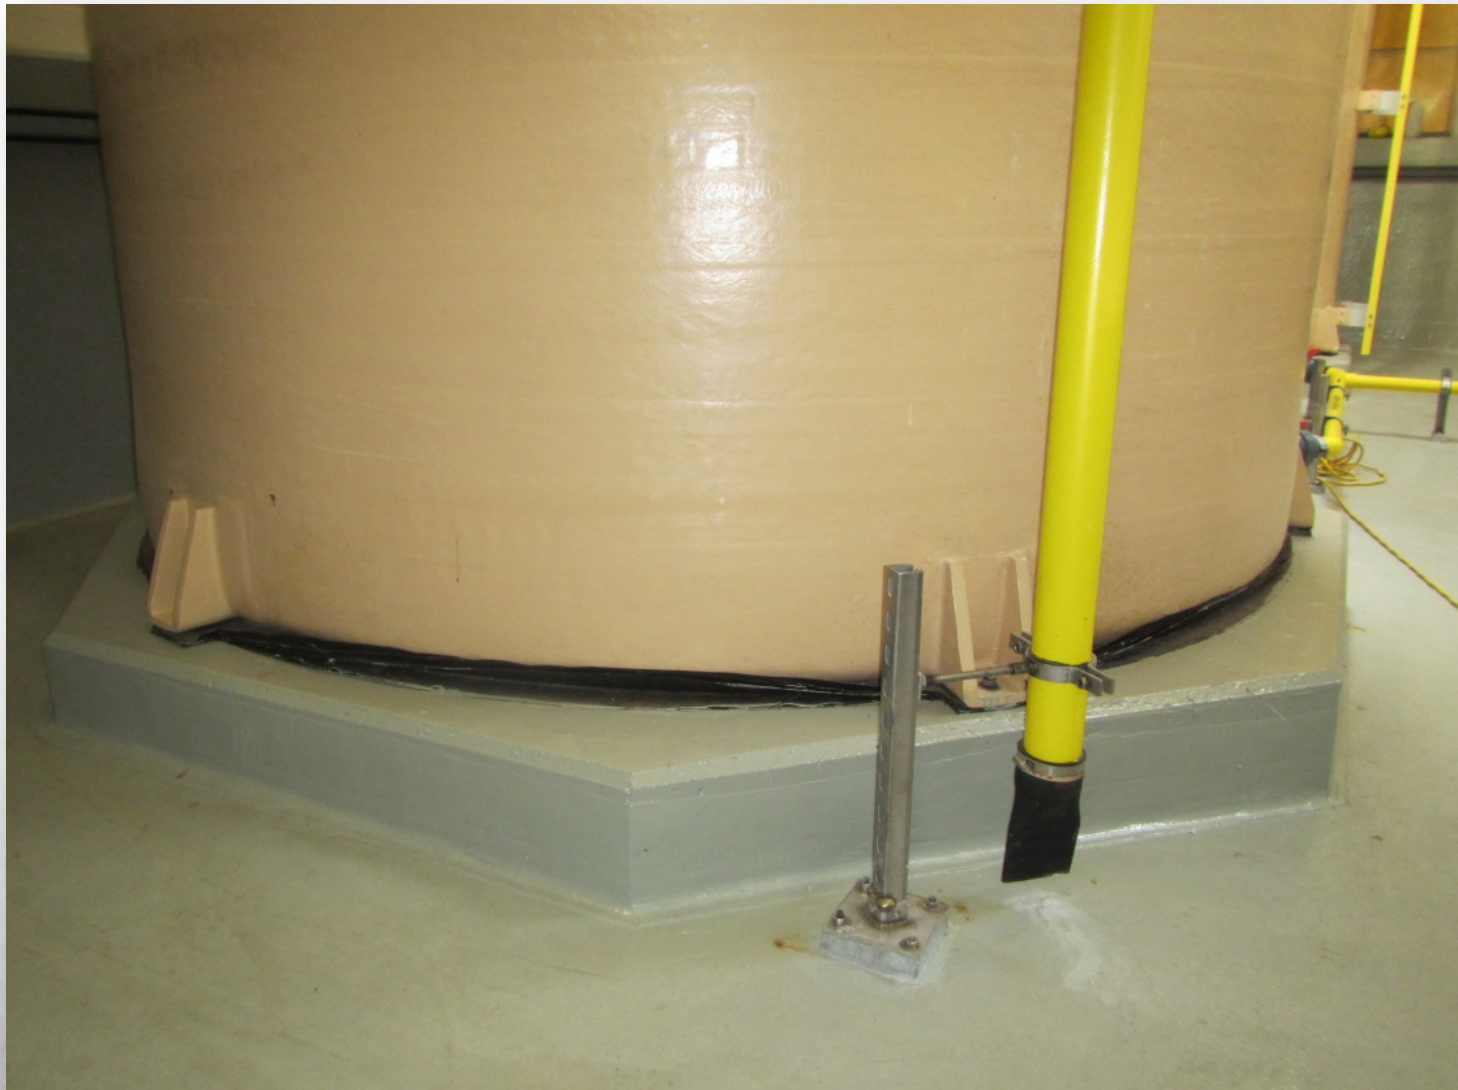
**Concrete tank base, containment
area and protective coatings**

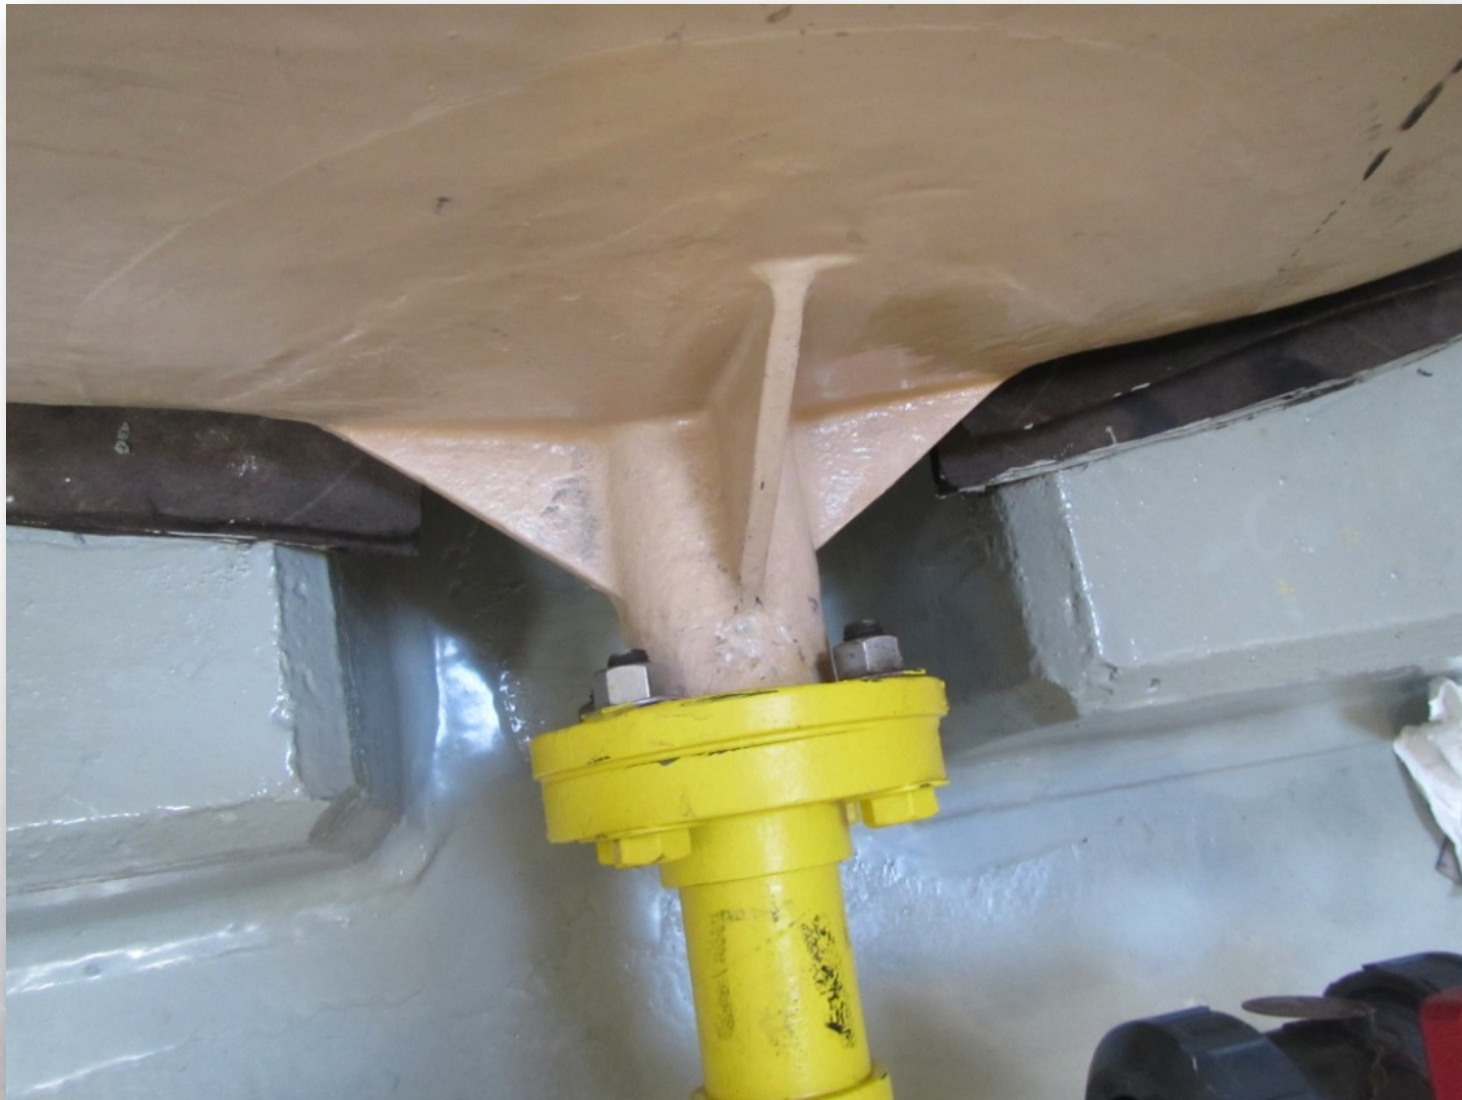
Gussets at tank drain pipe in the southwestern quadrant

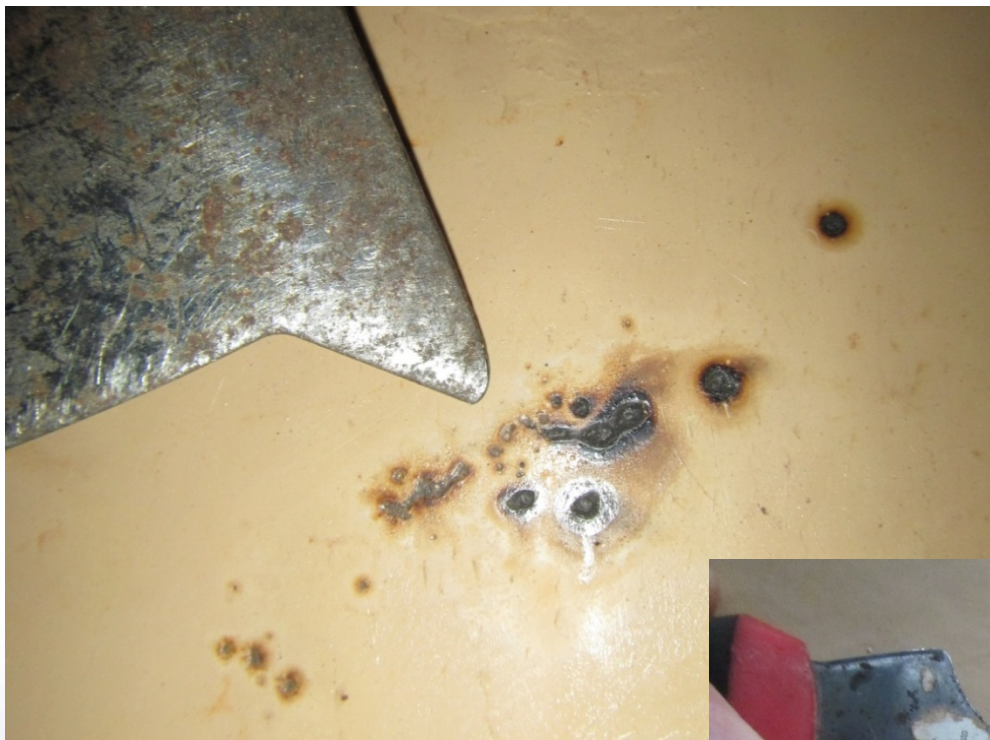
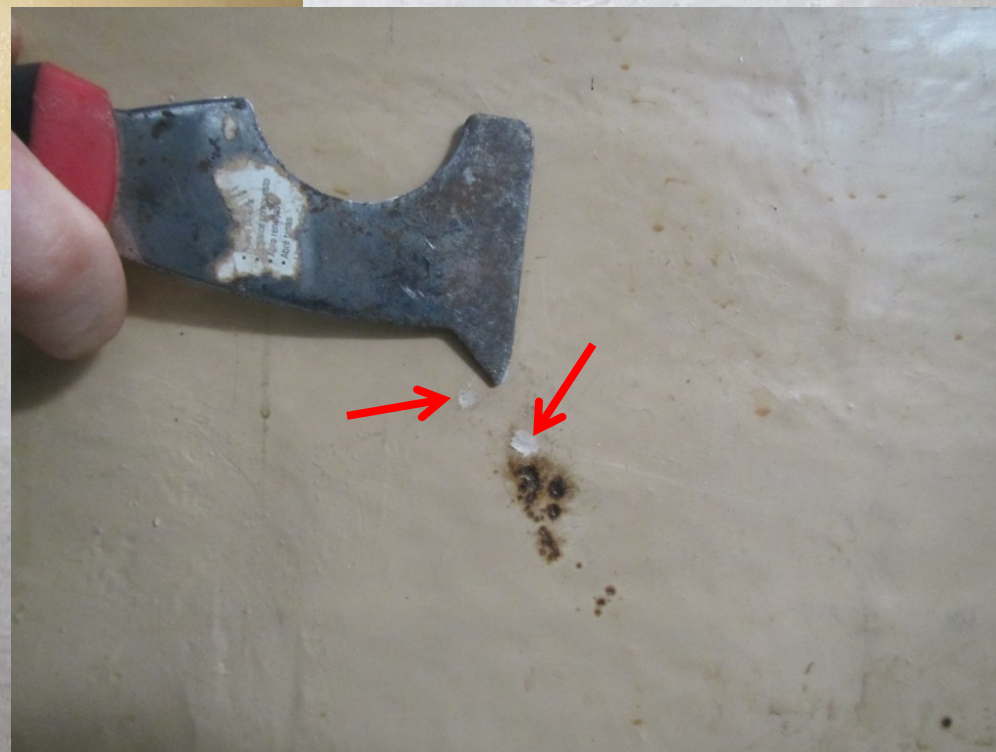
Detail of stain/burn marks in the northern quadrant of the tank interior

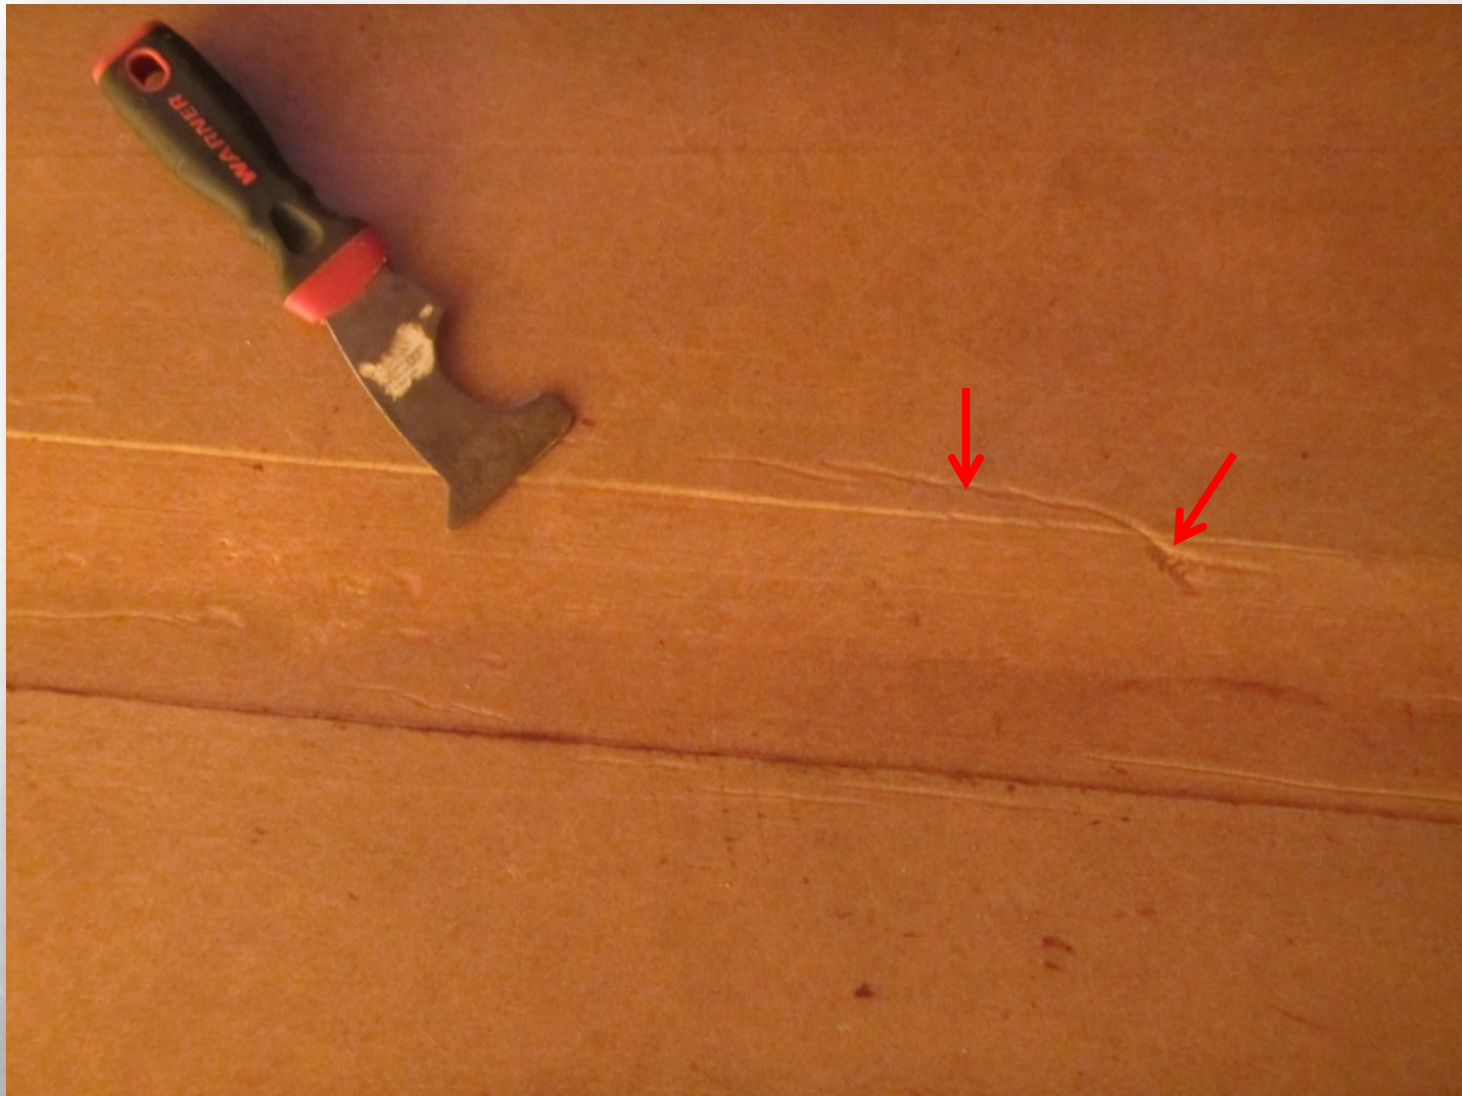
Detail of floor mold mark – note minor mechanical damage

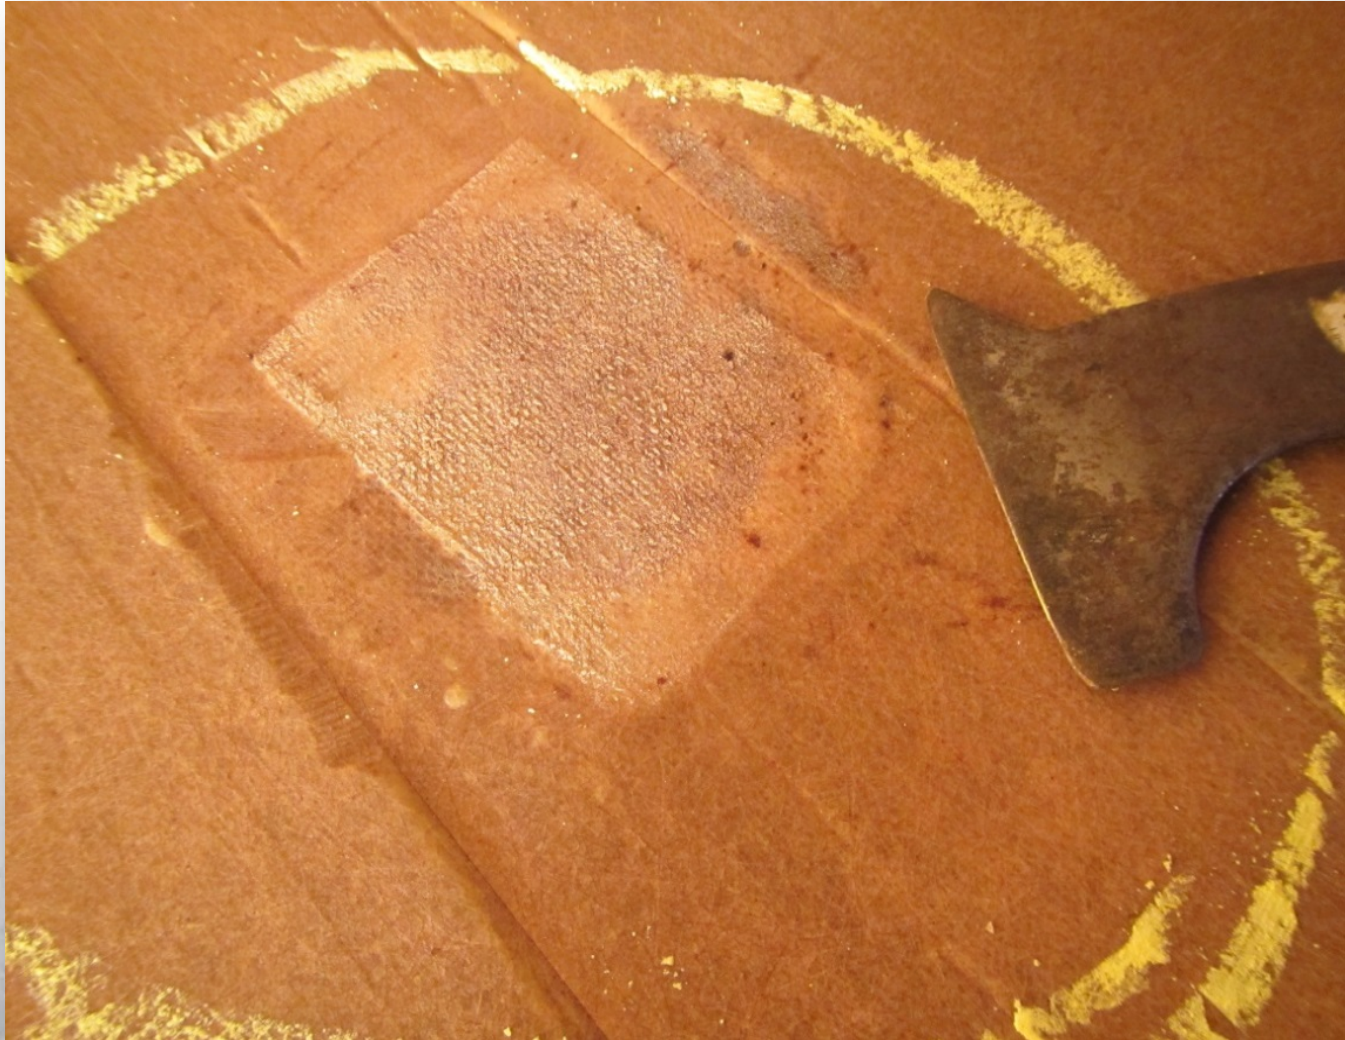
**Floor patch in the northwestern quadrant
with thinned gel coat/ corrosion barrier**

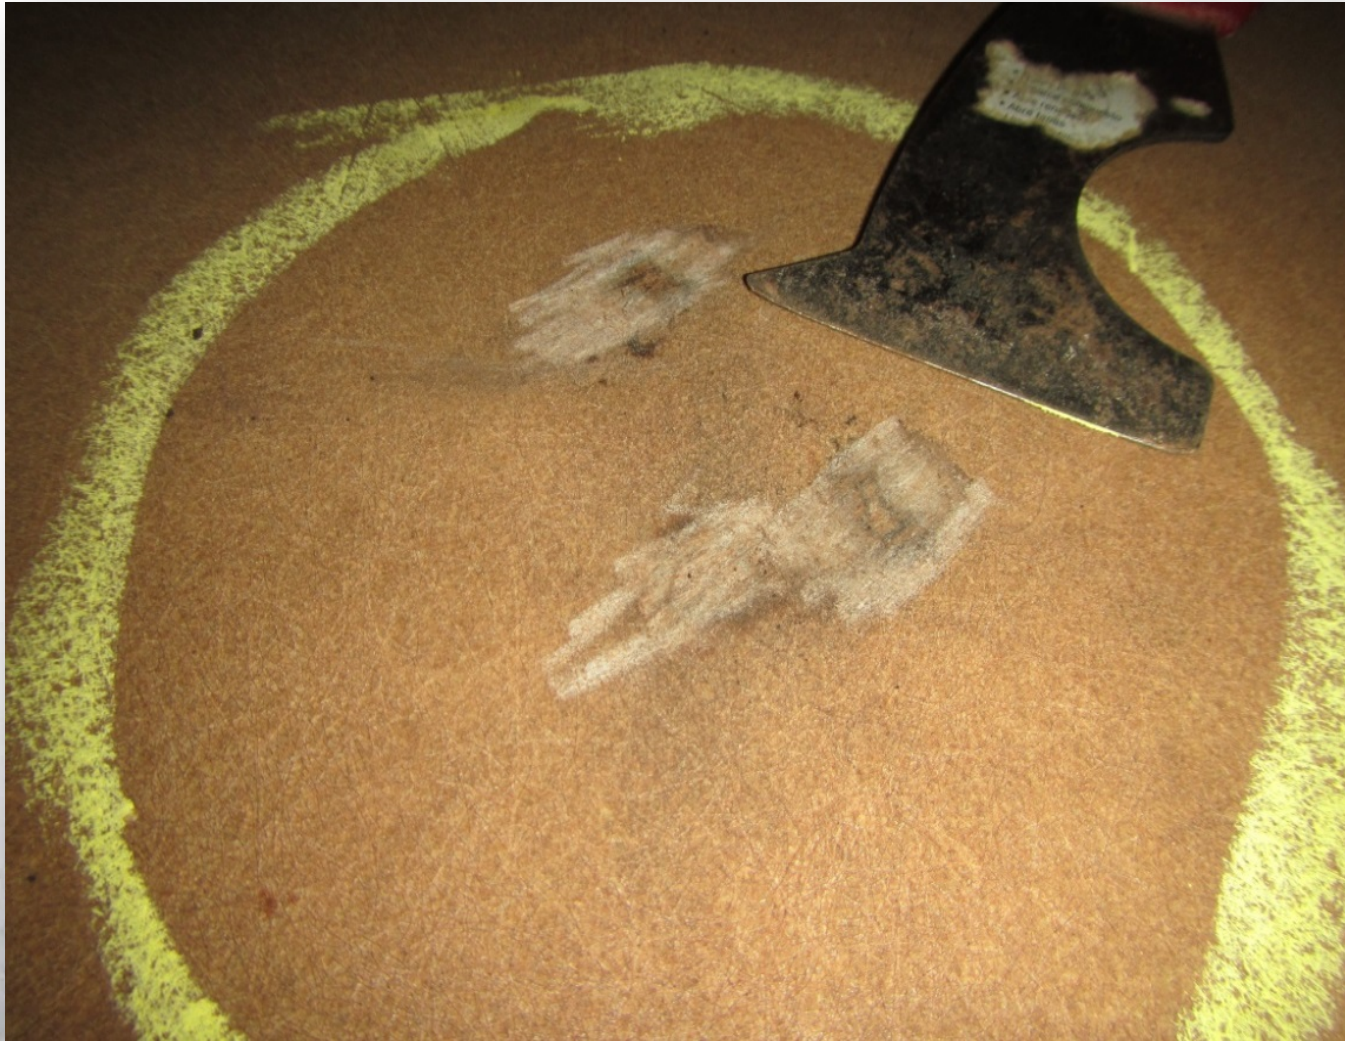
Staining in the eastern quadrant with scraped off gel coat - corrosion barrier intact

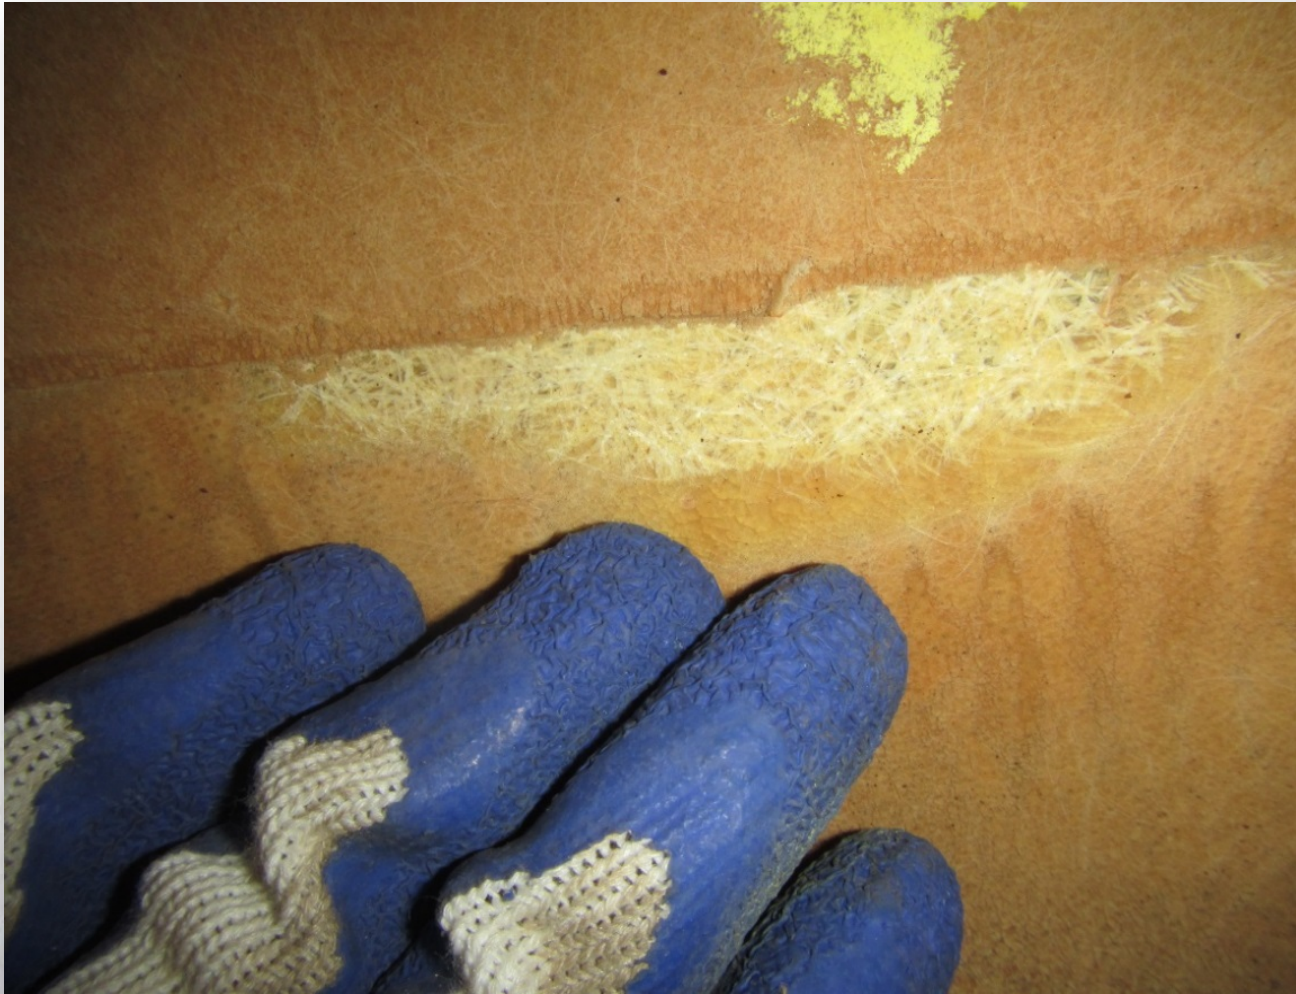
Exposed chopped mat at the top of the secondary lamination in the northeast knuckle area – no corrosion barrier damage

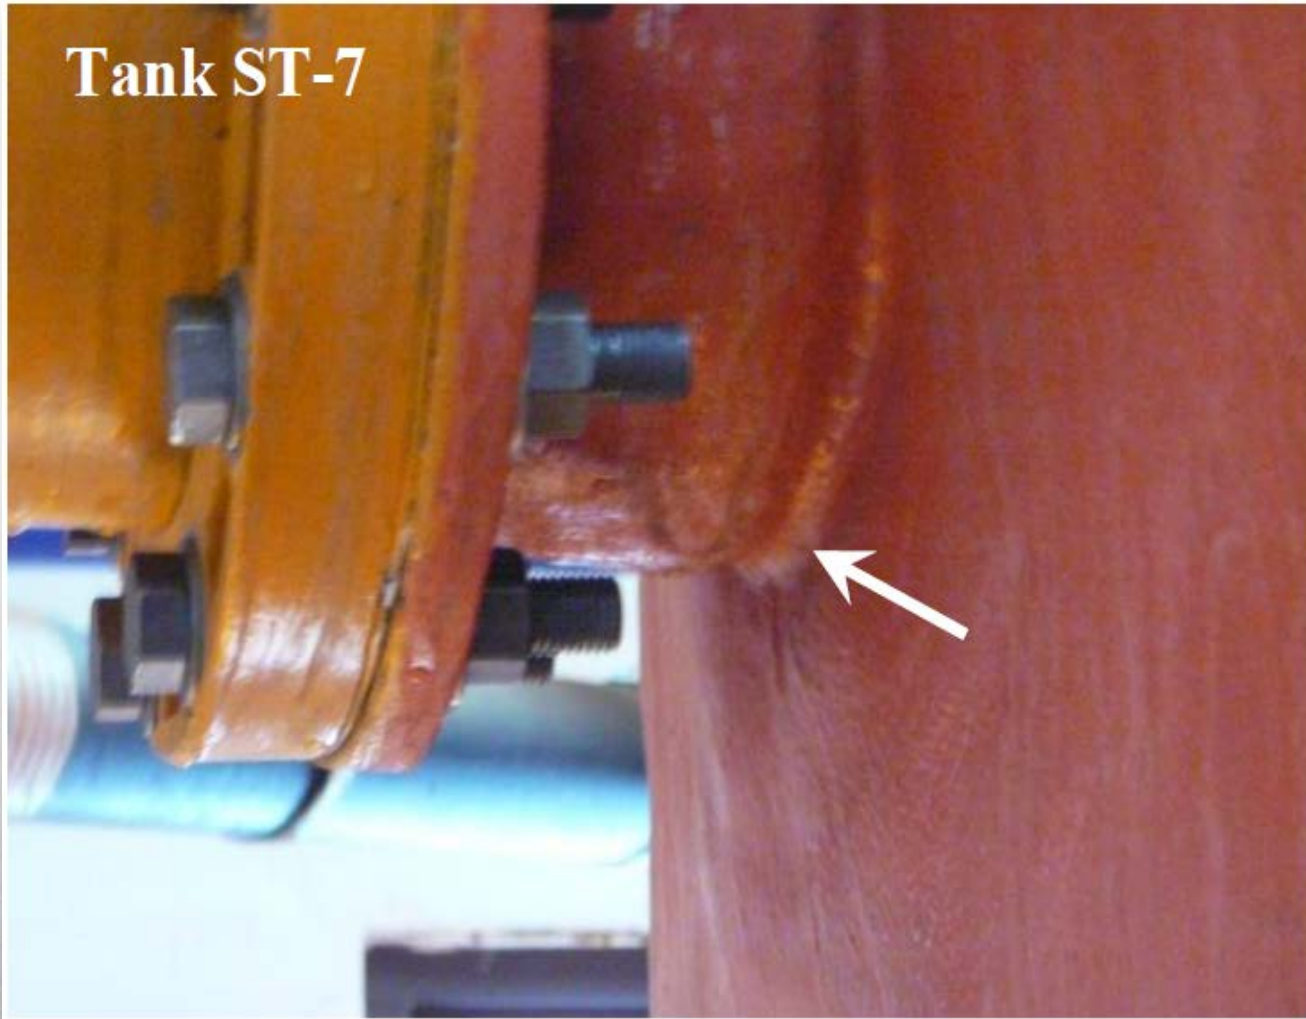
Cracking at nozzle lamination

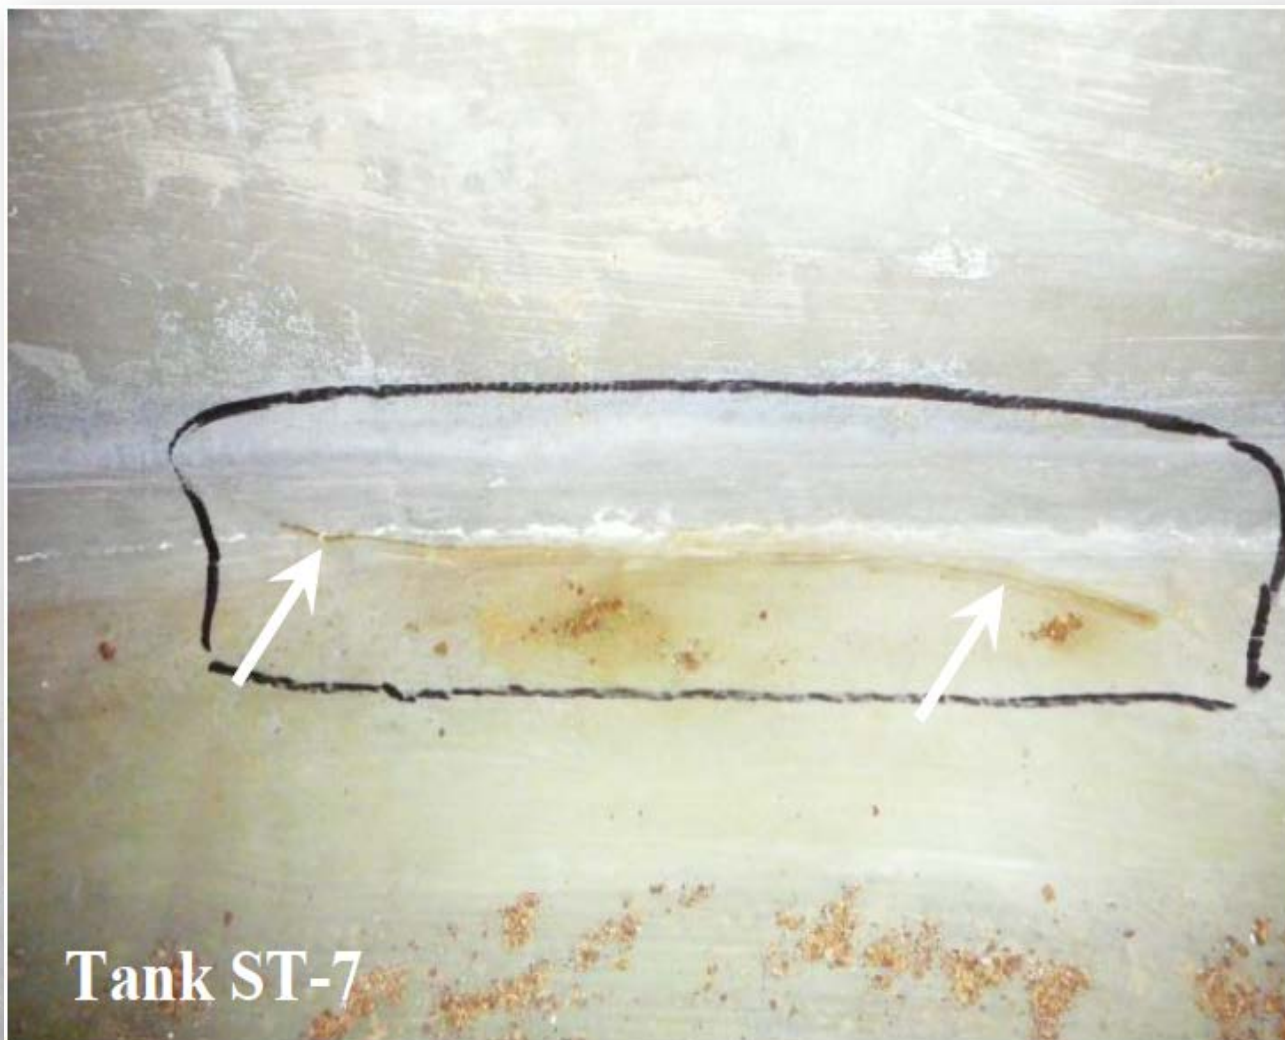
Internal cracking at knuckle

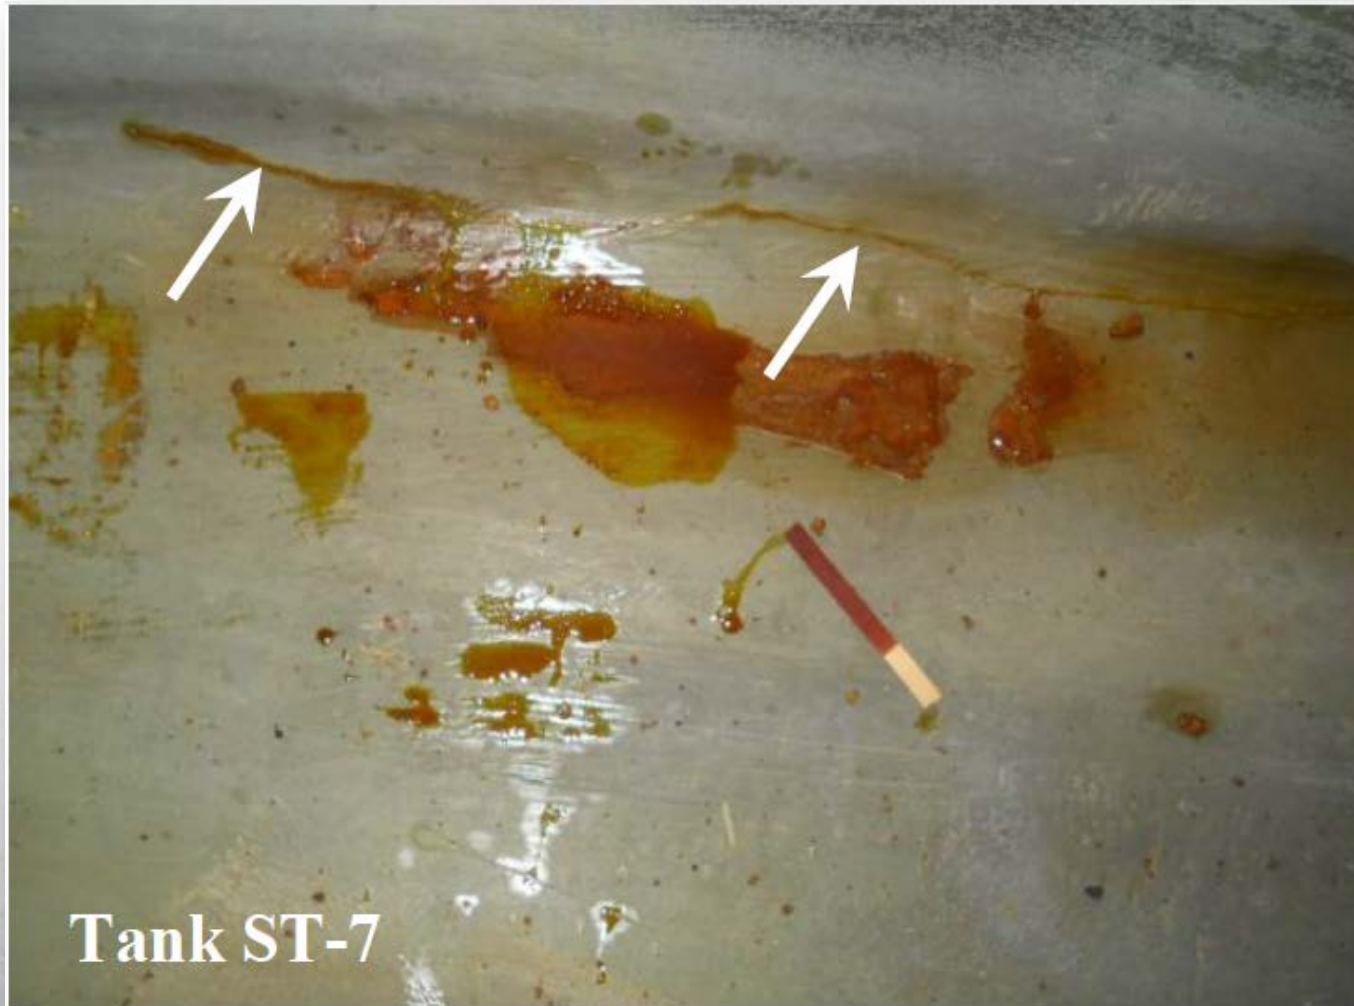
Cracking of corrosion barrier where floor laminate was applied over balsa core
