Non-Destructive Investigation and Proactive Hydrogen Sulfide Corrosion Rehabilitation of Collection System Infrastructure – Uxbridge, MA Case Study

James Legg | Town of Uxbridge, MA
Anastasia Rudenko PE, BCEE, ENV SP | GHD
Sara Greenberg | GHD
Benn Sherman | Town of Uxbridge, MA

NEWEA 2020

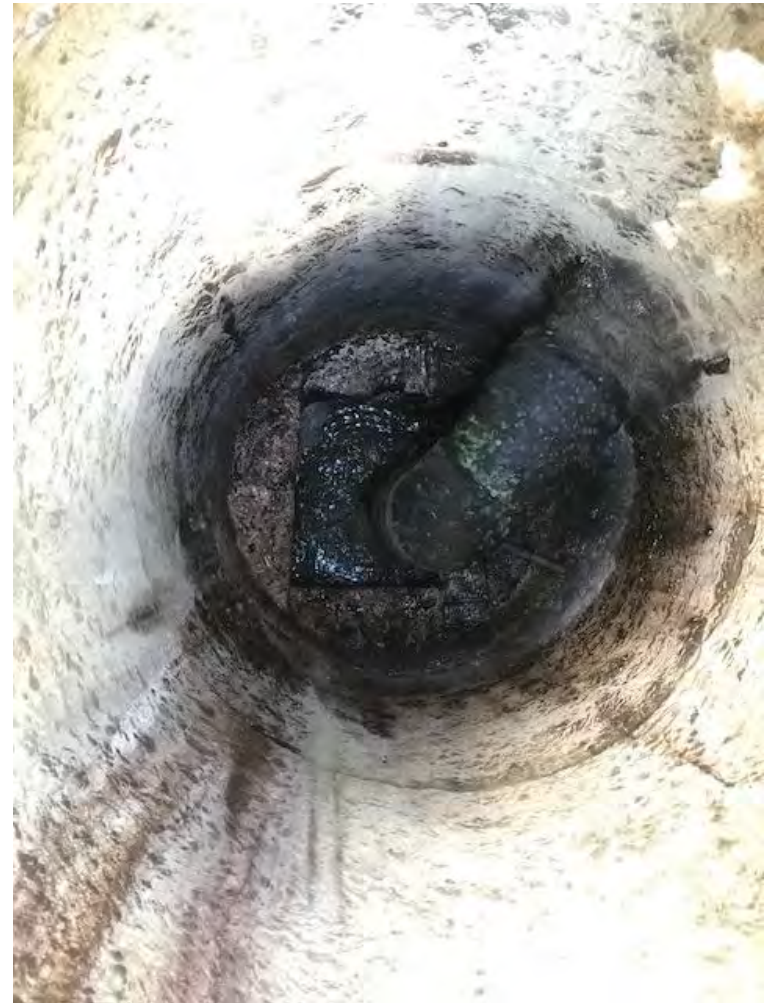
- Visual inspection of interceptor manhole indicated hydrogen sulfide degradation
- Turbulent conditions at this location indicated high hydrogen sulfide corrosion vulnerability:
 - Interceptor manhole
 - Downstream Reinforced Concrete Pipe (RCP) gravity sewer
 - Upstream Ductile Iron (DI) force main

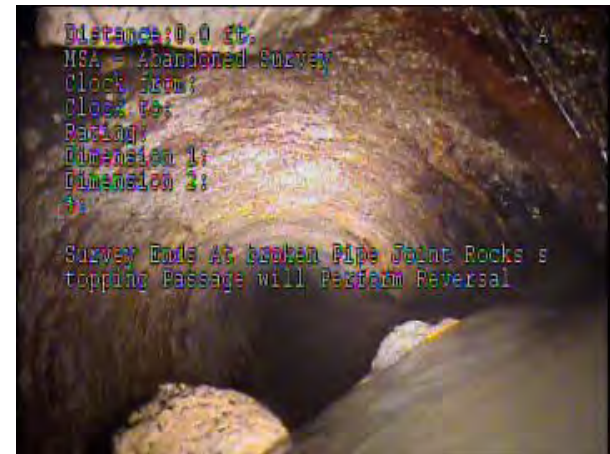
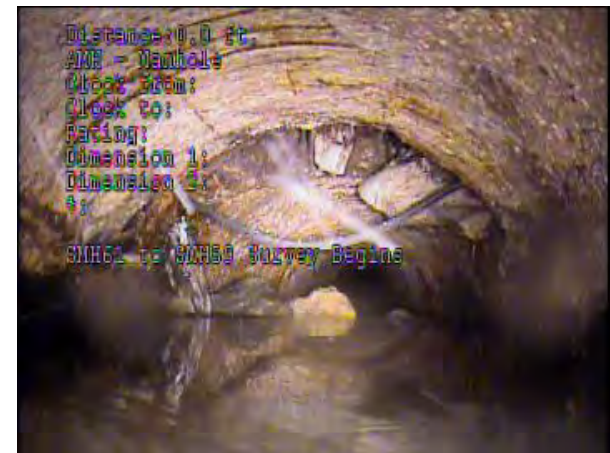
- Inspected
 - 1 upstream pipe segment
 - 2 downstream pipe segments
- CCTV indicated minor defects upstream of the interceptor manhole
- CCTV of downstream gravity interceptor found:
 - Aggregate visible
 - Intruding Sealing Ring
 - Infiltration gusher at broken joint

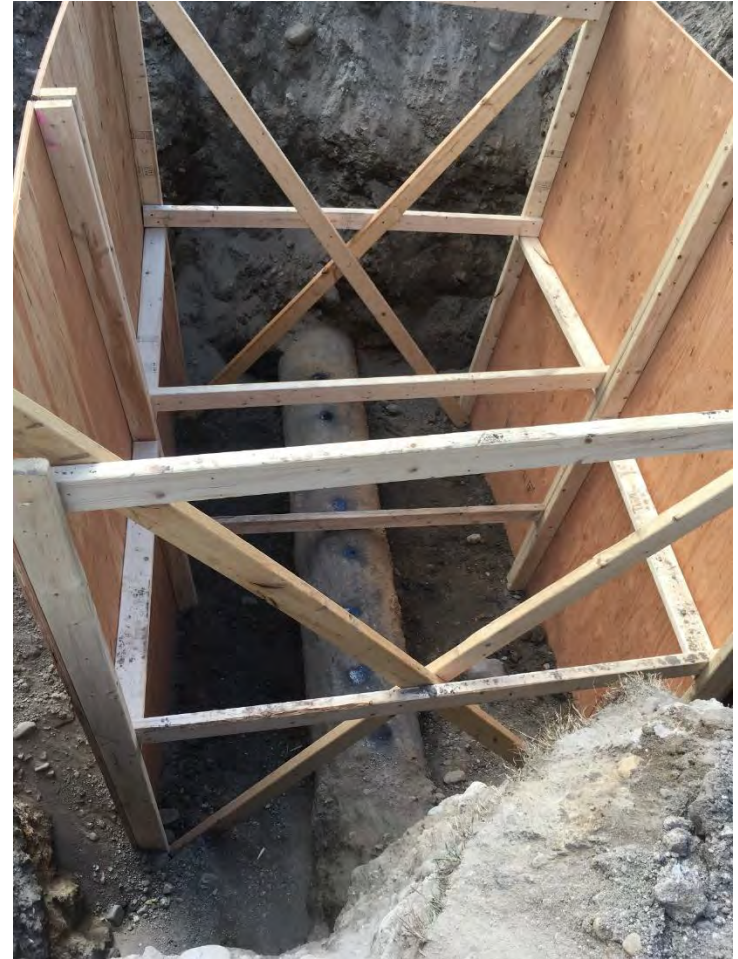
- Testing results indicated wall thickness losses between 0% - 49%
- Largest percentage of wall thickness loss immediately upstream of interceptor manhole (high point)
 - This section of pipe is partially empty at times
 - Highest corrosion rate along pipe spring-line

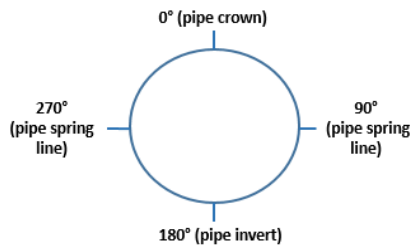
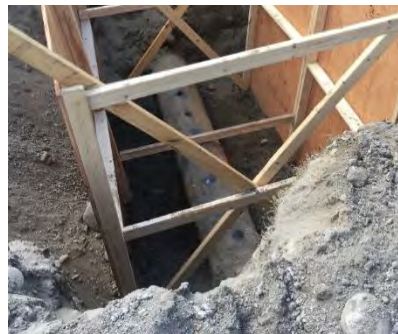
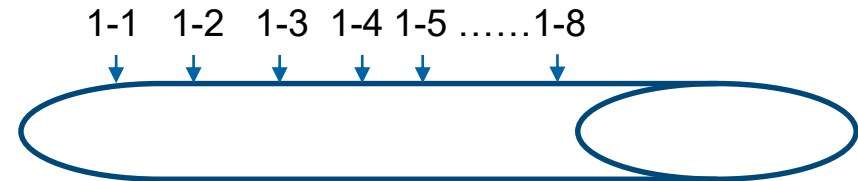
Force main – High point (Location 1)

Test #	Crown (0°)	Spring Line (90°)	Invert (180°)	Spring Line (270°)
1-1	6%	24%	13%	0%
1-2	11%	0%	0%	22%
1-3	2%	23%	15%	-3%
1-4	10%	31%	10%	37%
1-5	13%	46%	33%	41%
1-6	14%	36%	6%	46%
1-7	14%	49%	10%	44%
1-8	22%	17%	13%	29%

Rehabilitate portion of force main suspected of periodically sitting partially empty
