# Asset Management Planning for Wastewater Systems – A Case Study in Gardner, MA

**2021 NEWEA Annual Conference**

# Asset Management Matrix

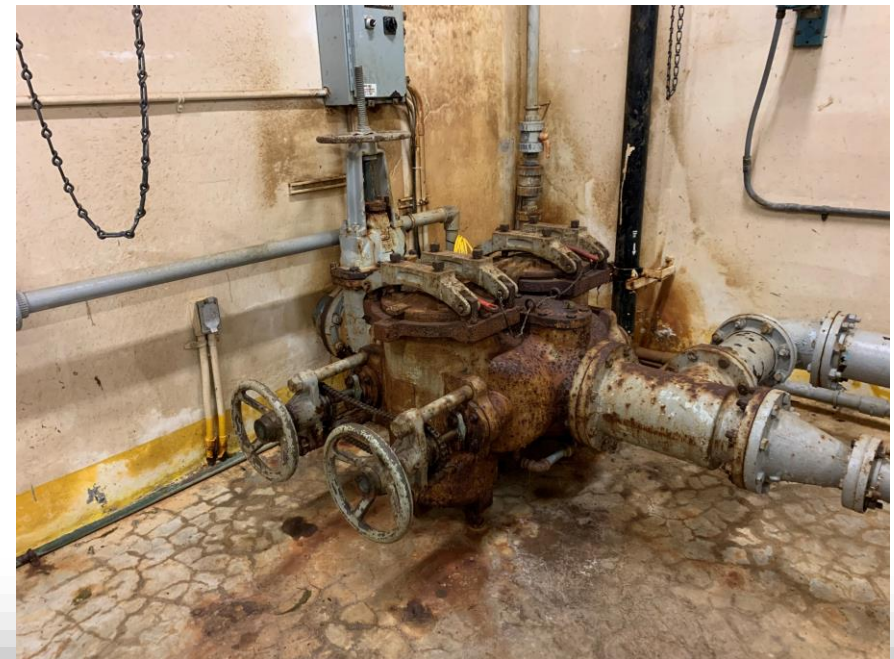
- Plant Water Pumps:
  - Asset ID: 26/27
  - Model: Peerless C810AM/BF
  - Condition: Very Poor
  - Redundancy: 100%
  - Consequence of Failure: Major
  - Install Year: 2000
  - Expected Useful Life: 25 years

Recommendation	Asset	Estimated Cost	Year
Replace Plant Water Pumps No. 1 and 2	Plant Water Pump No. 1, Plant Water Pump No. 2	\$150,000	2020

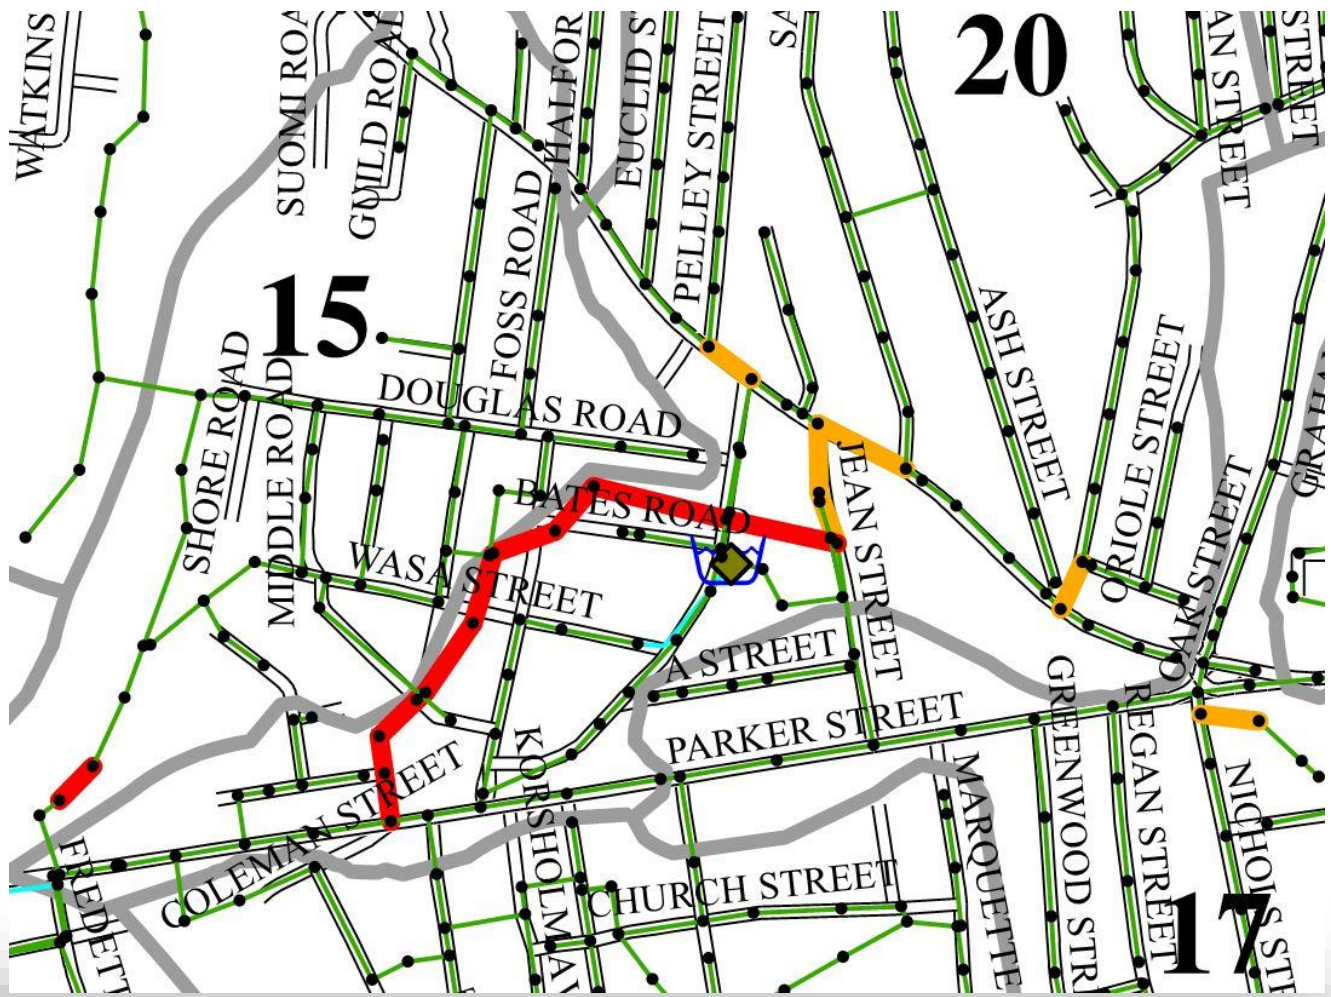
# Hydraulics - Hydraulic Deficiencies

- Hydraulically Sufficient
- Over 100% Capacity for 1 Year Inflow
- Over 70% Capacity for Max Day
