HAVE YOU EVER BEEN RAILROADED?

Lessons from a Force Main Repair in a Railroad Right-of-Way

Jeff Kalmes Water Resource Recovery Superintendent Town of Billerica, MA

Olivia Lafond, P.E. Project Manager Woodard and Curran

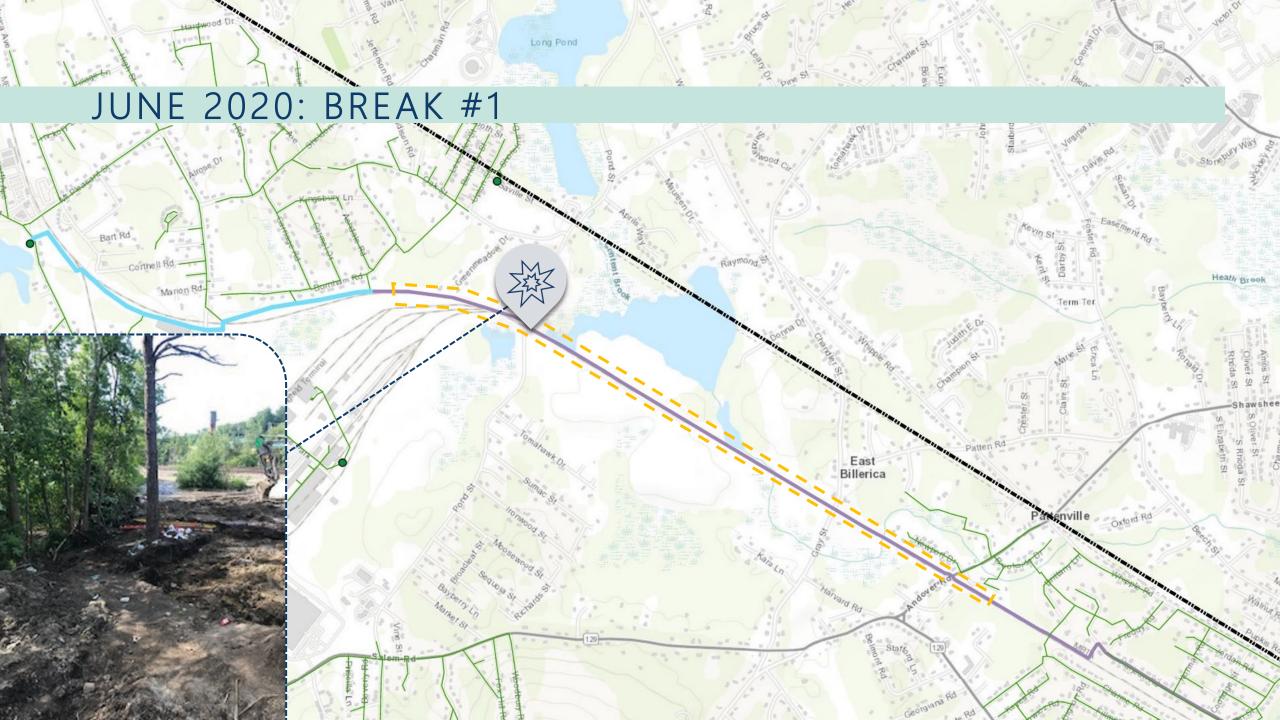
JUNE 2020: BREAK #1

- Located east of Pond Street crossing within RR ROW
- Reported the SSO to DEP, Con Com
- Contacted Railroad
- Repaired in 4 days
 - 2 days for pipe repair
 - 2 days for reconstruction of hillside and seeding
- Total Cost approx. \$60K

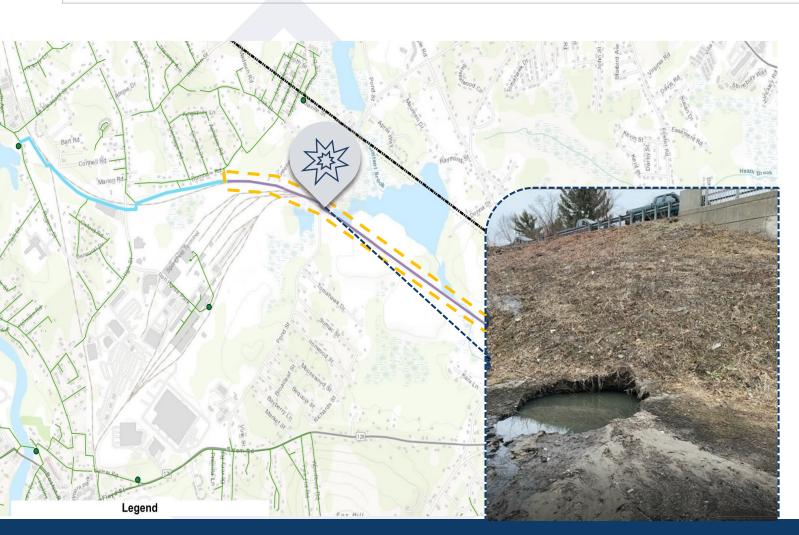
MARCH 11, 2021: BREAK #2

- Break identified in similar location
- Followed updated SOPs
- Agency coordination
 - Board of Health
 - Conservation Commission (break adjacent to wetlands)
 - DEP
 - MBTA & Keolis
- Hired Wayne's Drains to Pump out Brown Street Pump Station wet well
 - 24/7 for 2 weeks!
- Adjusted pump station output

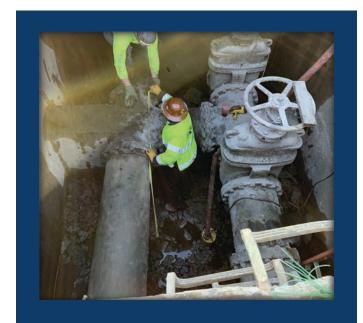
Installing line stop

- Purchase and weld 3000 feet of 16-inch HDPE pipe plus 350 feet of 6-inch.
 18" Ductile to 6" HDPE to 12" HDPE to 16" HDPE
- Install Line Stop special order, overnighted from Tennessee. Extra Cost!
- Core into existing manhole to connect bypass

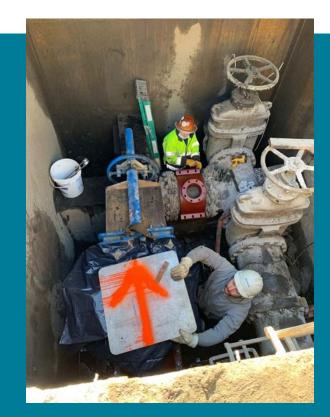
Bypass view

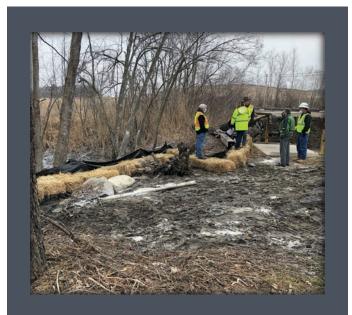
Working adjacent to wetlands

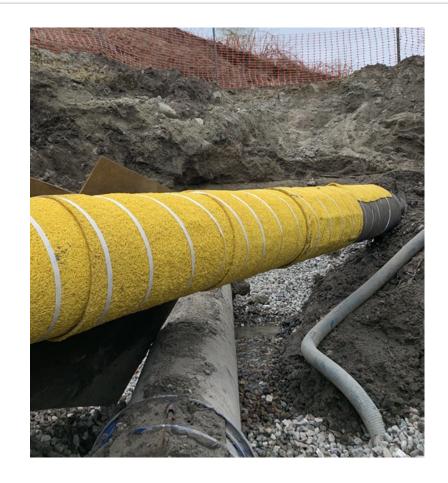
BREAK #2 SUMMARY

- Discovered on 3/11/21 Normal flow through repaired pipe on 4/22/21 (42 days!)
- Another 8 days to rebuild the hillside and protect the crossover pipe box. We also flushed out the bypass piping and capped it. (50 day total job)
- Failed ductile iron pipe was analyzed cause of the failure was corrosion due to groundwater and soil conditions, it rotted from the outside to the inside.
- Replaced 60 linear feet of force main with 16-inch HDPE pipe
- Total Job Cost = \$940,000
