Prioritizing Sanitary Sewer Collection System Repair on an Aging System

Case Study - Norwalk CT

NEWEA 2022 Annual Conference

Karina Massey, Water Resources Engineering
Professional, Jacobs

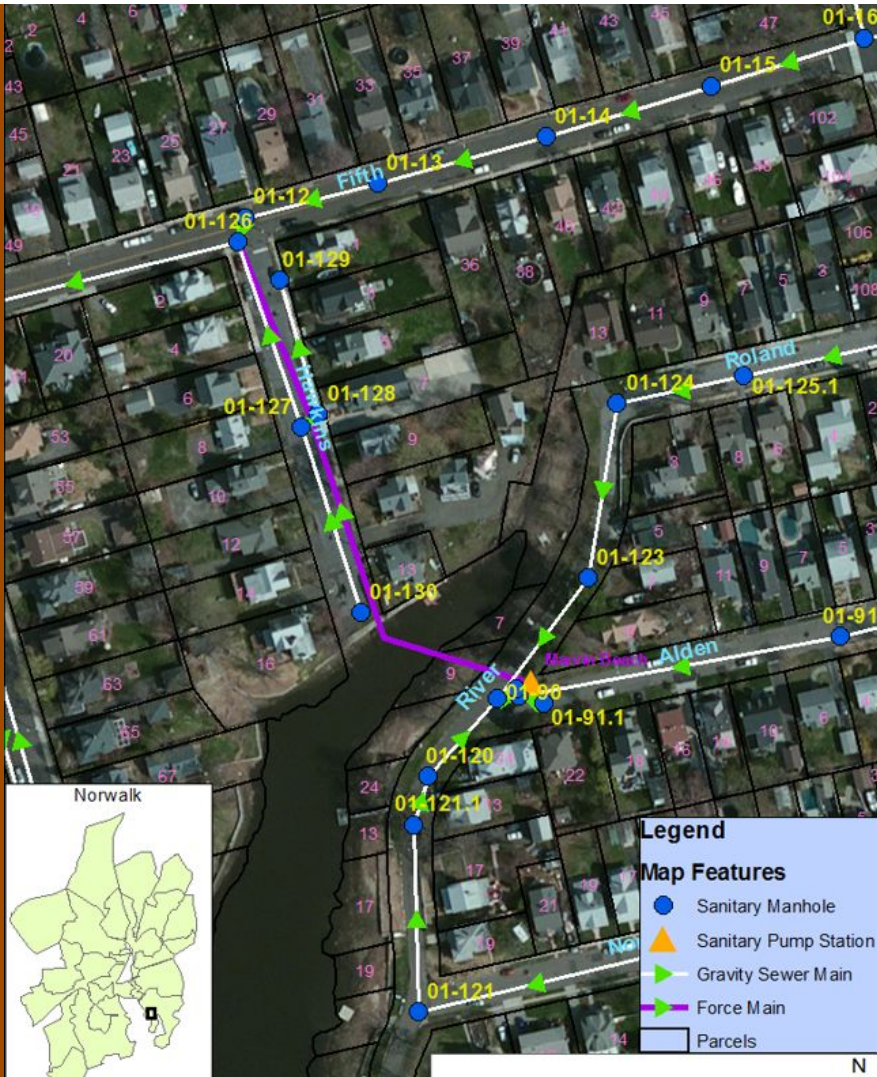
Force mains

- Marvin Beach Force main was selected to be repaired due to multiple pipe segment replacements taking place.
- Marvin Beach Force main broke during 90% design and was then completed under emergency conditions.
- Pipes down stream of other force mains were targeted due to H₂S gas.

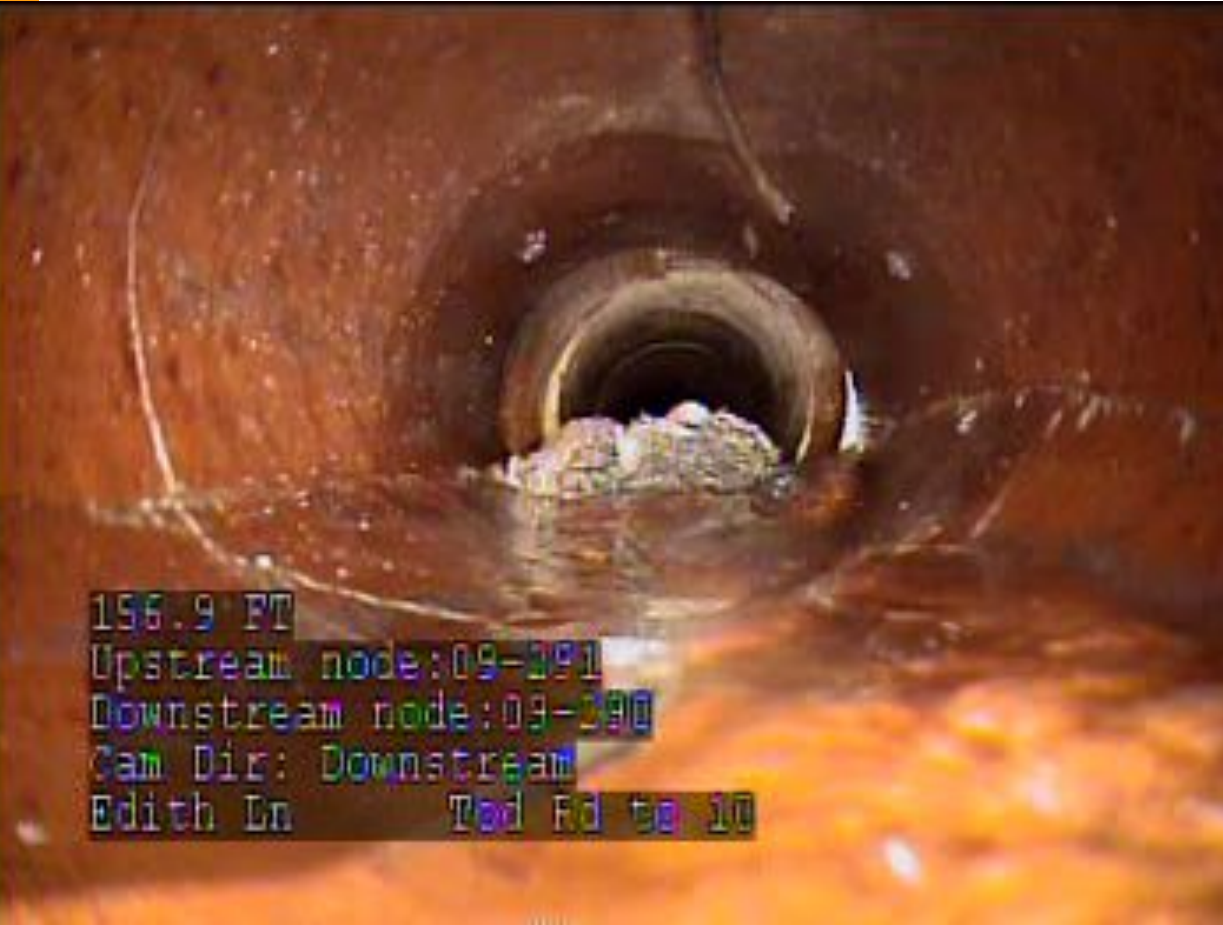
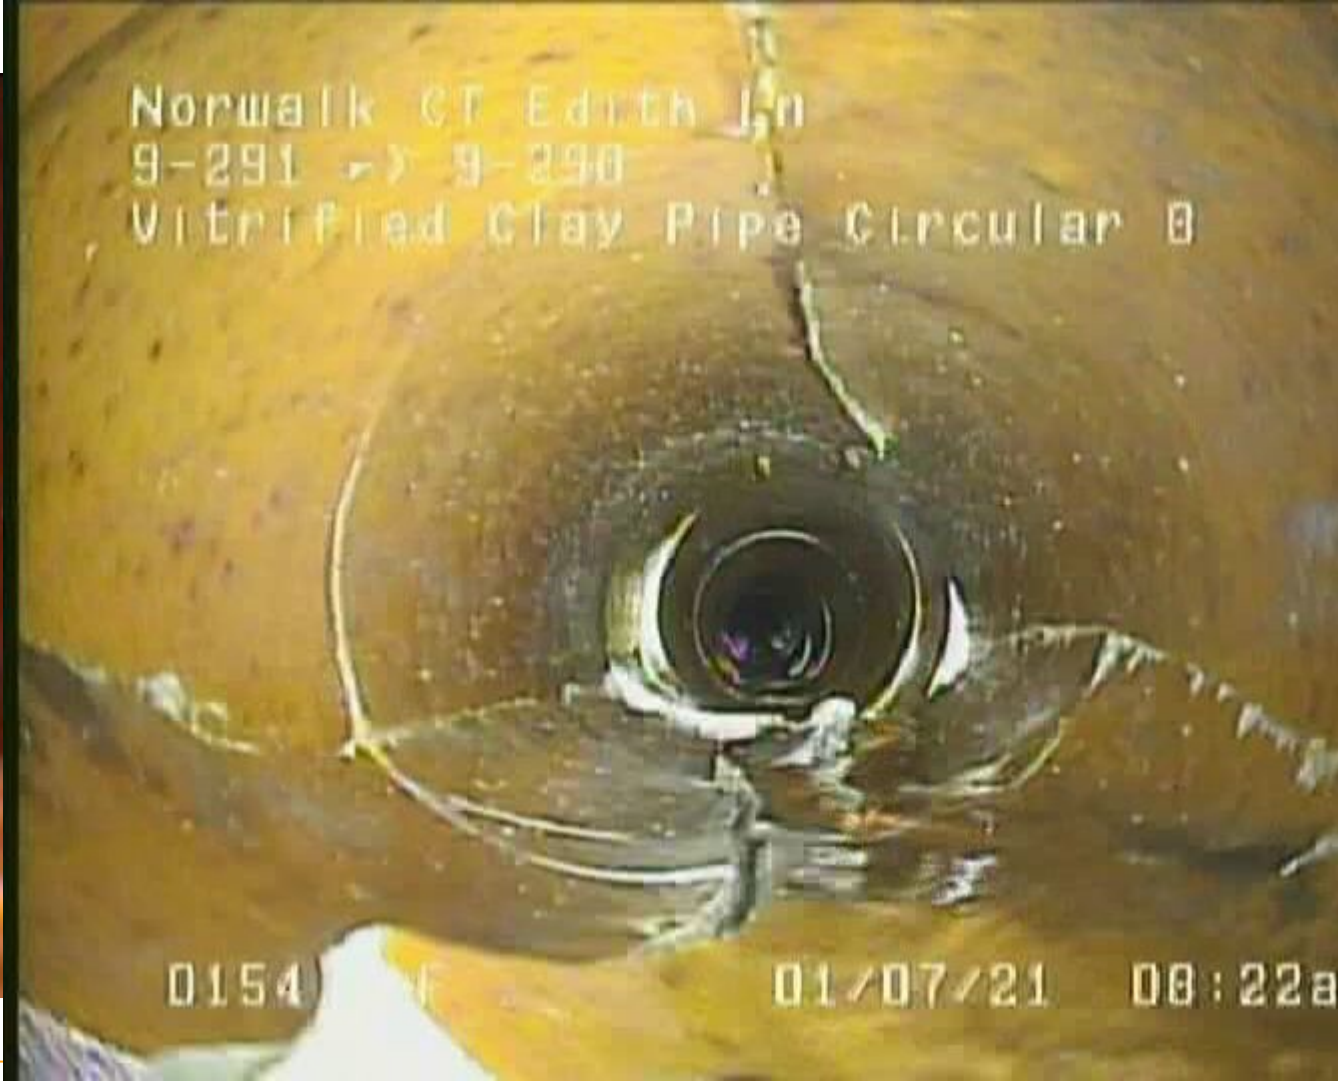
Lesson Learned: Pipe defects deteriorate quickly
