I/I Study Finds H₂S Corrosion to be the Critical Priority: Utilizing Institutional Knowledge to Guide Sewer Investigations and Rehabilitation in Darien, CT

NEWEA Annual Conference

January 25, 2023

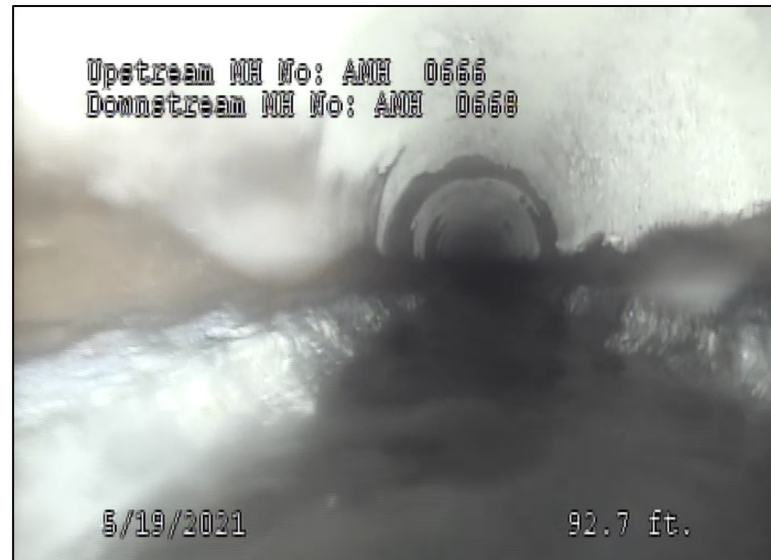
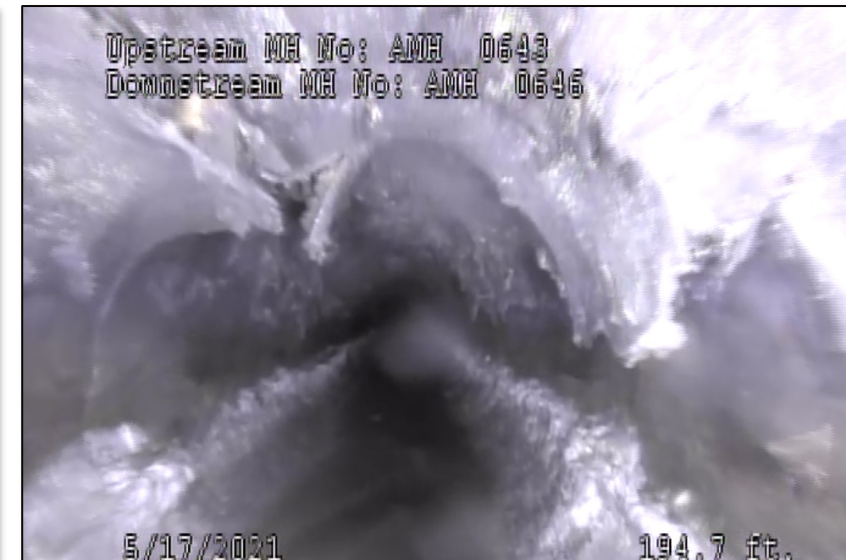
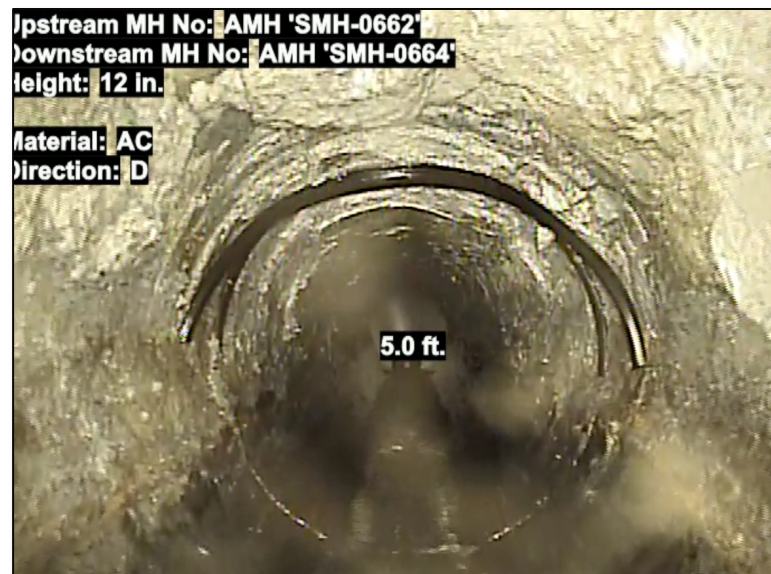
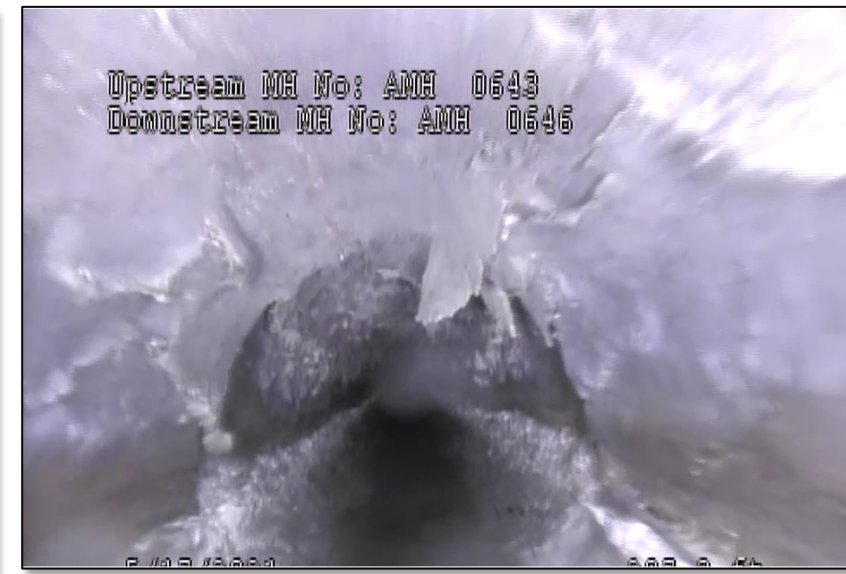
Upstream NH No: ANH 0643
Downstream NH No: ANH 0646

Findings – Pipes Condition

- All segments exhibiting varying degree of H₂S deterioration
 - Early deterioration – rough pipe/white deposits
 - Moderate deterioration – beginning to delaminate; isolated delamination
 - Significant deterioration – delamination; exposed gasket
- 2 segments with active infiltration at joints

- I/I Program – 3 Rehabilitation Phases
- Highest Priority – Old Kings Highway South
- Rehabilitation Recommendations
 - 3,400 LF cured-in-place pipe lining
 - 42 lateral liners
 - 18 manhole liners (cementitious and epoxy)
 - 15 manhole frame and cover replacements

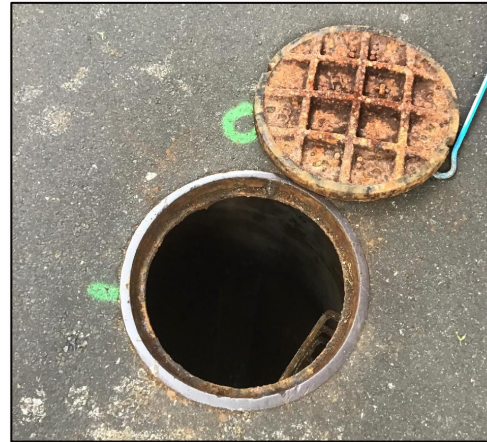
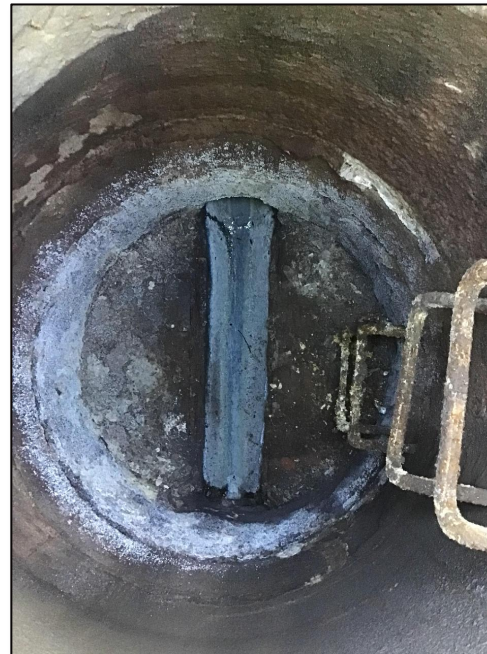
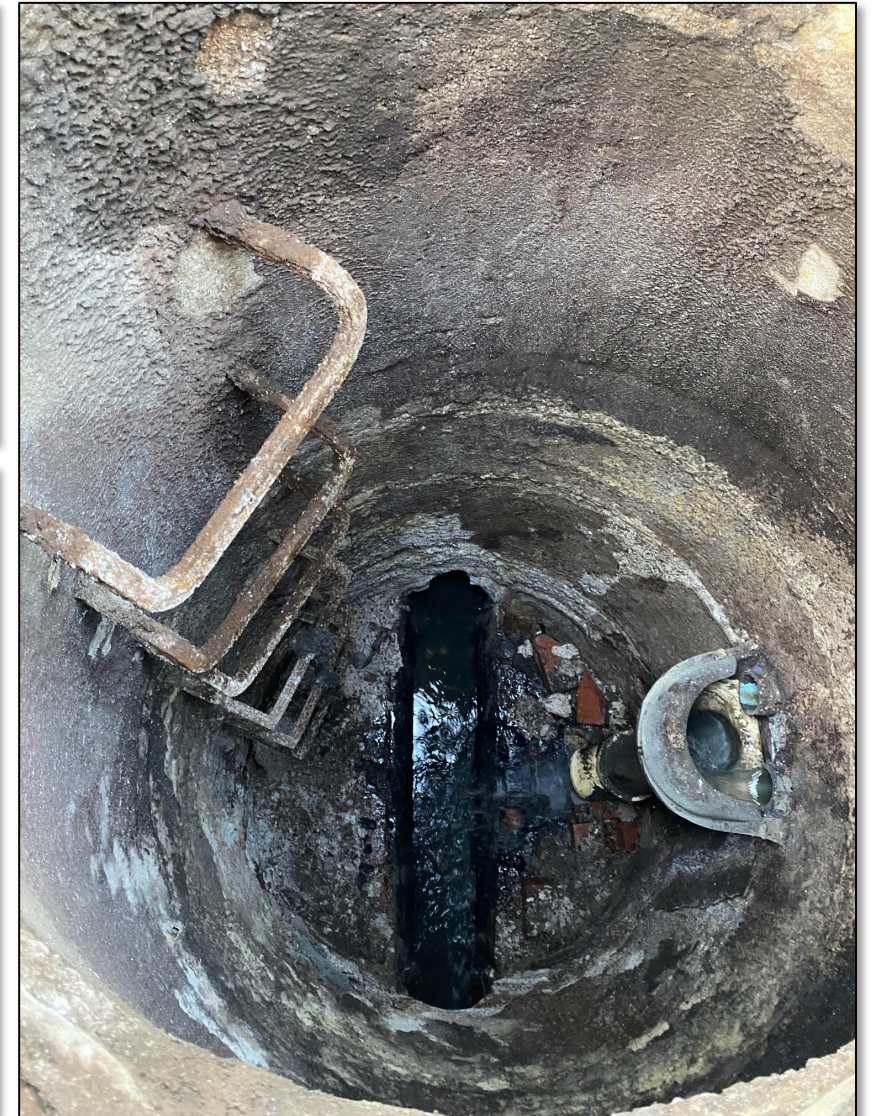
Findings – Manholes Condition

- All exhibiting varying degree of H₂S deterioration
 - Some early deterioration – white deposits on wall)
 - Some significant deterioration – loose/missing material; though no rebar exposed
- Frames/Covers
 - Covers – Minor to significant corrosion
 - Frames – Minor to moderate corrosion; cracks; chipping

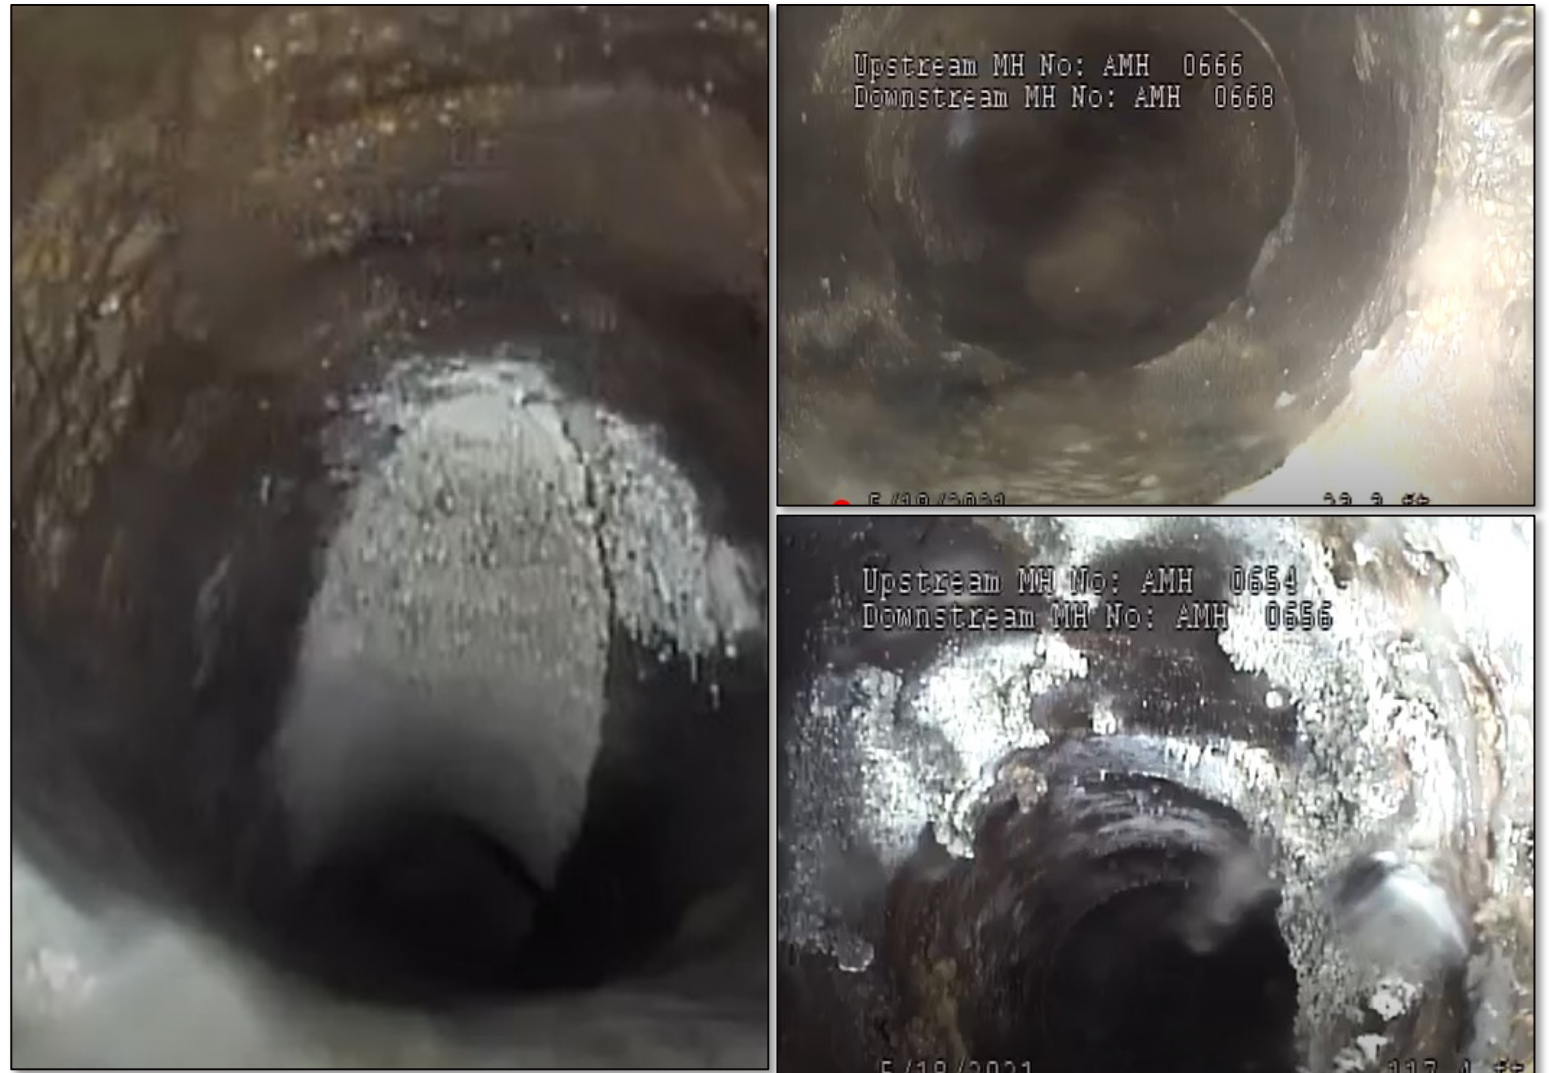
Findings – Service Connections

- Limited view – First few feet of SC → Performed full lateral inspections
- All SCs exhibiting varying degree of H₂S deterioration
 - Early deterioration – rough pipe/white deposits
 - Moderate deterioration – beginning to delaminate; isolated delamination
- 12 SCs – active infiltration or evidence of infiltration
