# HOW LONG WILL THAT FORCE MAIN LAST?

A Planning Approach for Evaluating, Assessing, and  
Rehabilitating Ductile Iron Force Mains

# RECENT FORCE MAIN FAILURE CASE STUDY

Town of Whitman, Massachusetts

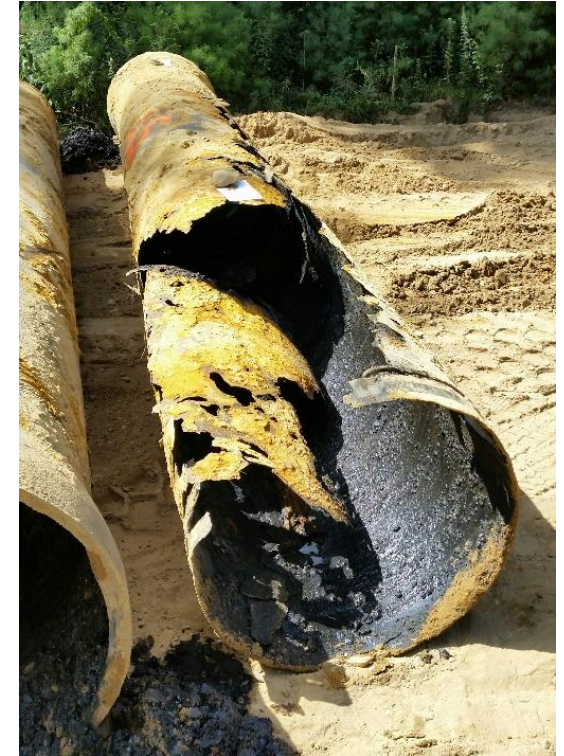
Failed Force Main Section

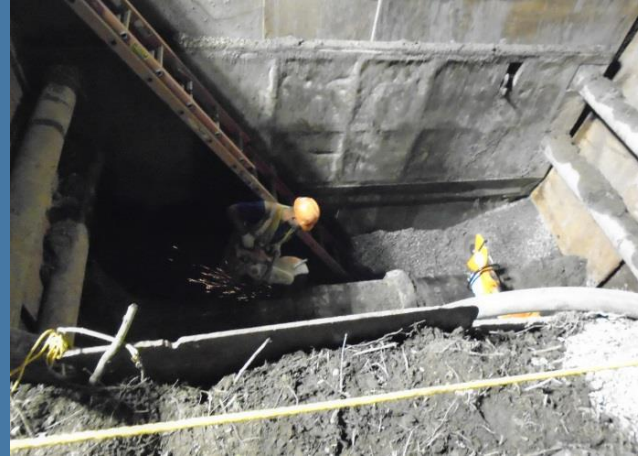
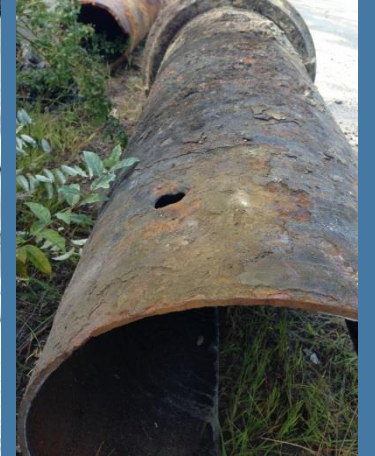
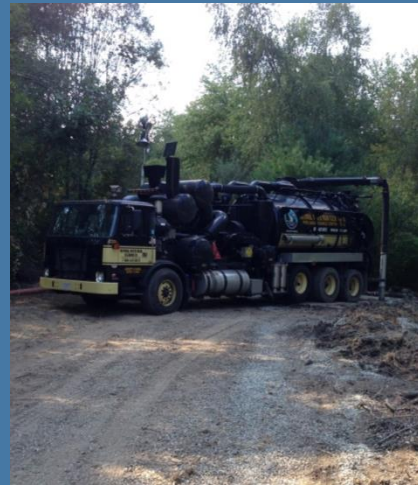
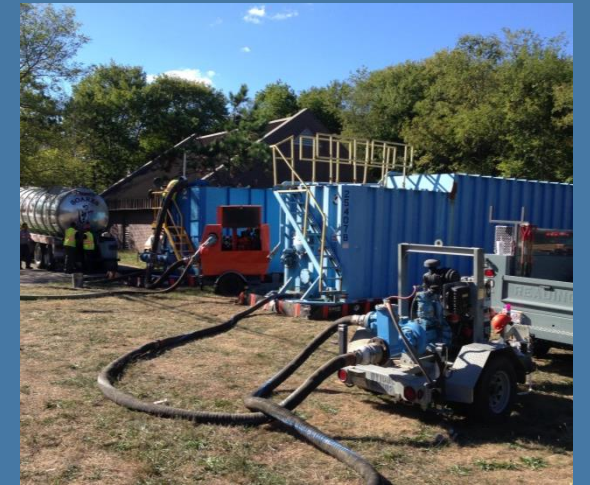
- Location: Alger Street
- Dates: 9/16 and 10/17
- Emergency Response
  - Tanker truck brigade from Auburn Street Pump Station to Brockton AWRF
- Approximate Cost of Emergency Response: \$500,000 Each Occurrence

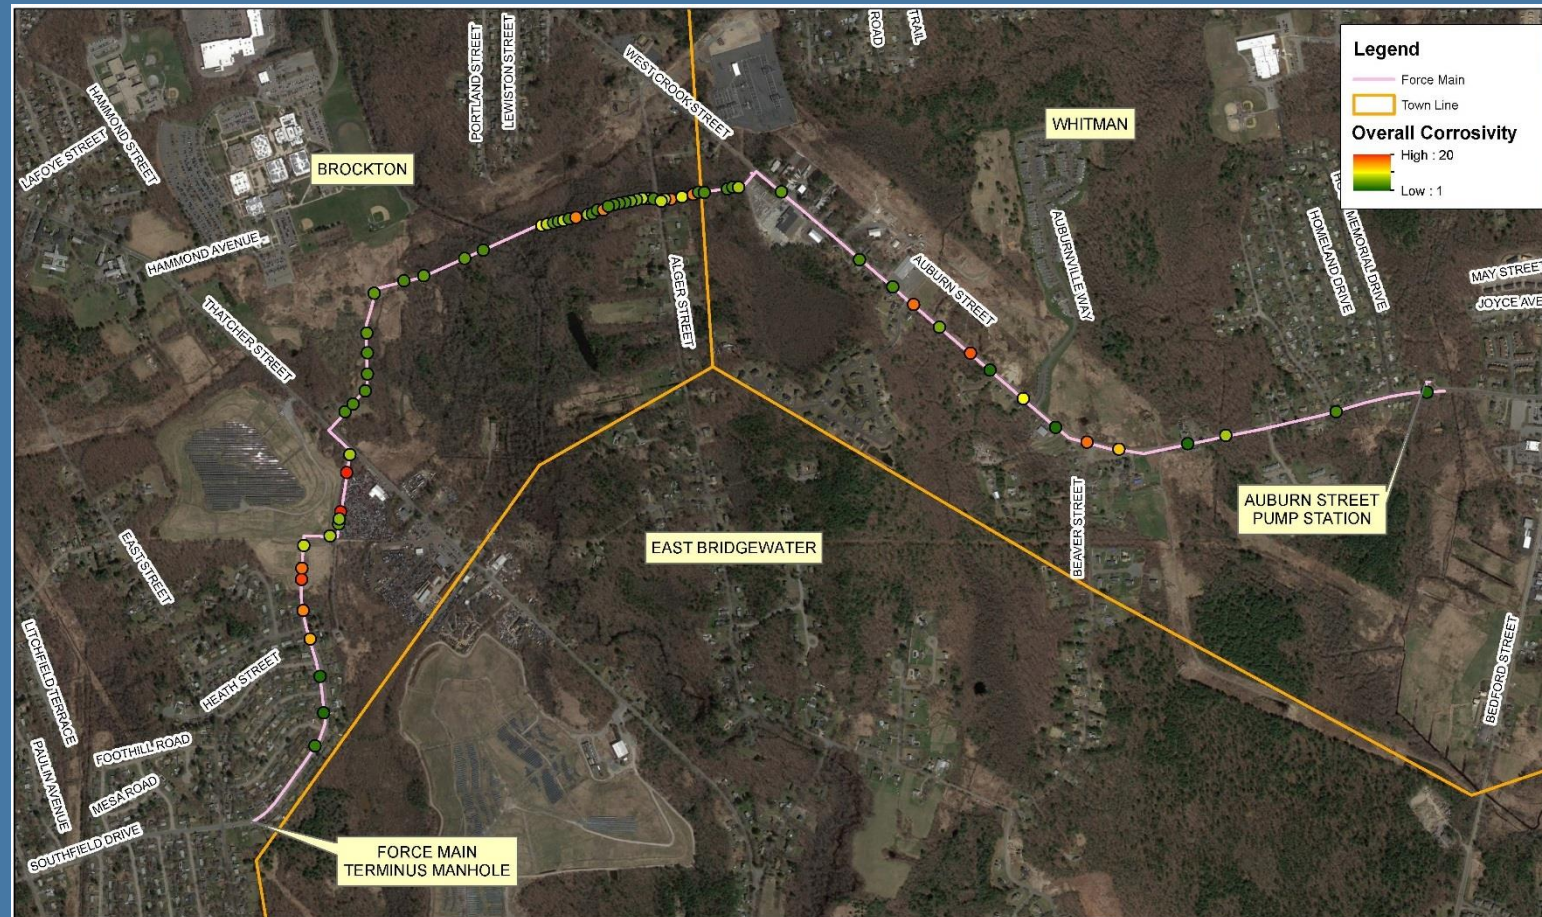
- 12/70 tested soil samples: highly corrosive to ductile iron pipe (AWWA "10-point system")

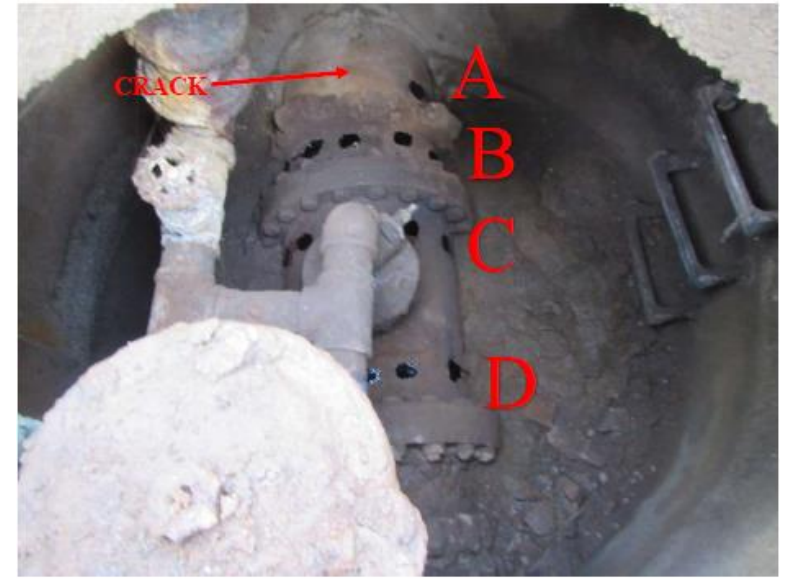
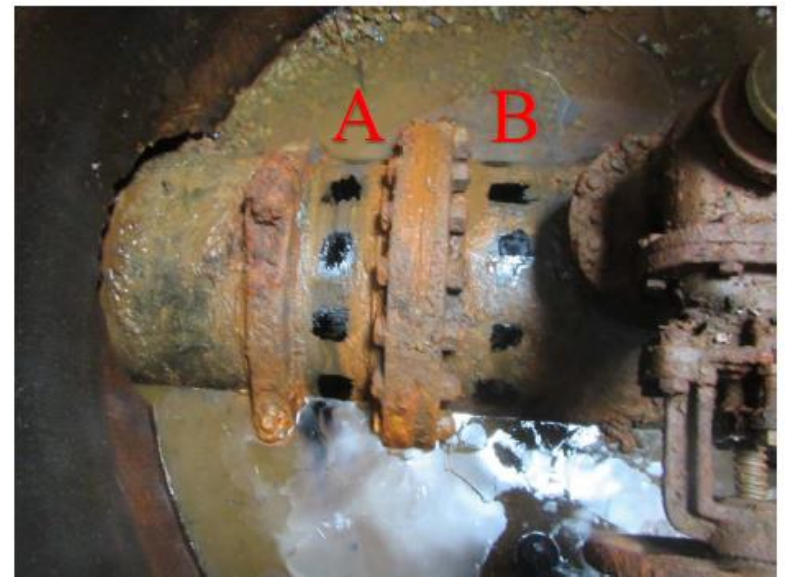
- No observed lower UT measurements at crown of pipe
- Force main is constantly flowing full
  - H<sub>2</sub>S attack is unlikely
- Probable cause of failure - External corrosion via highly acidic localized soils off Alger Street

- Existing 20-inch Sewer Force Main is:
  - At risk of failure due to highly corrosive soils along its alignment
  - Nearing end of useful life based on acceptable industry/design standards
- Repair/Replacement Alternatives:

Alternative 1 Selected: OPCC \$14.5 Million

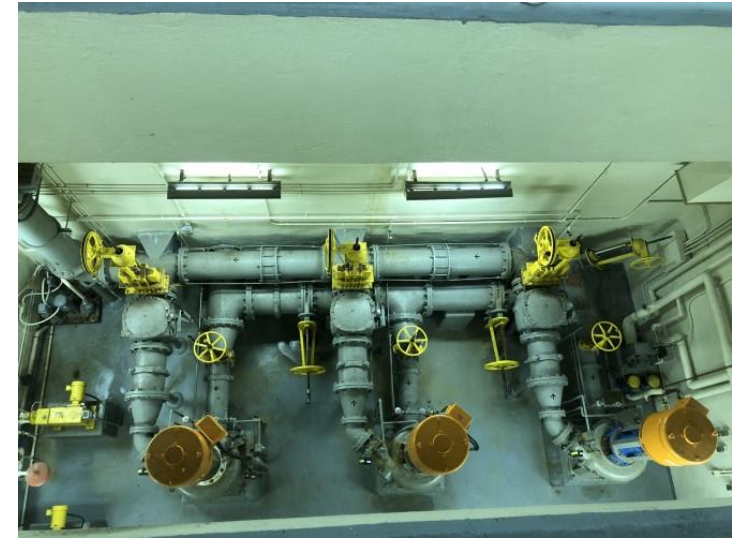
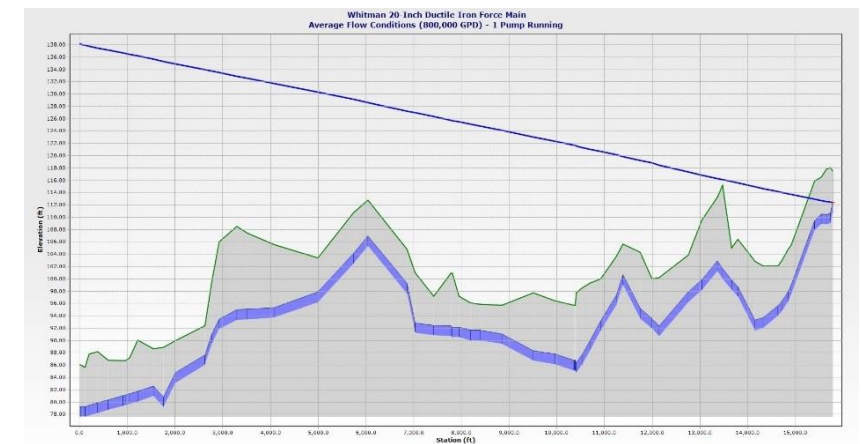
- Force main is constantly flowing full under pressurized conditions
  - Open channel flow is not present
- Under typical conditions, velocity in the pipeline is acceptable: 3.0 feet per second
- Force main and ASPS pumps are appropriately sized to handle current pump station flows
