The Hydrogen Sulfide Beast From Below: A Reactive, Responsive, and Proactive need for handling H₂S before it handles us

NEWEA Annual Conference

January 22, 2024

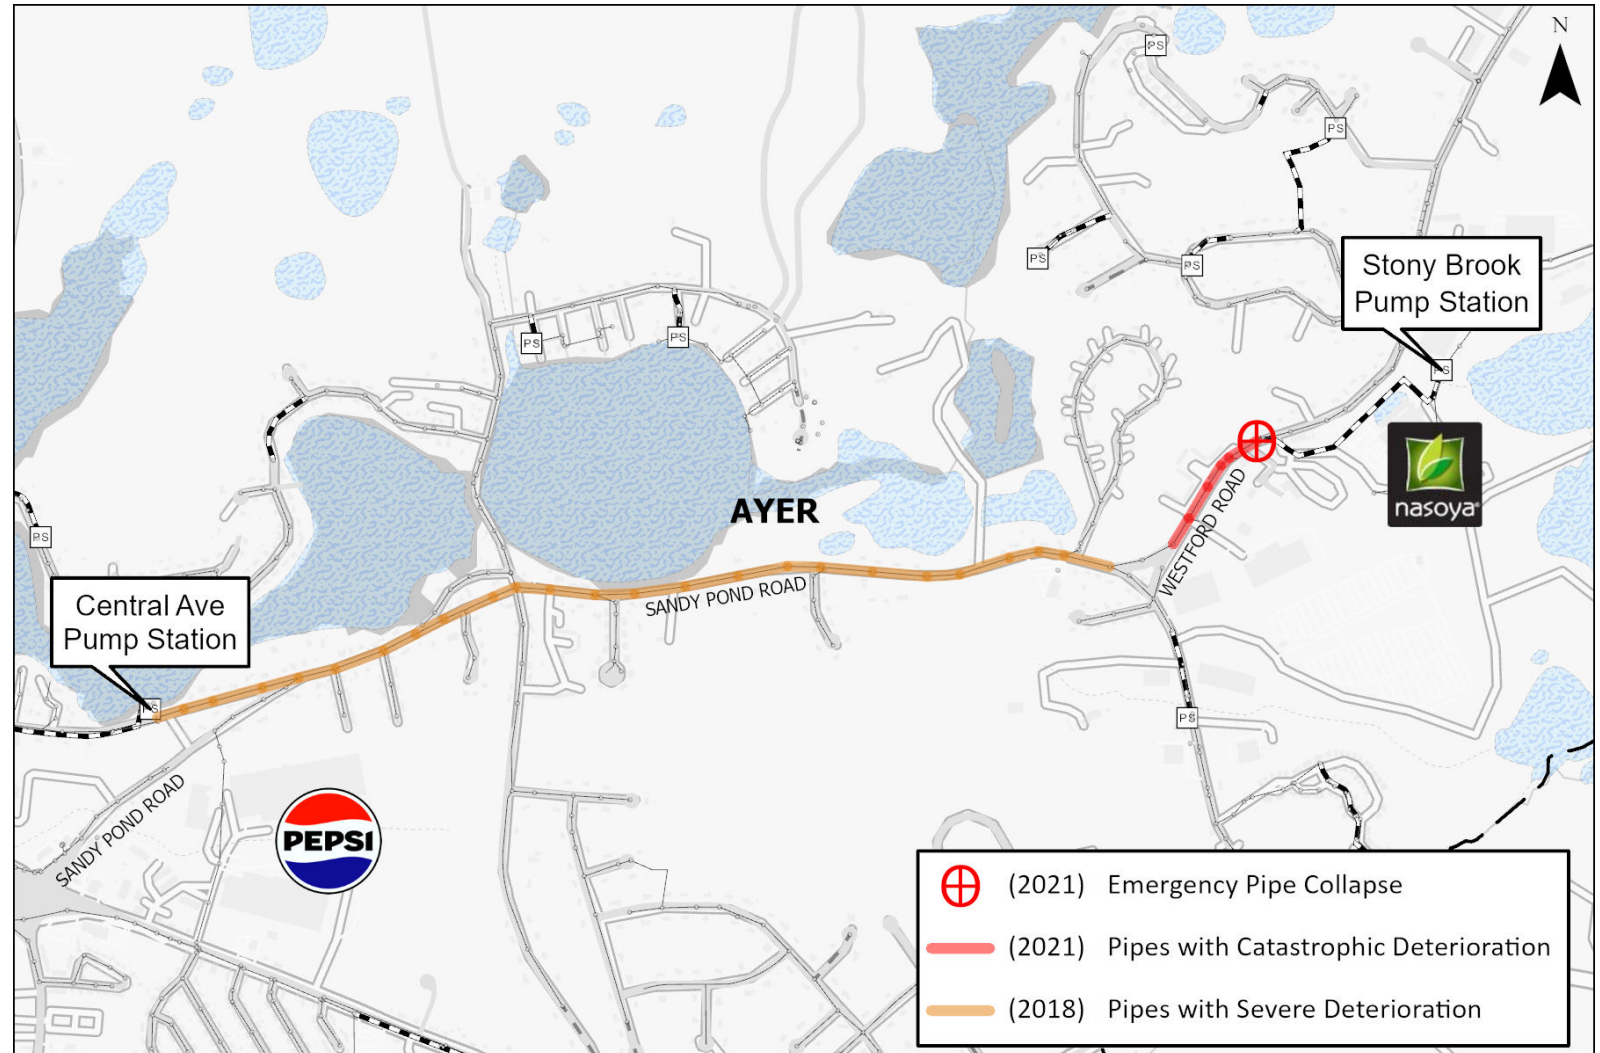
2018 - Sandy Pond Road

- Inspected 7,770 LF of 21" and 24" RC Pipe
- Sewer is adjacent Sandy Pond and Flannagan Pond
- Depth of Sewer ranges from 5 ft to 33 ft
- Severe H2S deteriorated

2021 - Westford Rd

- Downstream of discharge from Stony Brook PS
- ~18 LF of 12" AC Sewer Collapsed
- ~1,310 LF of Failed and severely deteriorated 12" and 15" AC pipe
- Unsafe to clean or inspect pipe
- Unsafe to inspect manholes

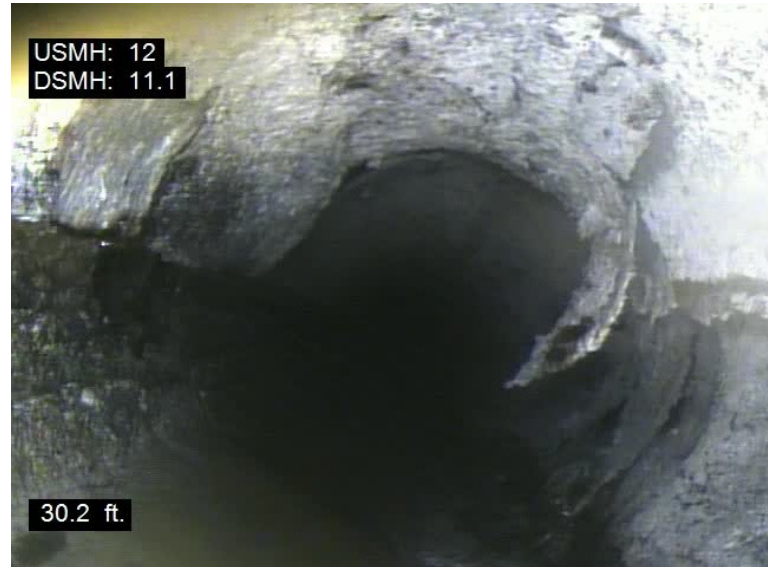
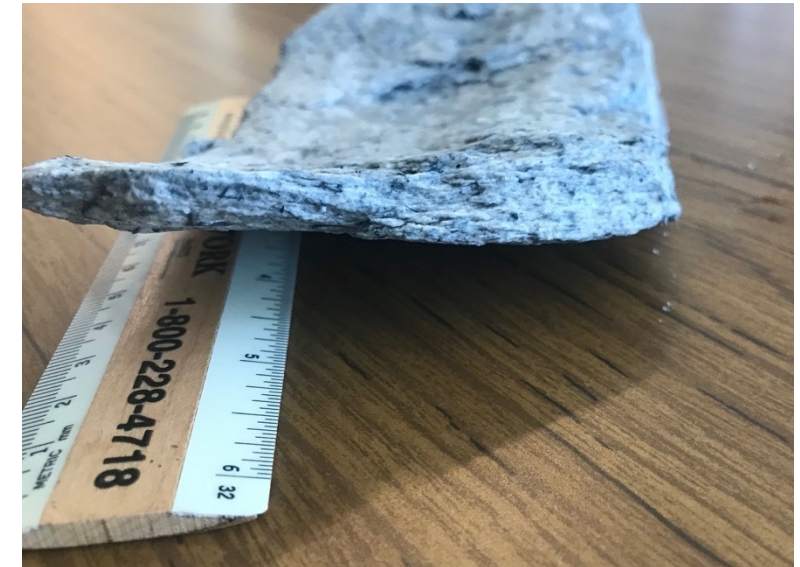
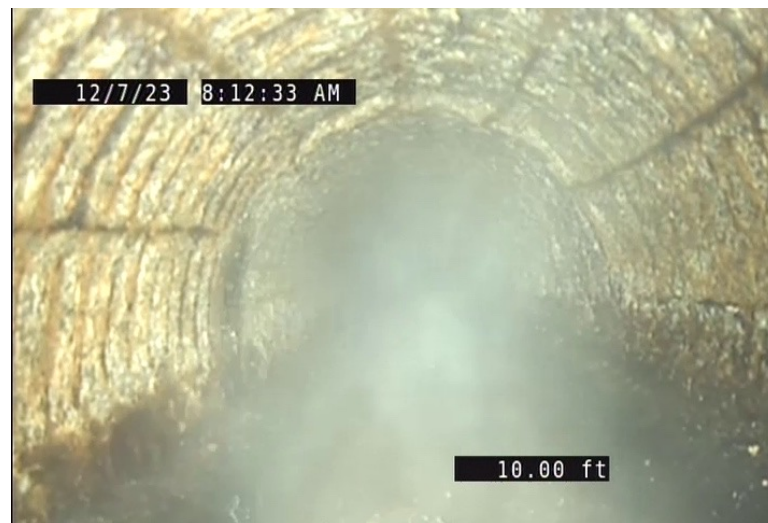
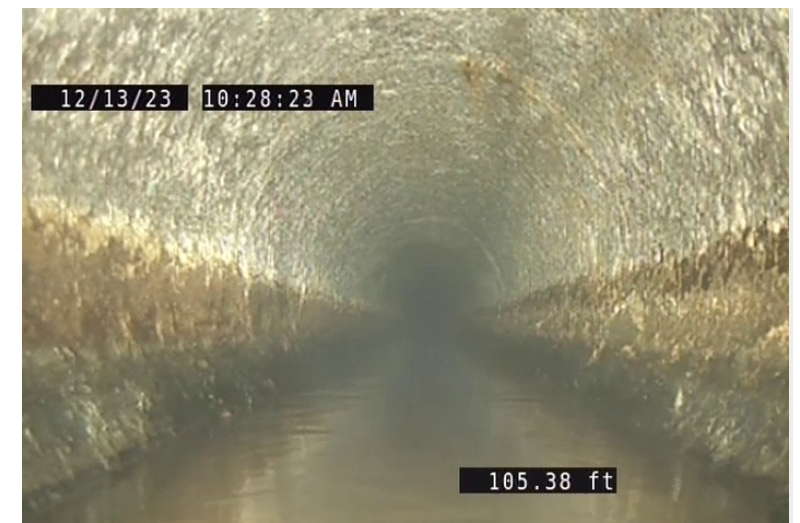
Different Stages of Deterioration Required Different Solutions

Severely deteriorated pipes on the verge of collapse had to be replaced or abandoned

Pipes retaining structural integrity while still transporting wastewater can be rehabilitated
