RUNNING BETWEEN RAINDROPS: Corrosion Repair of a Critical CSO Pump Discharge Pipe

**Massachusetts Water
Resources Authority**

Corrosion Probe, Inc.

MWRA PRISON POINT CSO (PPCSO)

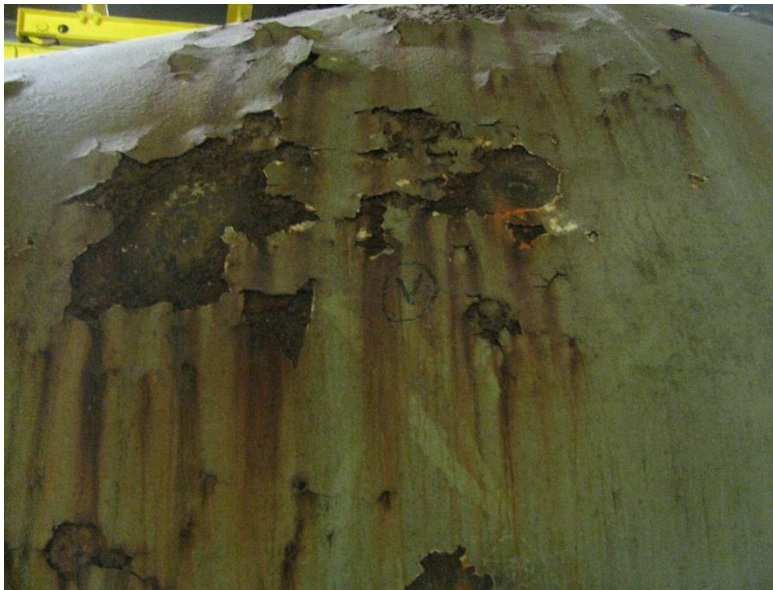
Coating Failure and Carbon Steel Corrosion

External: Isolated

Internal: General

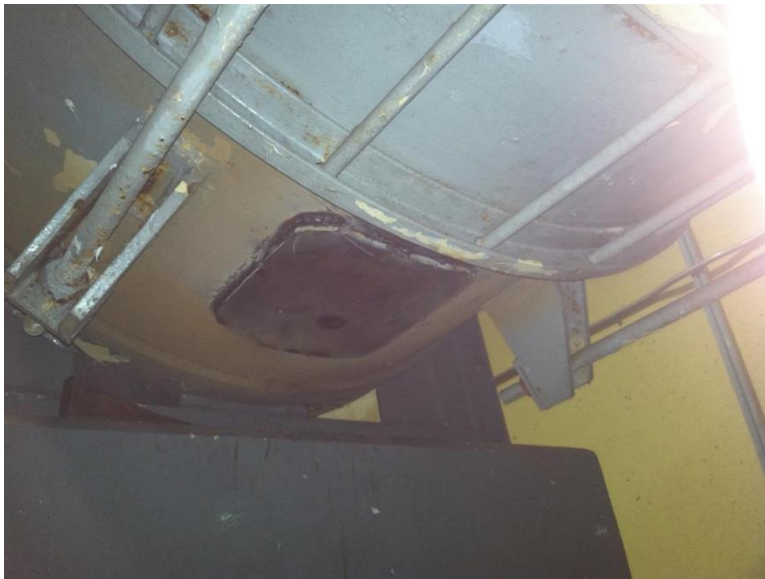
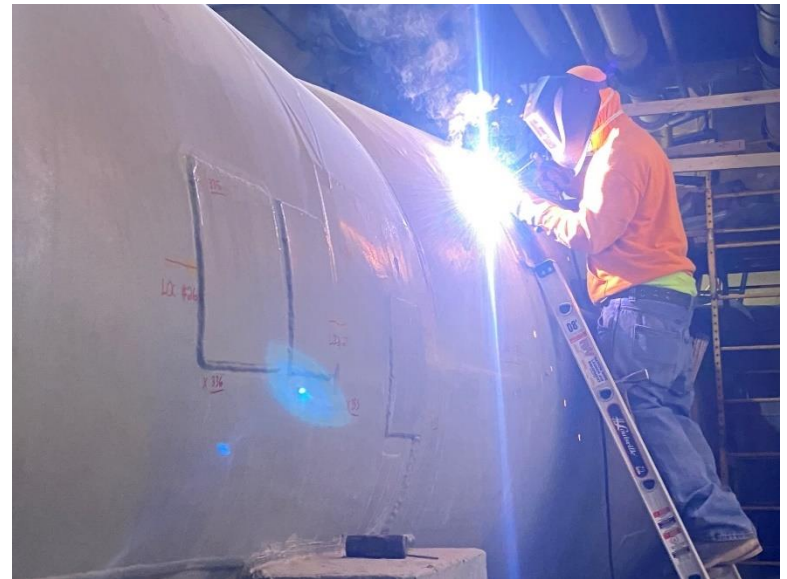
- Ongoing perforation & leakage
- External welded patch plate repairs

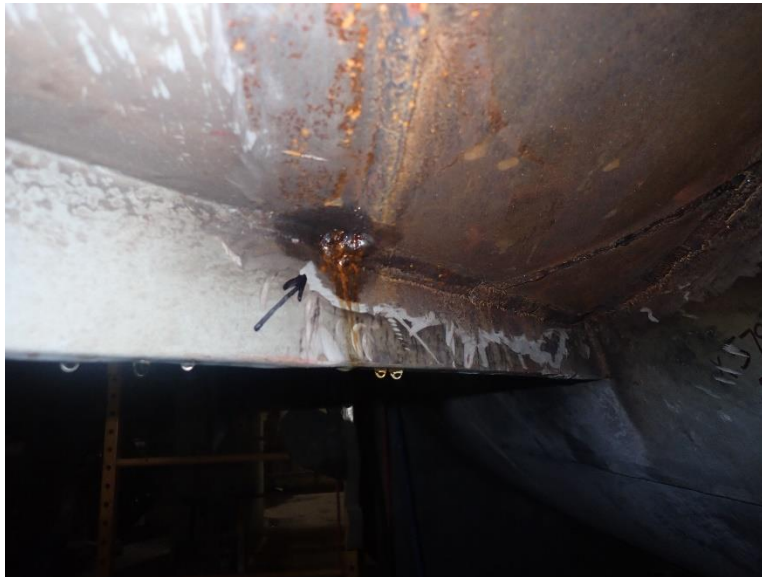
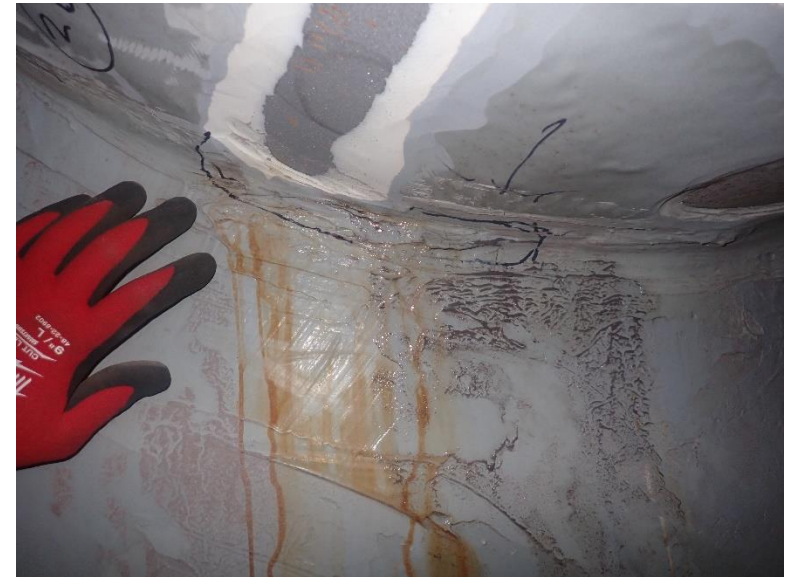
Activation Leaks
