Protecting Critical Infrastructure: Phases 1 and 2 of the Beardsley Force Main Renewal

“A Walk in the Park”

NEWEA Annual Conference

Beardsley Pump Station and Force Main

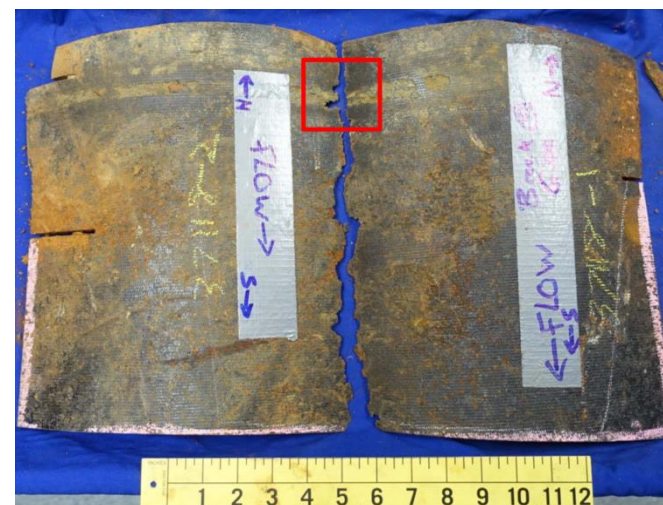
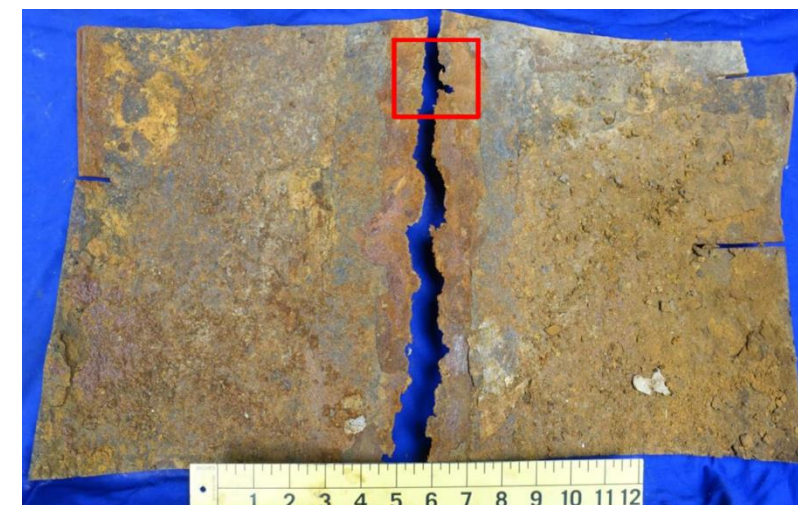
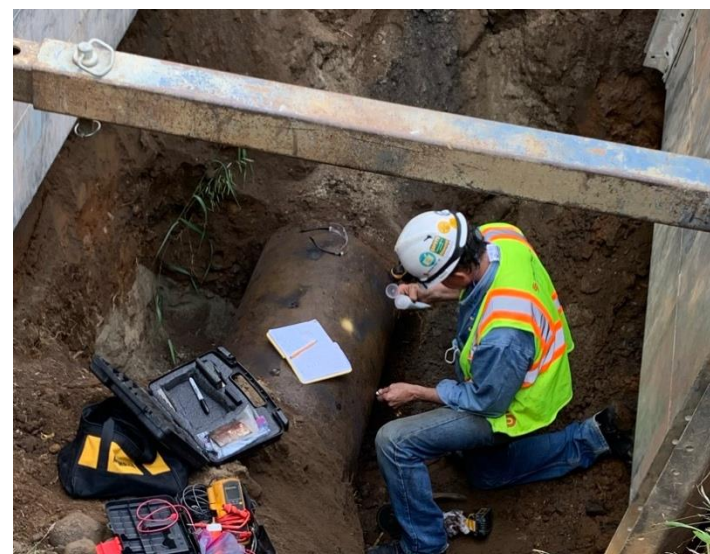
Testing Locations:

- Failure Analysis of removed pipe
 - Mode of Failure: Microbial Induced Corrosion (MIC)
- (2) Additional locations selected for UT testing

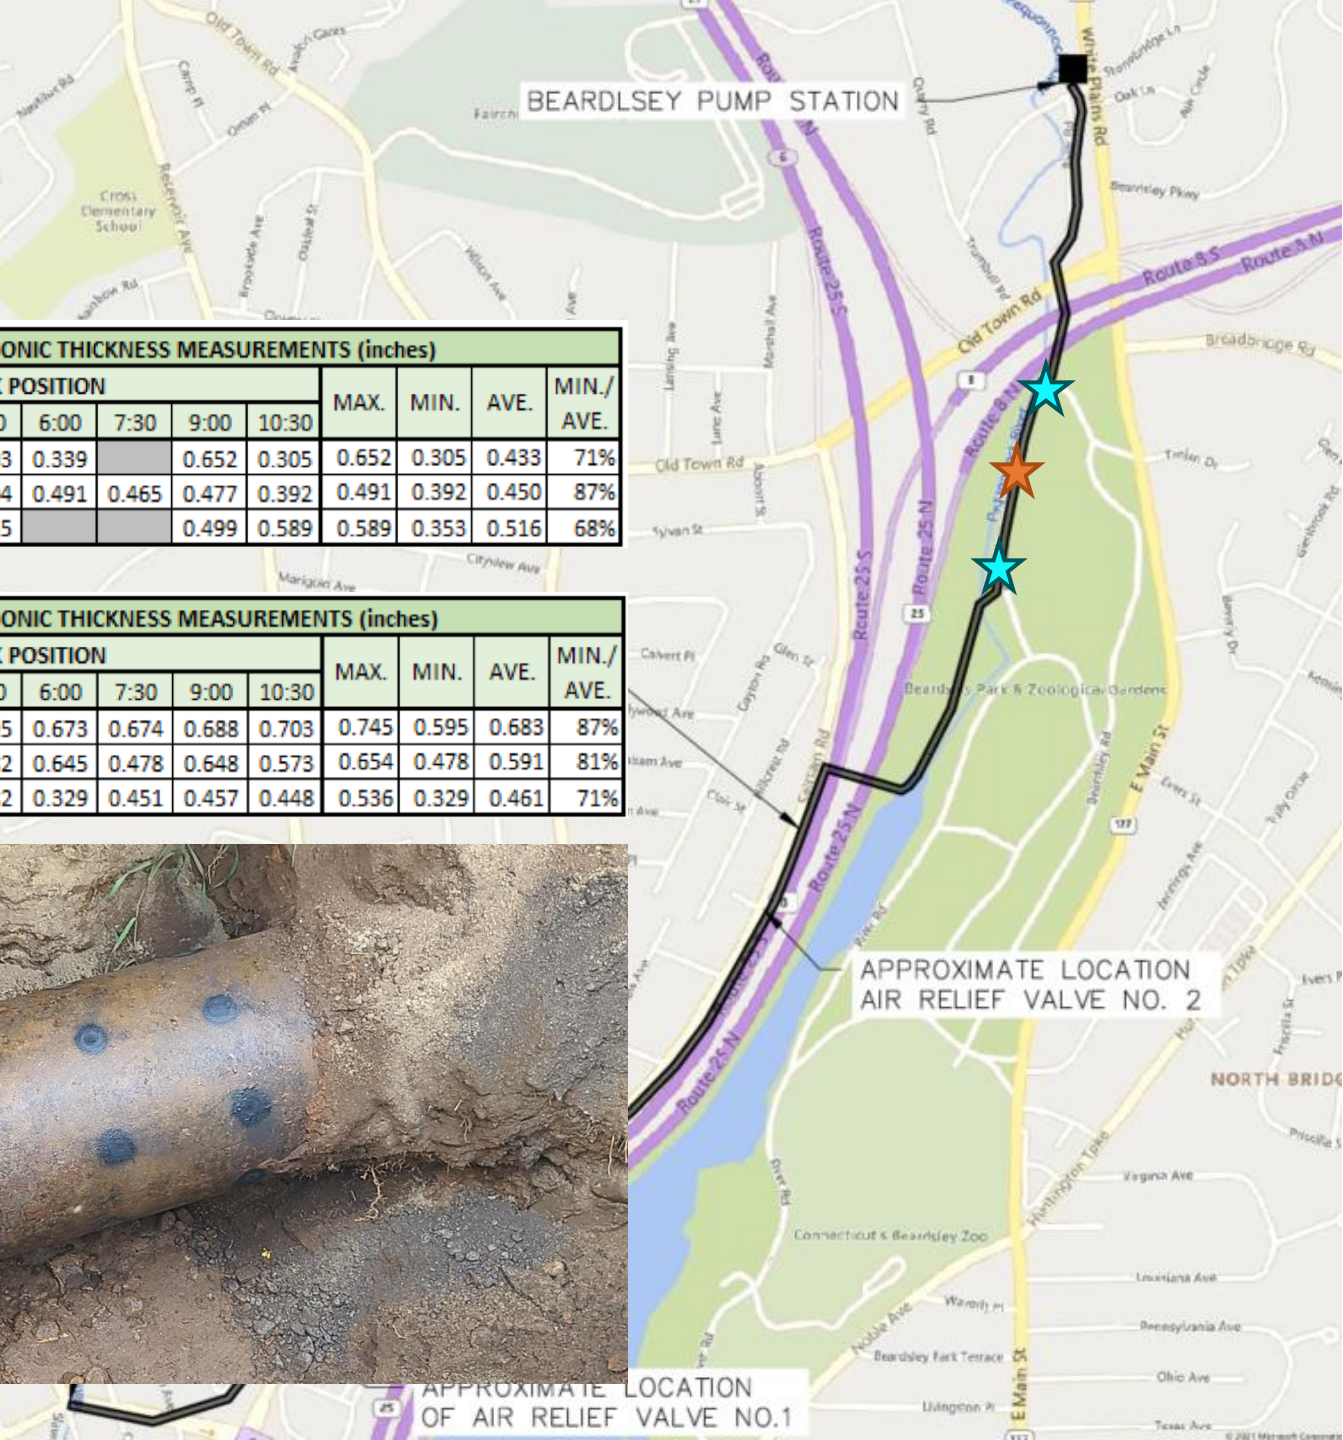
UT Testing

TABLE 3: 20" DI PIPING ULTRASONIC THICKNESS MEASUREMENTS (inches)													
LOCATION		CLOCK POSITION								MAX.	MIN.	AVE.	MIN./AVE.
COMPONENT	AREA	12:00	1:30	3:00	4:30	6:00	7:30	9:00	10:30				
TEST PIT 1 BEARDSLEY	A	0.437	0.437	0.455	0.403	0.339		0.652	0.305	0.652	0.305	0.433	71%
	B	0.411	0.486	0.477	0.404	0.491	0.465	0.477	0.392	0.491	0.392	0.450	87%
	C	0.550	0.353	0.547	0.555			0.499	0.589	0.589	0.353	0.516	68%

TABLE 4: 20" DI PIPING ULTRASONIC THICKNESS MEASUREMENTS (inches)													
LOCATION		CLOCK POSITION								MAX.	MIN.	AVE.	MIN./AVE.
COMPONENT	AREA	12:00	1:30	3:00	4:30	6:00	7:30	9:00	10:30				
TEST PIT 2 BEARDSLEY	A	0.651	0.745	0.737	0.595	0.673	0.674	0.688	0.703	0.745	0.595	0.683	87%
	B	0.550	0.598	0.654	0.582	0.645	0.478	0.648	0.573	0.654	0.478	0.591	81%
	C	0.492	0.492	0.536	0.482	0.329	0.451	0.457	0.448	0.536	0.329	0.461	71%

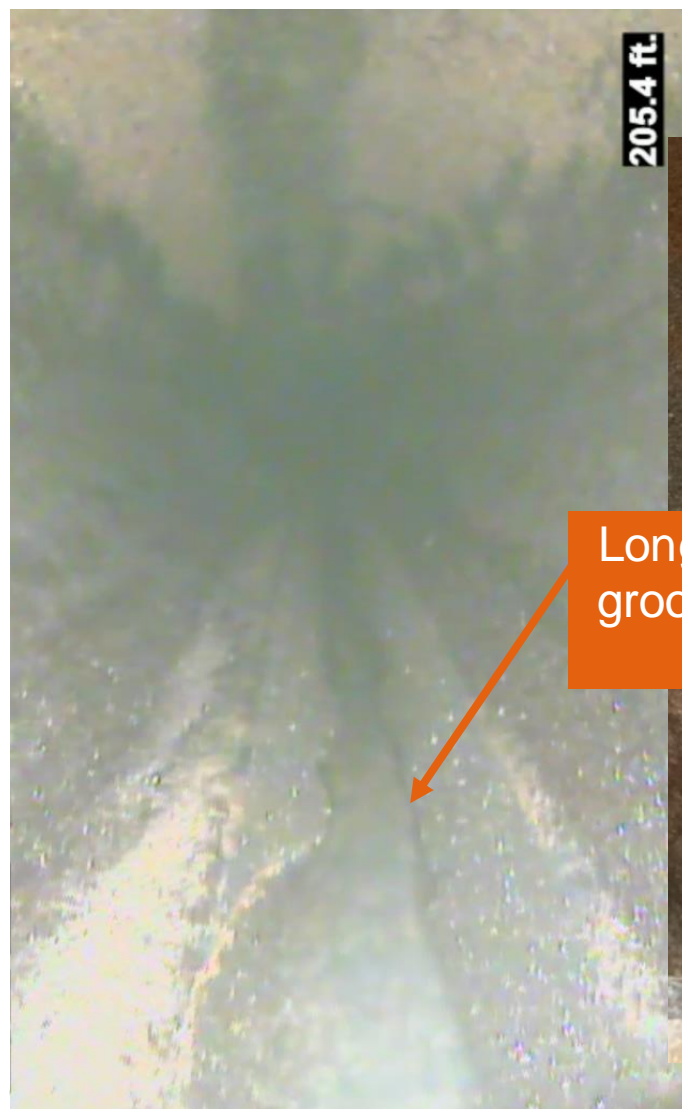
Long, continuous groove located at 6 OC

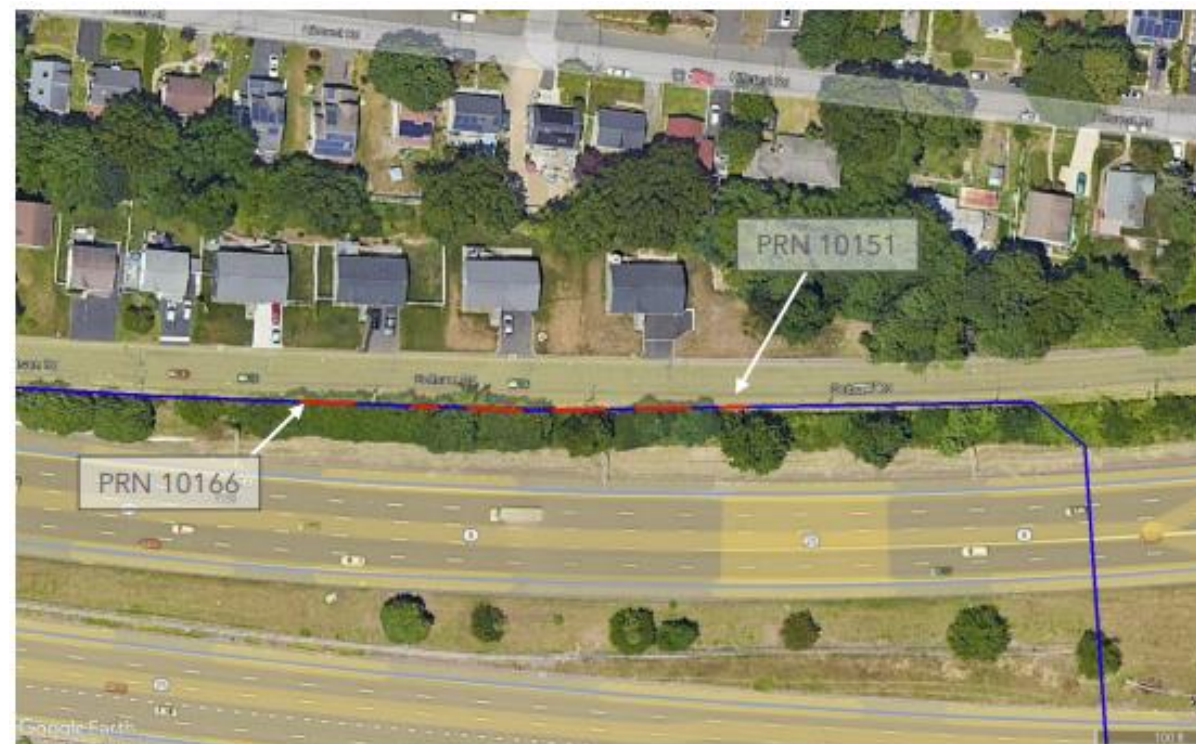
- Requested additional analyses of PipeDiver data
- Additional analyses found 52 areas of signal variation at pipe invert were identified across a total of 49 pipes.
 - Possible causes
- Comparison with prior BEM

Some locations of signal variation

- Widespread wall loss (not supported by overall inspection)
- Debris
- Pipe property variations
- Tool movement

1. Continue operating pump station under operational parameters that limit extended periods of low flow velocity, which was the cause of the microbial induced corrosion.
2. Additional external inspections at locations of signal variation
3. Re-inspect in 10 years
