# Targeted Inspections Used to Assess Force Main Condition After Failure

# About the Beardsley Pump Station Force Main

# Force Main Failure

# Outcome of Failure Analysis

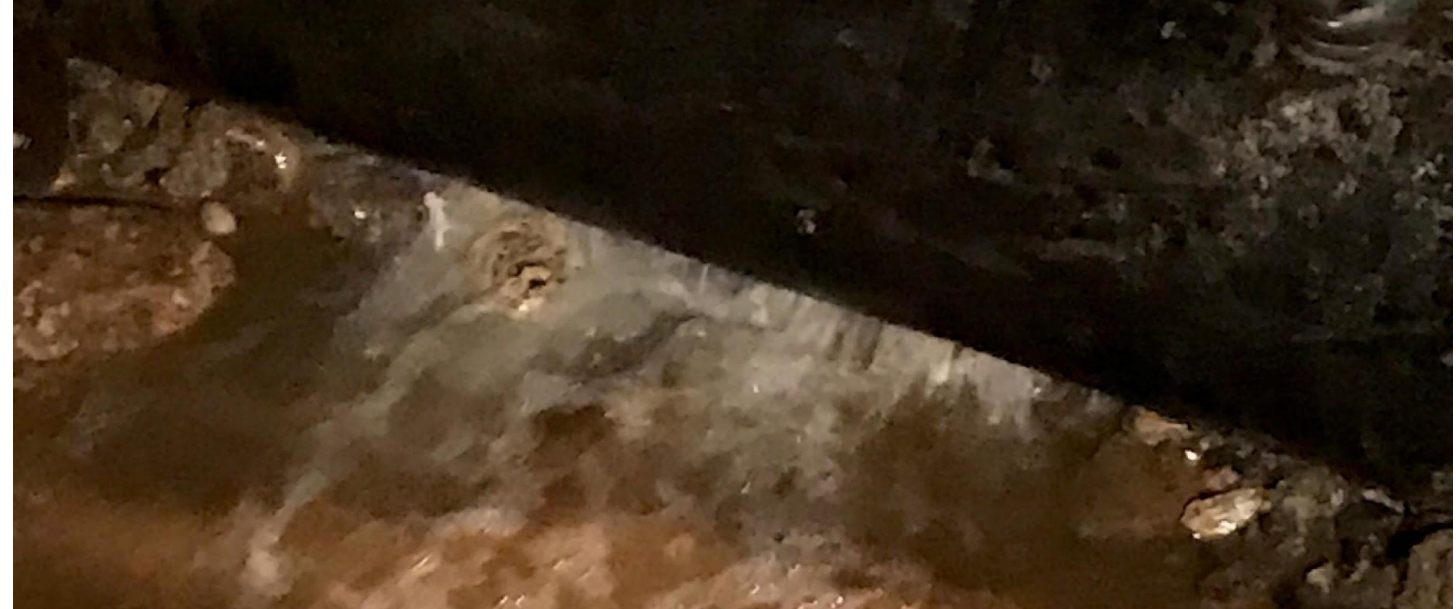
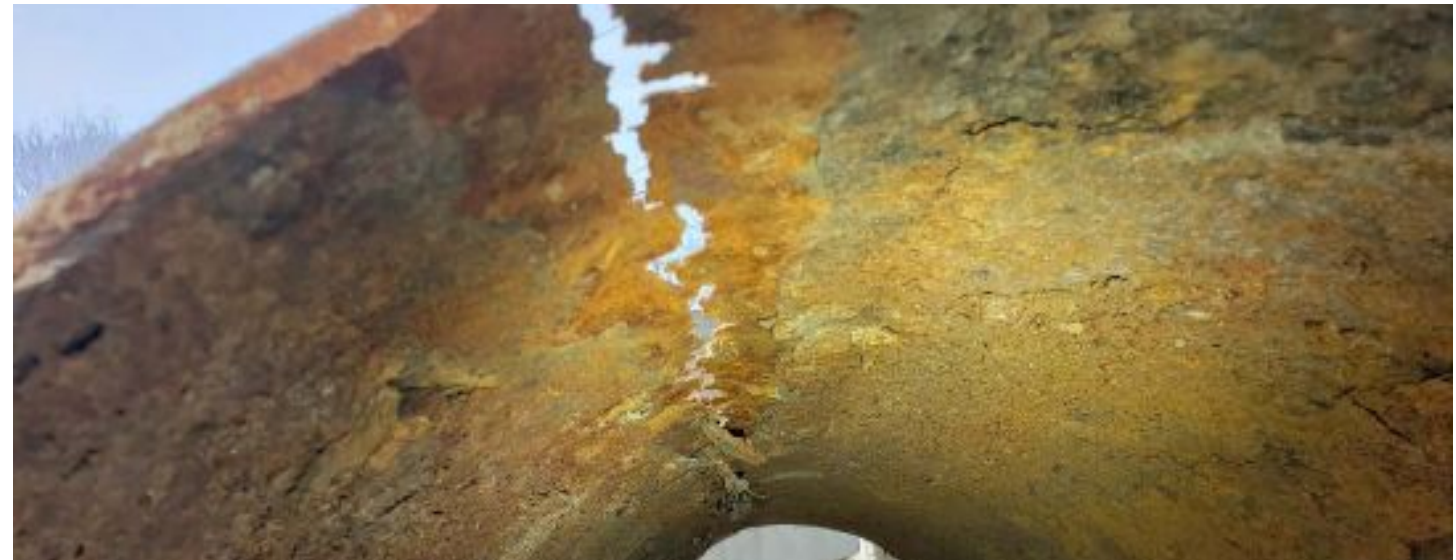
Occurred in January 2020

- Low Point in Pipeline located in Beardsley Park
- Failure occurred at the pipe invert along a 15 foot section – See top photo for active leakage
- Emergency Repair Completed
- Piping Retained for Analysis

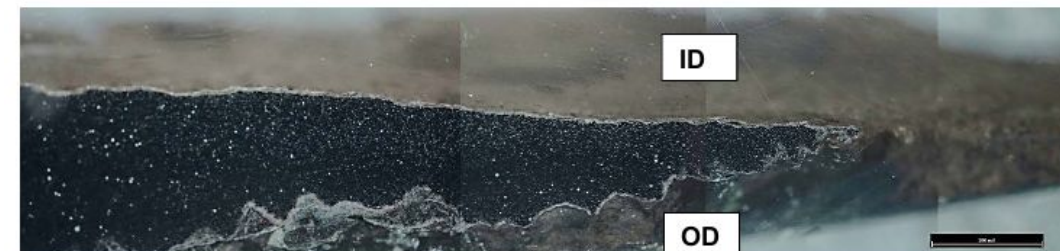
Cross Section of Pipe Invert

- Root Cause of Failure determined to be graphitic corrosion combined with MIC
- Acidic environment at the invert of the pipe was the likely result of a build-up of biosolids and under-deposit corrosion associated with sulfate reducing bacteria (SRB)
- **Failure location alone does not distinguish whether the problem is systemic or localized**

- Sulfate Reducing Bacteria (SRB) suspected cause of failure. Slime Buildup from low velocity, acidic environment (third pump never installed at pump station; inadequate scour velocity)
- Replacement of piping recommended and design/permitting is proceeding

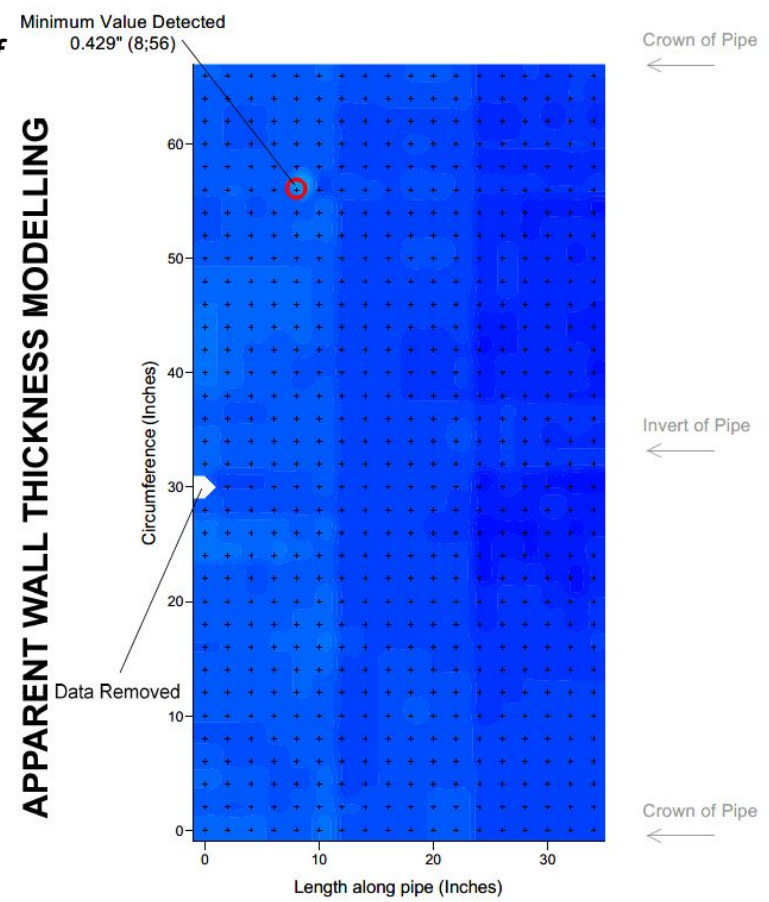
Test Pit at Sylvan Ave

Potential pitting at top of pipe

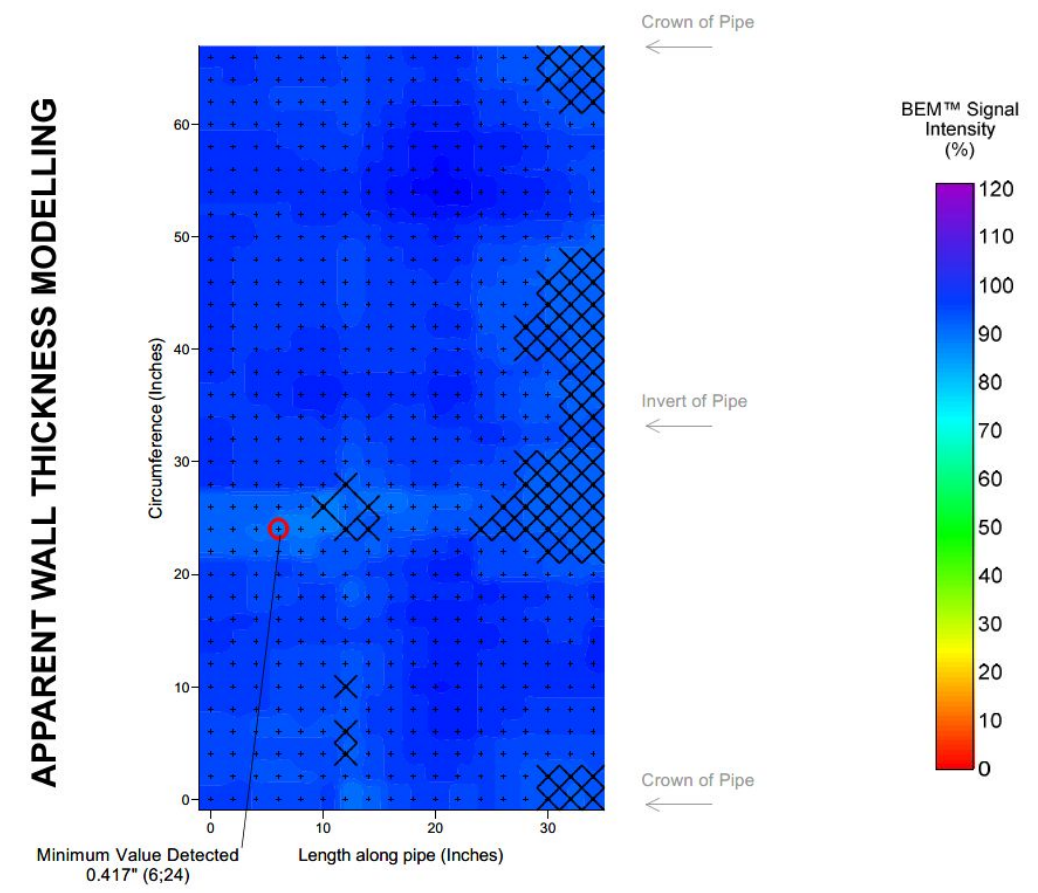
Test Pit at Eric Street

Light Blue:  
General Thinning  
at Pipe Invert
