## Extreme Makeover Outfall Edition

Chelsea Waite, PE Erik Osborn, PE January 26, 2022

Inspection of the Town of Hull's Water Pollution Control Facility Effluent Outfall

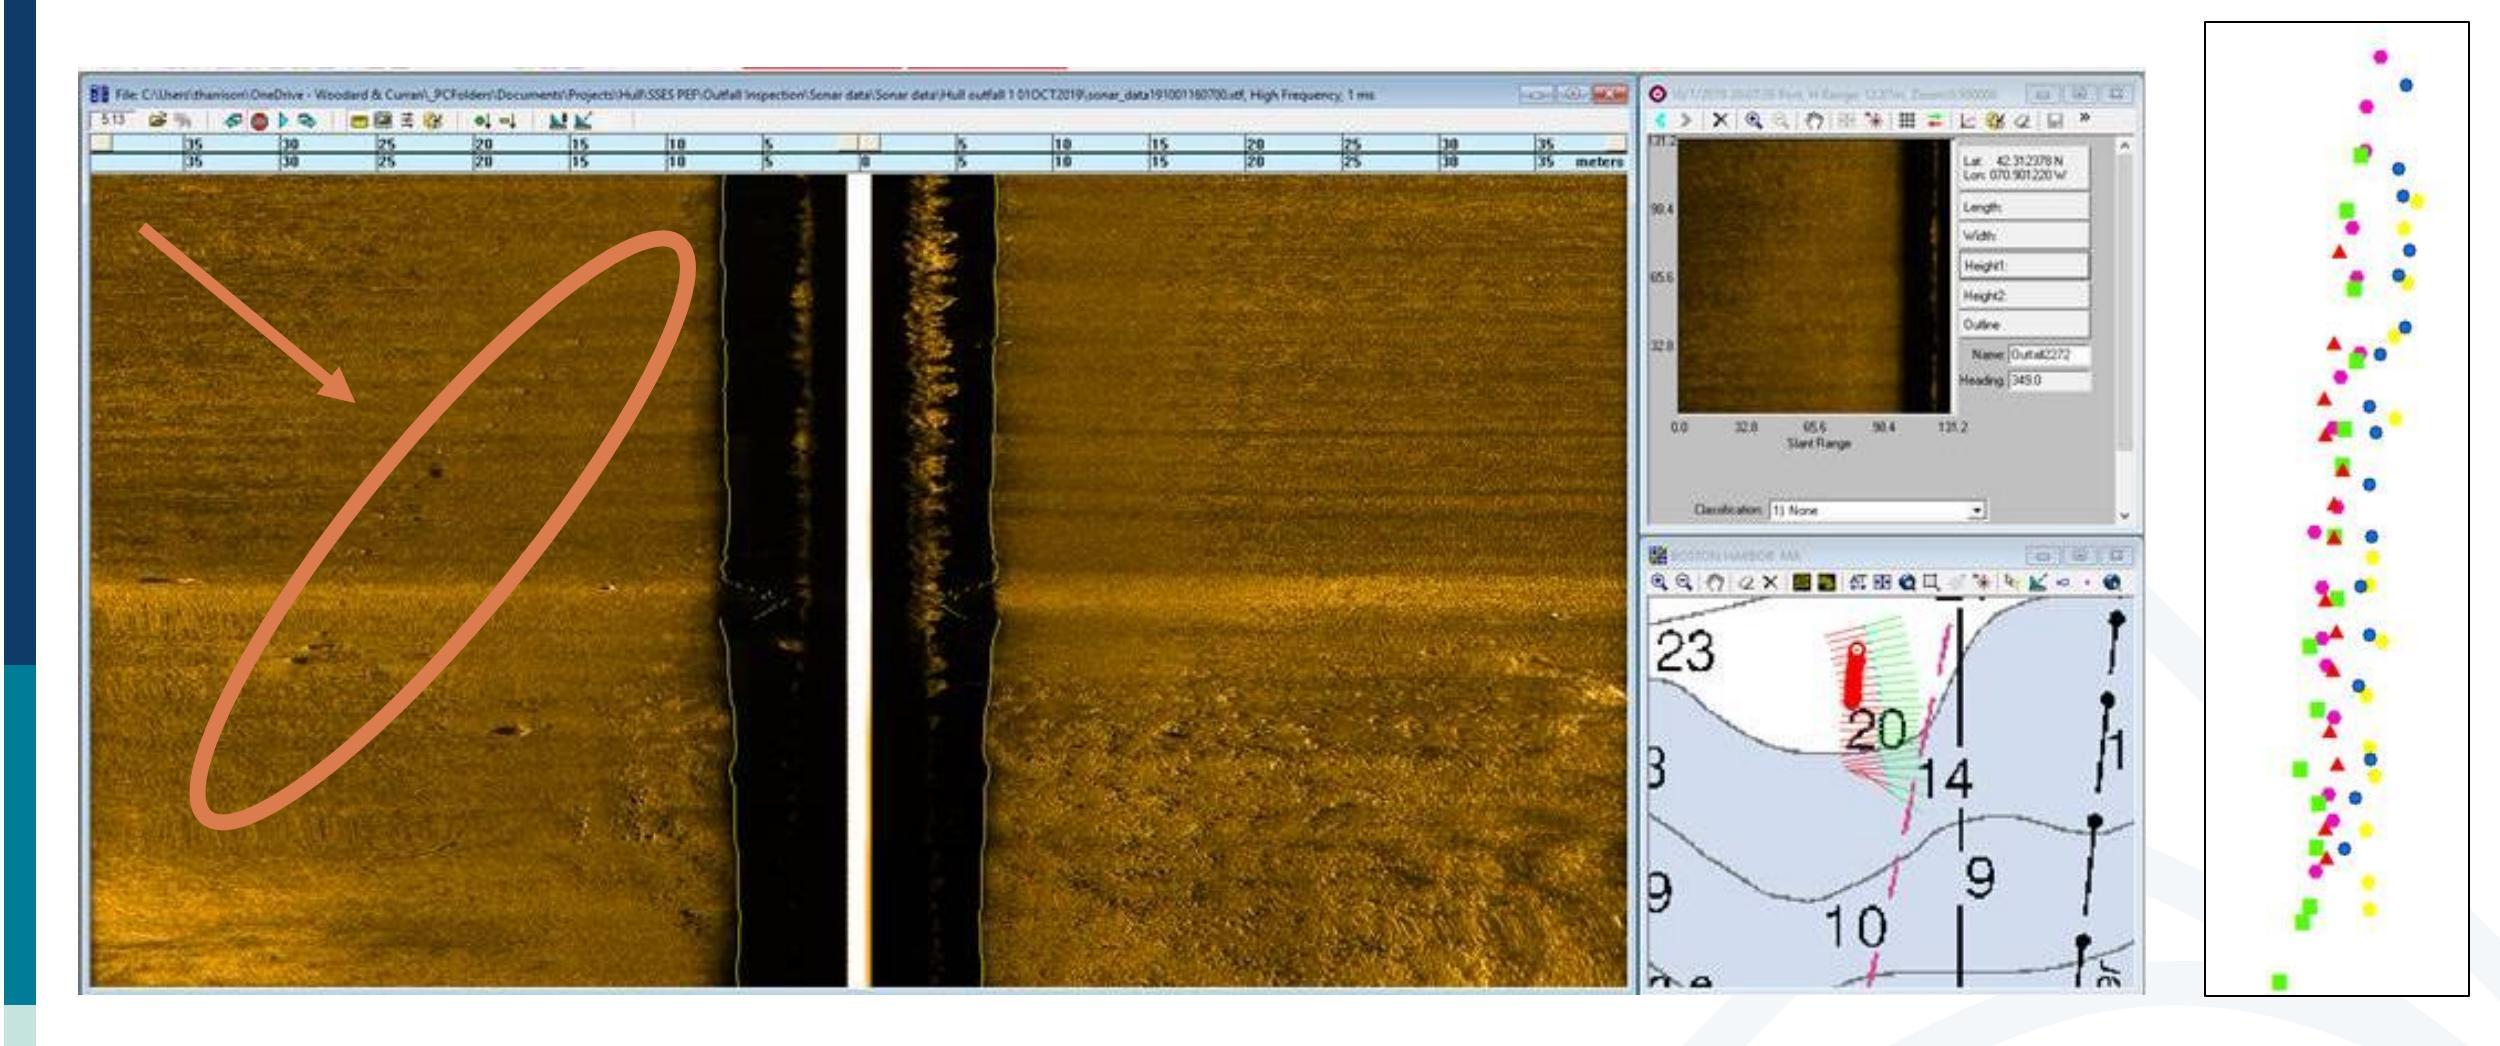
#### Side Scan Sonar

Locating the outfall in the field

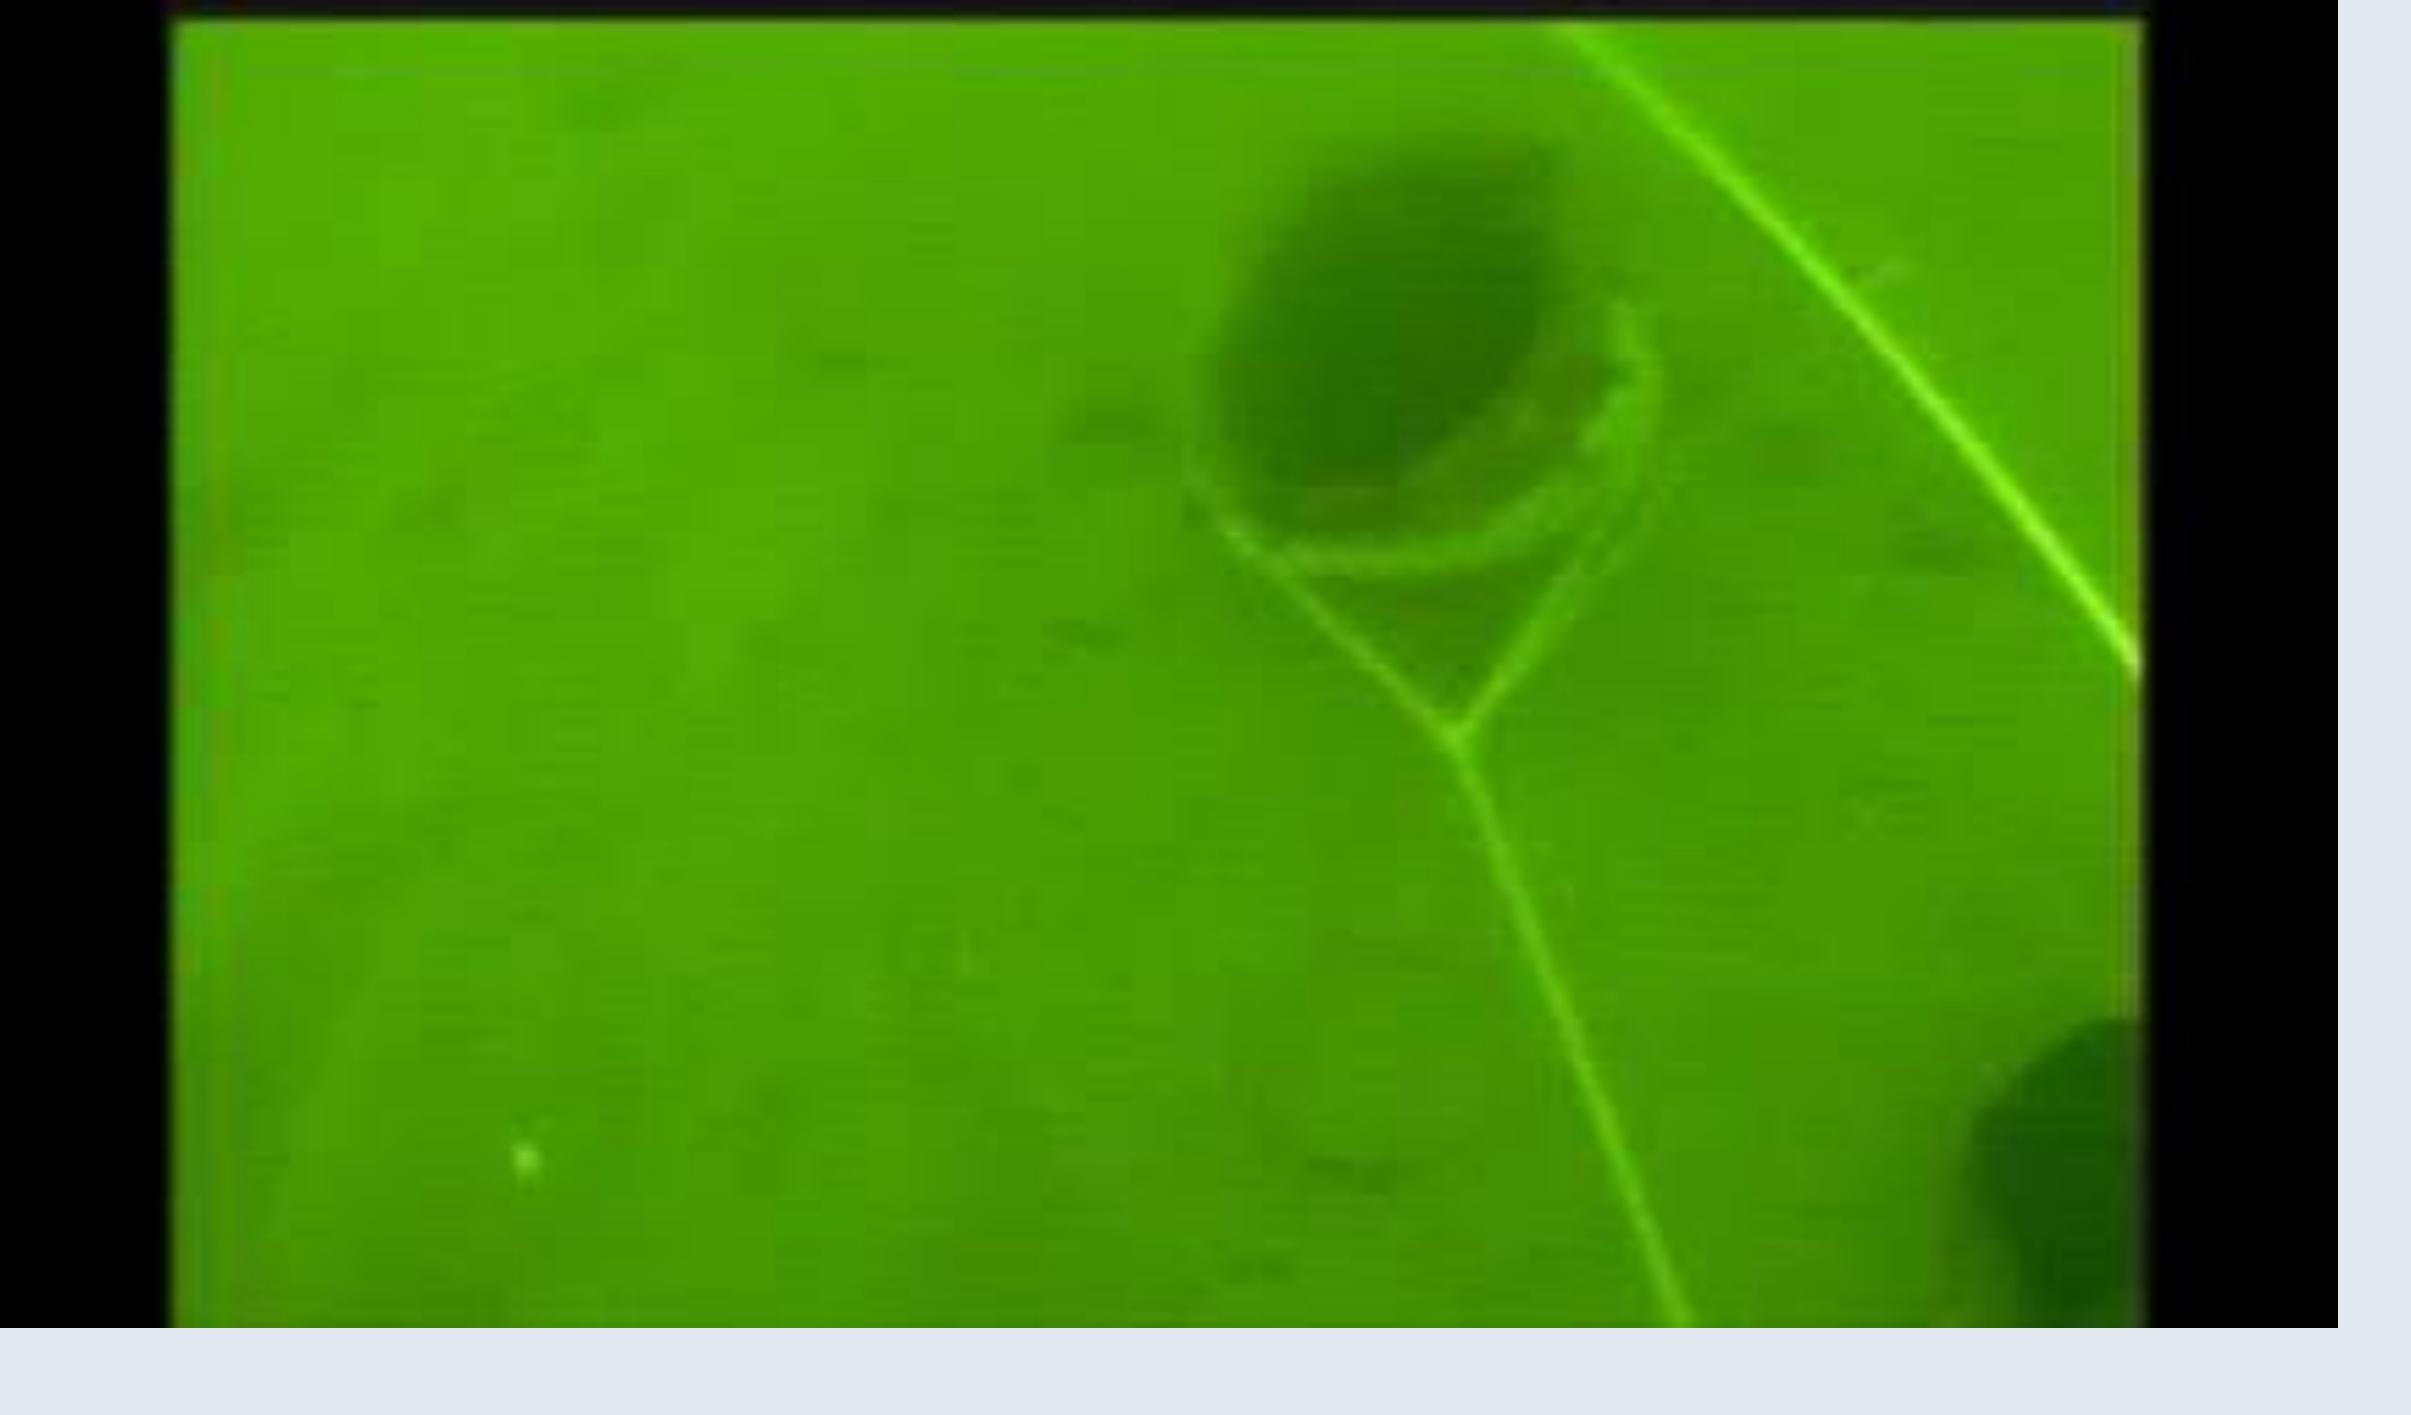
### **External Inspection Conclusions**

- 18 diffuser ports were located
- Diffusers were 3 to 8-inches from seafloor
- 17 of 18 diffusers had flow
- Inside of diffusers had little to no marine growth
- Three most inland diffusers were in two- to four-foot diameter crater-like depressions
- Diffuser spacing was every 10 feet except for two locations where it was about 20 feet.
- The diffusers were not damaged
- Diffuser openings were cut flush on a diagonal alternating east and west

Located Diffuser	Distance to	Average Height	Flow	Notes	
1 on	(Feet)	(Inches)			
1 (North/Farthest from Shore)	20	3.5	Stronger Flow		
2	10	5.5	Stronger Flow		
3	10	8	Stronger Flow		
4	10	5.5	Stronger Flow		
5	10	11	Stronger Flow		
6	10	7.5	Flowing		
7	20	7.5	Stronger Flow		
8	10	3.5	Flowing		
9	10	2	Stronger Flow		
10	10	9	None	Packed sand; Slushy when probed	
11	10	7	Flowing		
12	10	5.5	Flowing		
13	10	8	Flowing		
14	10	3	Flowing		
15	10	1	Flowing		
16	10	1	Flowing	2.5' x 4" Depression	
17	10	0	Flowing	3.5' x 12" Depression	
18 (South/Closest to Shore)	N/A	1	Flowing	3' x 6" Depression

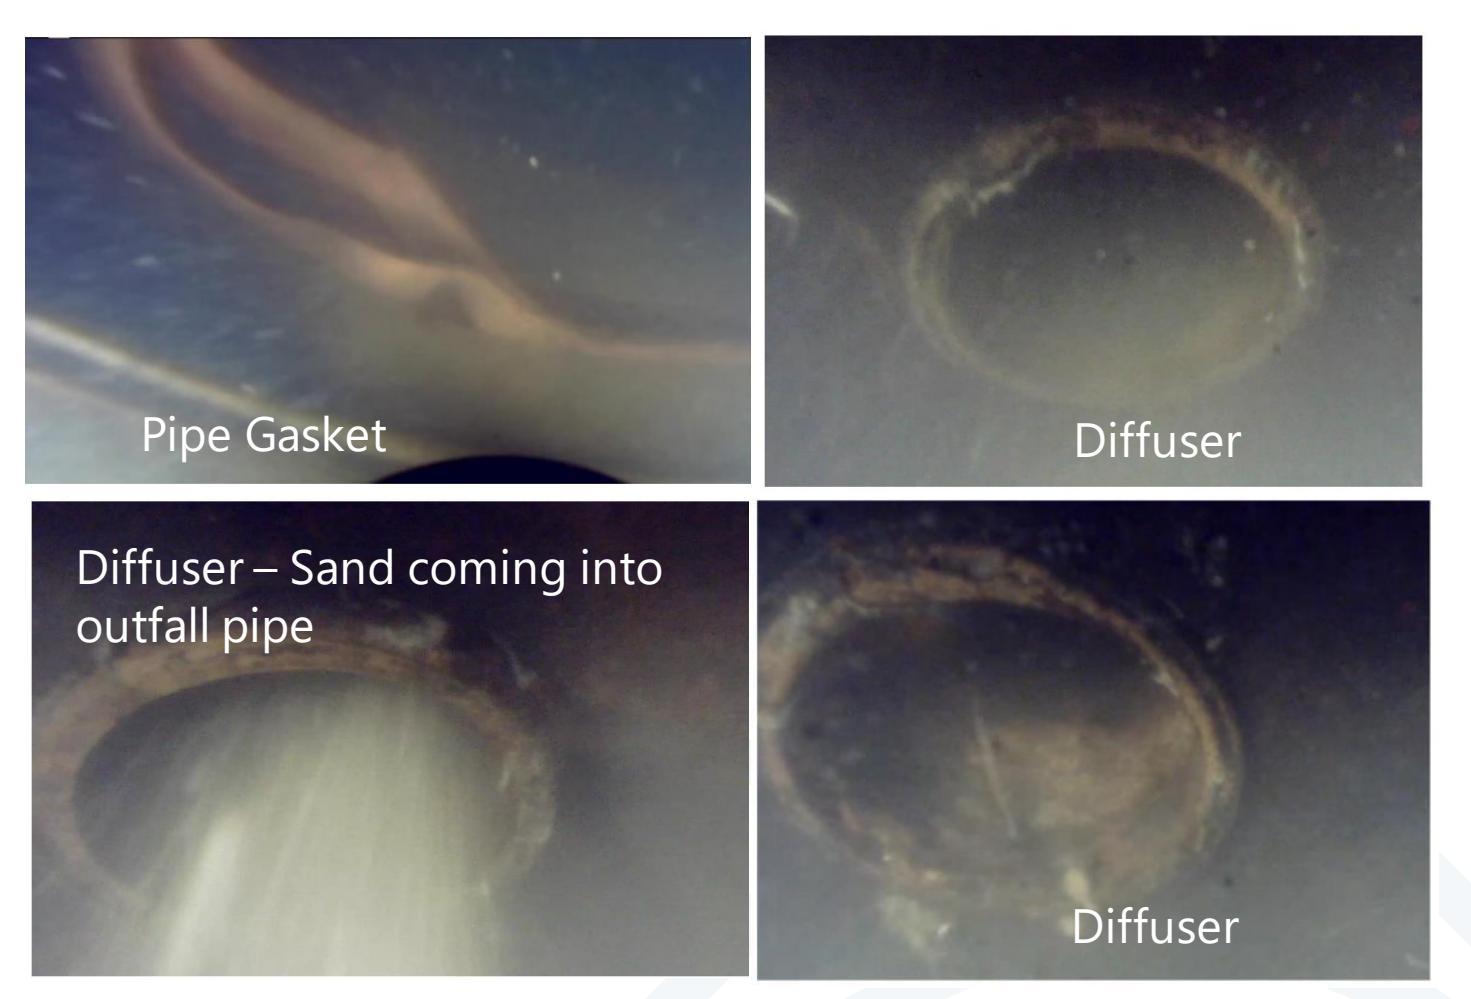
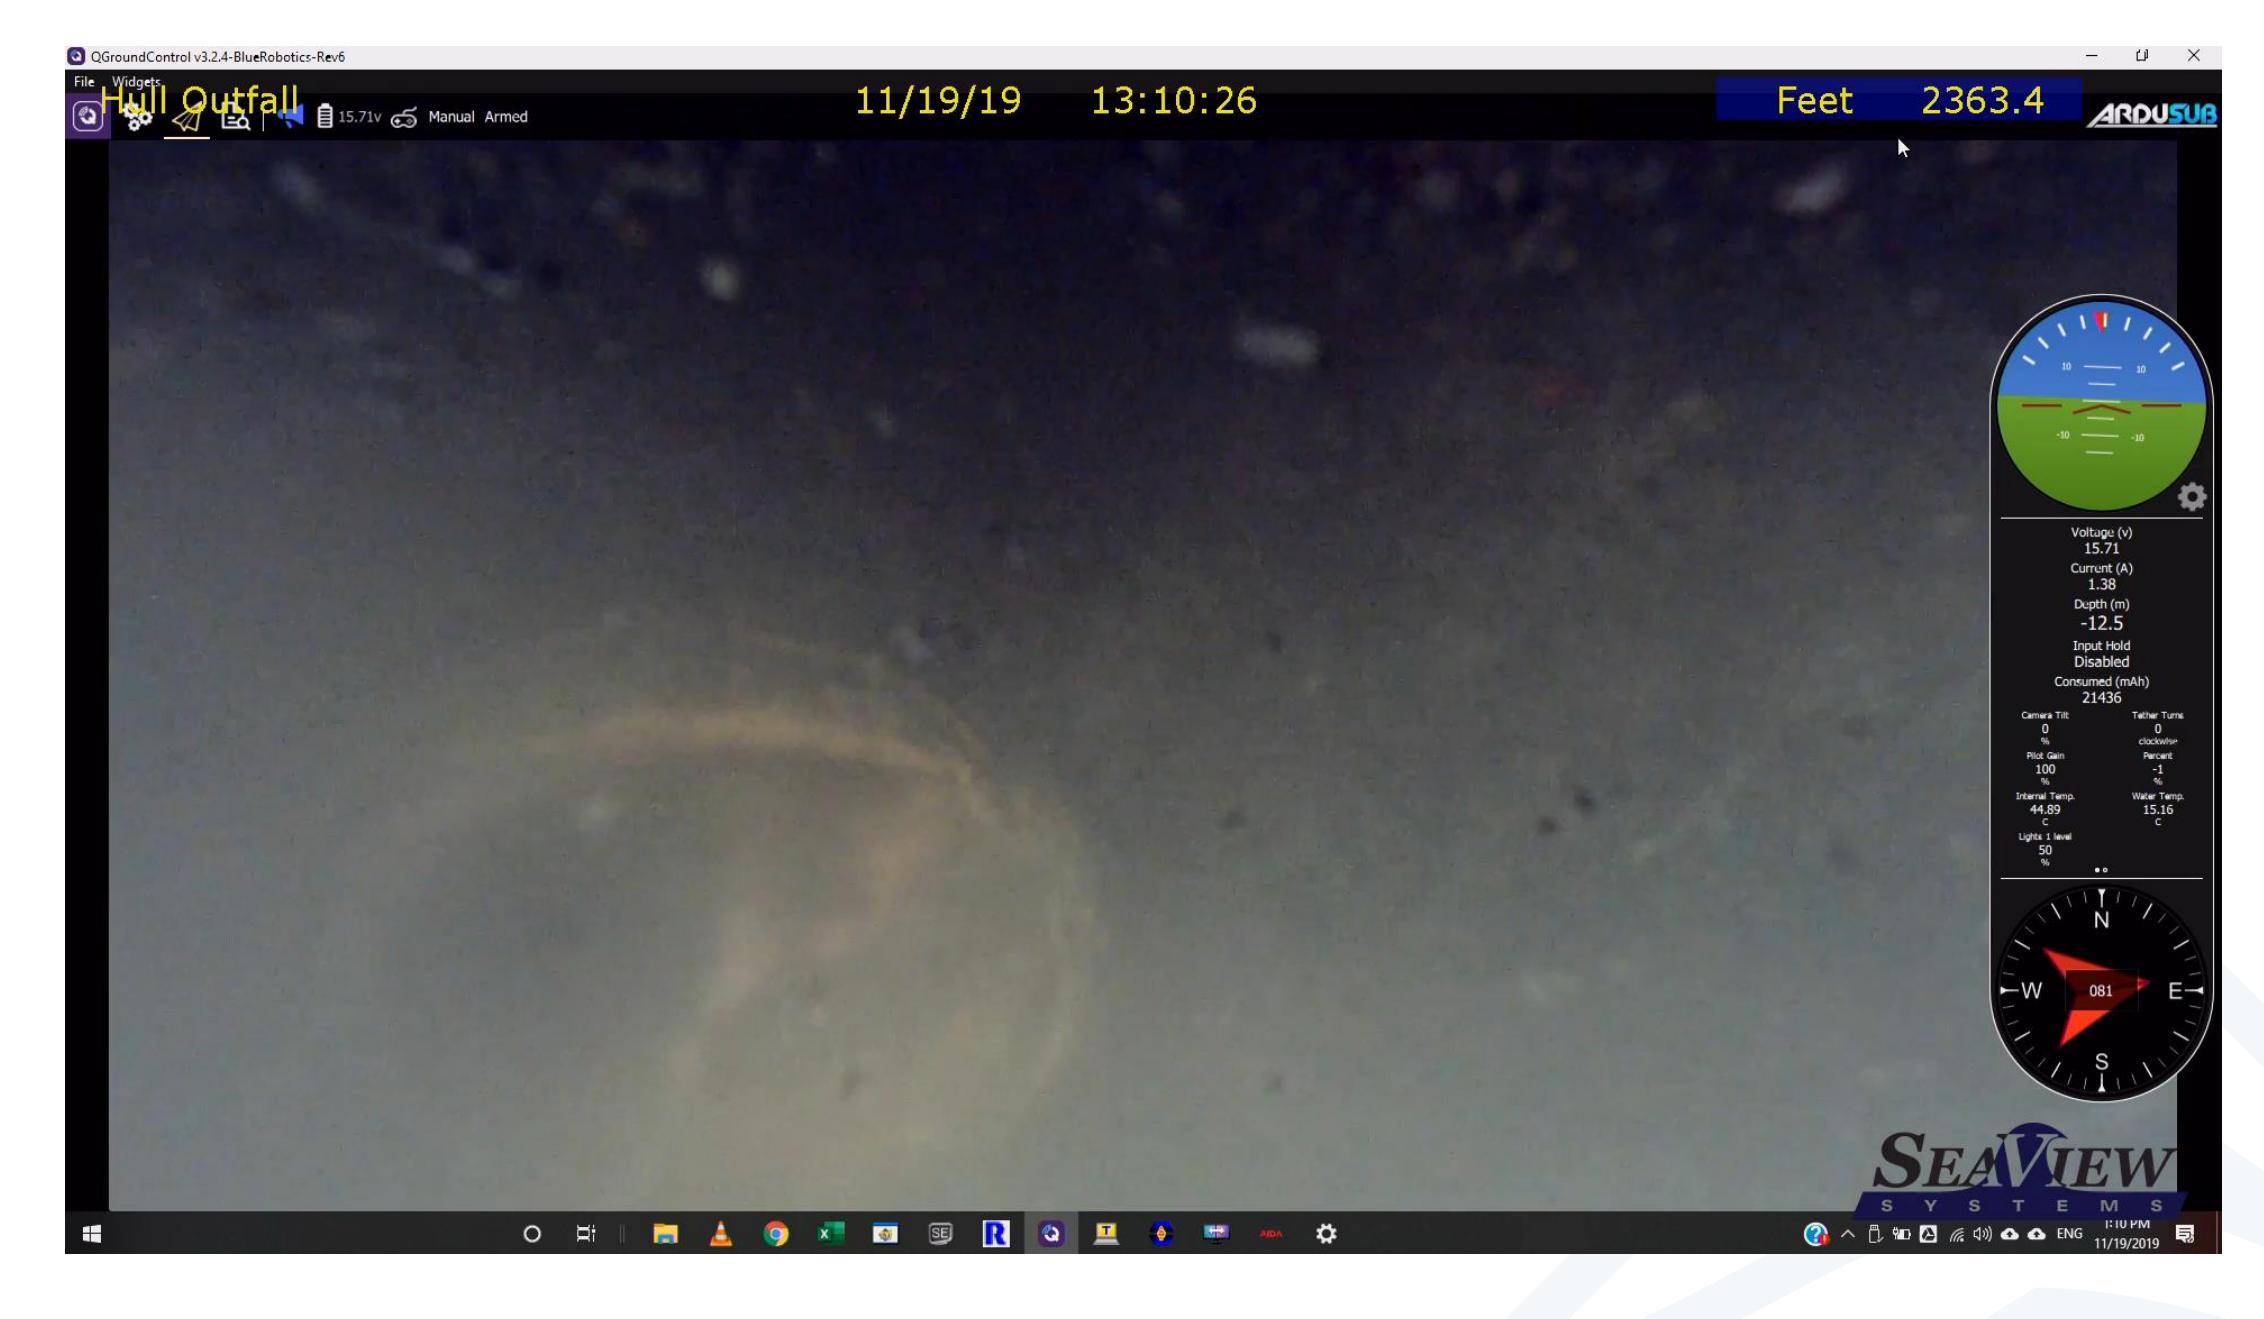
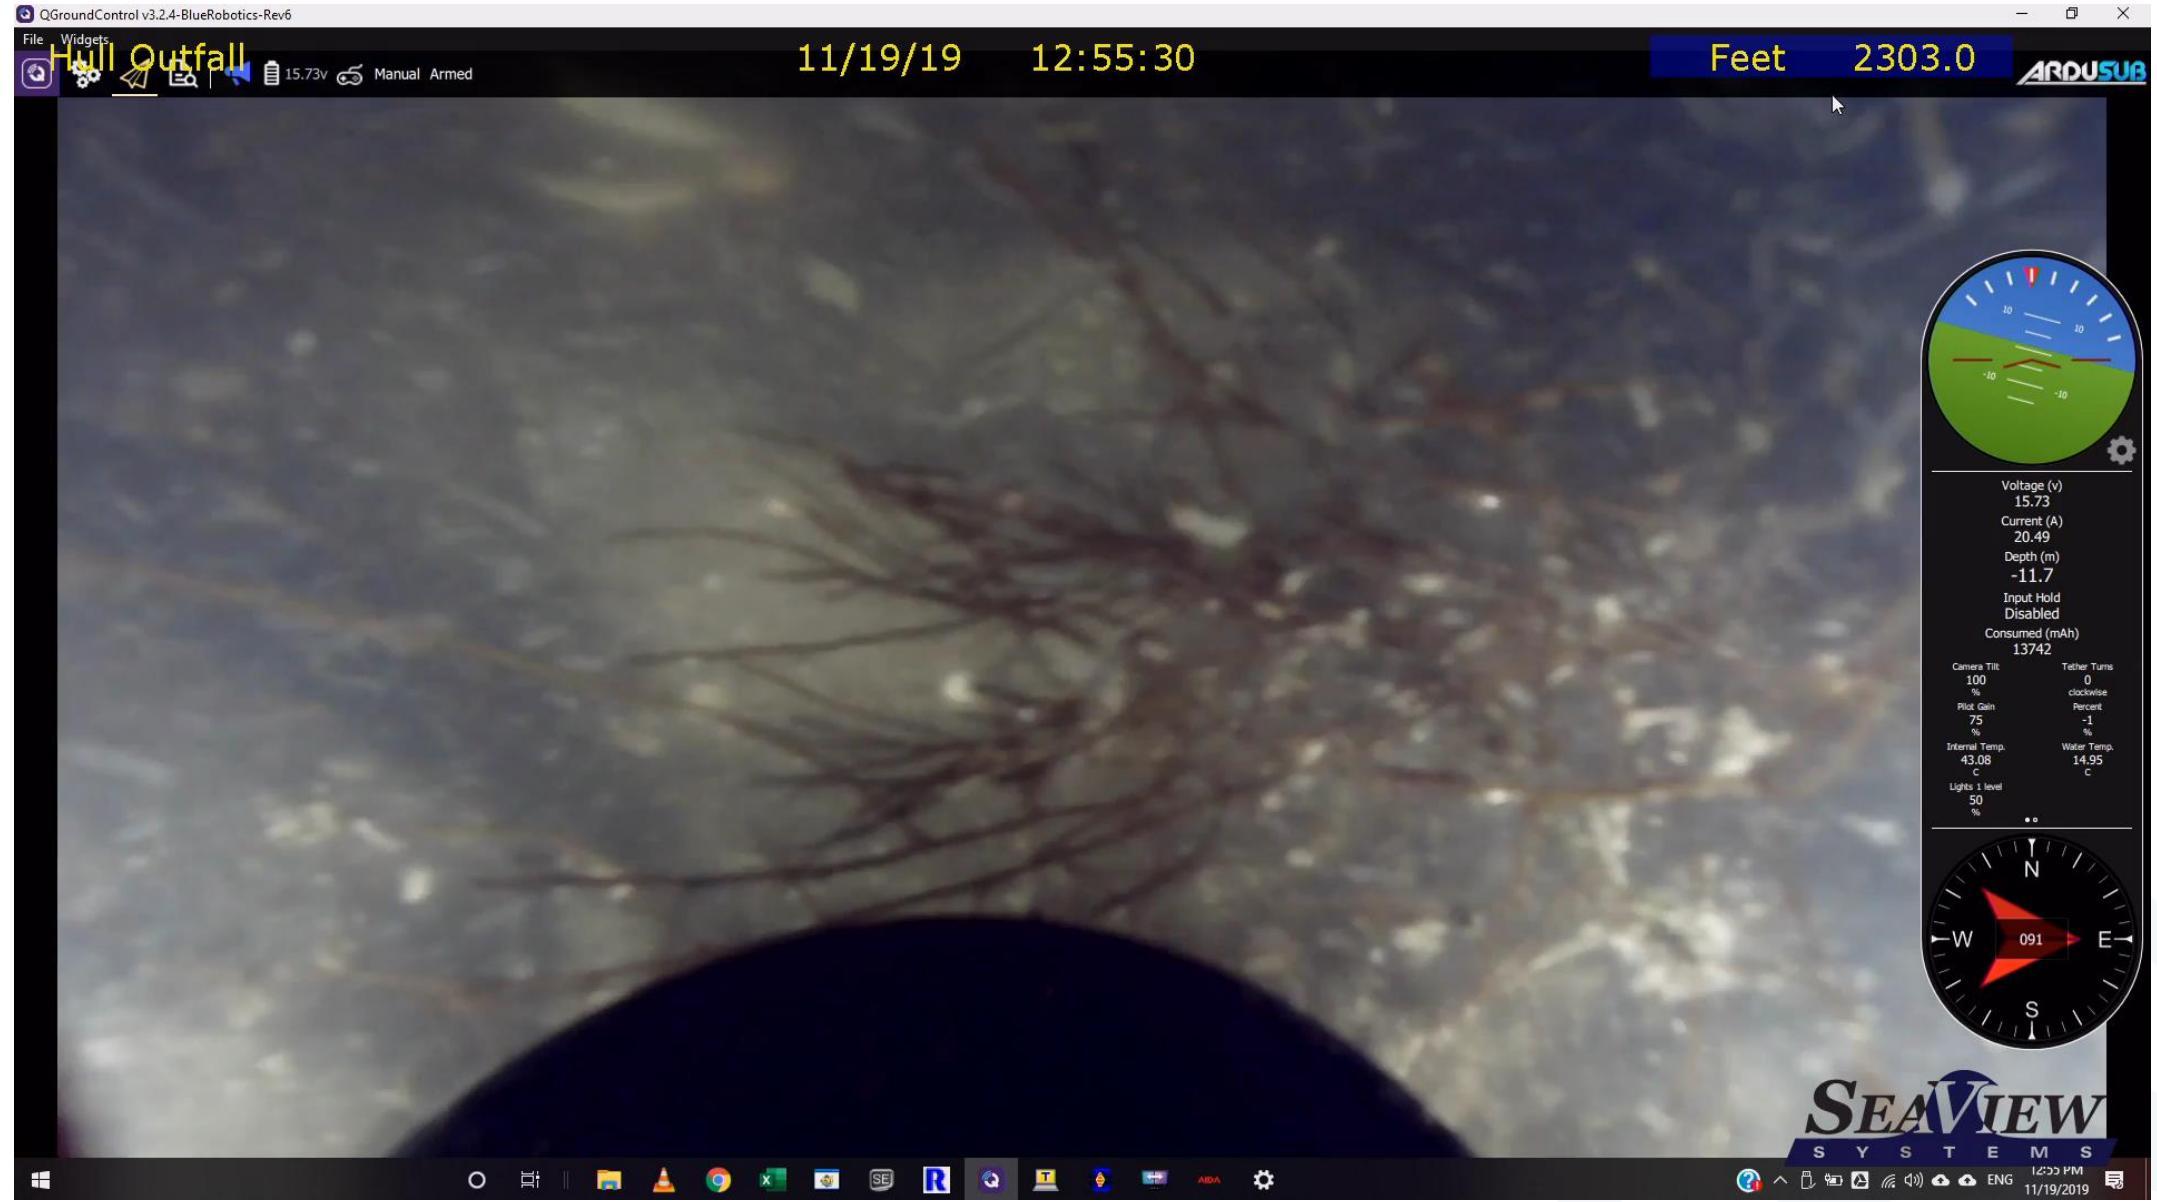
#### **Internal Inspection - Observations**

- Ten diffuser ports
- Rubber material/pipe gaskets
- Horizontal bend locations ROV headings
- Sediment in the outfall

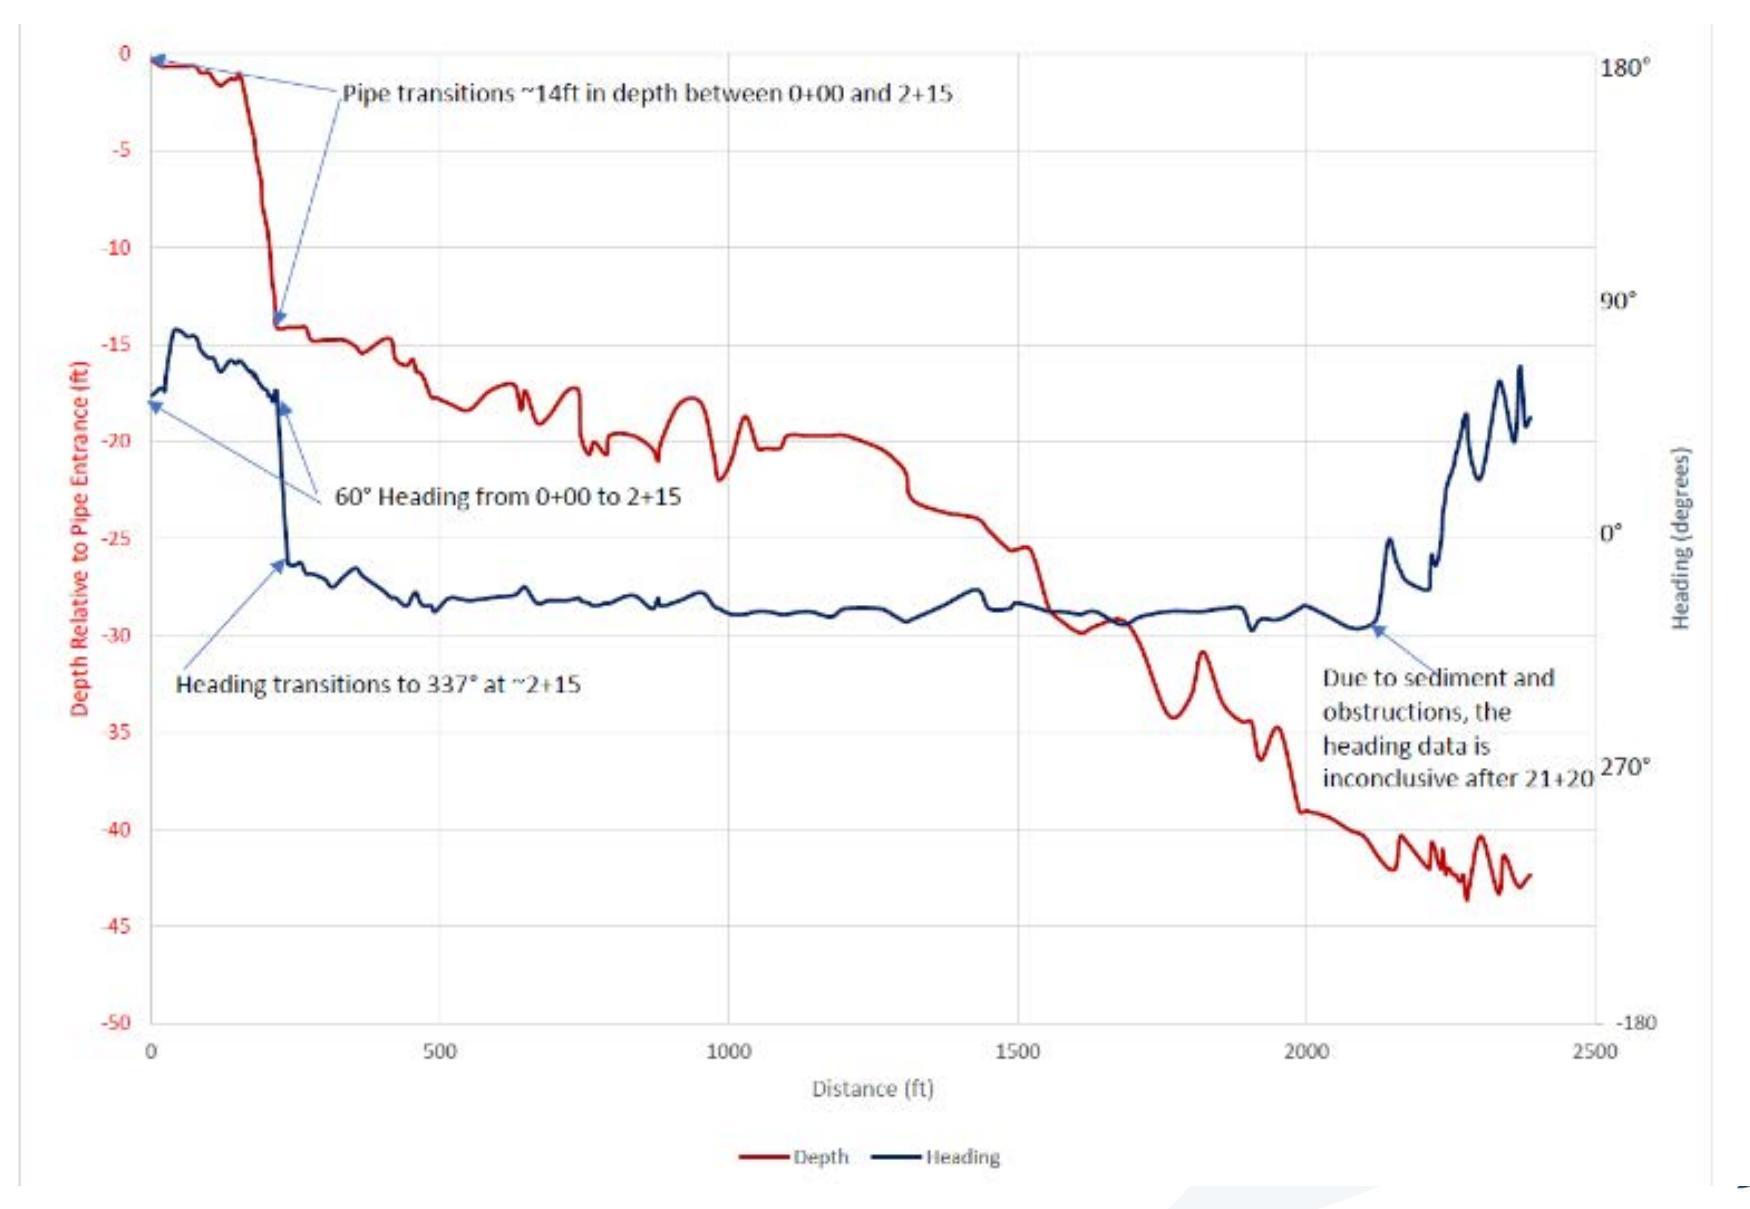
#### **Inspection Data**

#### Internal Inspection Summary

Survey abandoned at ~2,394'; Sediment depth ~10" • Diffuser J at 2,384'; Flow observed, Sediment depth ~7" O Diffuser I O Diffuser H; Flow observed O Diffuser G; Flow observed O Diffuser F O Diffuser E Diffuser D; Sand Sediment depth ~3" O Diffuser C; Sand O Diffuser B Q Diffuser A at 2,279'; Capped; ~6" Surface defect Gaskets at 14', 65', and 164' WPCF CCT
