# Mitigating Sunshine Flooding in the City by the Sea

Newport, Rhode Island

May 2022

Andrew Smith, PE

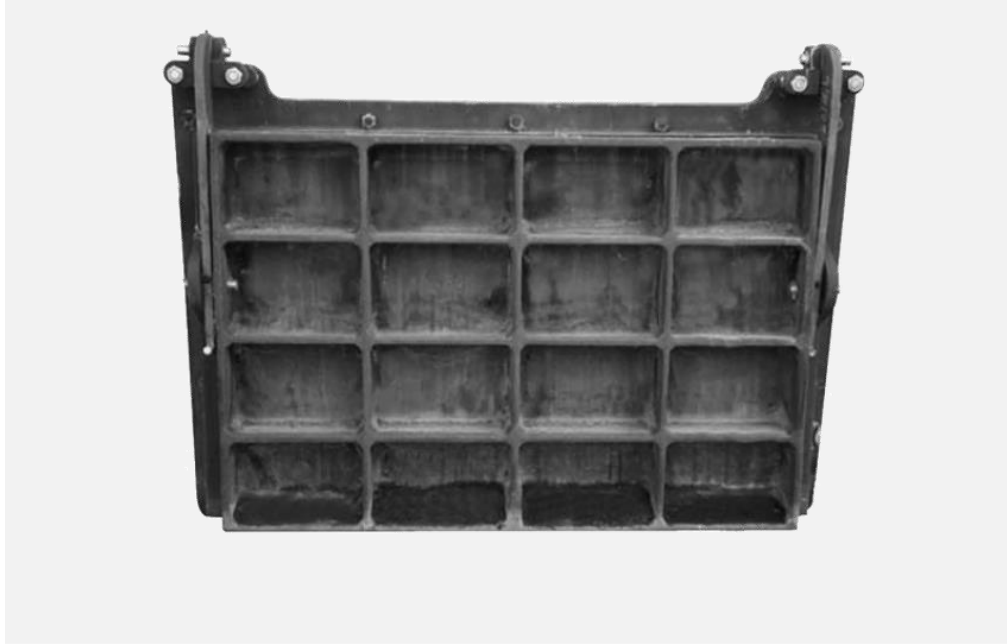
## Flap Gate

- Prone to debris and marine growth preventing the flap from seating properly
- Difficult to maintain at submerged outfall
- Higher headloss than alternative
- Prone to corrosion in marine environment

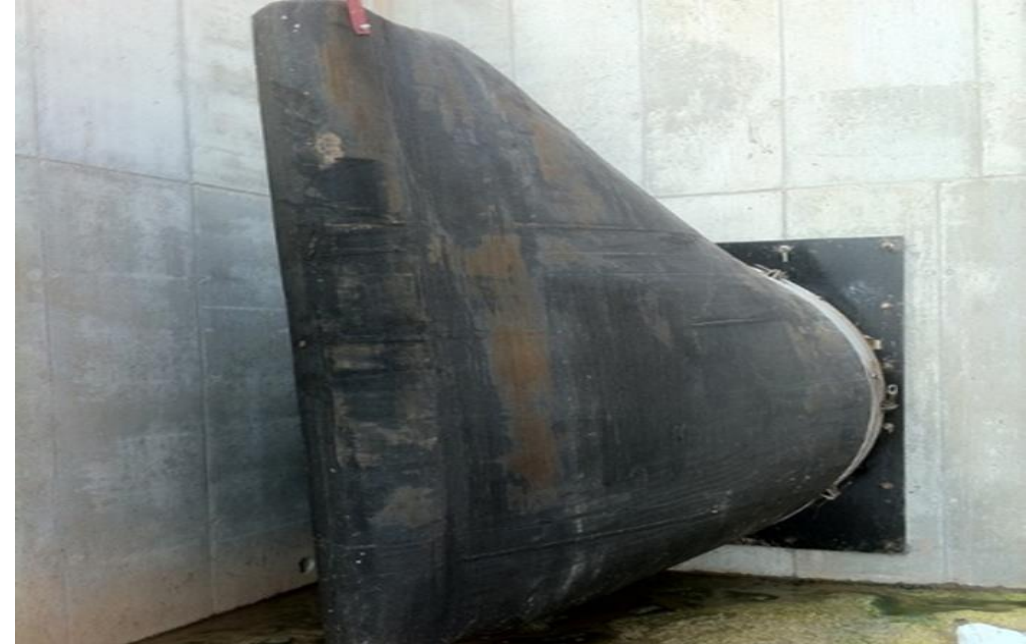
## Tideflex Duck Bill Type Check Valve

- Less prone to debris and marine growth problems
- Check valve allows the valve to compress around trapped debris
- Low headloss compared to traditional gates
- Not affected by rust or corrosion

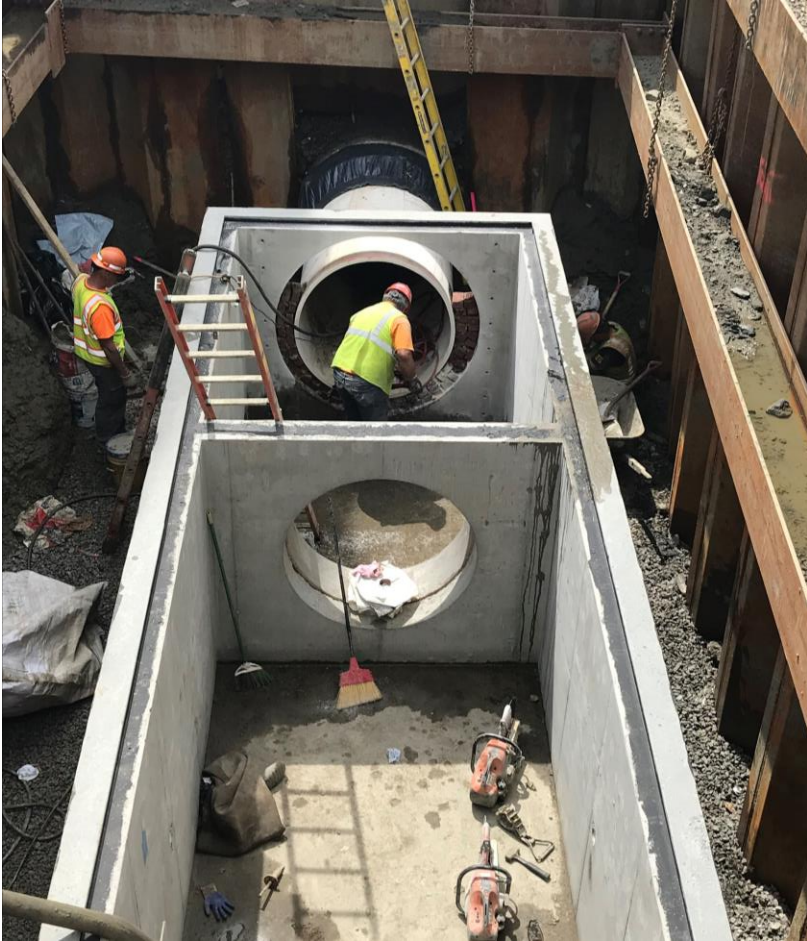
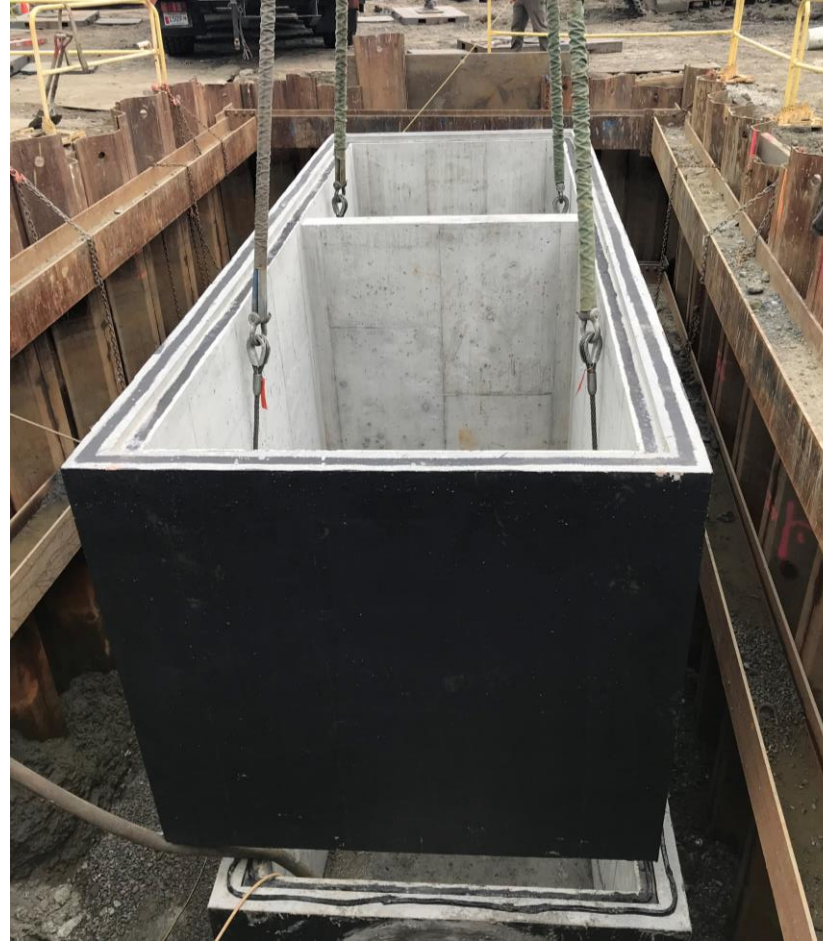
- Spool pieces were installed and parged and the top section was set

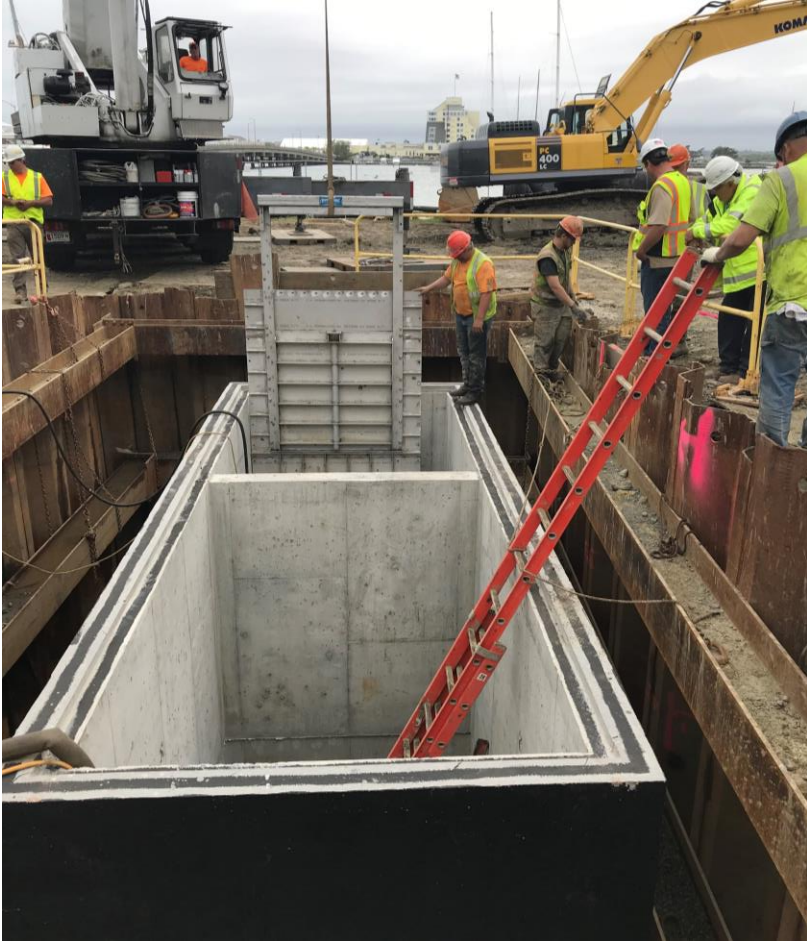
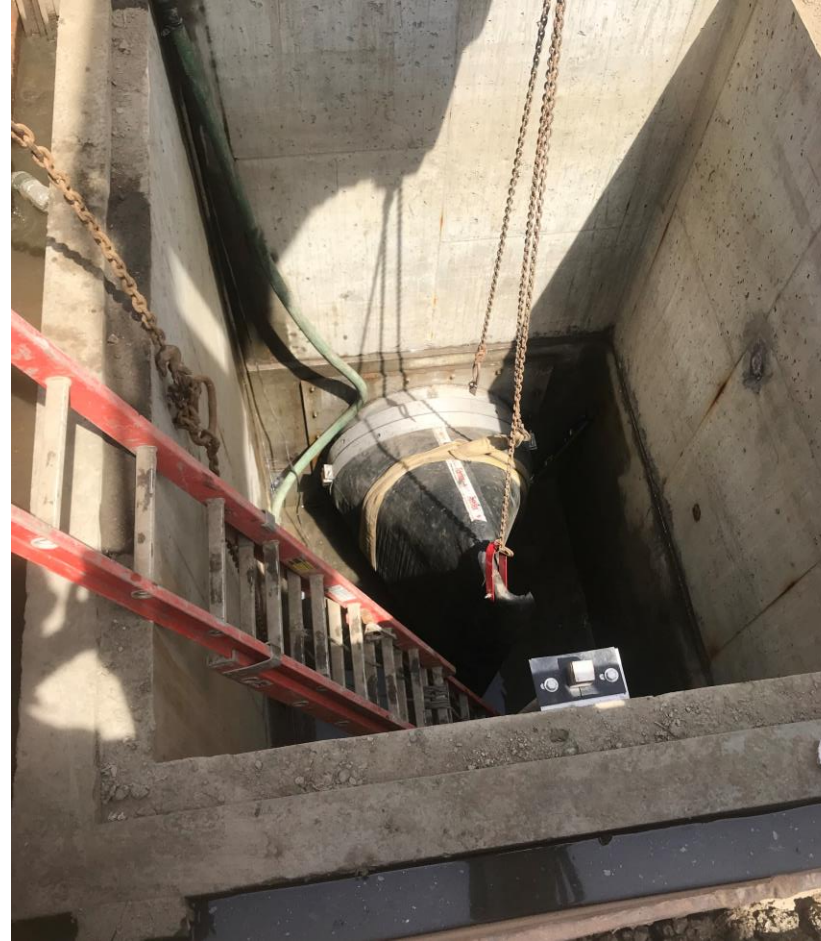
- Slide Gates were installed toward end of very long day
- Once the gates were in place, the plugs were removed, and gates closed
- The vault had to be dewatered, again then the “Duckbill” was installed on a thimble

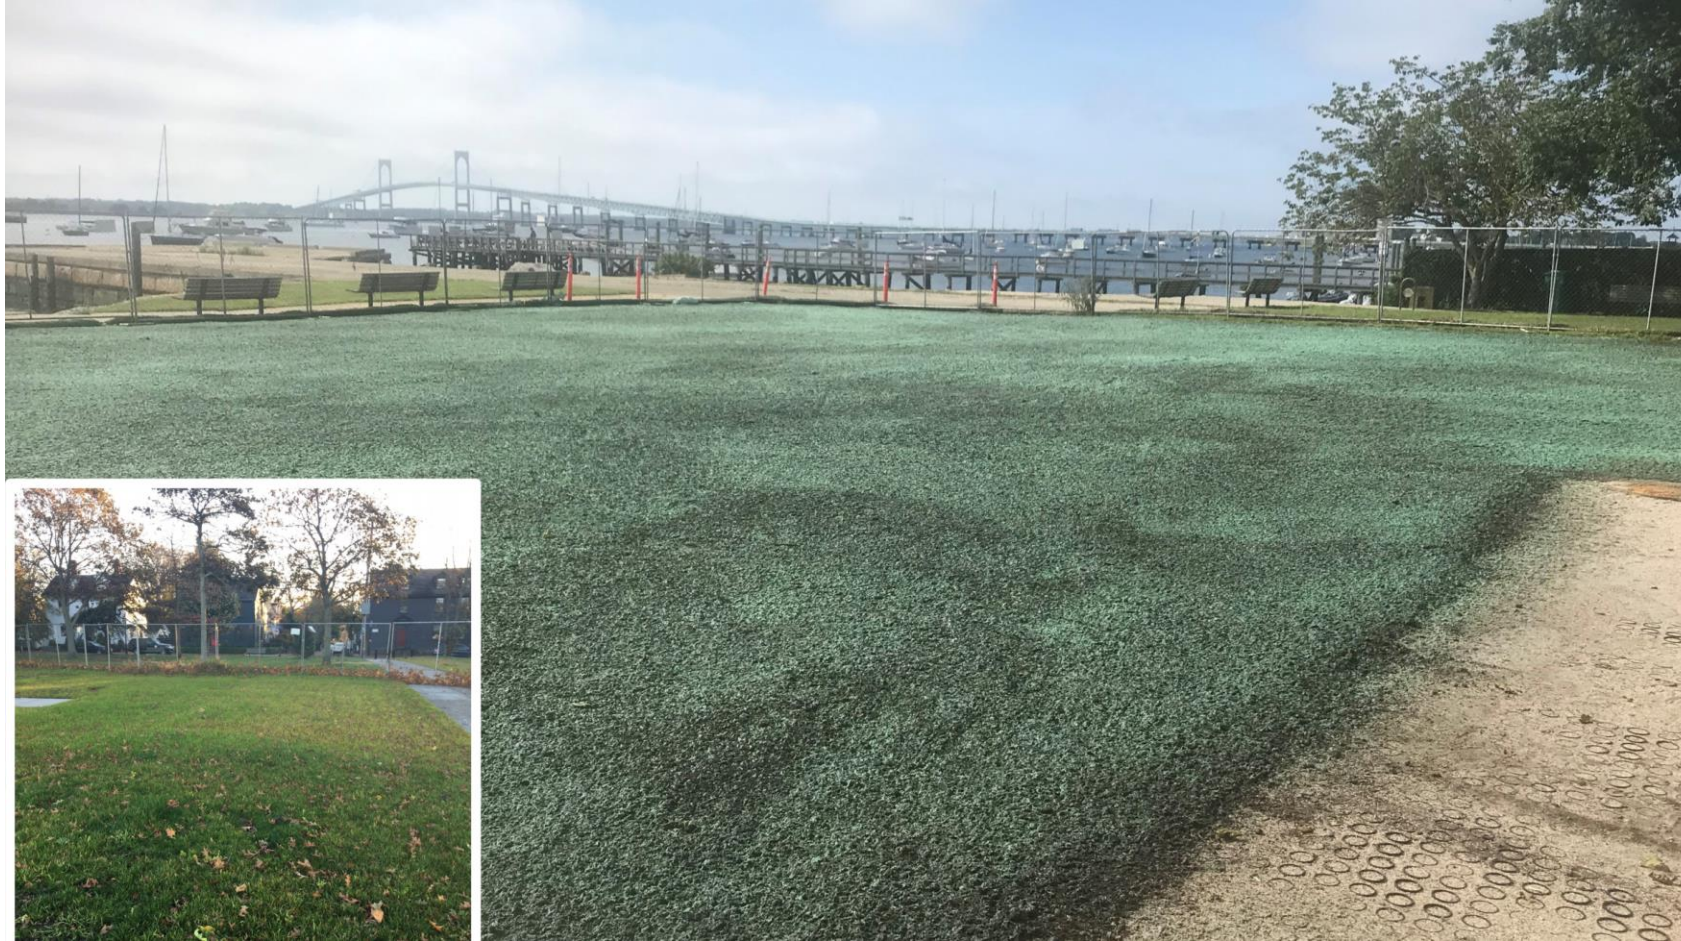
- The remainder of the site was hydroseeded
- Only evidence of the vault is the stainless-steel hatch cover set at grade
