Permeable Interlocking Concrete Pavement

New England Water Environment Association
(NEWEA) 2015 Annual Conference

Collaboration between Tighe & Bond and the University of New Hampshire and Industry Partners

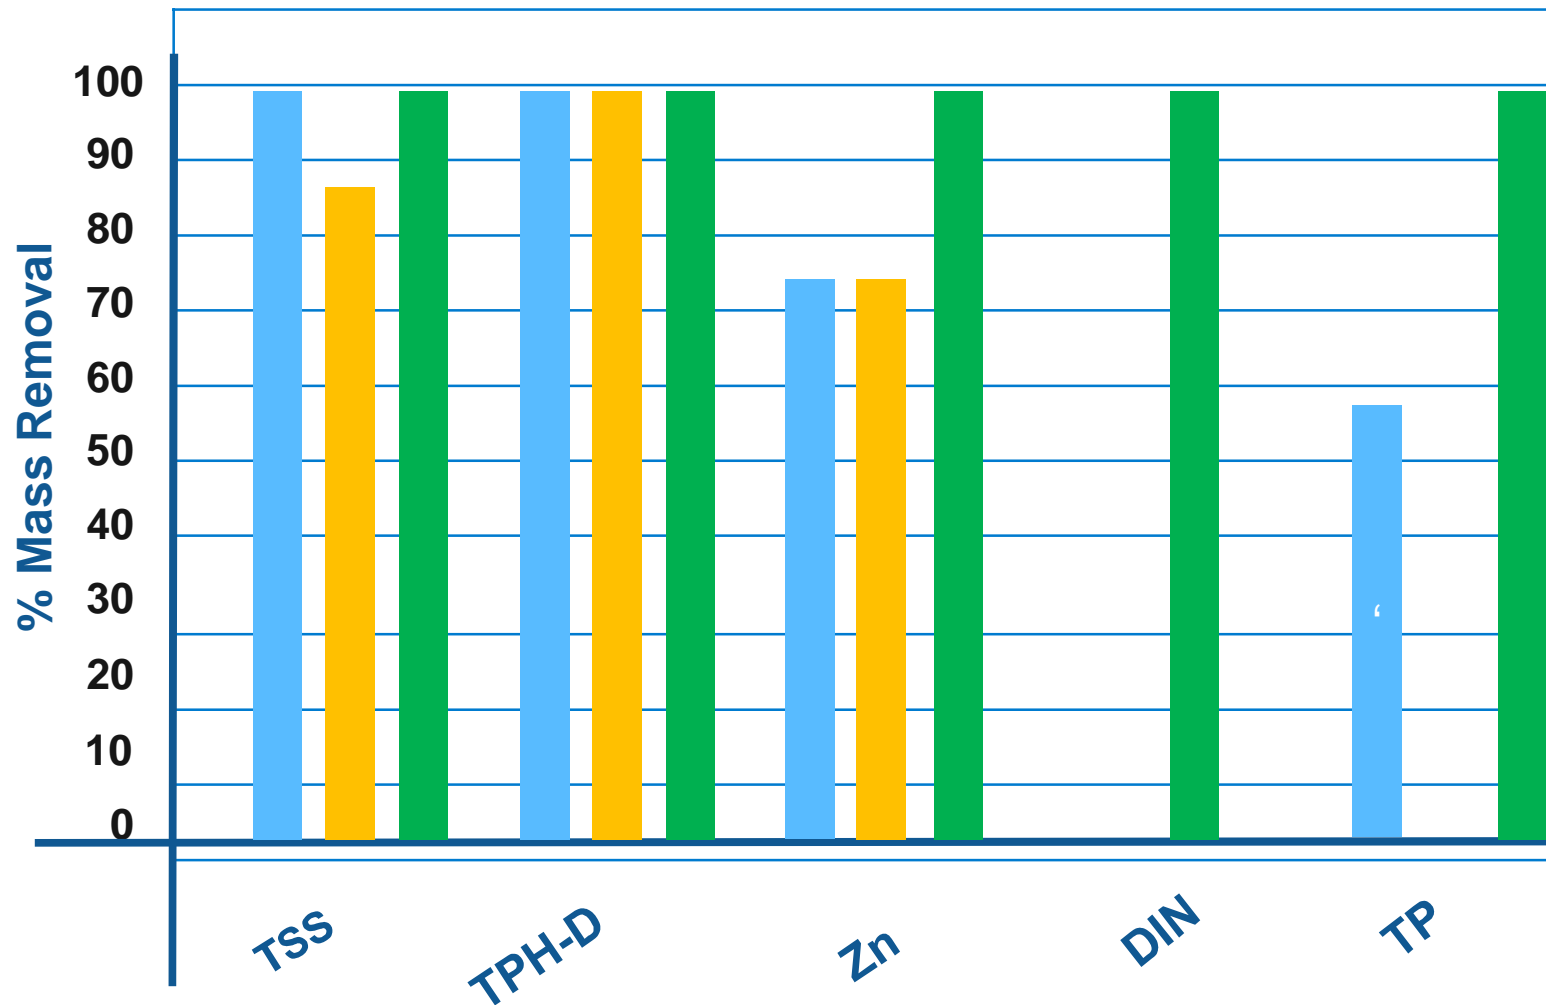
RE and V_r Examples

92%
Volume
Reduction
=
92%
Load
Reduction

0%
Volume
Reduction
=
95%
Load
Reduction

70%
Volume
Reduction
=
83%
Load
Reduction
