Managing Phosphorus Loads to Pearly Pond

NEWEA 2016 Annual Conference
Boston Marriott Copley Place

Pearly Pond Watershed Restoration Plan

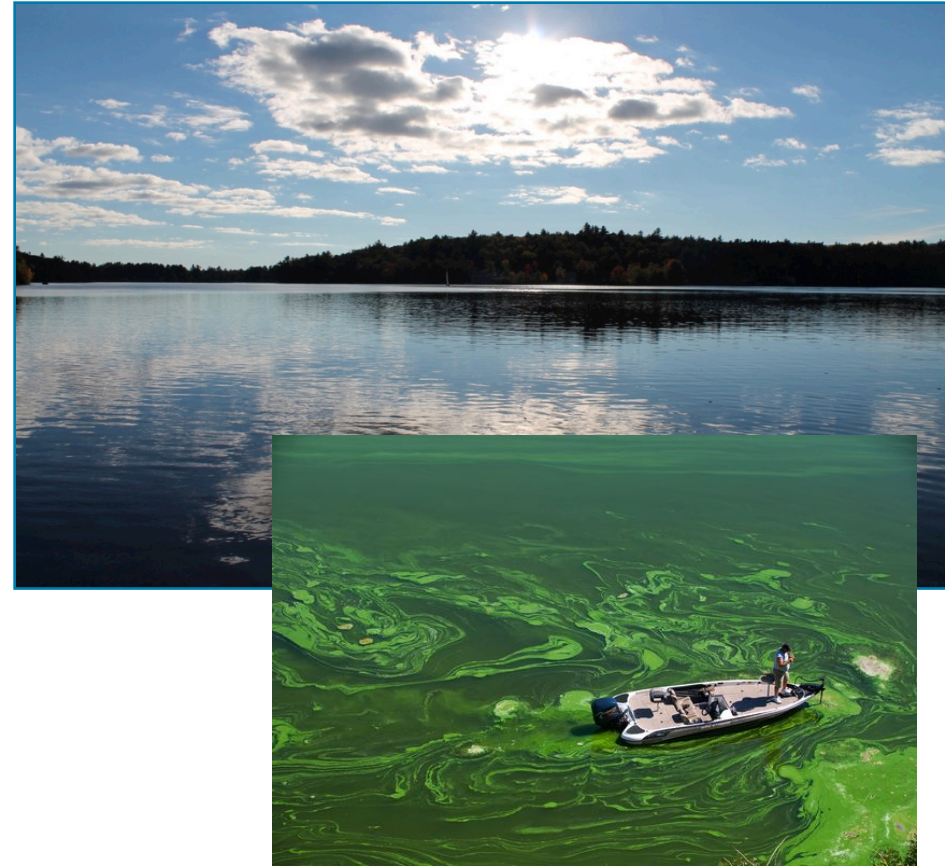
- High Chlorophyll-a – pigment found in algae, indicator of algal biomass
- Low Dissolved Oxygen (DO) – Excess algae leads to low DO

Underlying cause: Too much phosphorus → too much algae!

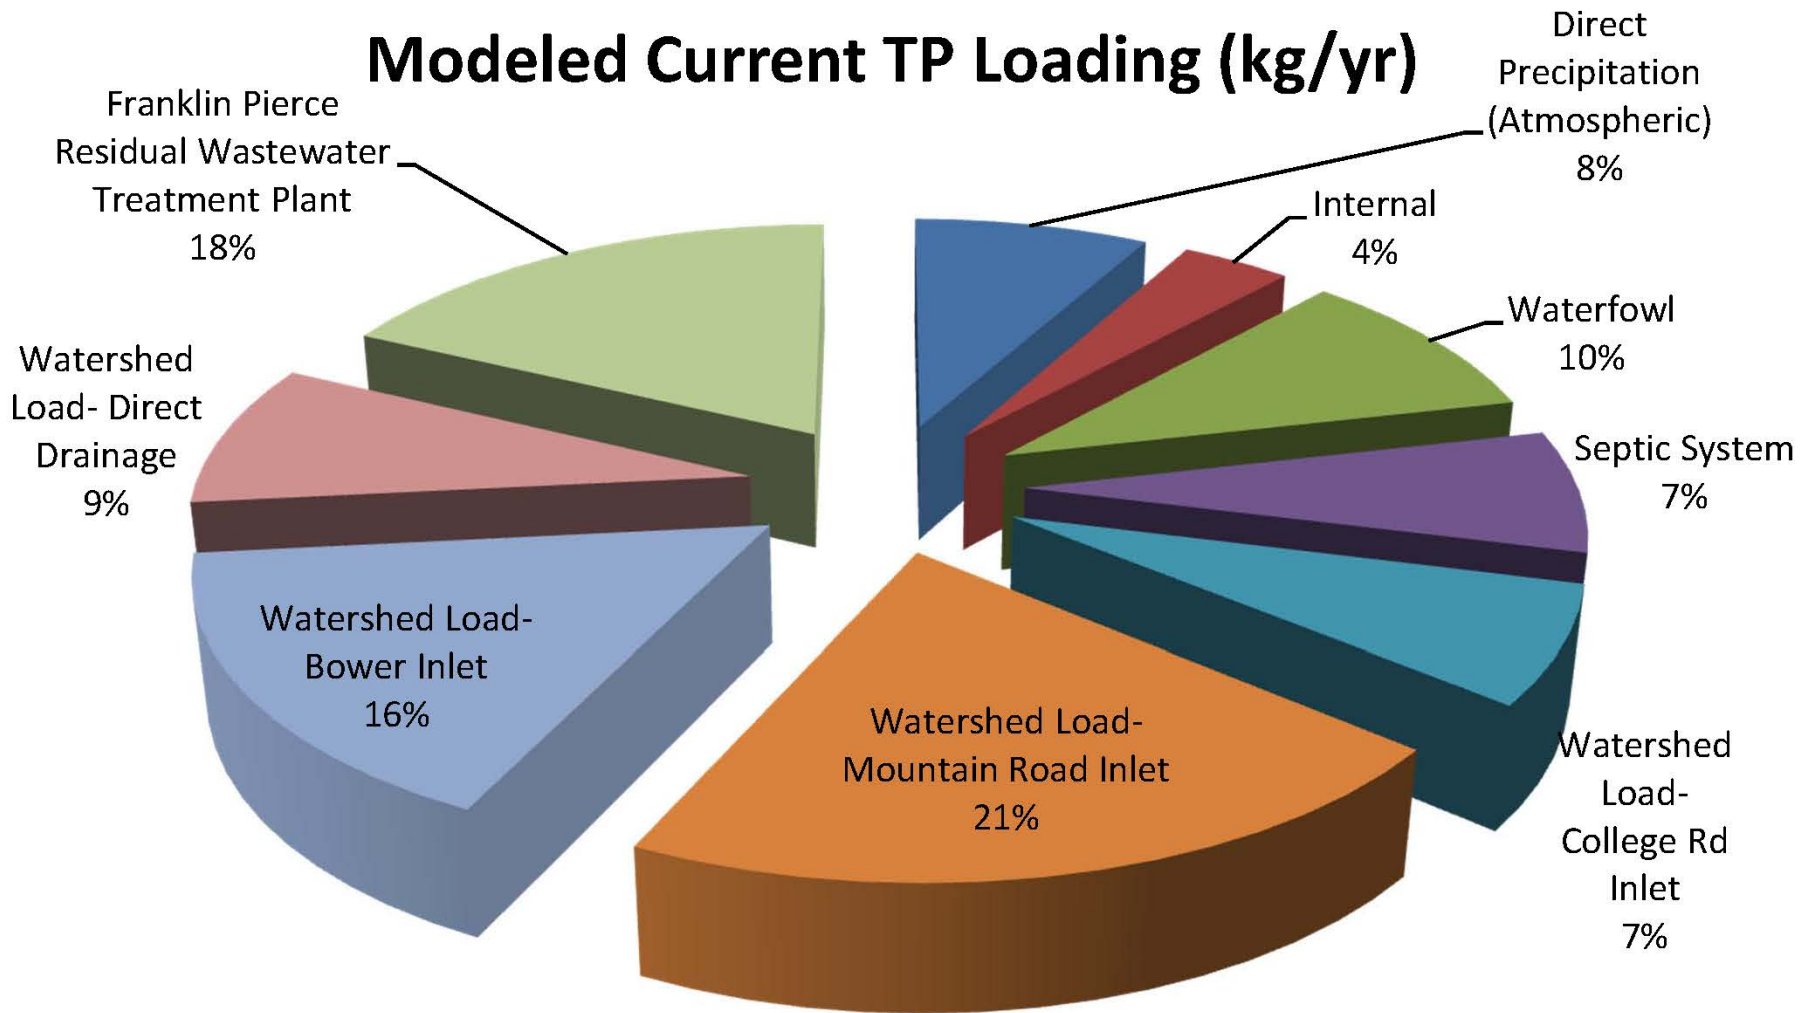
Modeled Current TP Loading (kg/yr)

- Stormwater Surface Runoff & NPS Pollution Contributes 45% of the TP Load
- Estimated Load of 240 kg/yr of TP to Pond

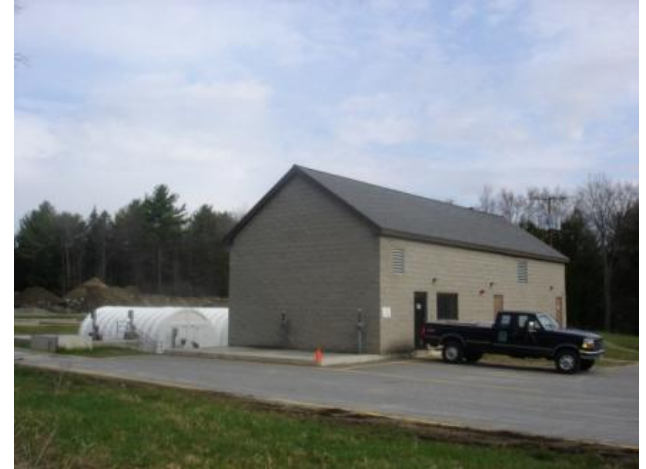
Wastewater treatment facility (WWTF)

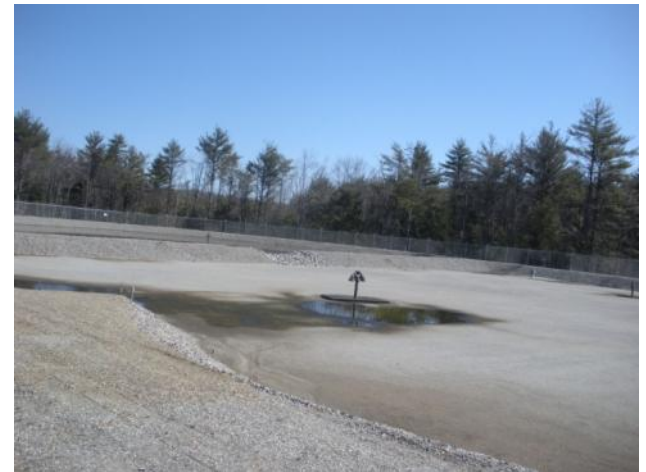
RIB=Rapid Infiltration Beds

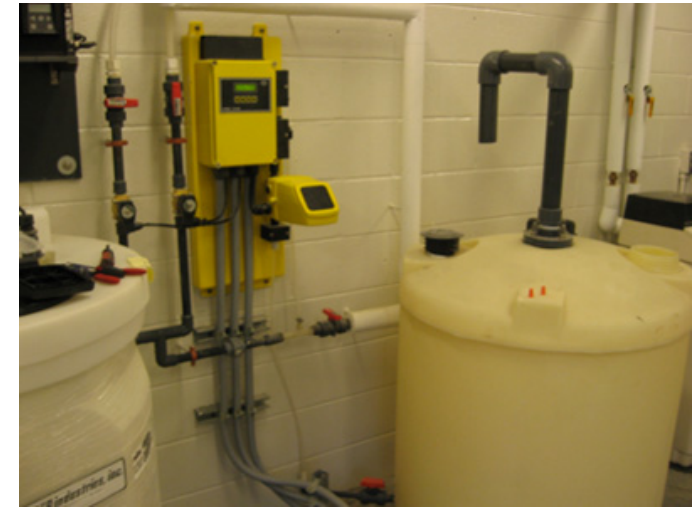
- Increase TP Removal
 - Chemical/biological additives for the Rotating Biological Contactor (RBC)
 - Increase Aluminum Sulfate (flocculent)
 - Increase Sodium Hydroxide (pH controls)
 - Iron Enhanced Sand in RIBs

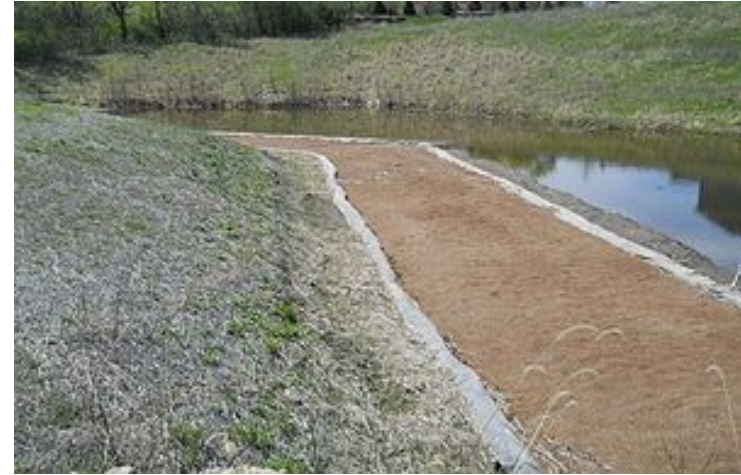
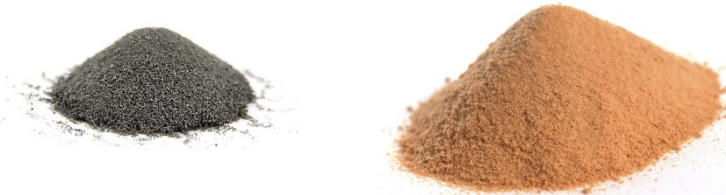
- Iron Enhanced Sand Filter
 - Binds phosphorus (iron enhancement 6-8% by wt.)
 - Install at existing trail crossing
 - Requires shallow water depths & needs to fully drain to provide wet/dry cycles
 - Replace ~5 years

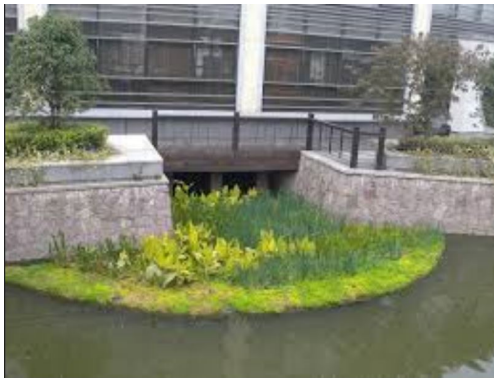
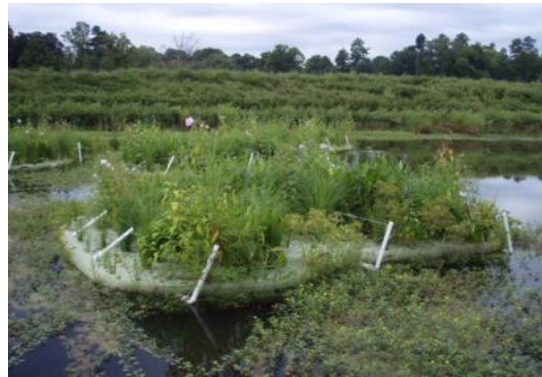
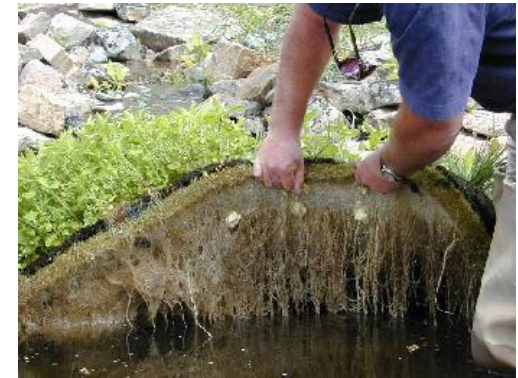
- Floating Treatment Wetlands
 - Inexpensive and simple to construct and install (volunteers)
 - Requires 2-3 feet water depth
 - Requires removal during winter months
 - Maintenance would include replacement of dead vegetation

Treatment Islands
