CONSTRUCTION CHALLENGES OF THE SEEKONK COMBINED SEWER OVERFLOW (CSO) INTERCEPTOR

Roger Norton, P.E., CDM Smith

January 2016

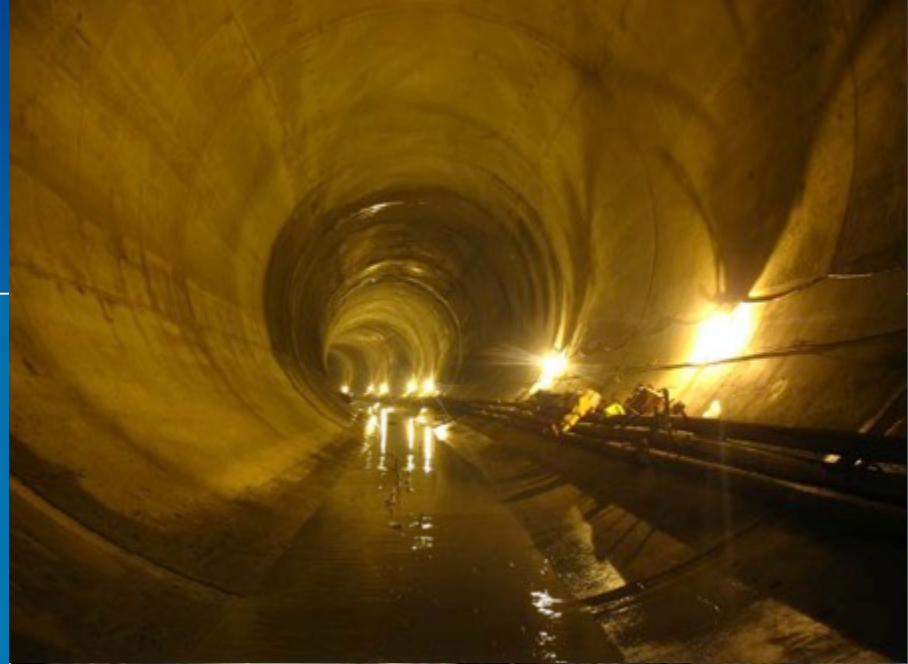
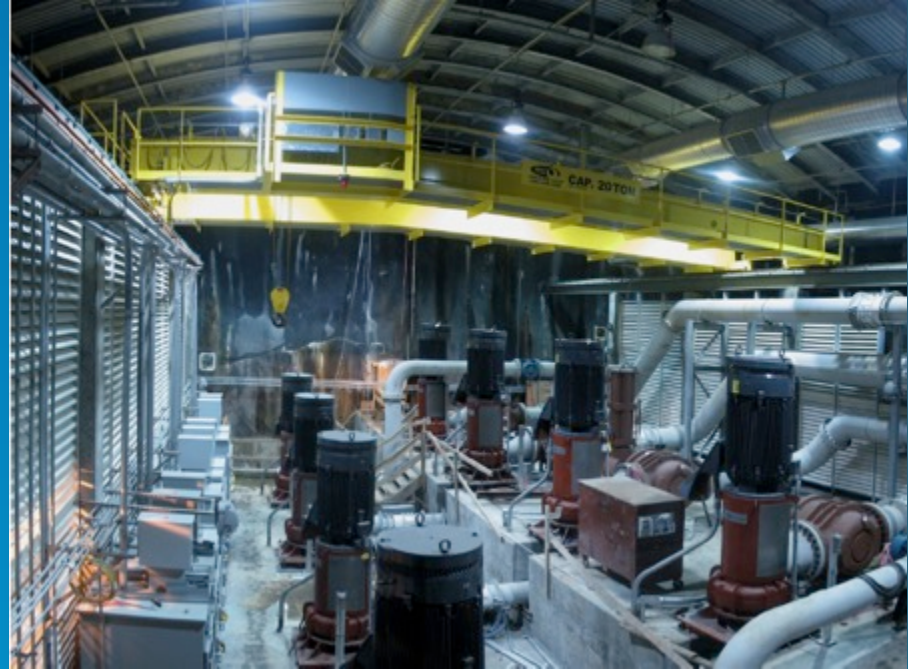
- 16,248 ft long, 26 ft diameter, 230 ft deep storage tunnel
- Seven drop shafts and connecting adits
- Field's Point Pumping Station

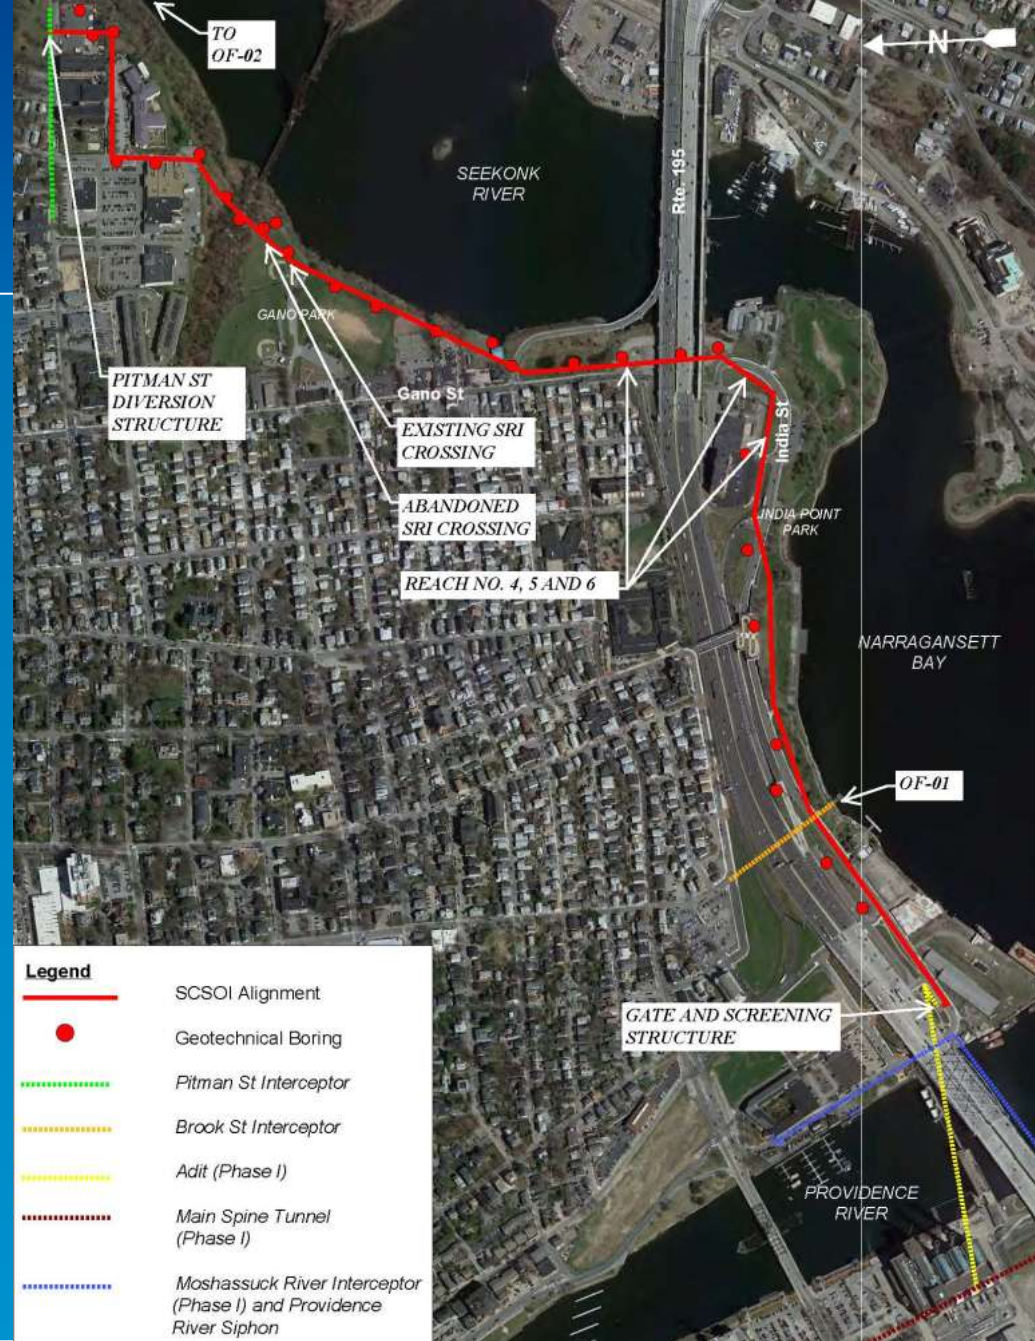
- Seekonk Combined Sewer Overflow Interceptor (SCSOI):
 - 7,210 ft of 48-in to 60-in pipeline
 - 13 Manholes
 - Two Diversion Structures
 - Interceptor Relief Structure
 - Modifications to Regulator

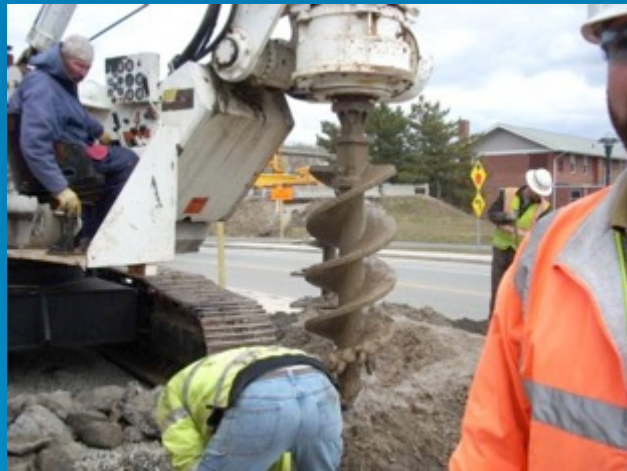
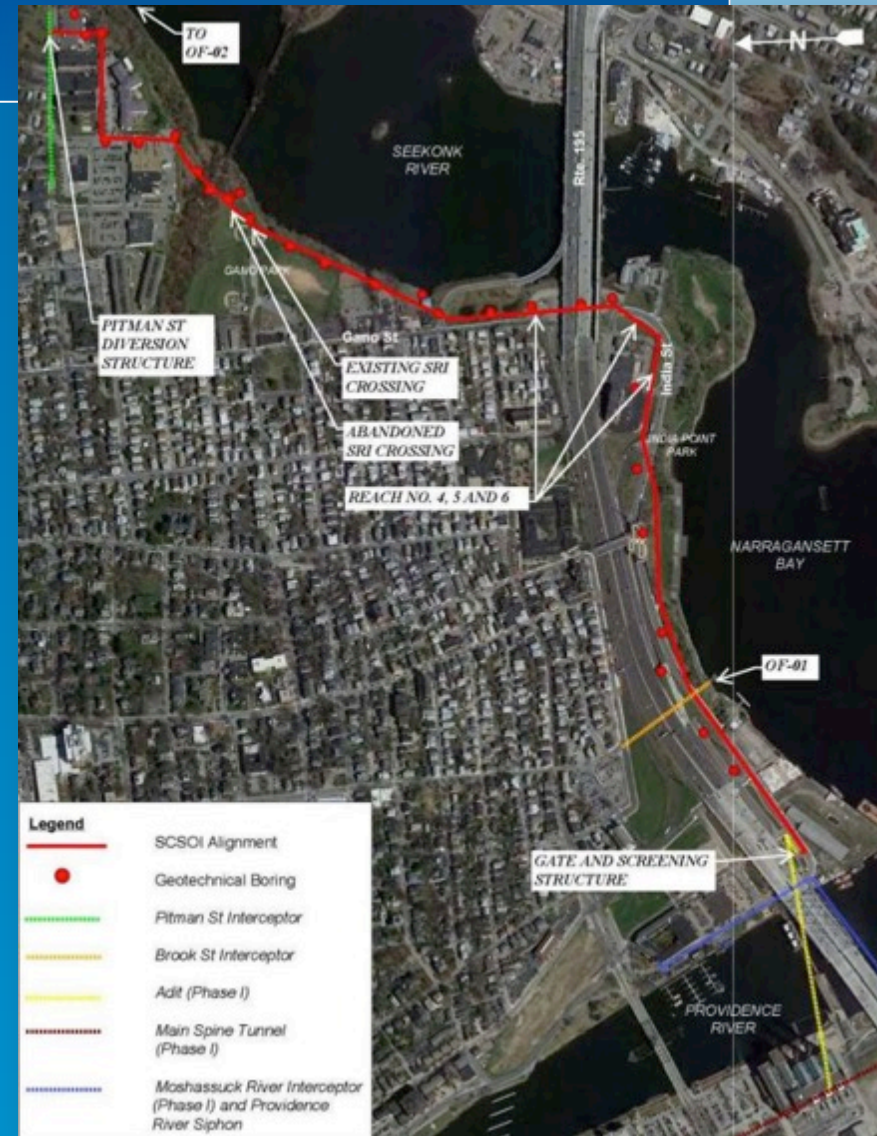
- 32 borings spaced at 250 to 300 ft
- Two large auger borings (3 ft)
- Borings from previous projects
- No GBR developed
- GDR Provided

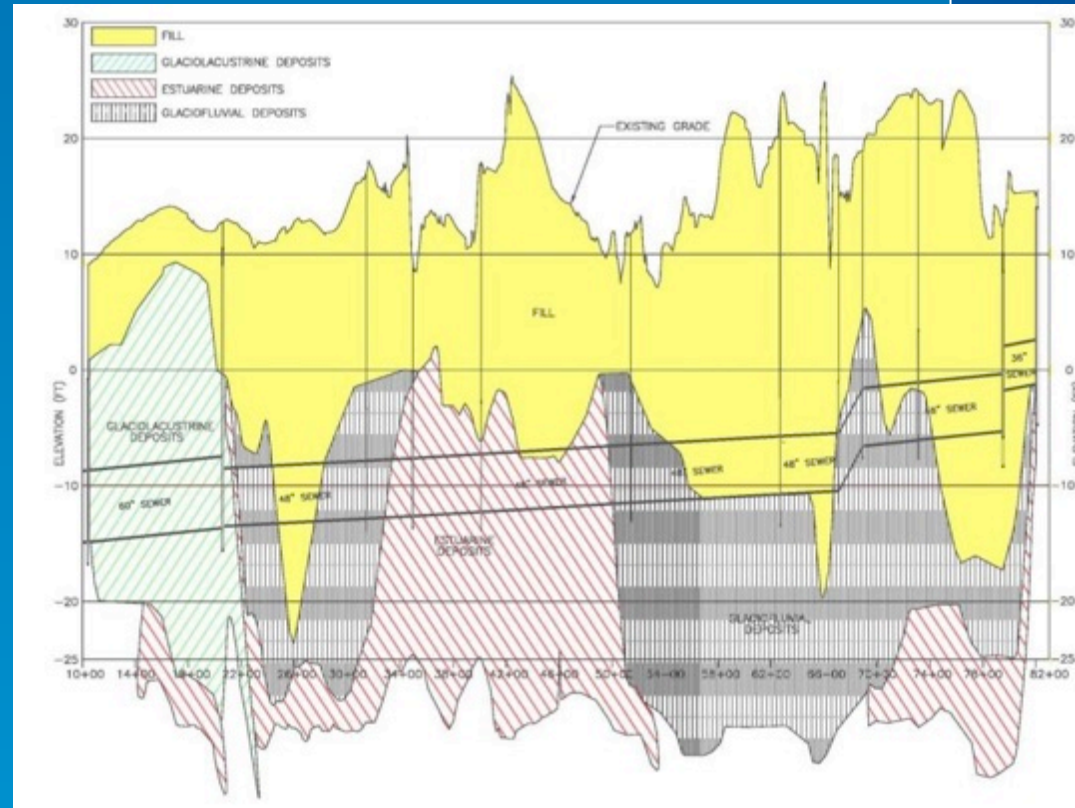
- Fill
- Glaciolacustrine Deposits
- Glaciofluvial Deposits
- Estuarine/Bottom Bay Deposits

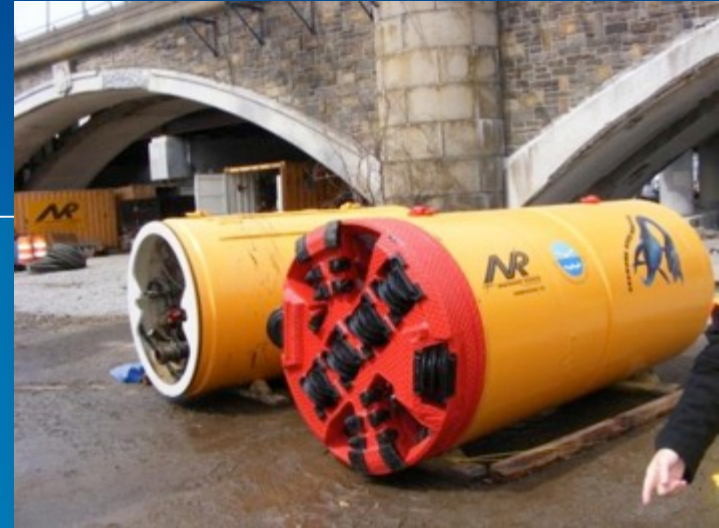
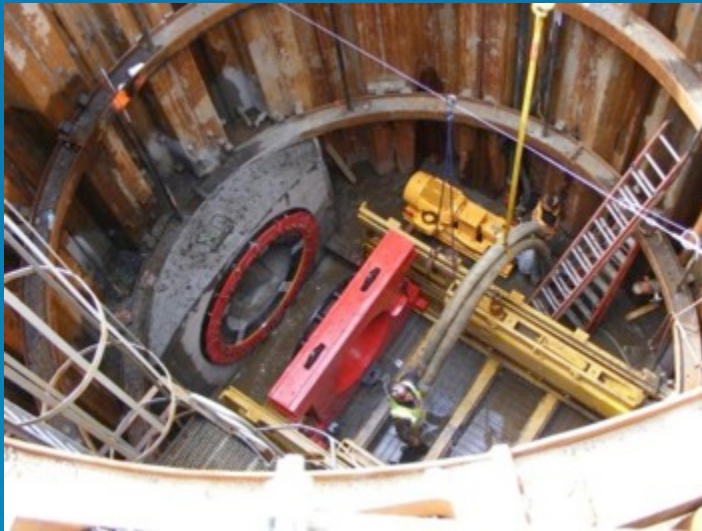
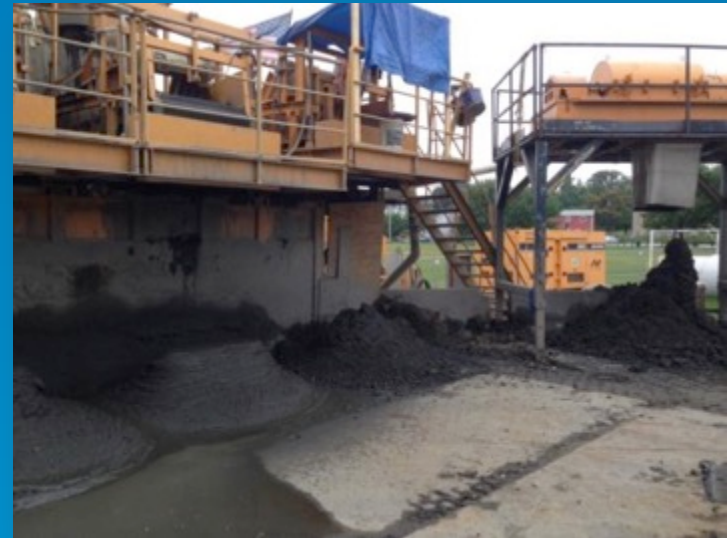
- Closed-face MTBM
- Circular launch/receiving shafts (sheet pile with steel ring beams)

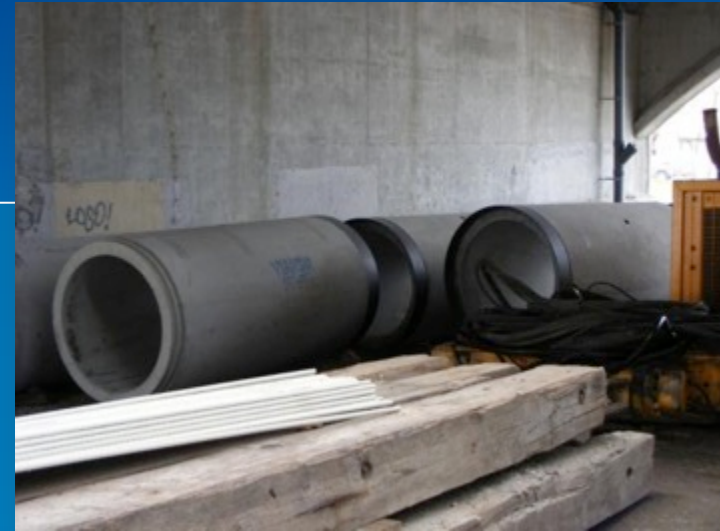
- 48-inch Precast Reinforced Concrete Carrier Pipe

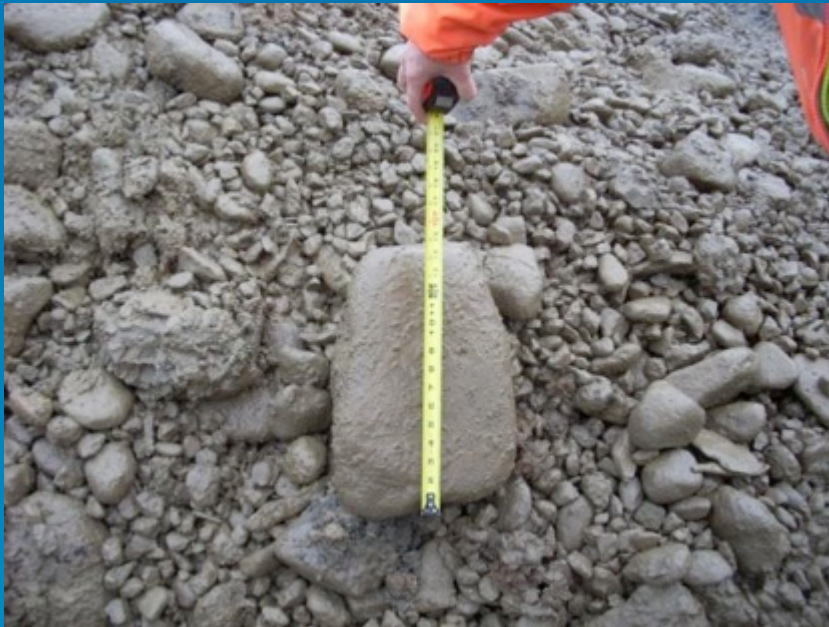
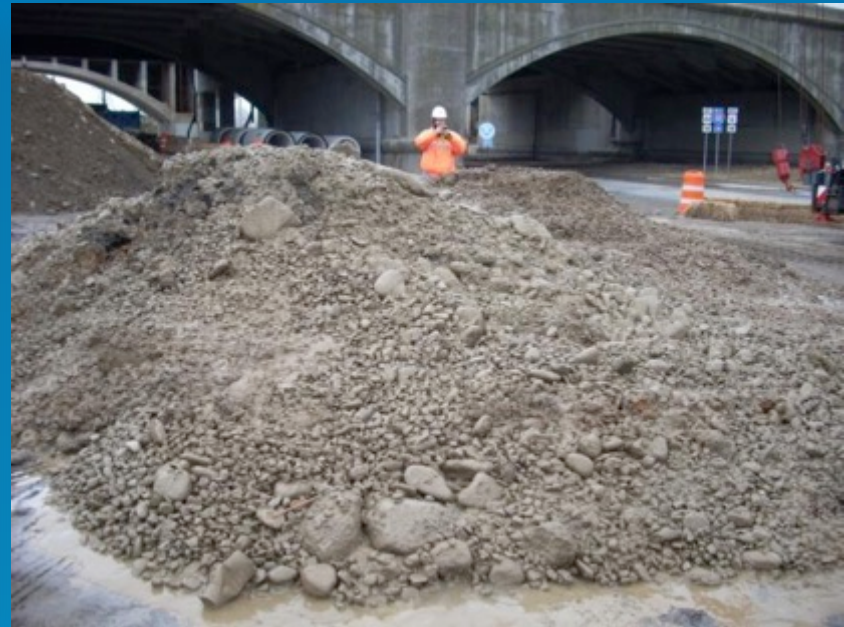
- Difficult Subsurface Conditions
 - Frequent boulders and nested cobbles in Glaciofluvial Deposits

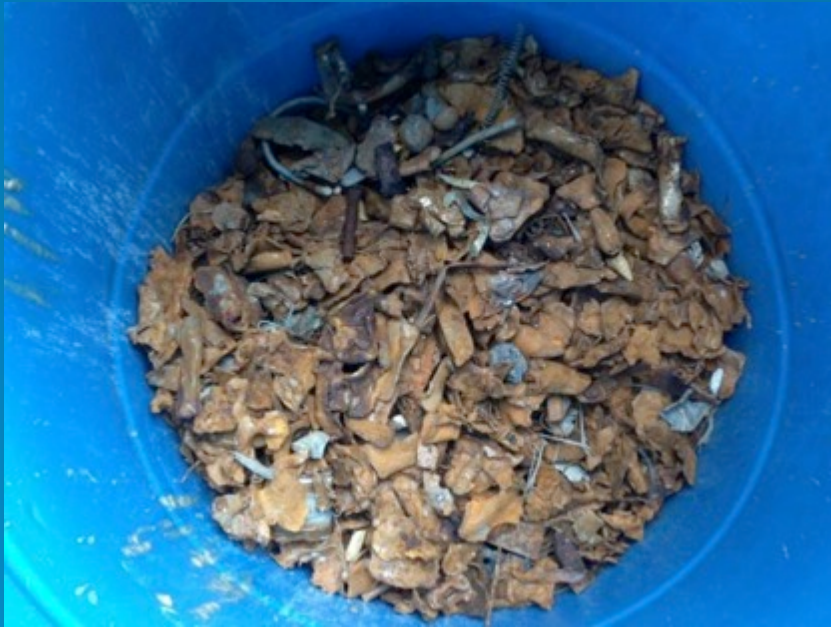
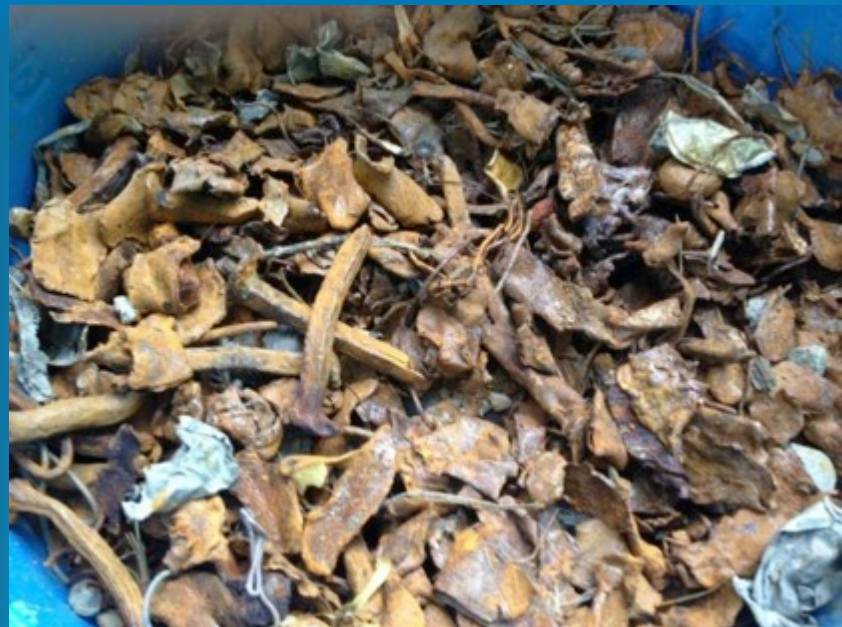
- Difficult Subsurface Conditions
 - Timber, metal pieces, railroad spikes in Fill Deposit

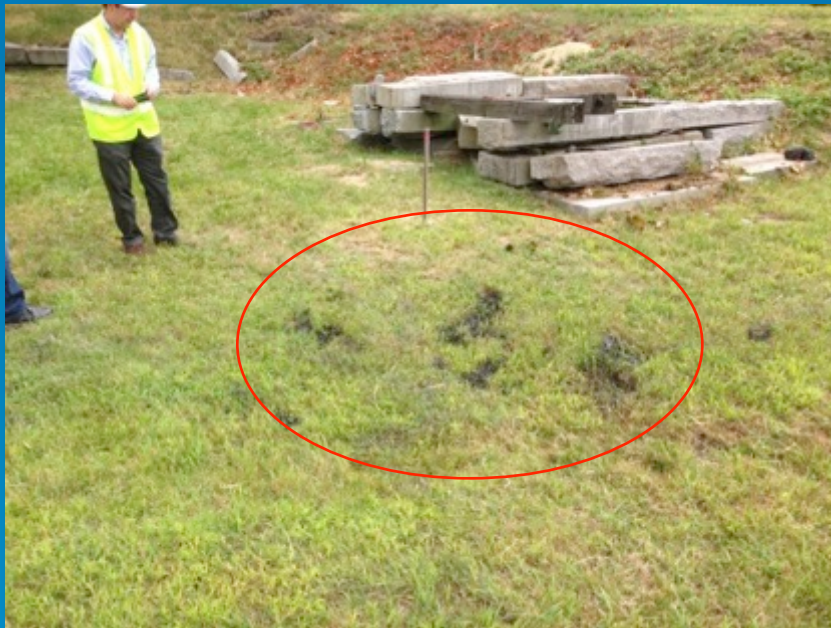
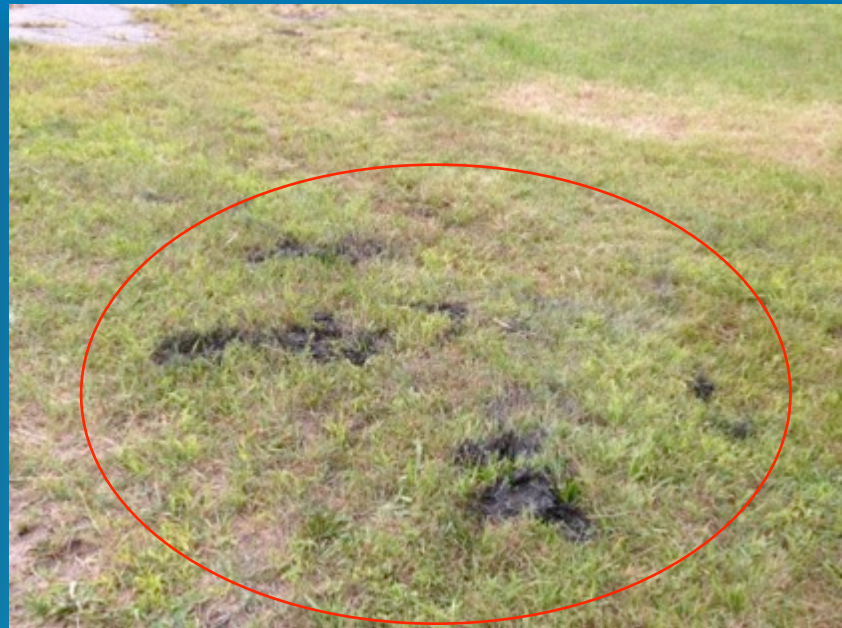
- Difficult Subsurface Conditions
 - Slurry blow out caused by radical flushing to remove slurry return blockages (microtunneling through buried timbers)

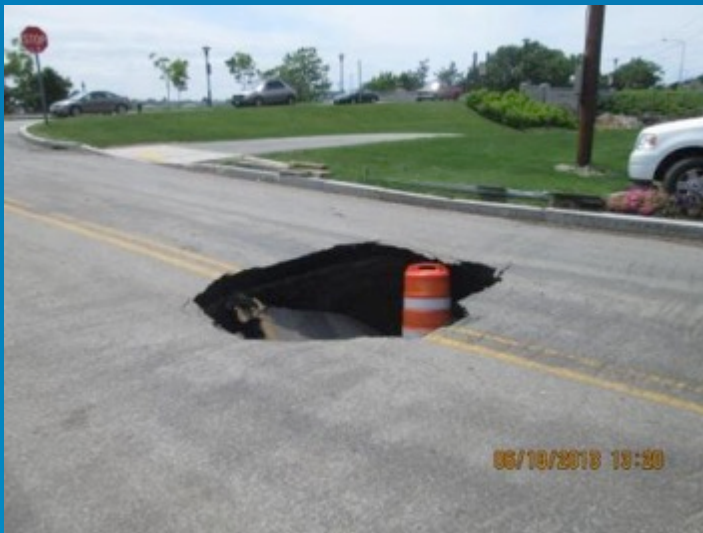
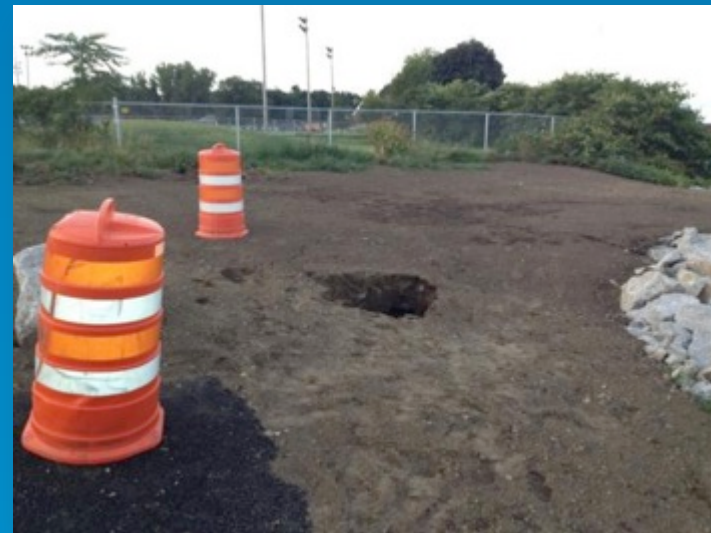
- Difficult subsurface conditions resulting in sinkholes
 - Frequent boulders and nested cobbles in Glaciofluvial Deposits
 - Microtunneling in fill deposits

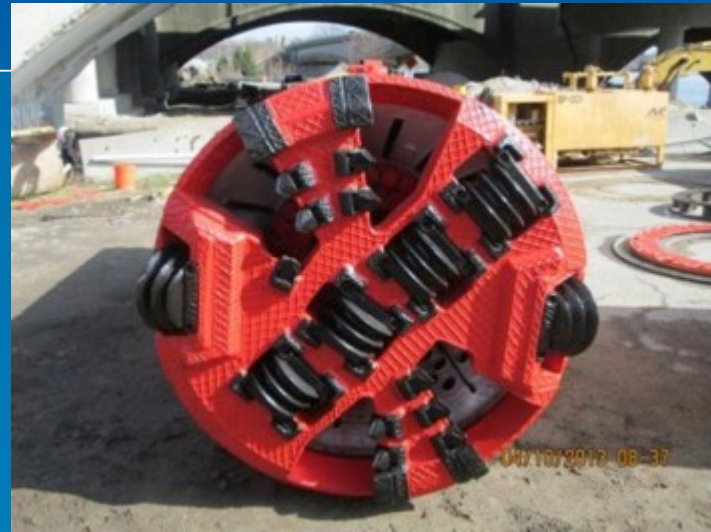
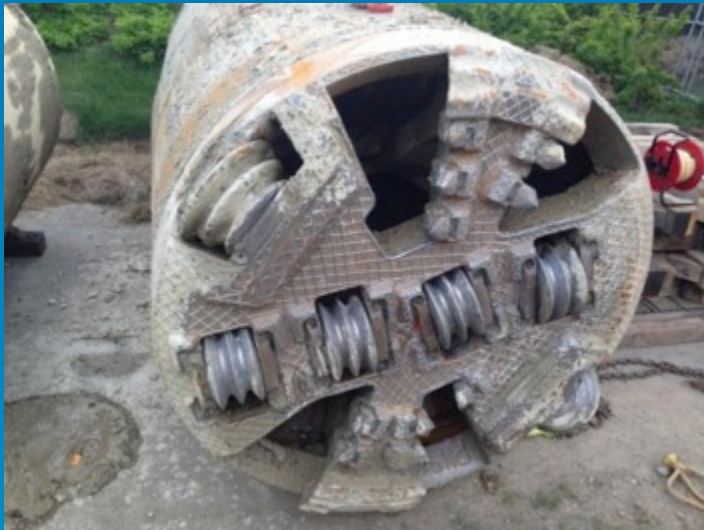
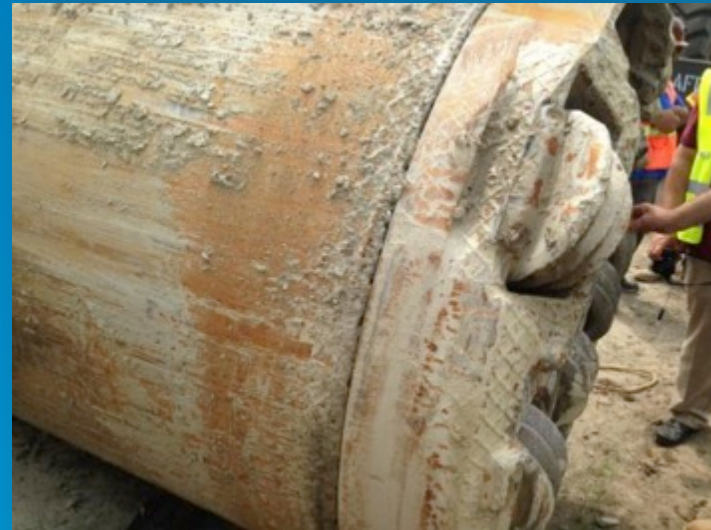
- Difficult subsurface conditions resulting in wear and tear of MTBM

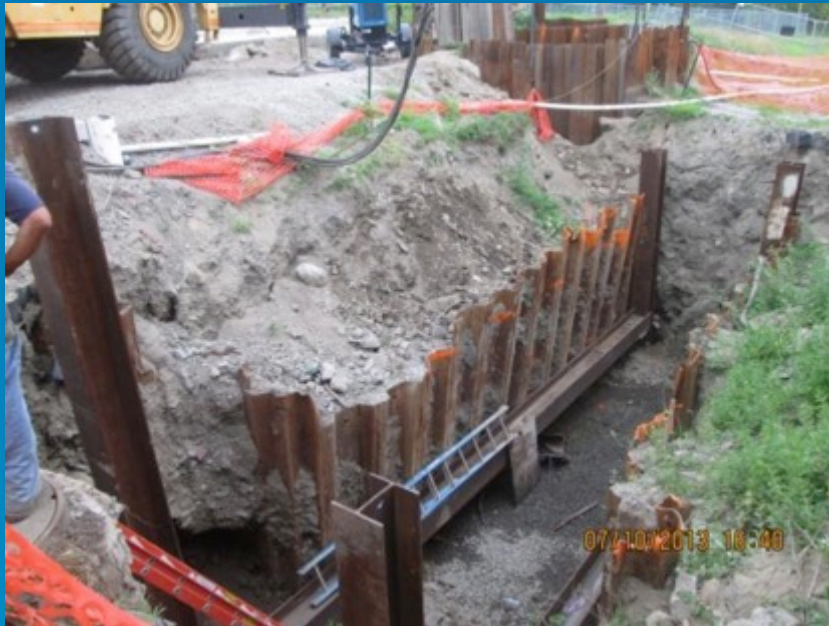
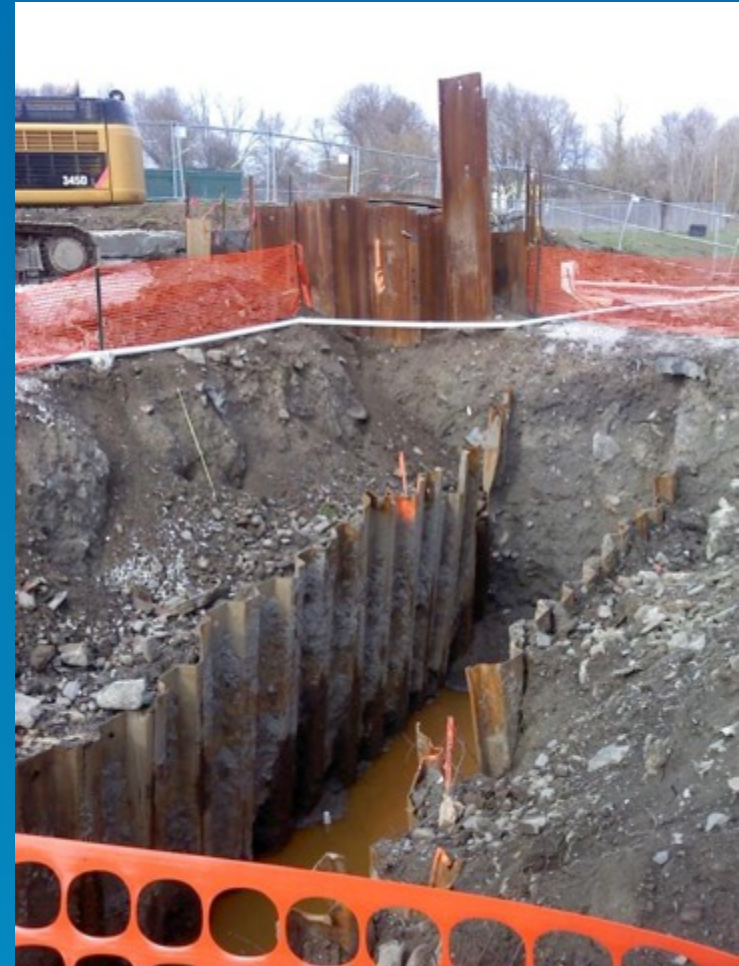
- Passing Under Sensitive Utilities
 - 42-inch Pre-Stressed Concrete Cylinder

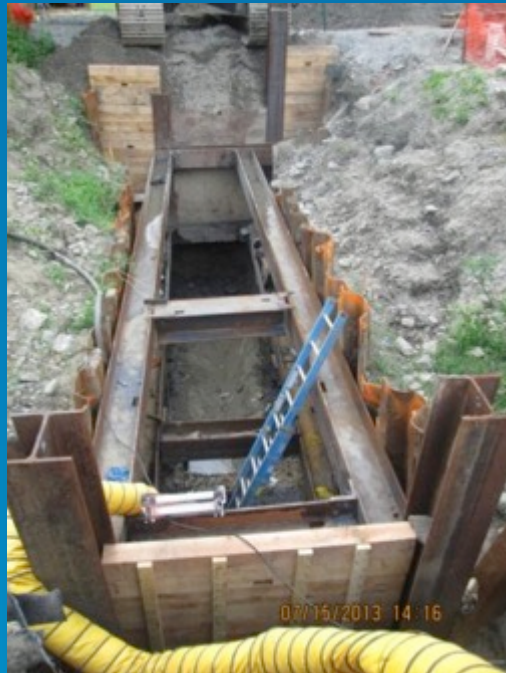
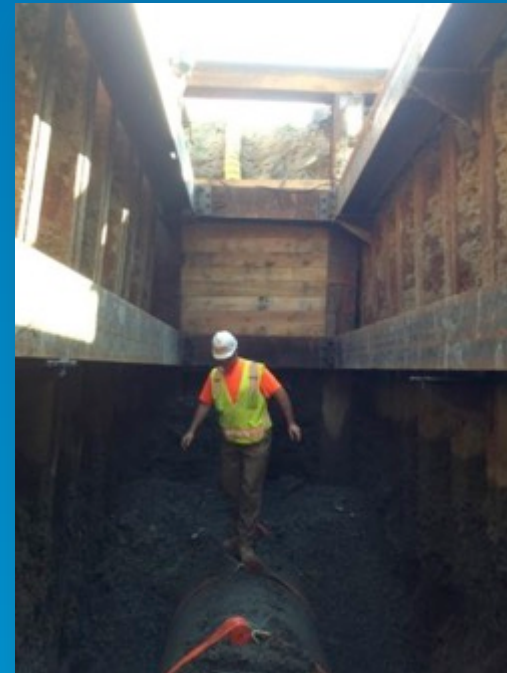
- Passing Under Sensitive Utilities
 - 42-inch Pre-Stressed Concrete Cylinder Pipe

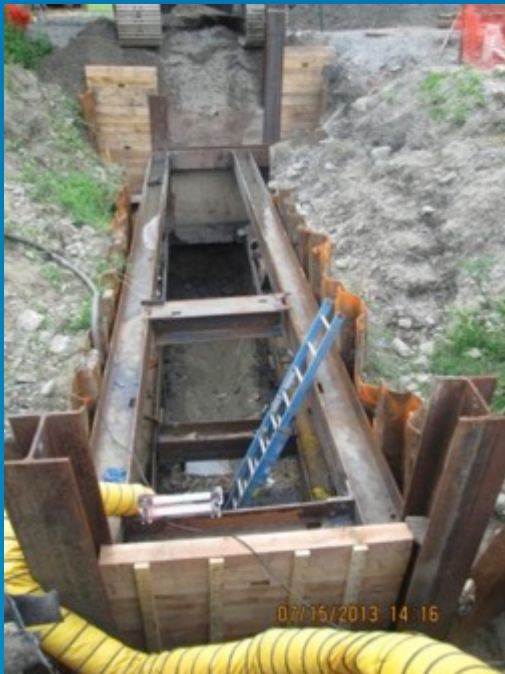
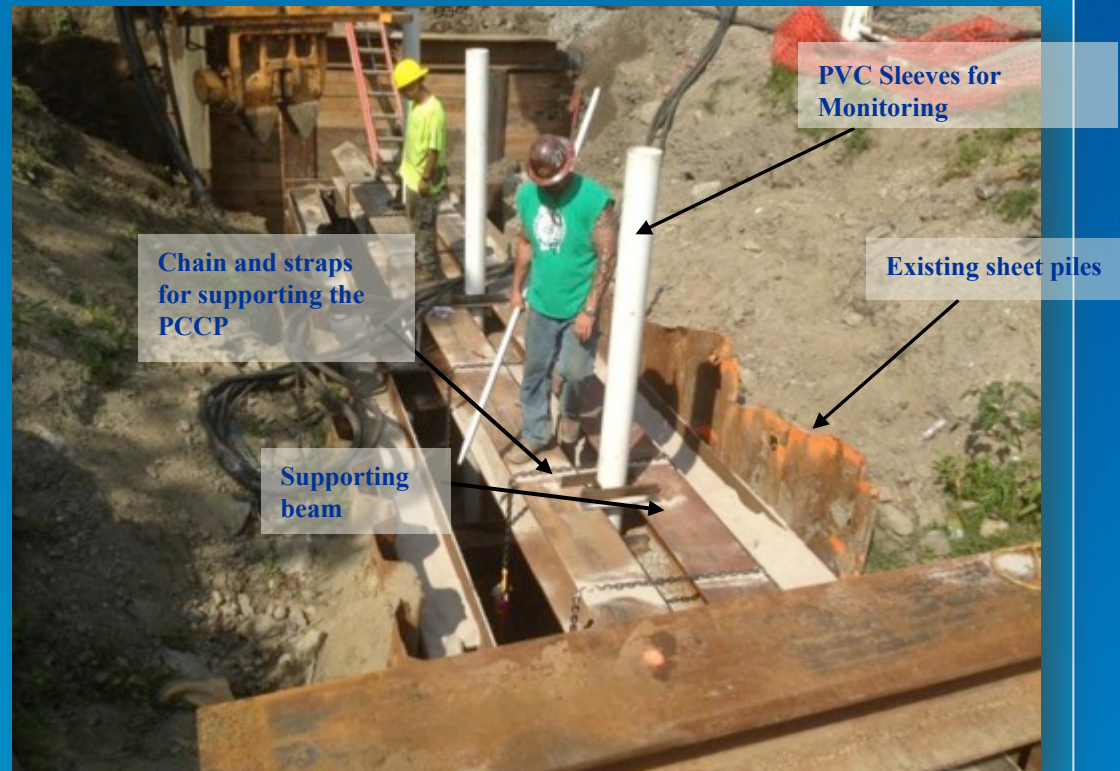
- Passing Under Sensitive Utilities
 - 42-inch Pre-Stressed Concrete Cylinder Pipe

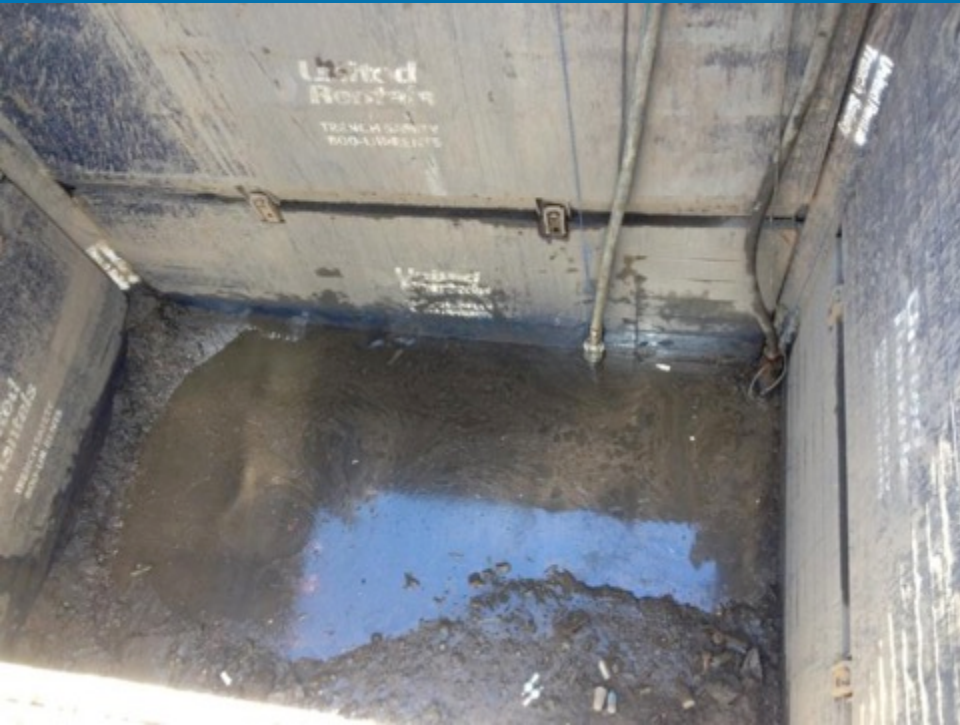
- Crossing through Known Obstruction
 - Timber Piles Supporting Abandoned 42-inch CI SRI

**Excavation Support
System**

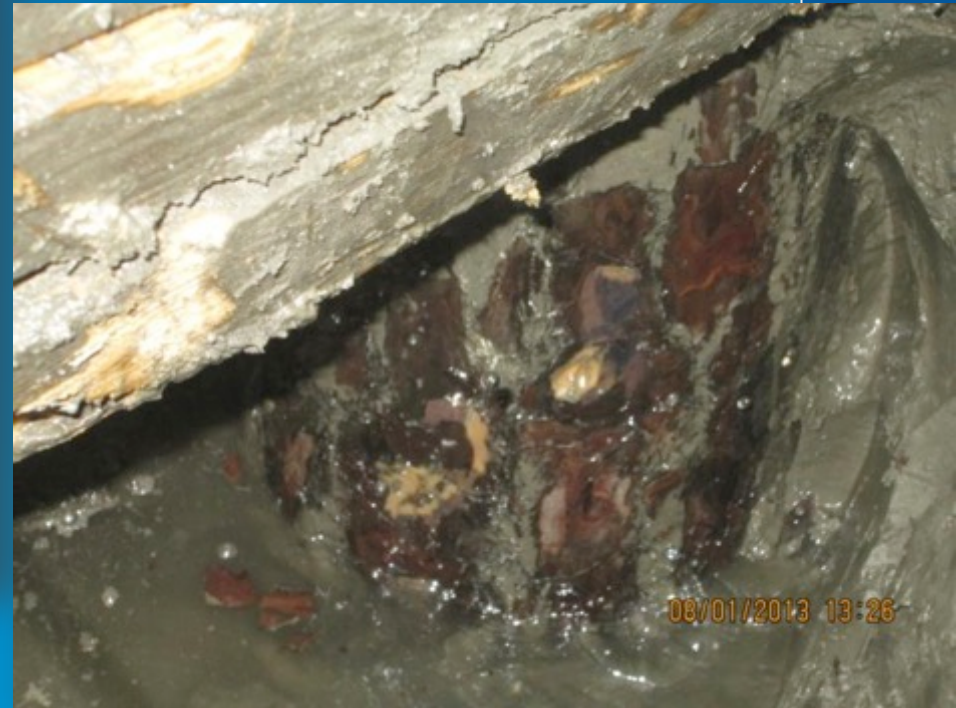
**Exposed Timber Pile Cap
and Pile**

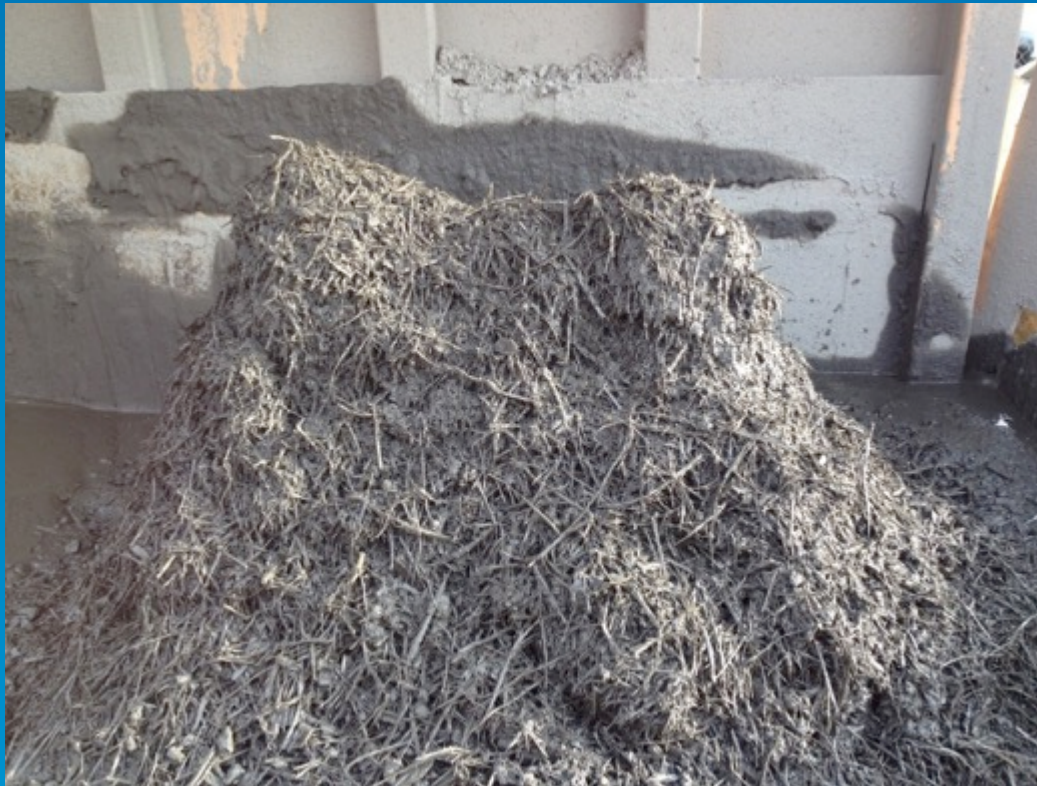
- Curved Alignment
 - Encountering Timber Piles
