**NEWEA & NYWEA Joint Spring Meeting
Technical Conference & Exhibition
June 6, 2016**

Sewer Trunkline Repairs and Stream Stabilization

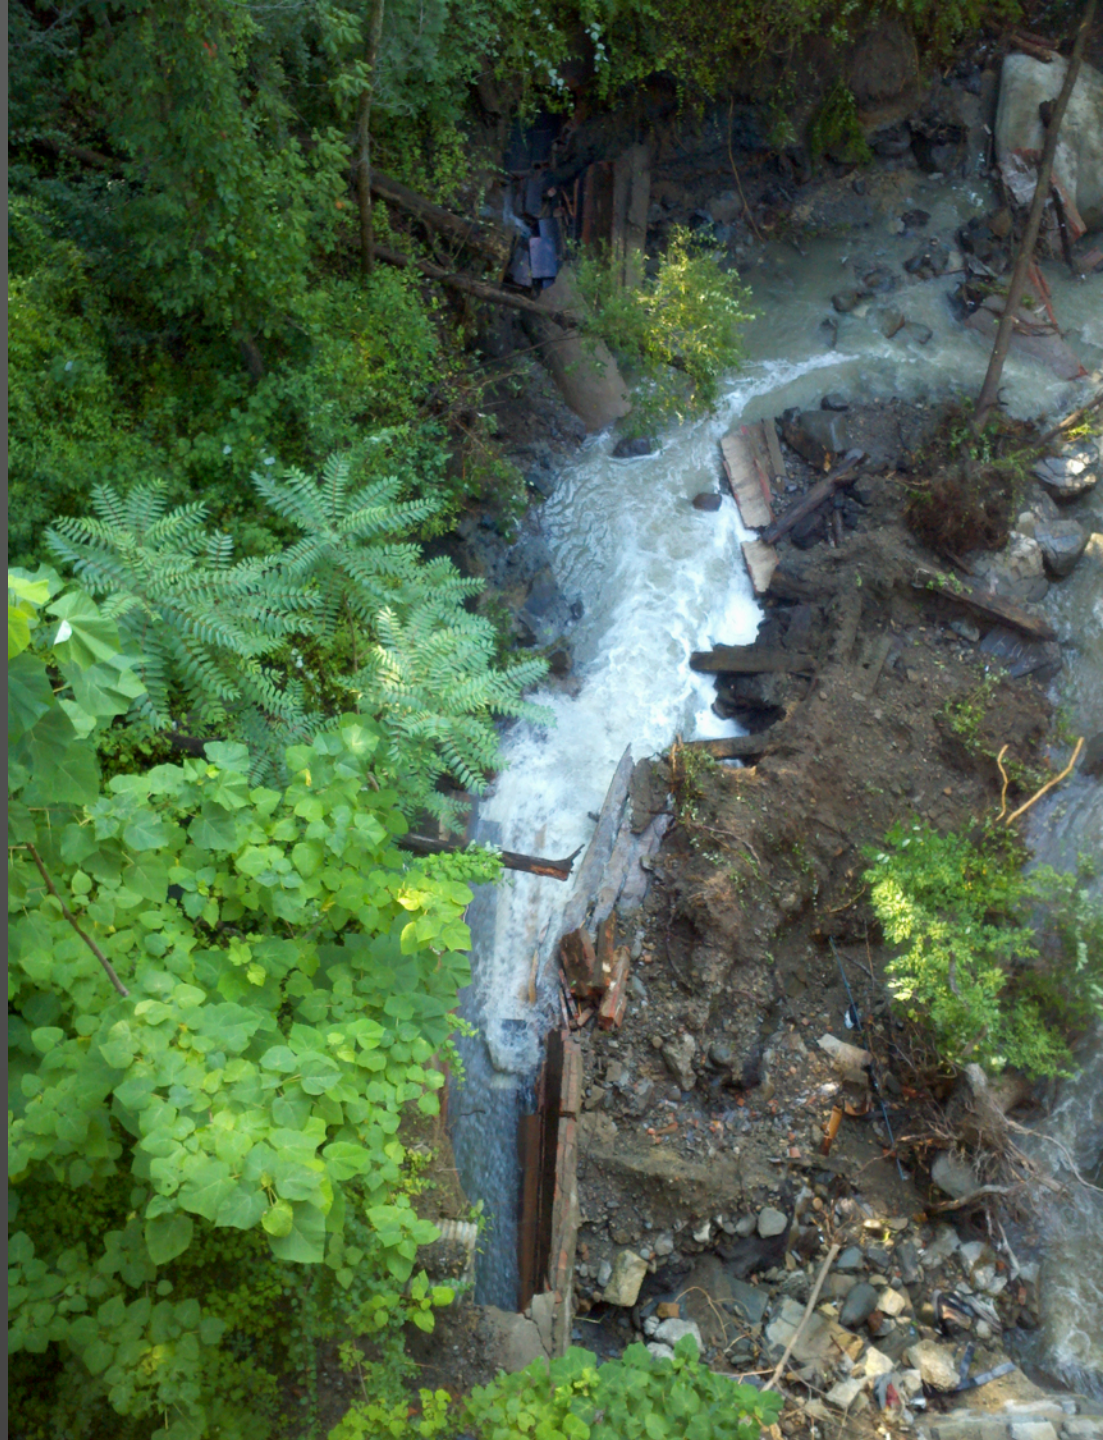
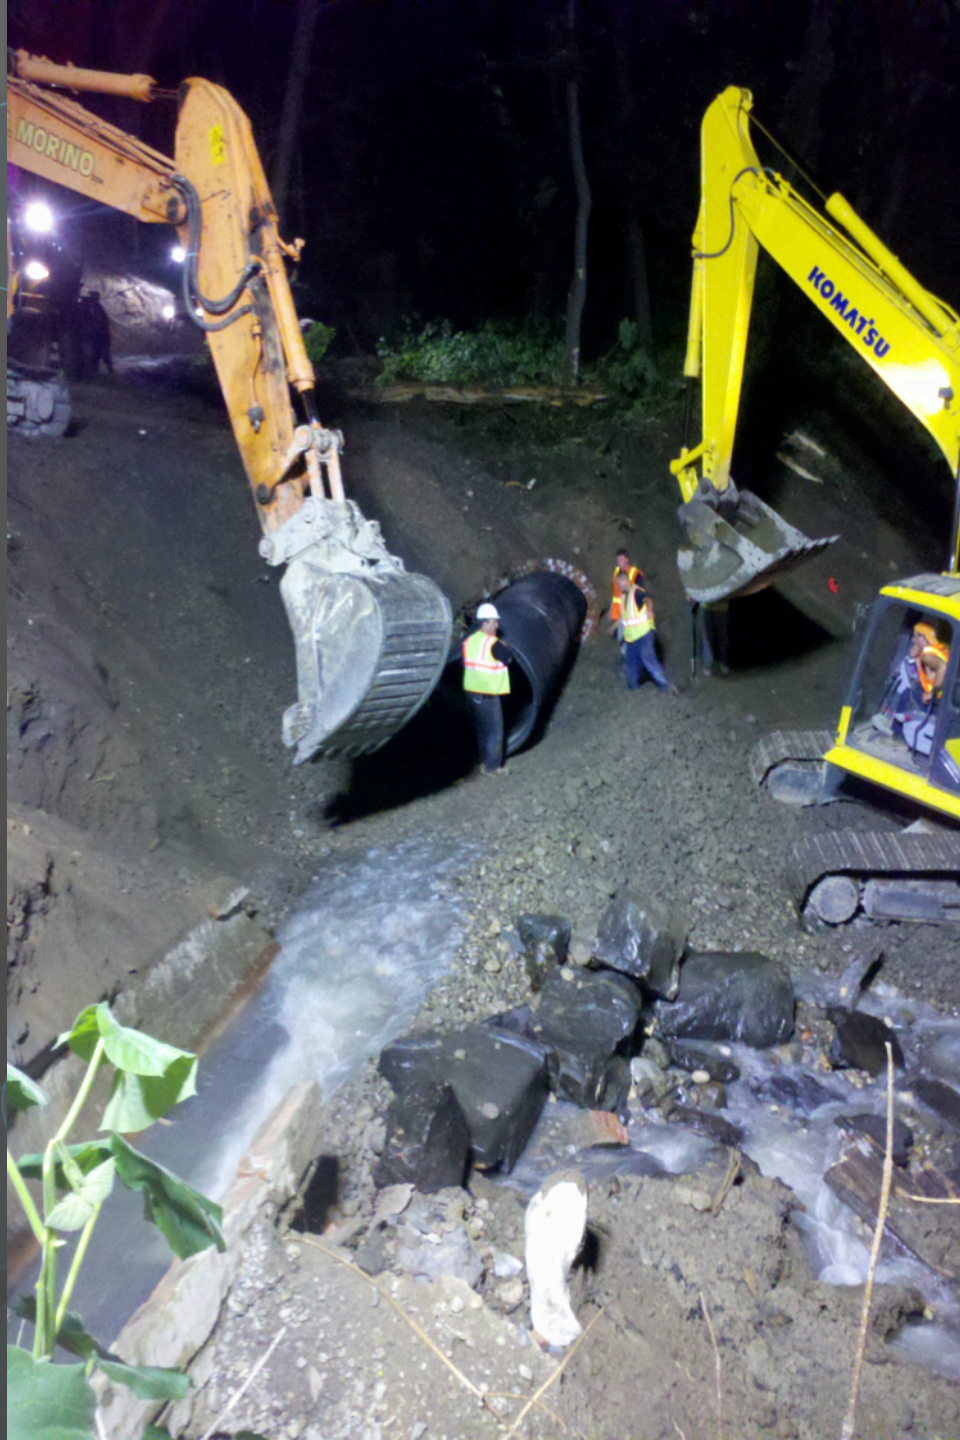
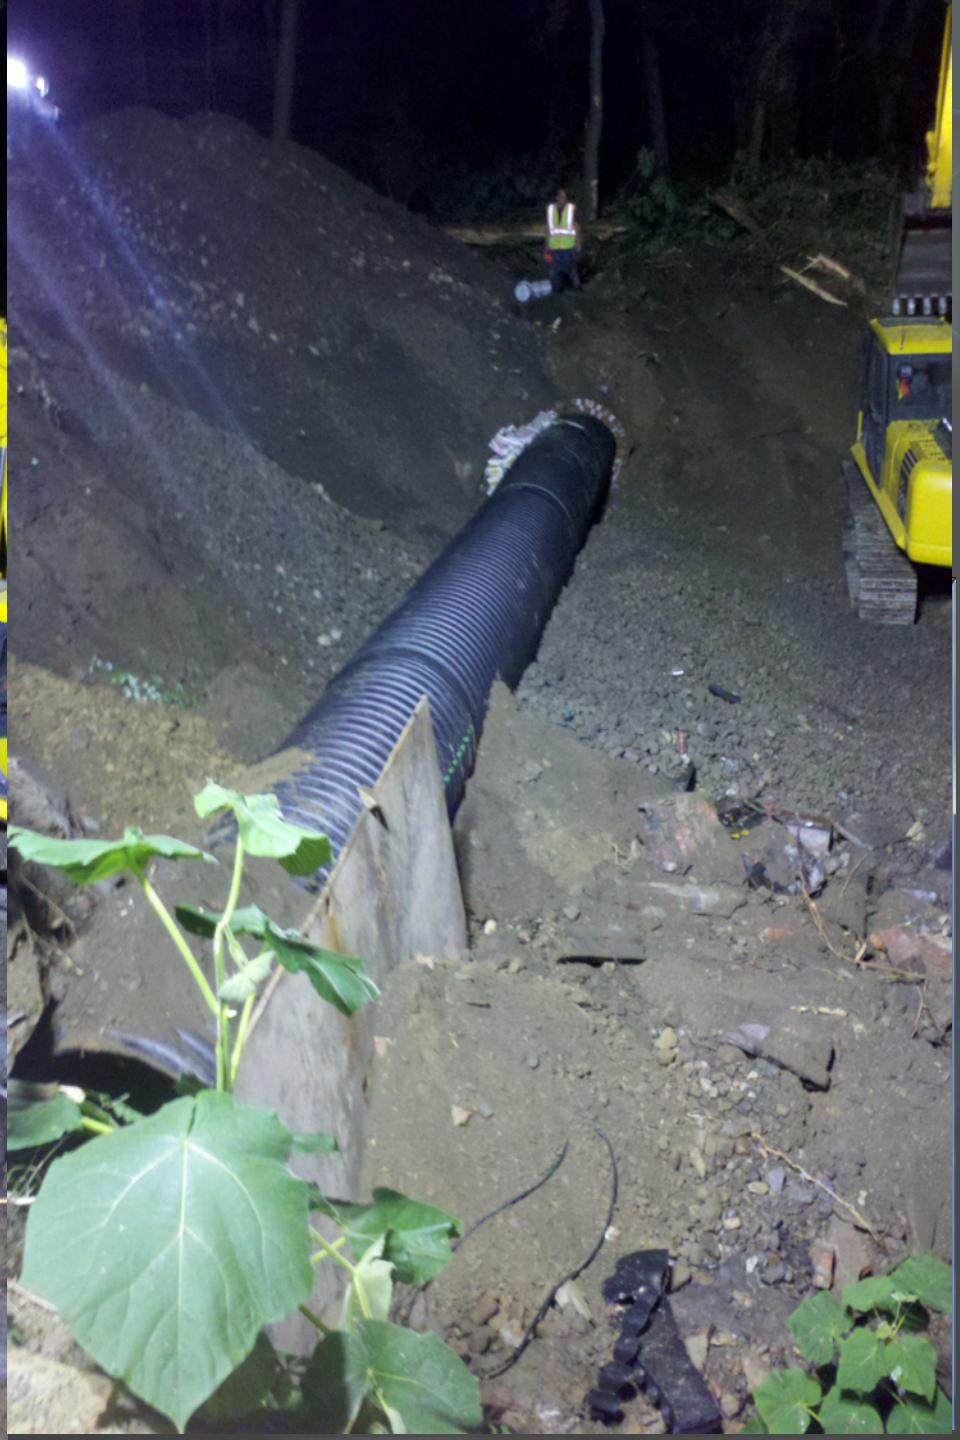
July 16, 2012

Received a call at 6:30 AM Monday Morning from the WWTP Operator that there was significantly reduced flow at the WWTP which is not typical for a Treatment Plant within a Combined Sewer System during a 1.18" rain event.

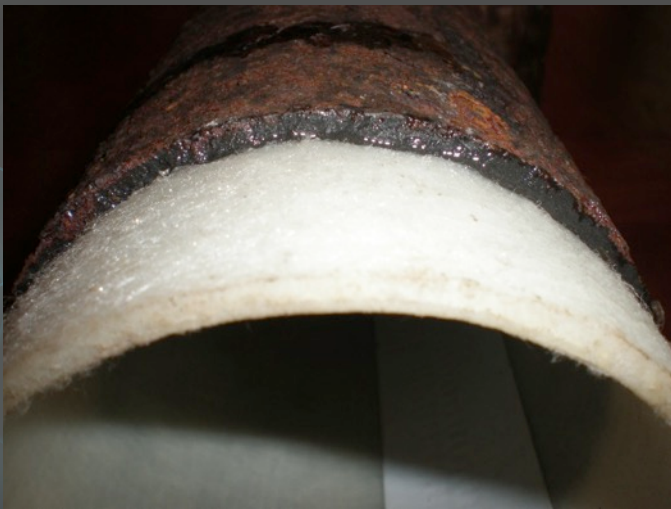
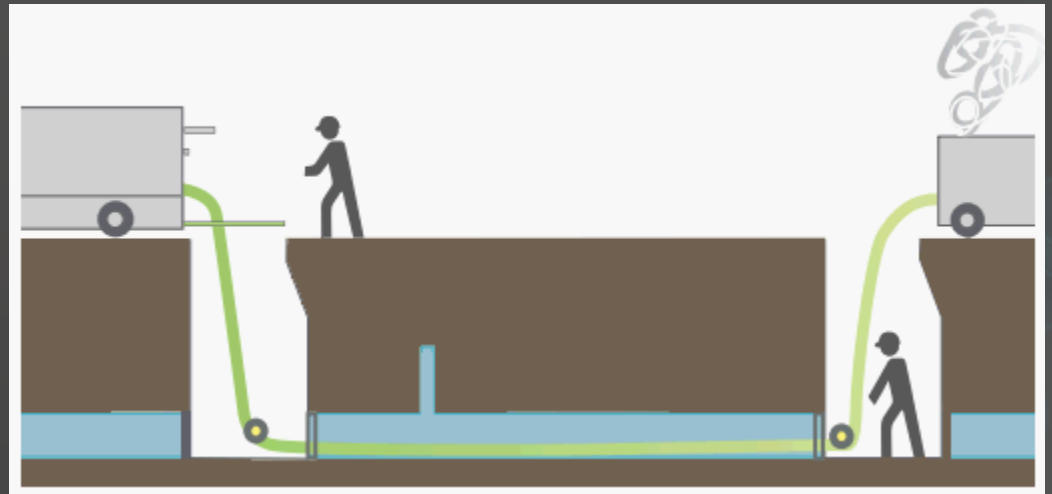
Sewer Pipe Rehabilitation – Contract 1

- Cured-in-place pipe (CIPP) 54-inch Walsh Rd to MH 5
- CIPP 36-inch Robinson Ave
- CIPP 18/24-inch Mill St
- Manhole rehabilitation (MH's 5, 4, 3, 2, 1)

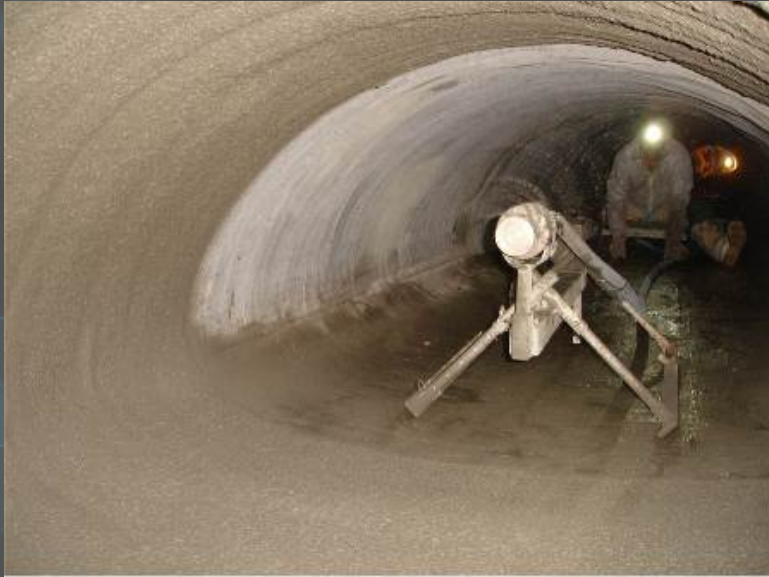
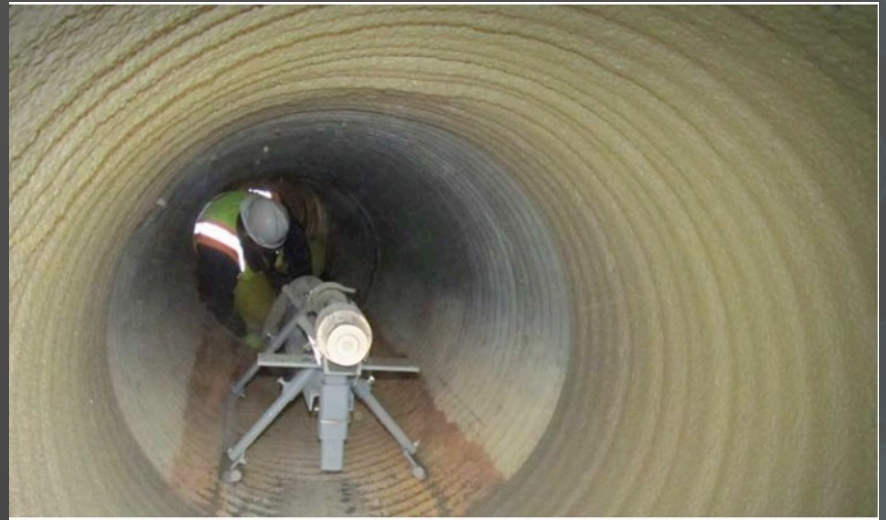
Sewer Pipe Rehabilitation – Contract 2

- Spot repairs along overflow and interceptor
- Centrifugally Cast Concrete Pipe overflow

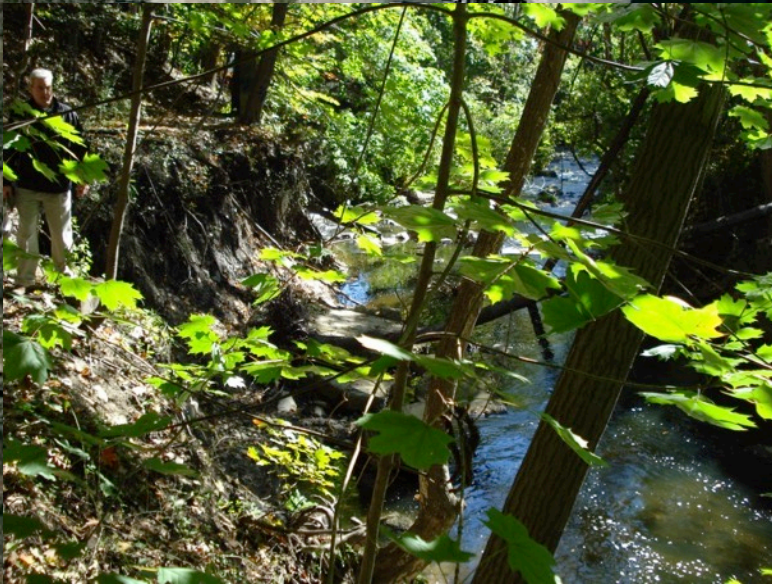
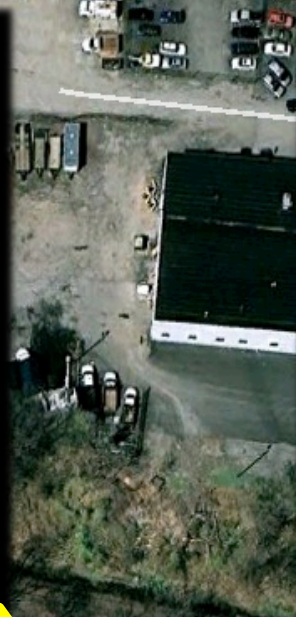
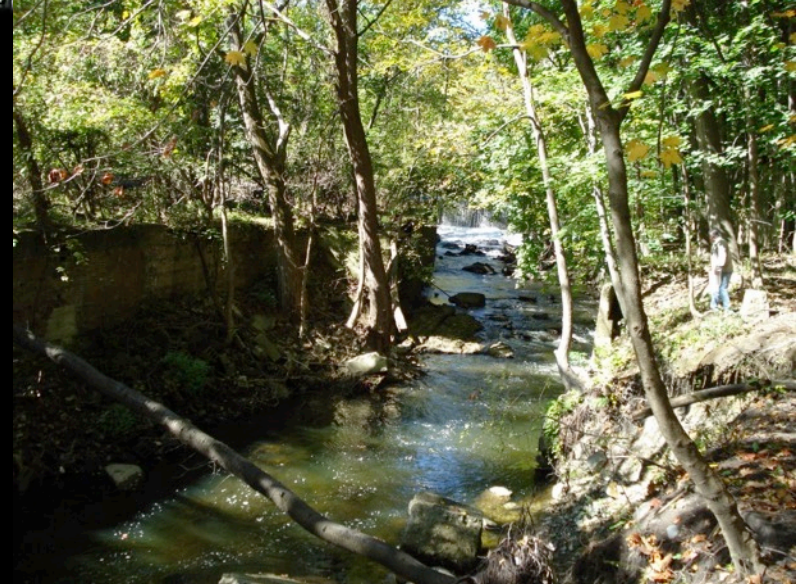
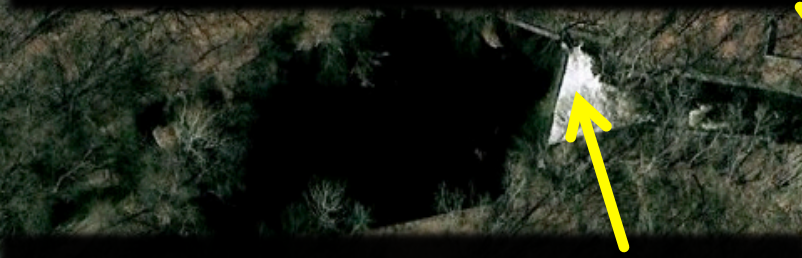
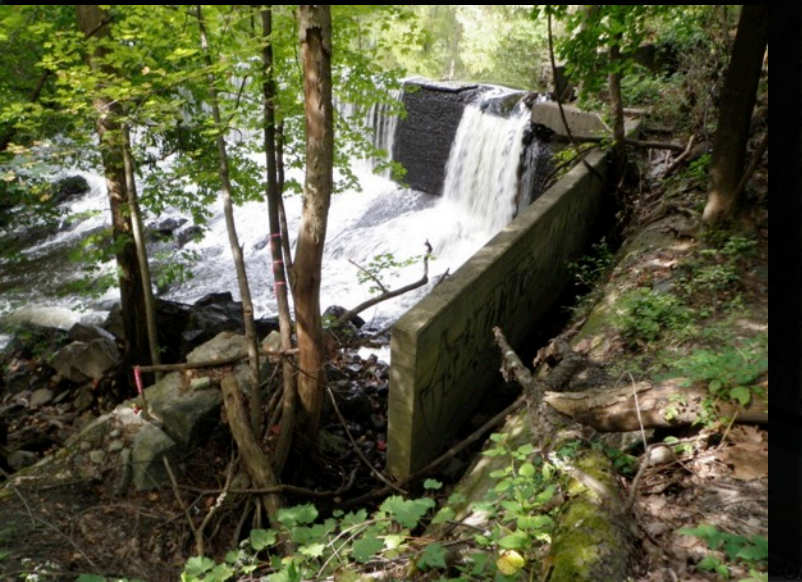
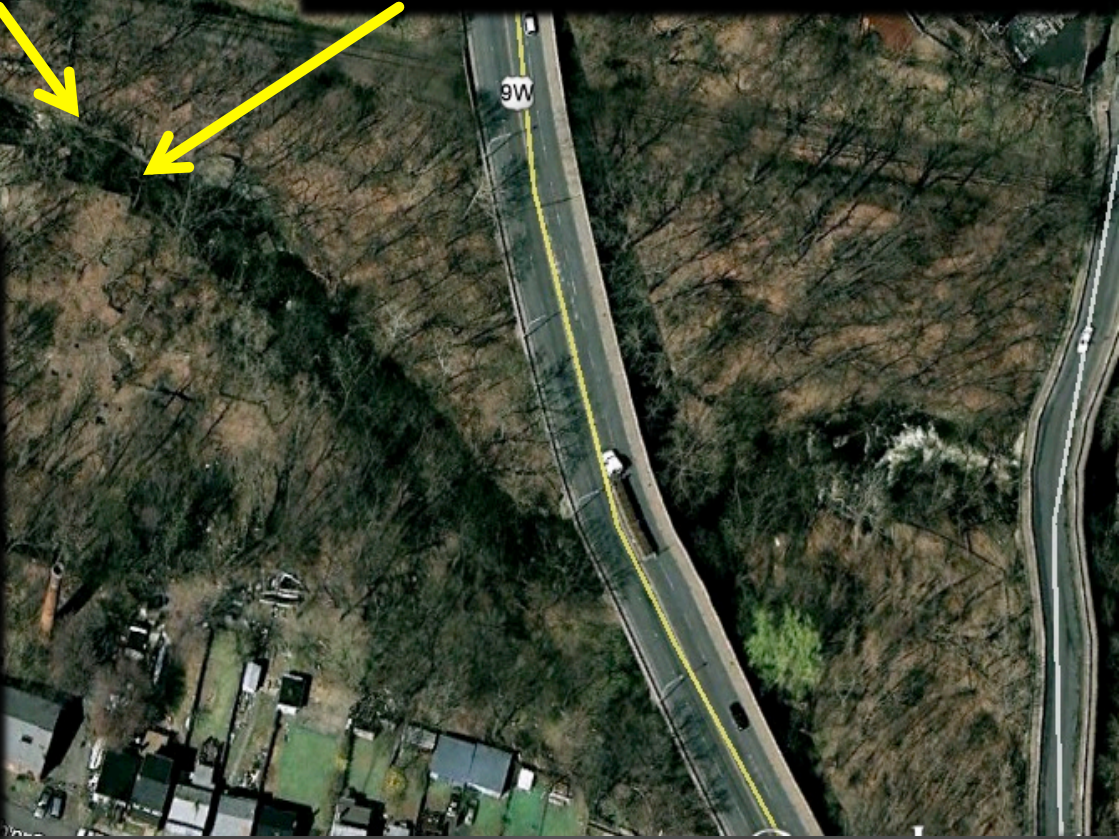
Unconfined Channel

- Reduced depth and velocity
- Reduced shear stress
- Lower erosion potential

Laterally Confined (Entrenched) Channel

- Increased depth and velocity
- Higher shear stress
- Greater erosion potential

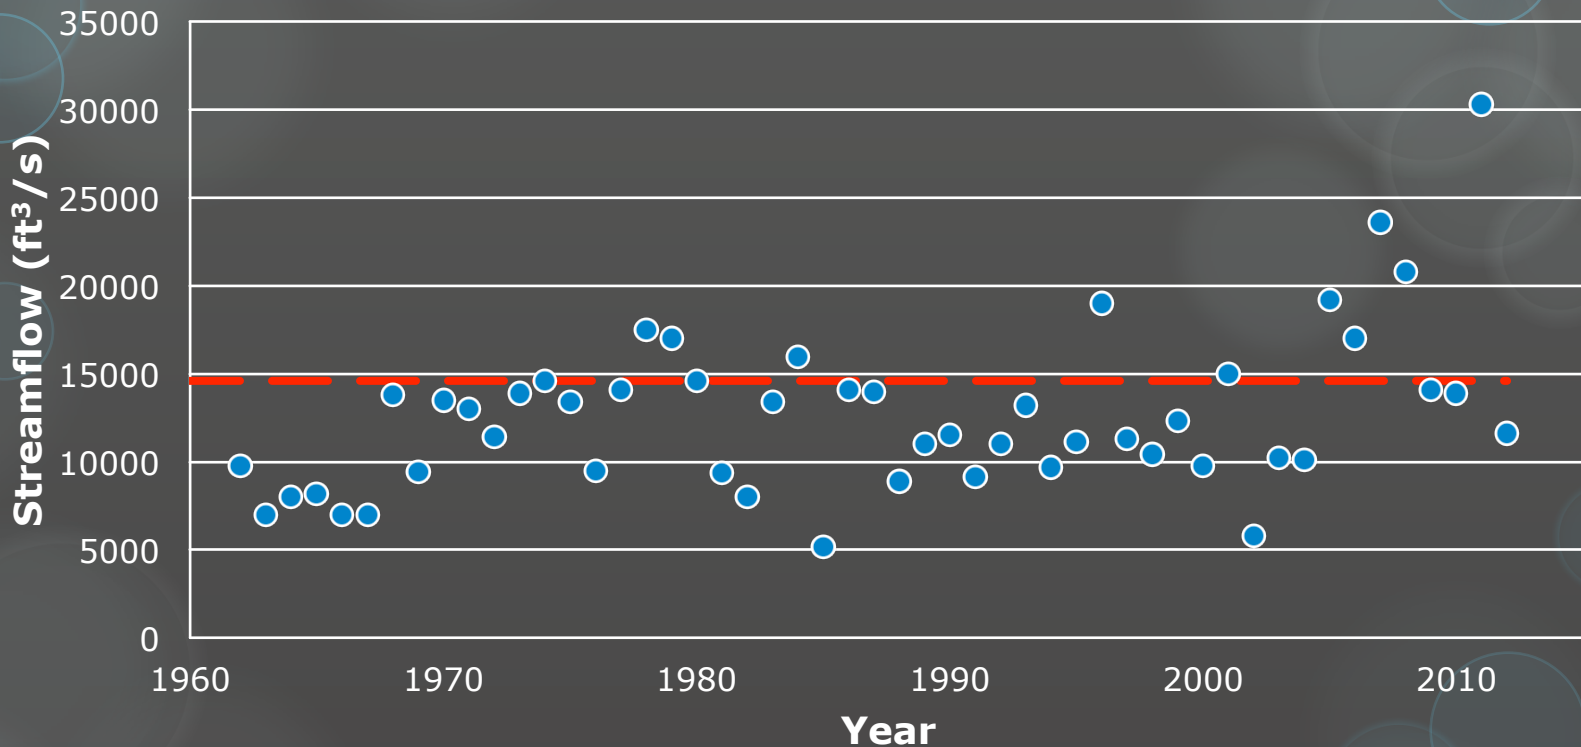
Peak Annual Streamflow Wallkill River - Gardiner, NY

- 1960 – 2000 (40 years) → 4 floods exceed 80th percentile
- 2000 – 2010 (10 years) → 6 floods exceed 80th percentile

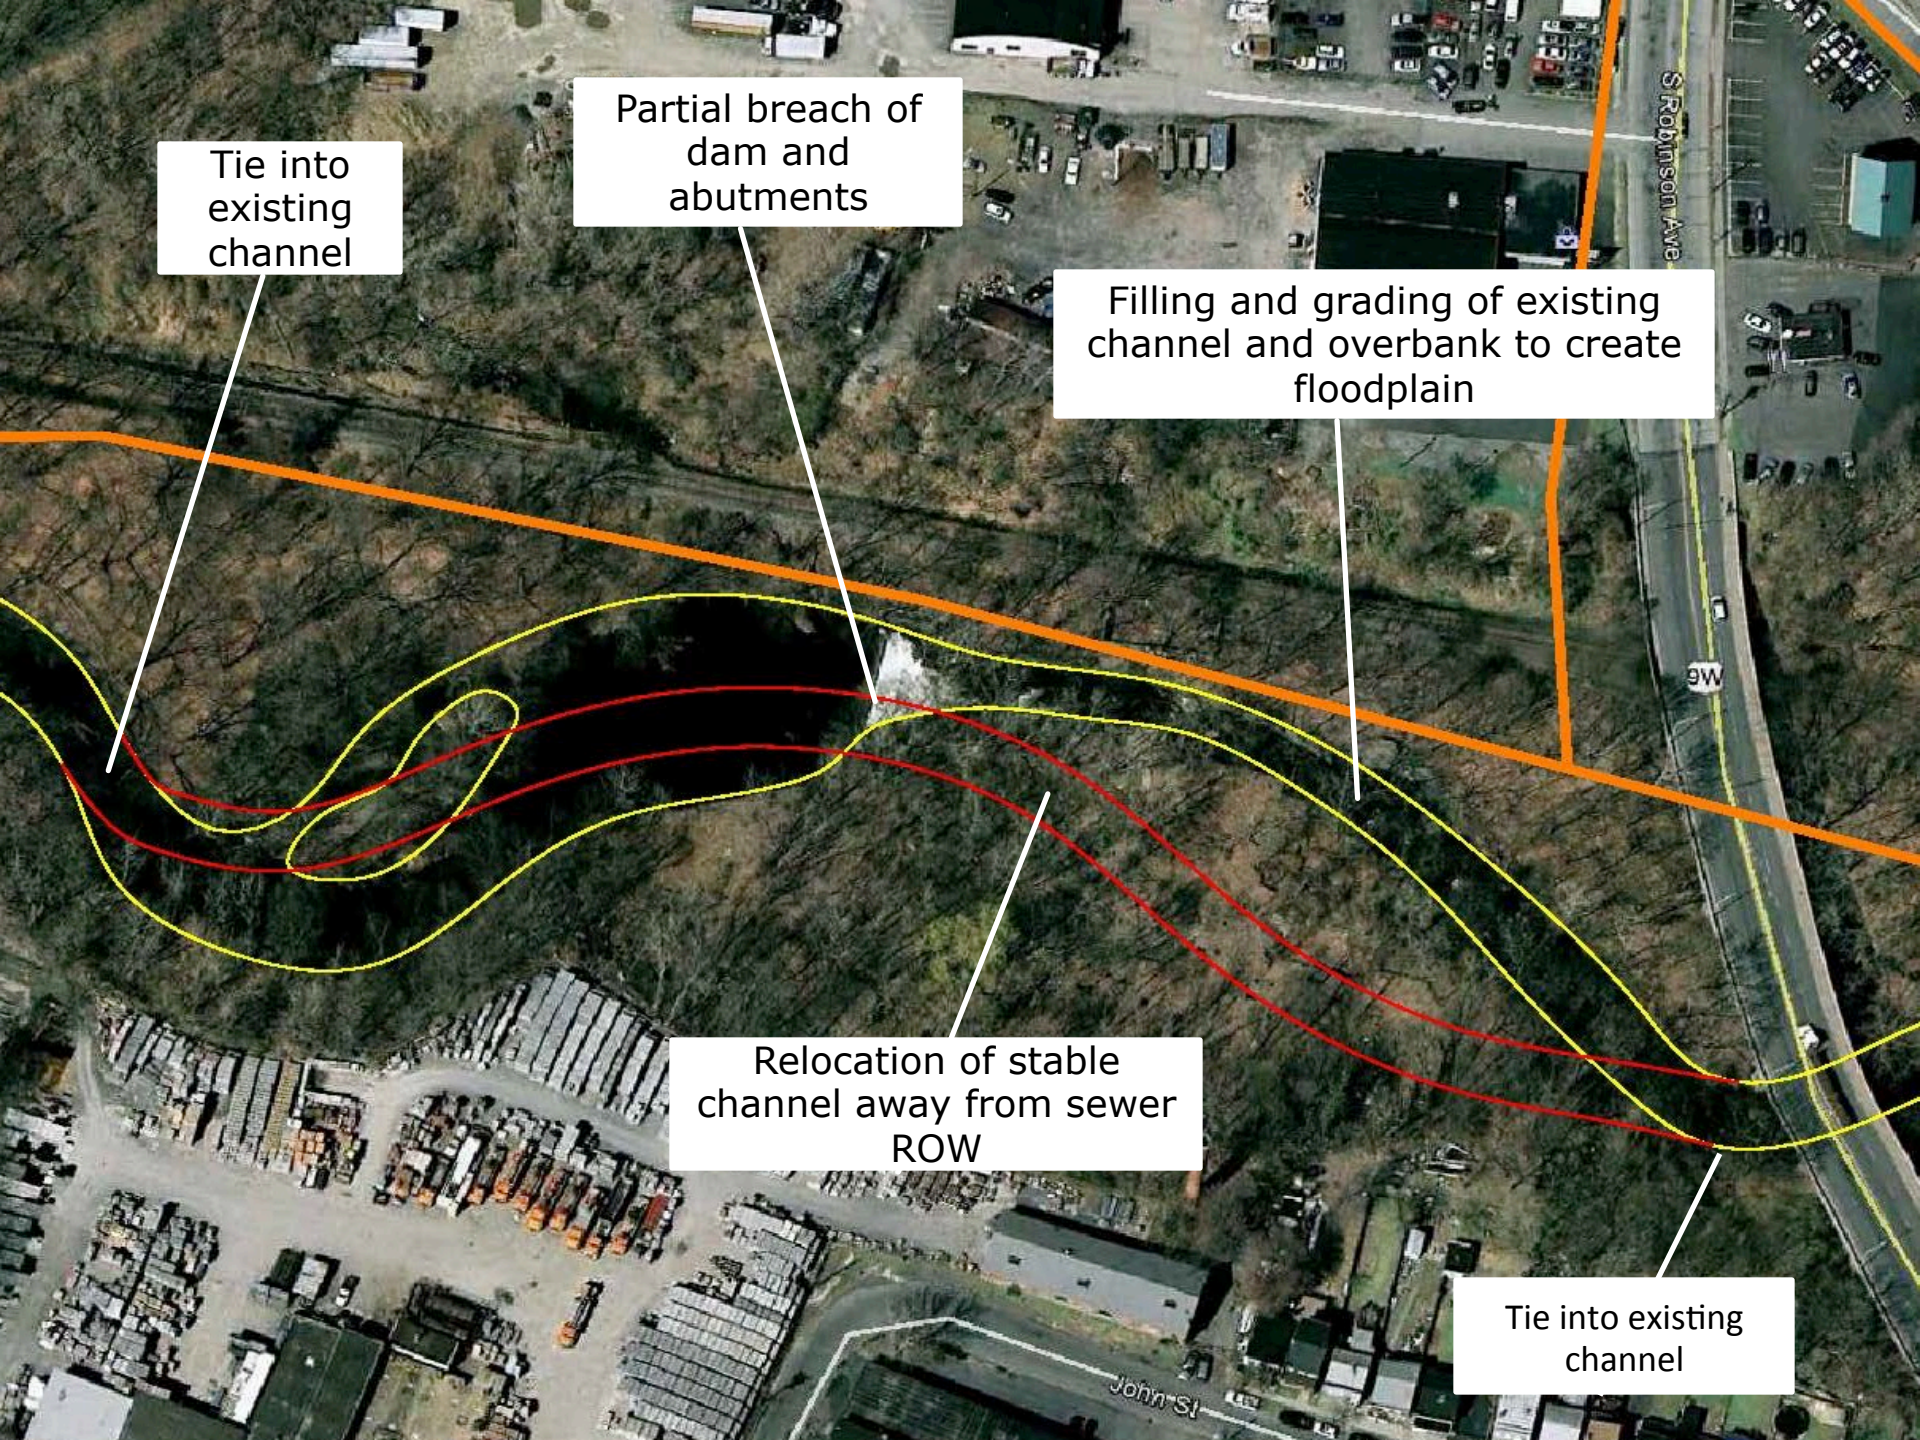
Tie into
existing
channel

Partial breach of
dam and
abutments

Filling and grading of existing
channel and overbank to create
floodplain

Relocation of stable
channel away from sewer
ROW

Tie into existing
channel

- **Relocate active channel away from sewer ROW**
 - Eliminate risk of stream encroachment
- **Construct stable channel to reduce bank erosion**
 - Eliminate recurring risk of bank failure
- **Create wide floodplain buffer to protect sewer ROW**
 - Provide additional structural stability to sewer line
- **Eliminate concrete channel**
 - Remove risk to longevity of sewer line

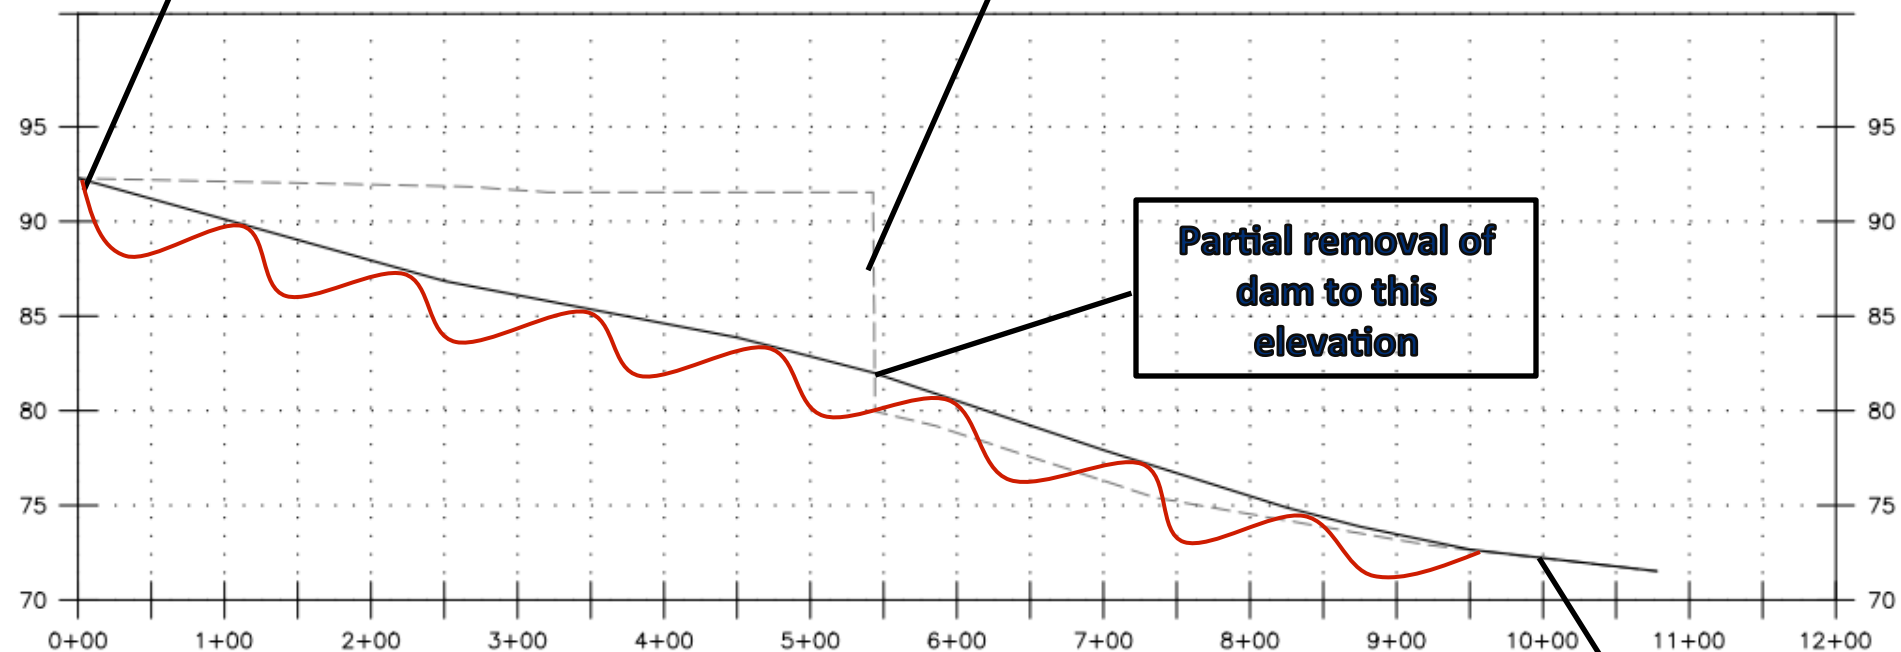
STREAM PROFILE

**Tie to existing
stream channel**

**Existing Holden
Dam**

**Partial removal of
dam to this
elevation**
