BOOM! Hydraulic Transient Problems – Emergency and Long-term Solutions for Lexington's Main Wastewater Pumping Station

Town of Lexington, Massachusetts

Presented by:
Kevin M. Olson, PE
NEWEA Collection System Specialty Conference
September 12, 2016

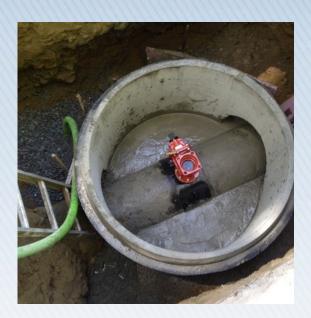
Strategy 3

- Install a 396 ft³ (2,960 gallon)
 Surge Tank at the Pump Station
- Install Two Air-Vacuum Relief Valves on the FM
- Install Bottom-Mounted Dashpot, "Oil-Cushioned" Check Valves

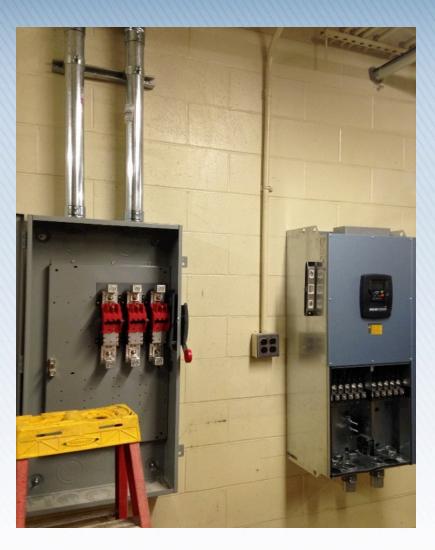
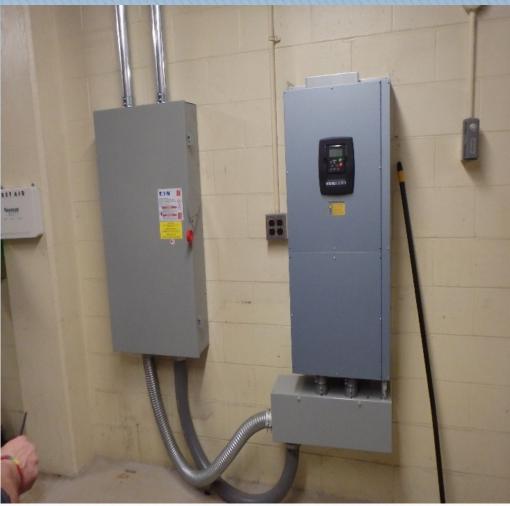
Emergency VFD Installation

- Immediate (Emergency) Solutions
 - Install VFD on Pump No. 2 Created "soft start/stop
 - Immediate Positive Affect
 - Communicate Weekly with Residents
 - Run Pumps at Full Speed Occasionally to Flush FM
- Longer-Term Solutions
 - Install Surge Tank on Force Main Header at PS
 - Install New Automatic Air-Vacuum Valves on FM
 - Install New Oil-Cushioned Check Valves
 - Install VFD's and New Motors on all Pumps
 - Install New Control System
 - Install New Pig-Launch Assembly at PS

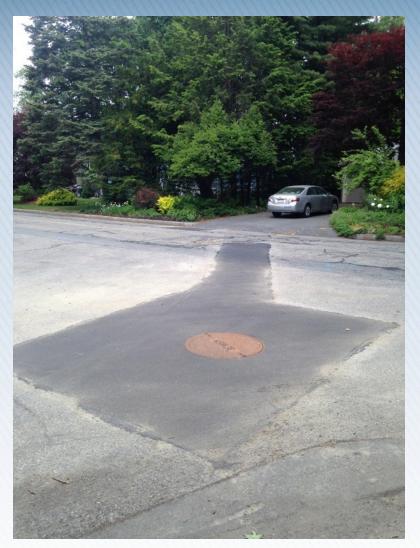
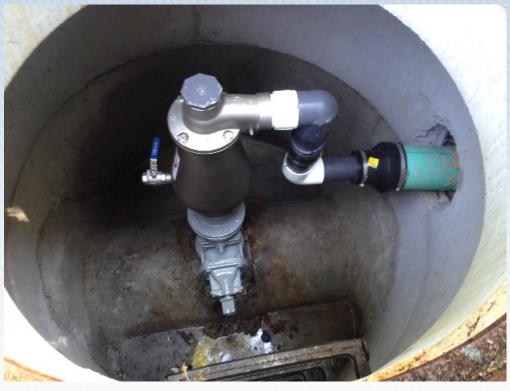
Force Main Air-Vacuum Valves and Drains

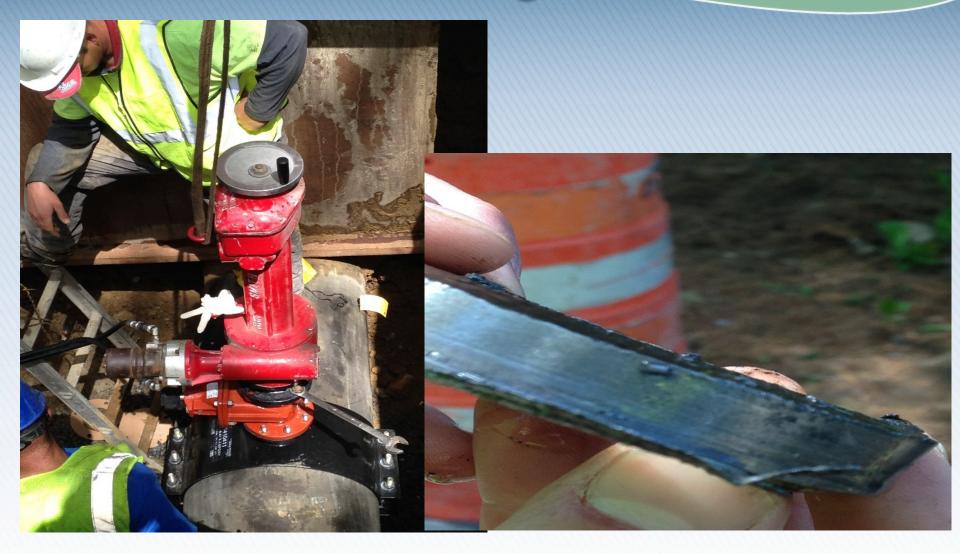
Force Main UT Testing

- Perform Testing During Construction of Longer-Term Solutions
 - At both FM Relative High Points UT Pipe and Soils Testing
 - Check FM Pipe Thickness (Pipe Coupon) During Installation of Automatic Air-Vacuum Valves
- Perform Smart Ball® Testing of entire FM

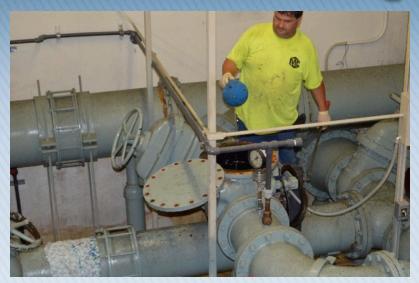
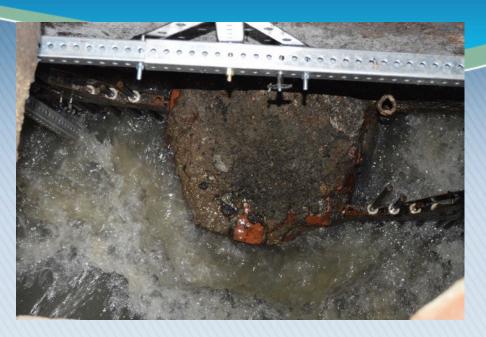
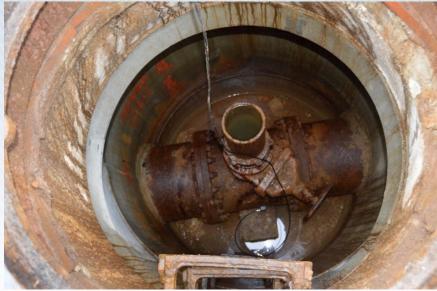
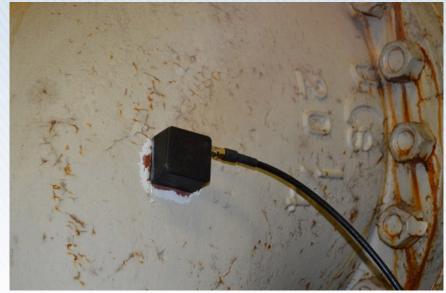
Smart Ball Testing

Collected Acoustic and Pipe Wall Assessment Data (Magnetic Changes)

Sensors (4)Located Along Force Main for Tracking

- Ball Records Flow Velocity Through System
- Continuous and Constant Flow During Test
- No Air Pockets, Identified 19 Anomalies (small-medium)
 - Recommended to Excavate and Assess FM at 4 Locations

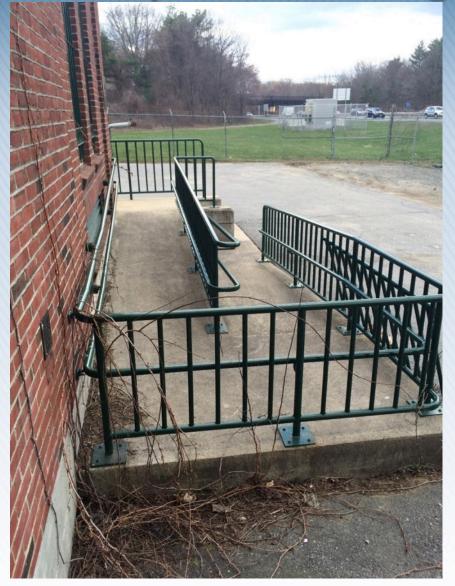
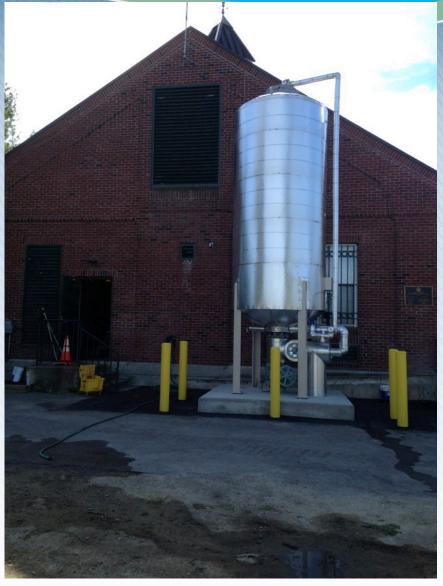
Pump Station Surge Tank

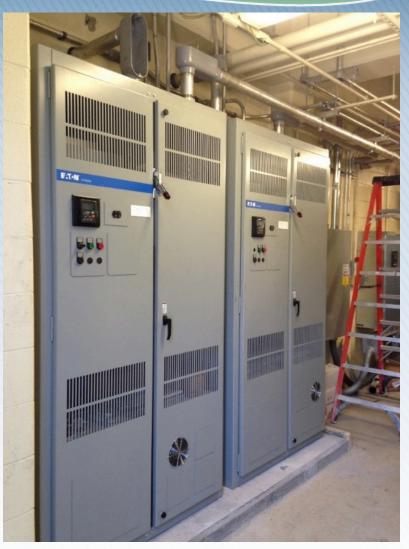
Pump Station Controls

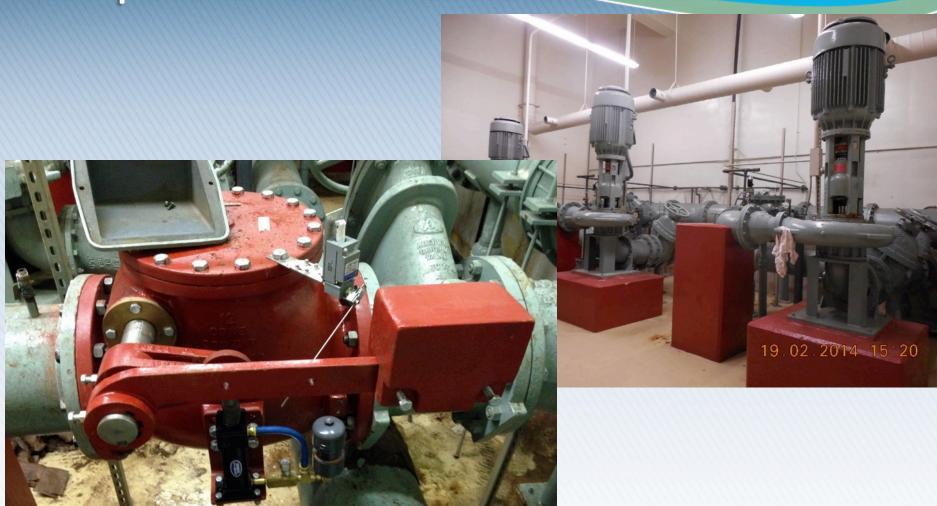
Pump Station Oil-Cushioned Check Valves

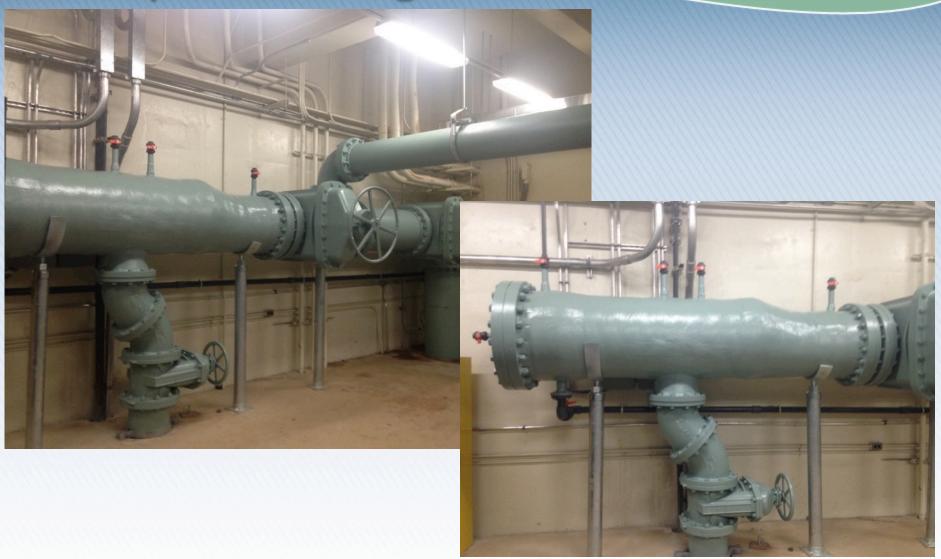
Pump Station Pig Launch

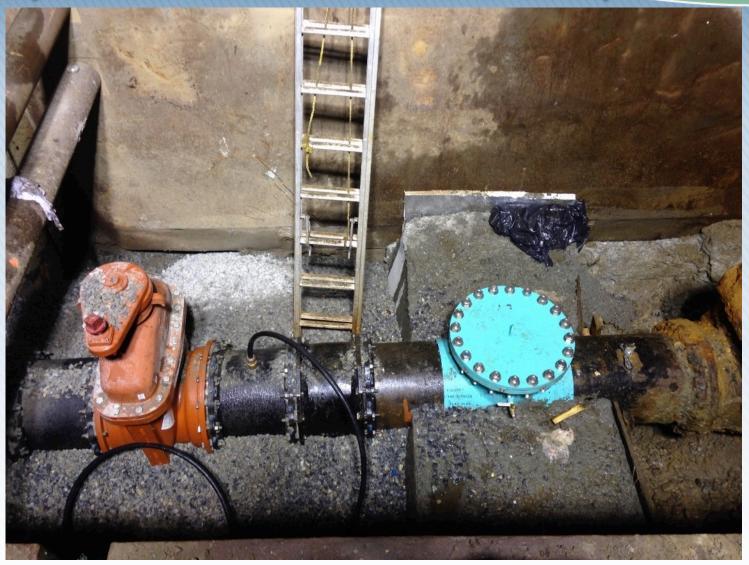
Pump Station Force Main Line Stop and Valve

- Resident Communications and Coordination
- Immediate Solution Timeframe
- Additional Items During Construction
 - Line Stop and Valve Required
 - HVAC Additions
 - Emergency Lighting Updated
 - Mission Alarm System Improvements
