Wastewater Treatment Facility Influent Sewer Rehabilitation

Charles Gore, Brown and Caldwell
Janine Burke-Wells, Warwick Sewer Authority

New England Water Environment Association Annual Conference
January 23, 2017

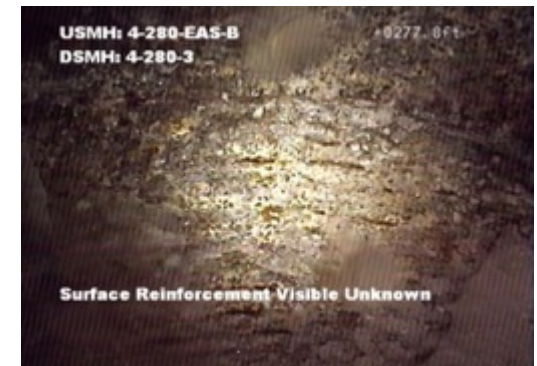
Loss of concrete and exposed reinforcement were observed

- Wall section loss from 7 O' Clock to 4 O' Clock
- Section beneath I-95 deemed to have structural deficiencies
- Tech Memo containing an evaluation of rehabilitation and replacement options prepared by BC

Recommendation: Sliplining

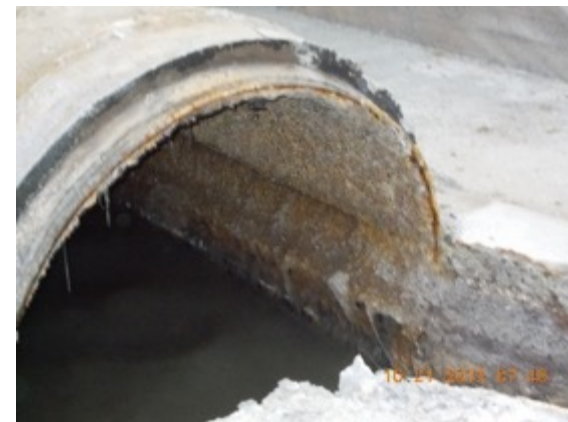
Existing Sewer exposed during construction

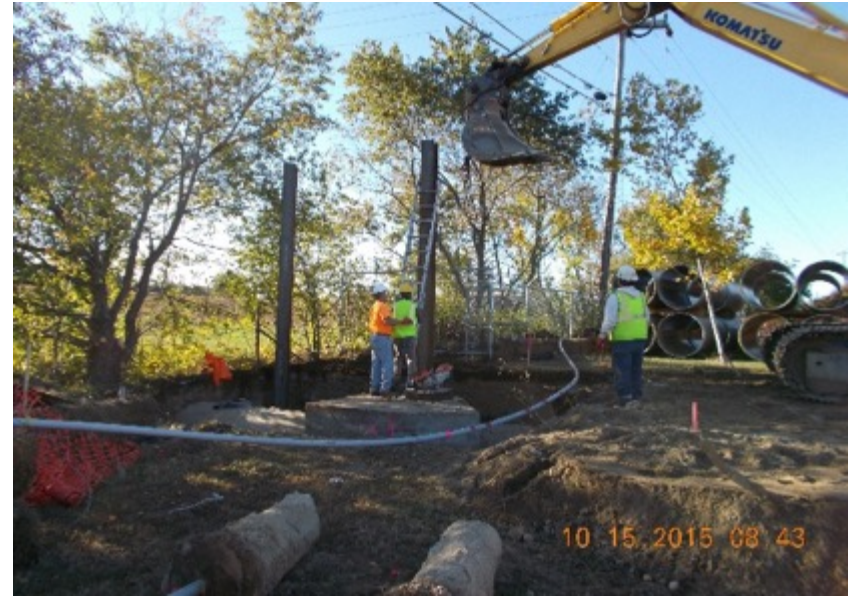
WSA fence removed – RIDOT fence intact

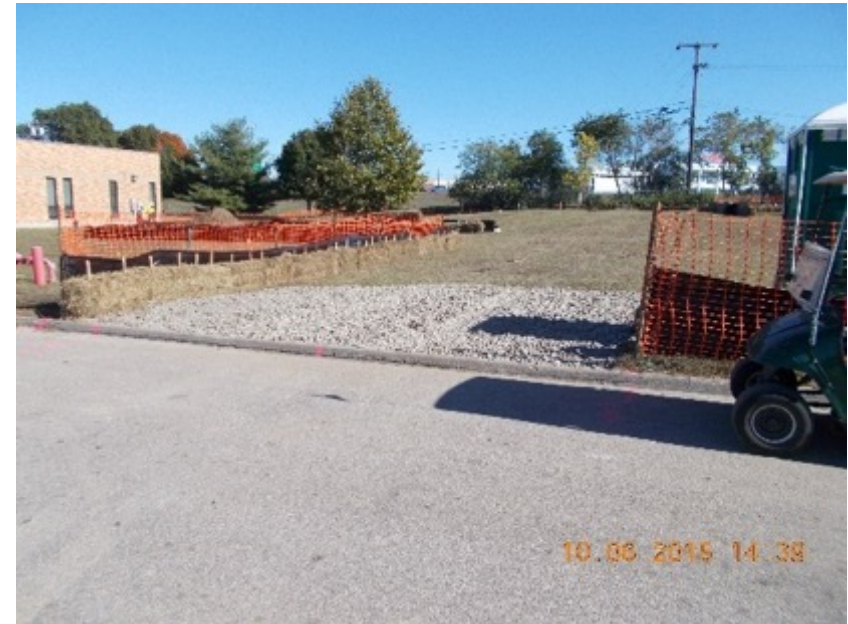
Construction Entrance

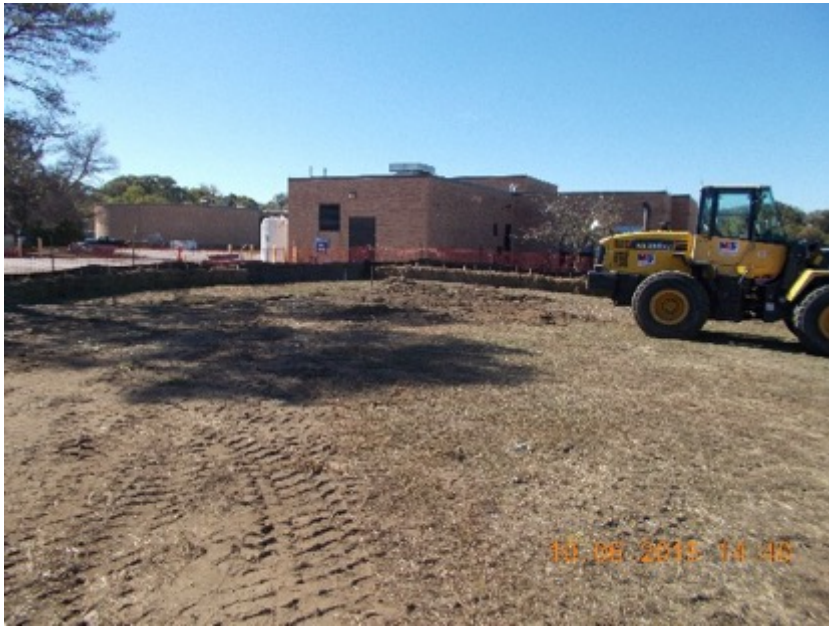
Staging and Laydown Area

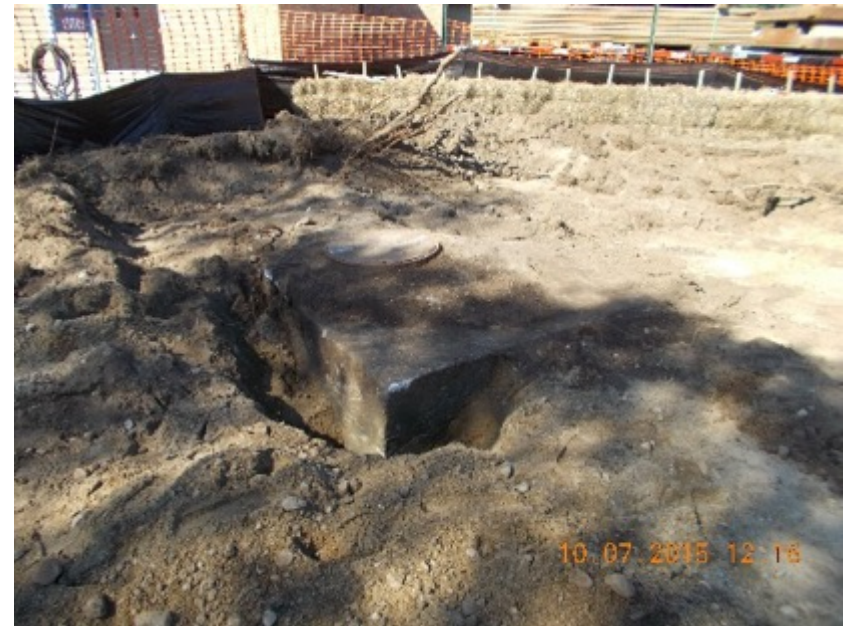
Exposing Existing Sewer

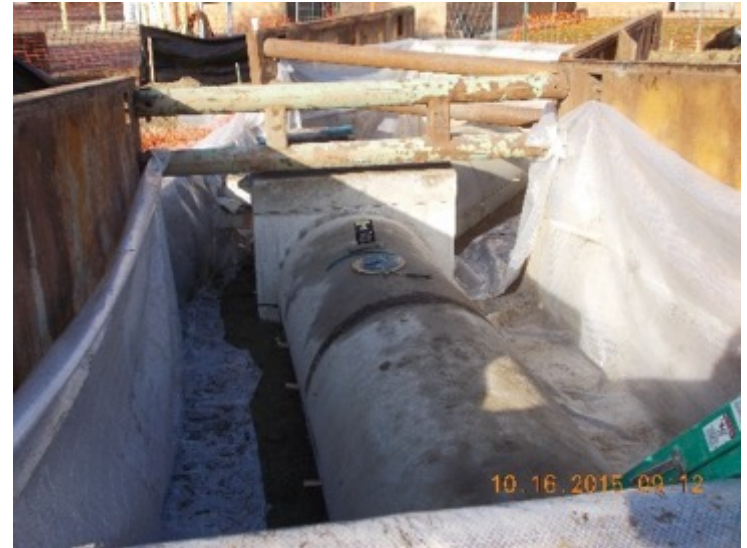
Flow Containment Controls

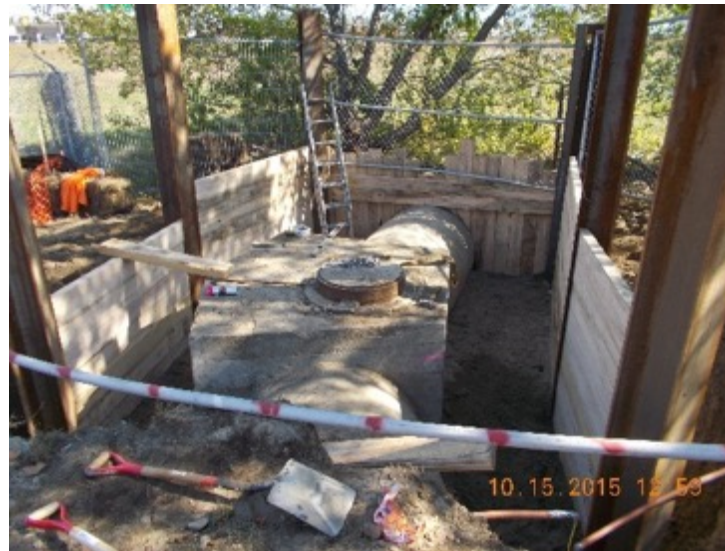
Access Opening Construction

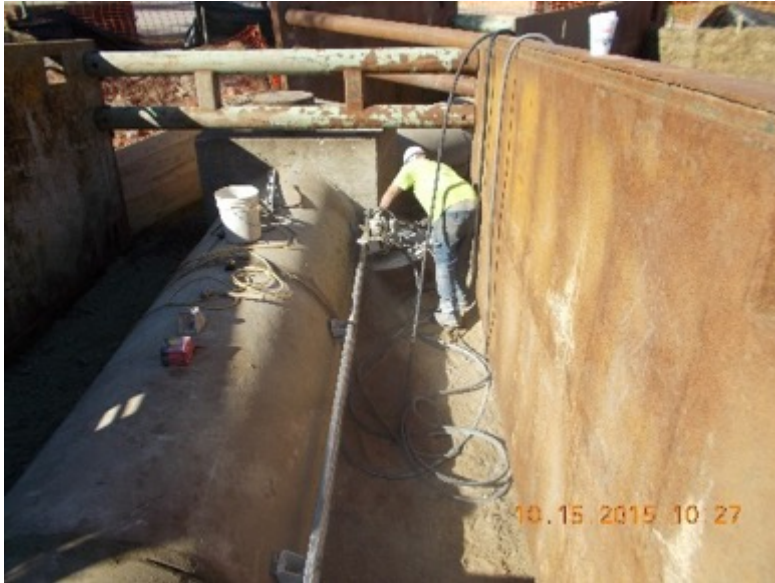
Concrete Cutting

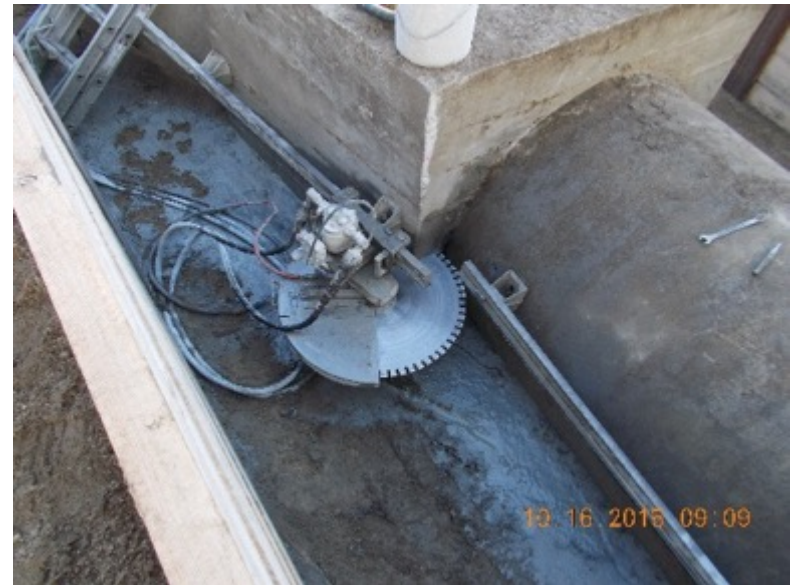
Concrete Cutting at Manhole

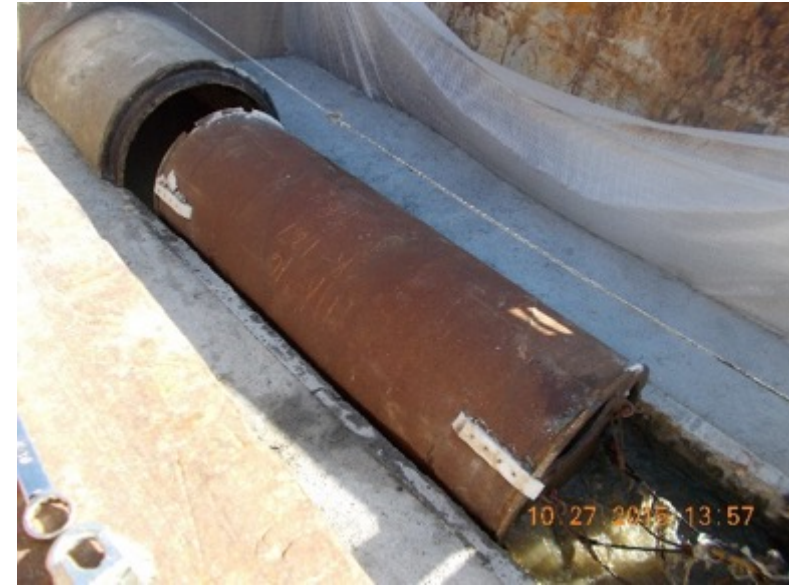
Mandrel

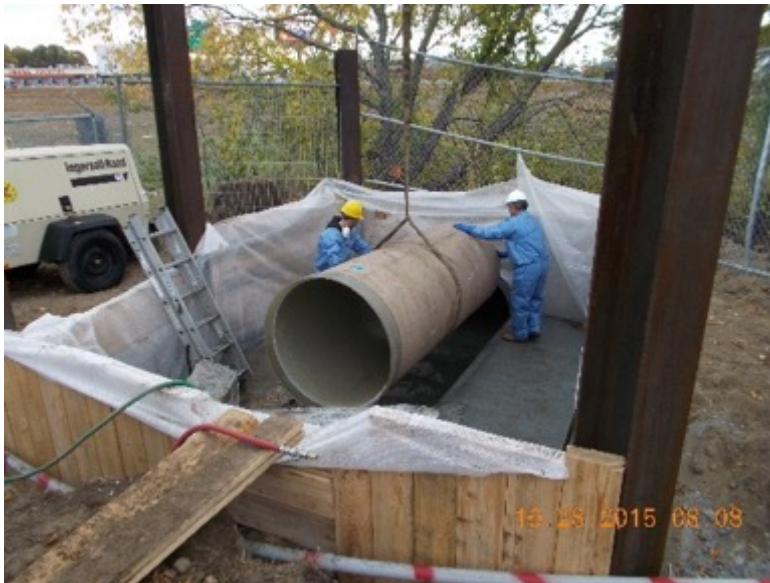
Pipe Installation

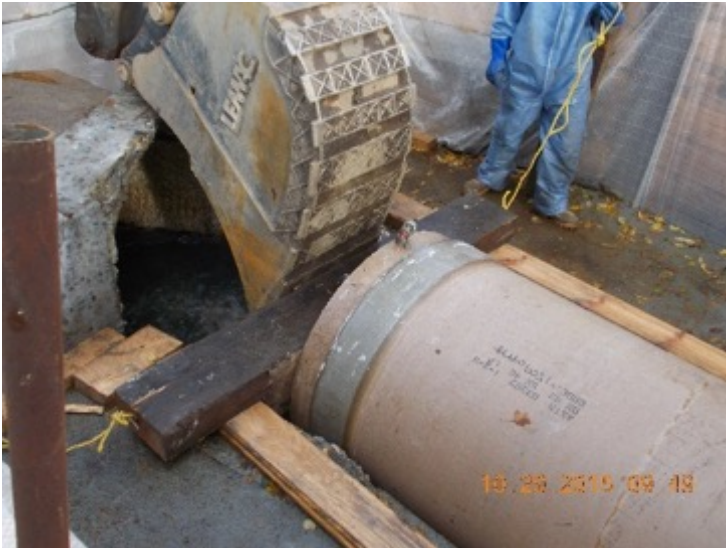
Pipe Installation

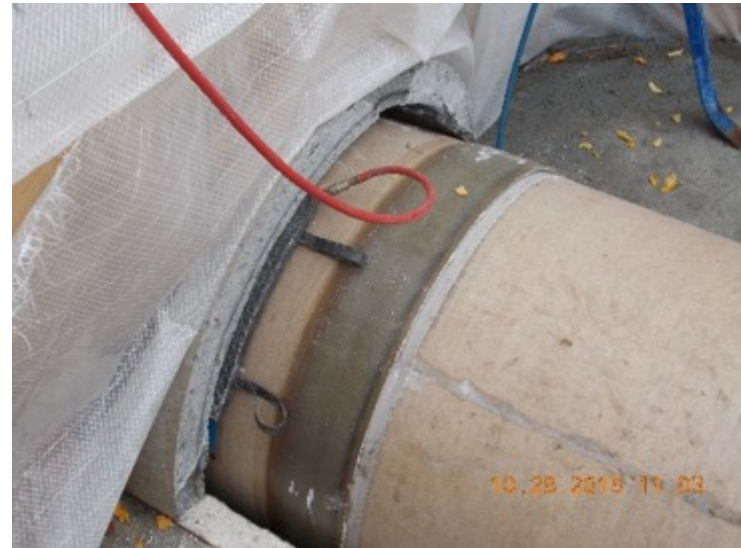
Pipe Installation – Pipe held in place for joining

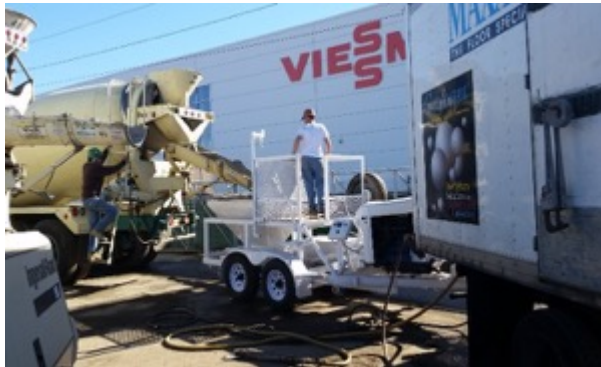
Grout Pump and Foaming Agent Truck

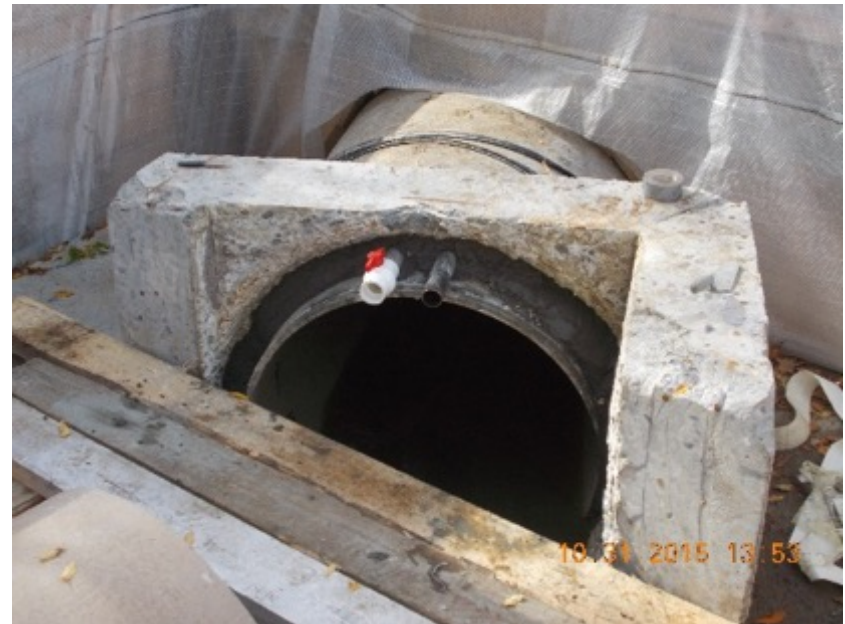
Bulkhead with Grout Port and Air Release Lines

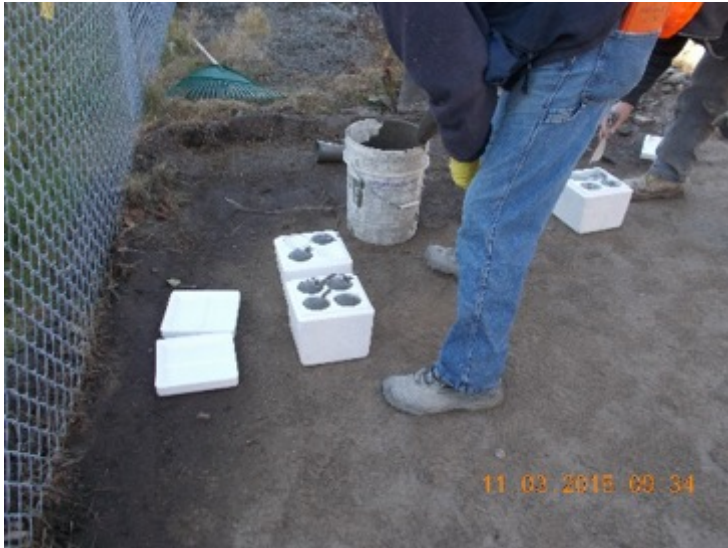
Grout Samples

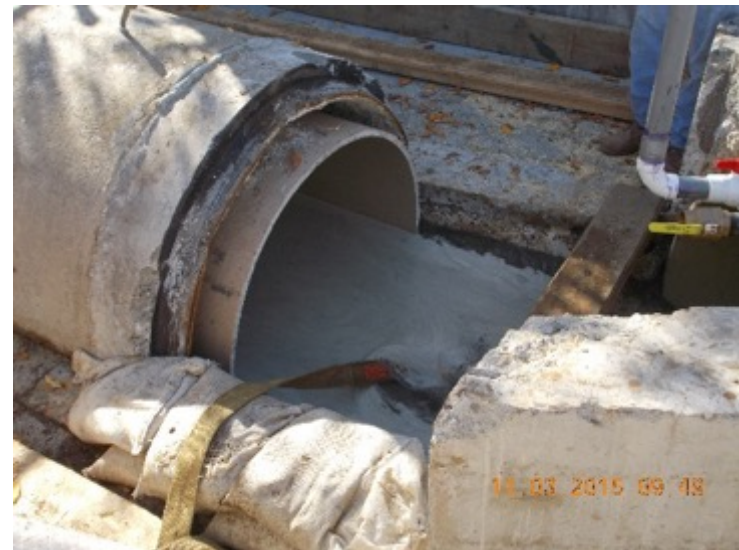
Grout Leakage into Pipe

- Bulkhead leakage contributed to pH spike
- Anticipate potential for excessive debris capture & removal
- Protection of existing facilities is important
- Teamwork to address issues
- Proactive approach dealing with project abutters minimizes issues
- Keeping regulators informed

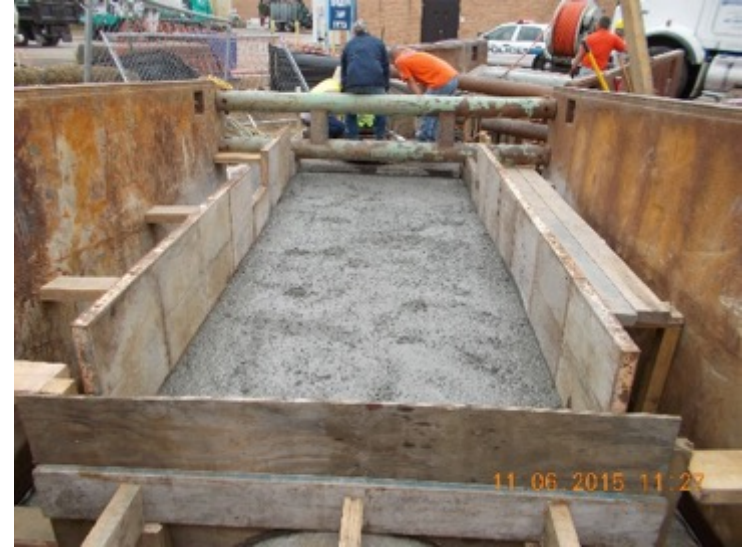
Completed Concrete Encasement

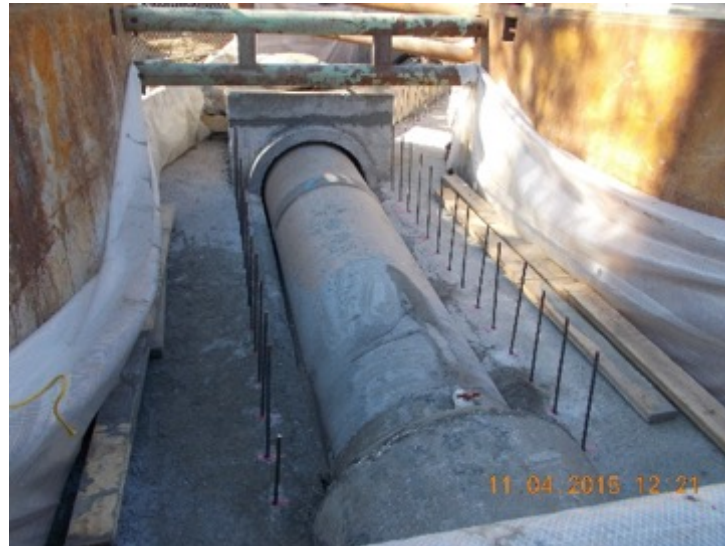
Rebar for Concrete Encasement

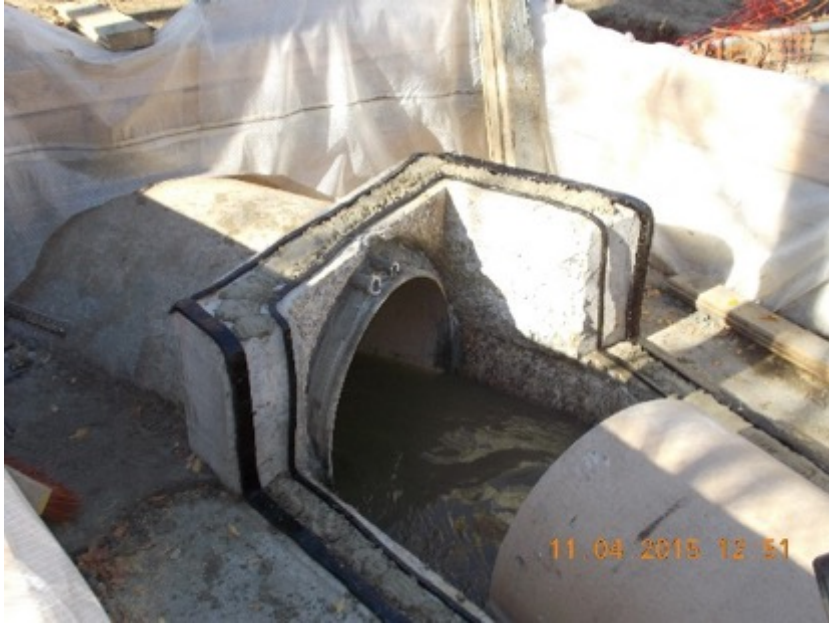
Manhole Restoration

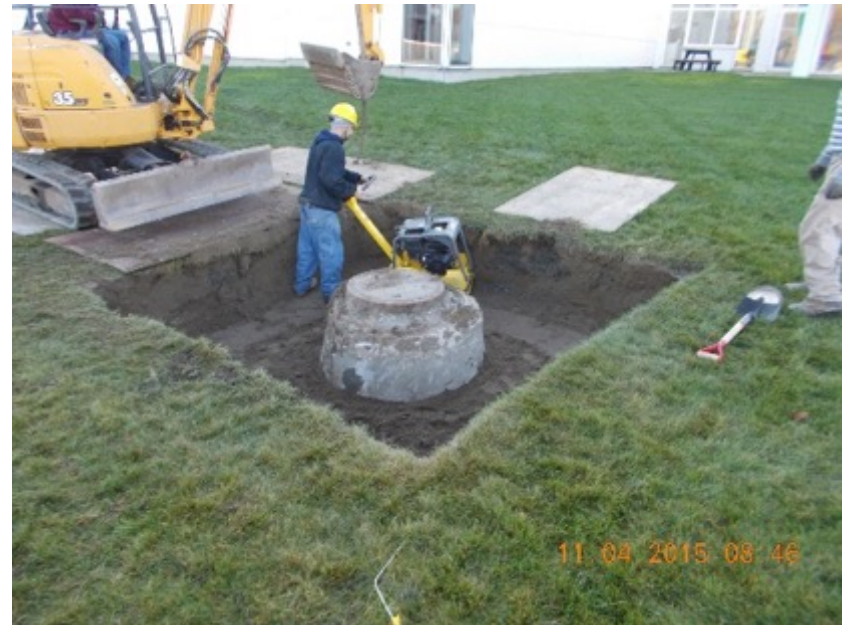
Sliplining Receiving Location Restoration

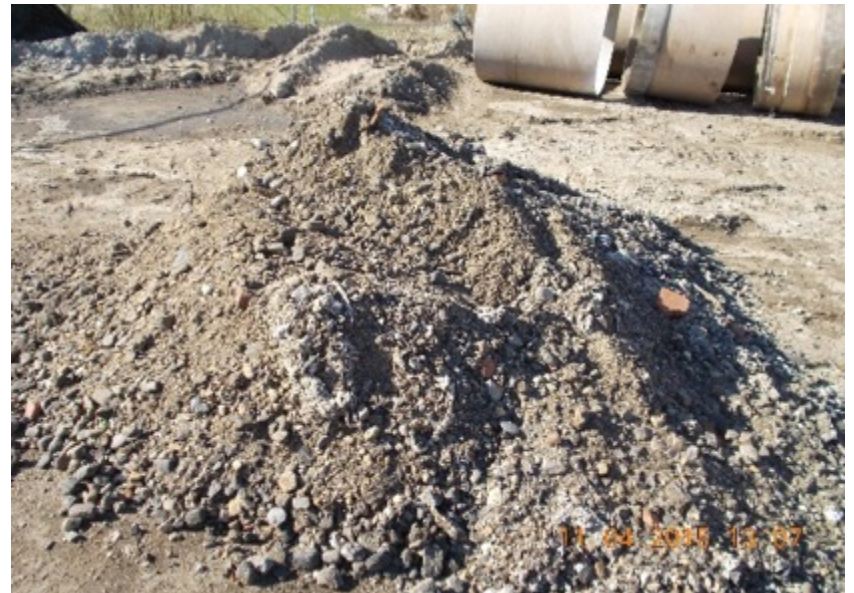
Debris Removed from Screen Chamber in Headworks
