Town of Madawaska, ME

CSO Success – Overcoming Funding & Design Challenges

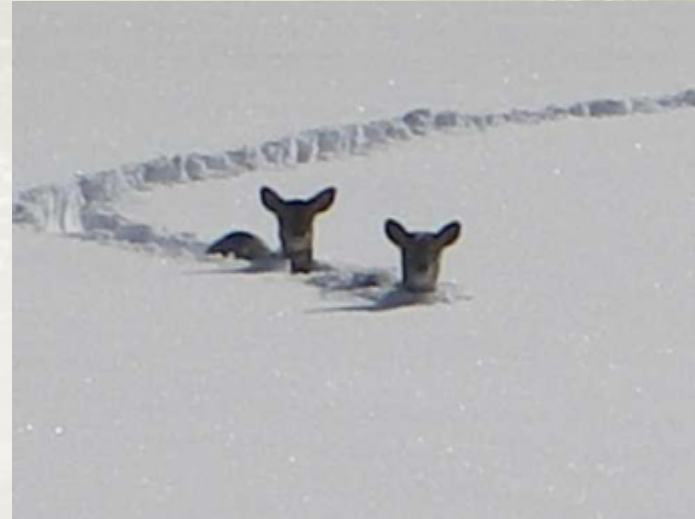
- #1: Spring Rains
- #2: High Volume of Snow Melt
 - Typical Average Snowfall
 - 112 Inches Per Year
- Increased I/I & CSOs
- Example: Monthly average flow for April 2009 was 1.55 MGD
- Typical Dry Weather Flow = 0.25 MGD
 - 6 Times More Flow For Single Month
 - Caused by Snow Melt & Spring Rainy Season

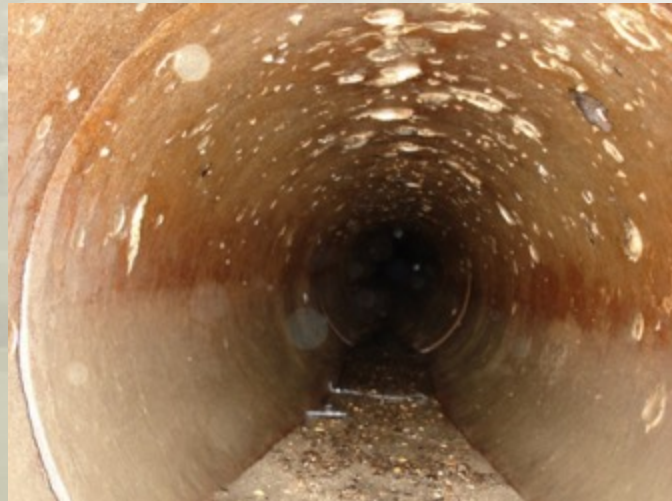
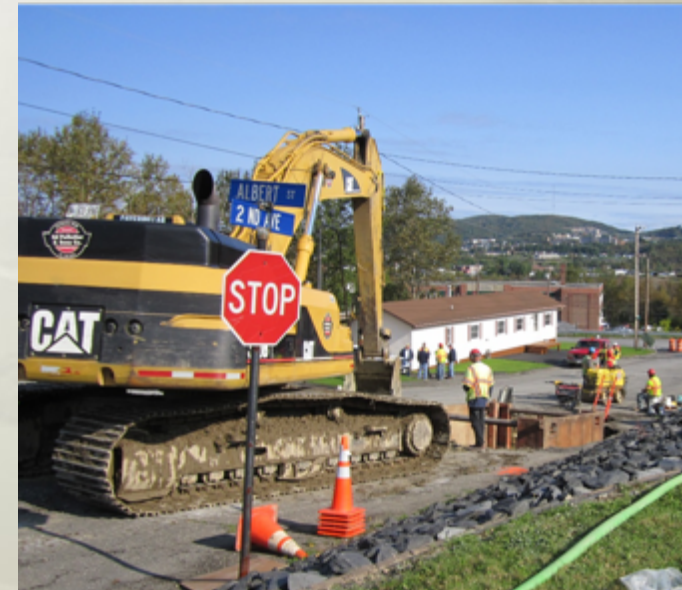
- Holistic approach for the Town – Not Just End of Pipe Solution
 - Targeted repair of high priority areas
 - TV inspections and smoke & dye testing allowed prioritization of areas.

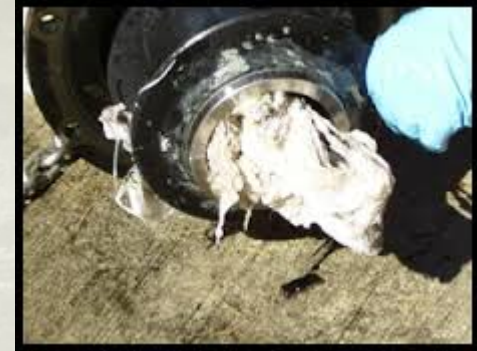
- Improvements to two pump stations (Fraser P.S. & Main P.S.)
- Three Main Areas of Focus
 - Pump Clogging, Communications, & Standby Power
- Fraser P.S.
 - Relocation due to Federal Government Border Crossing
 - Pump Clogging: 2 to 3 Times Per Week & Lead/Lag Configuration
 - No Dedicated Standby Power – Large Station 2/3 of Flow
 - Poor Communications – Lack of High Level Alarming or Faults Lead to CSOs
 - Interference with Canadian Signals
 - Fraser Upgrades – Most Challenging Aspects Of Entire Project

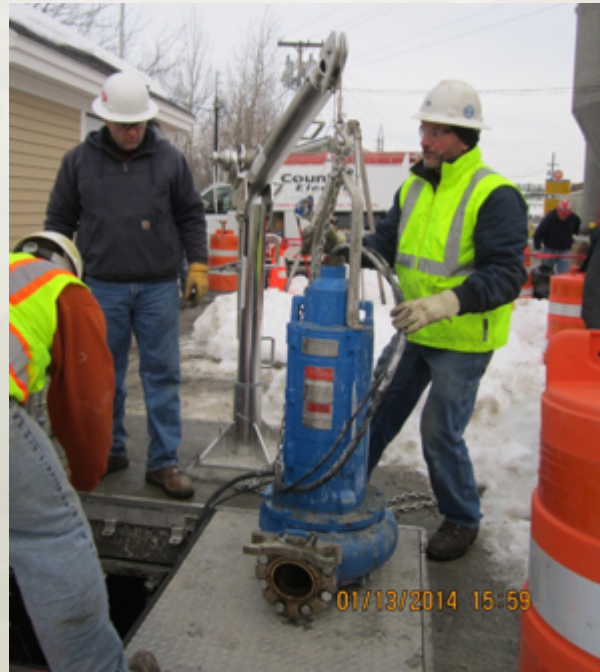
- New Pump Technology - In order to reduce mechanical failures, clogging, and repairs (Submersible Chopper)
- Prior to the recent upgrades the old station experienced weekly pump clogging, which led to many of the previous CSO events

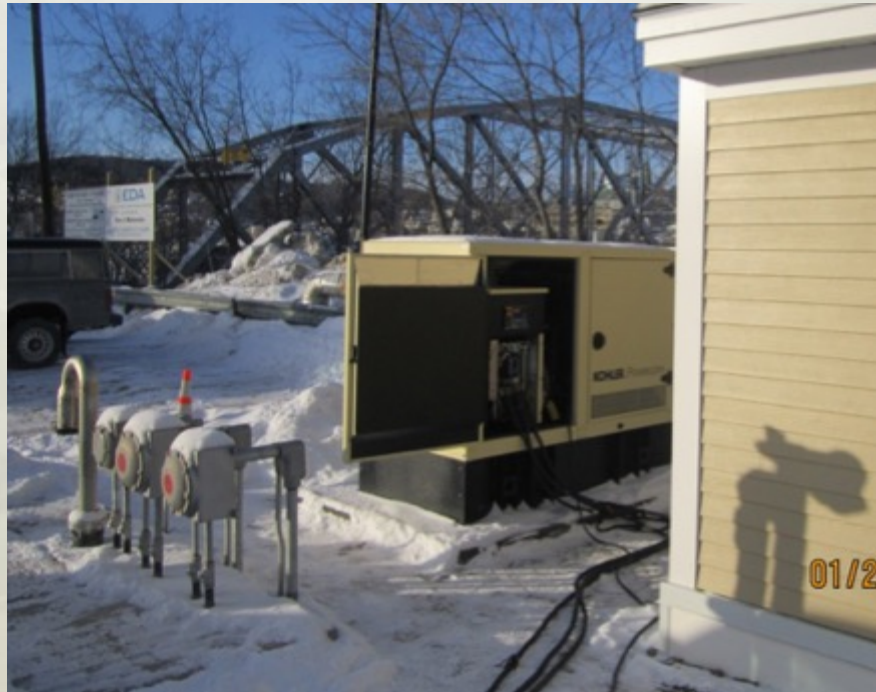
- Dedicated Standby Power - Including dedicated standby power
- Communications: A new dedicated licensed radio communications system to transmit alarms and status back to the staff
 - Radio path study US FCC & Canadian FCC 220 Mhz band for more reliable signal

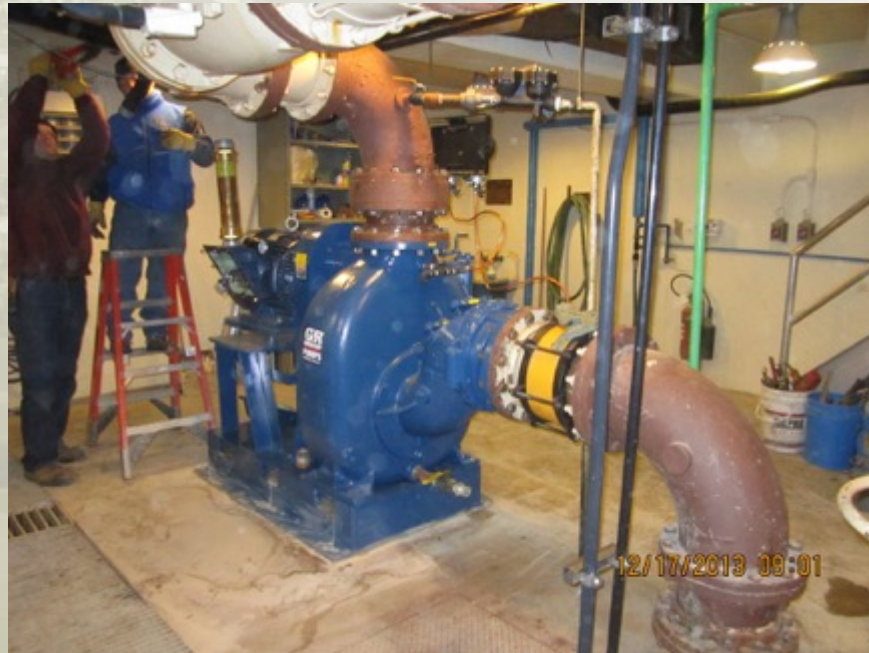
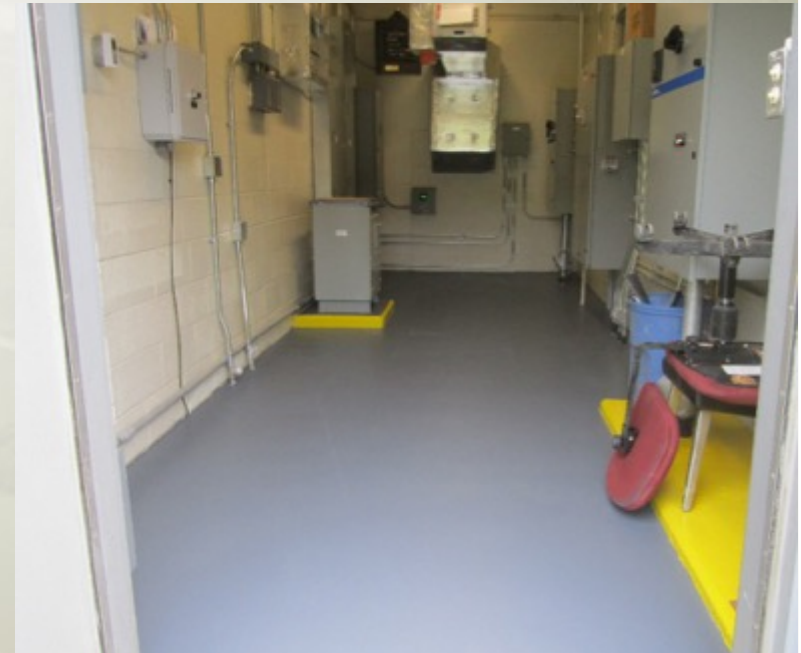
- New higher capacity pumps
- Electrical System Upgrades – Previous VFDs did not allow pumps to run full speed leading to CSOs
- New communications & control systems

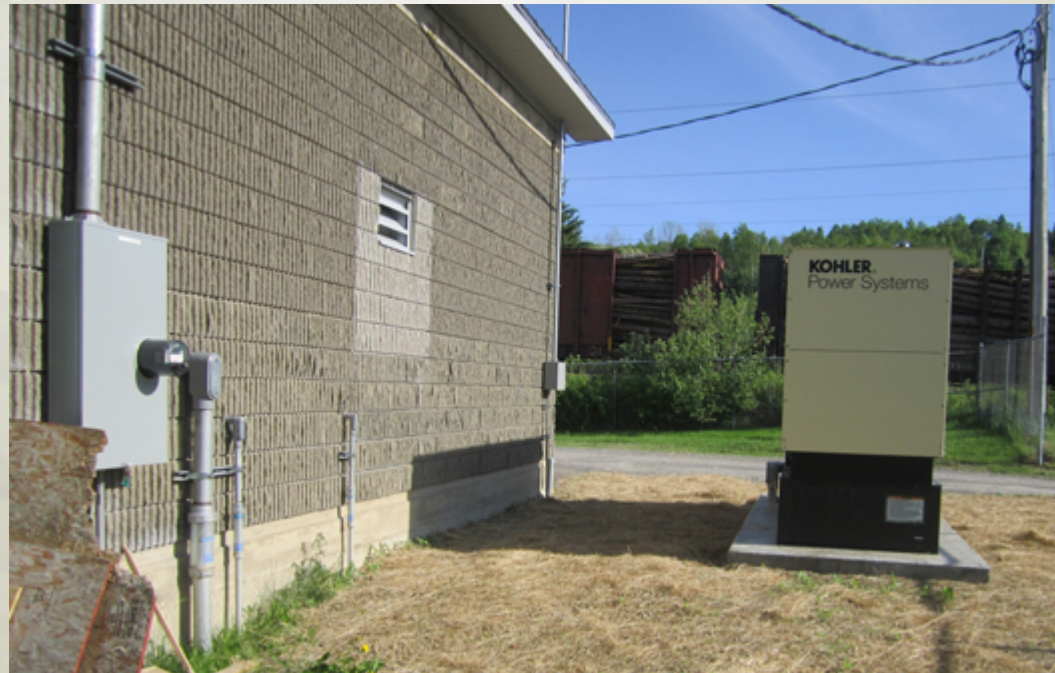
- Adjustment of CSO monitoring equipment to avoid false readings due to storm water
- New dedicated generator to accommodate station
- Switch to Lead/Standby pump configuration instead of Lead/Lag

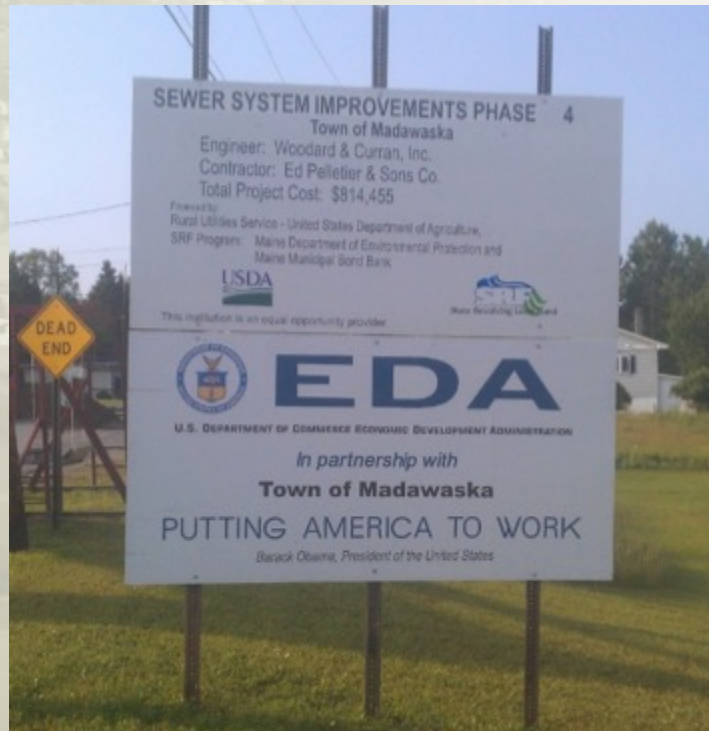
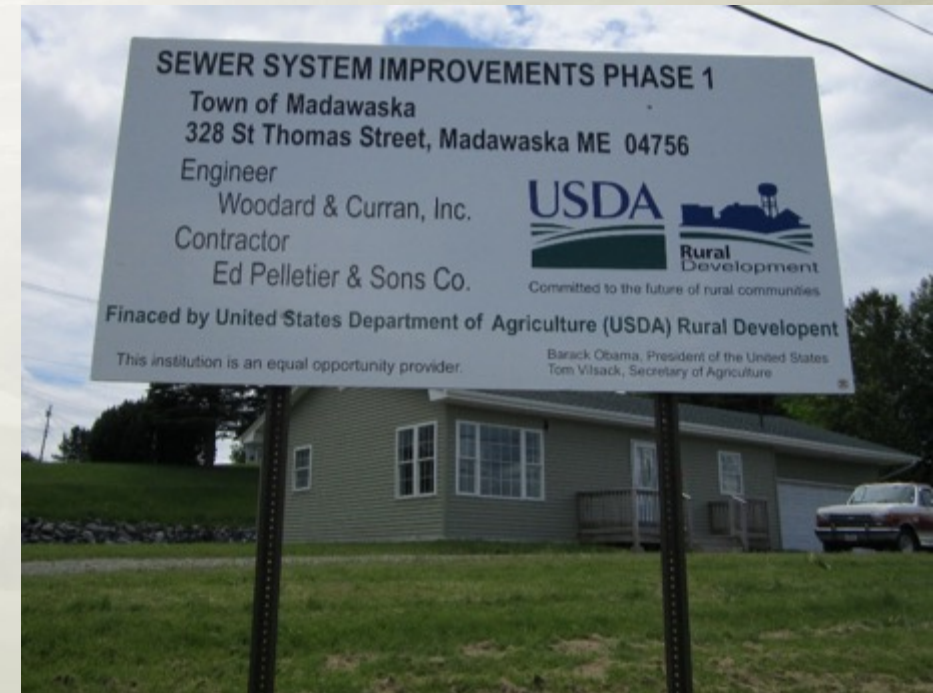
- Approximately 47,000 feet of sewer replacement to Date
 - Resulting in approximately 45% of the system upgraded since the Original CSO master plan was approved

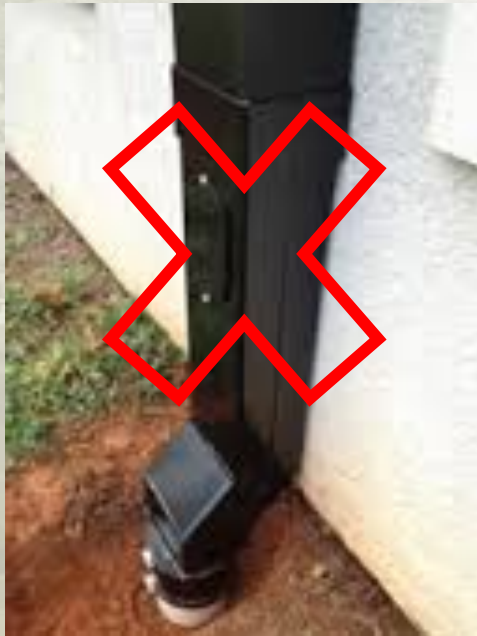
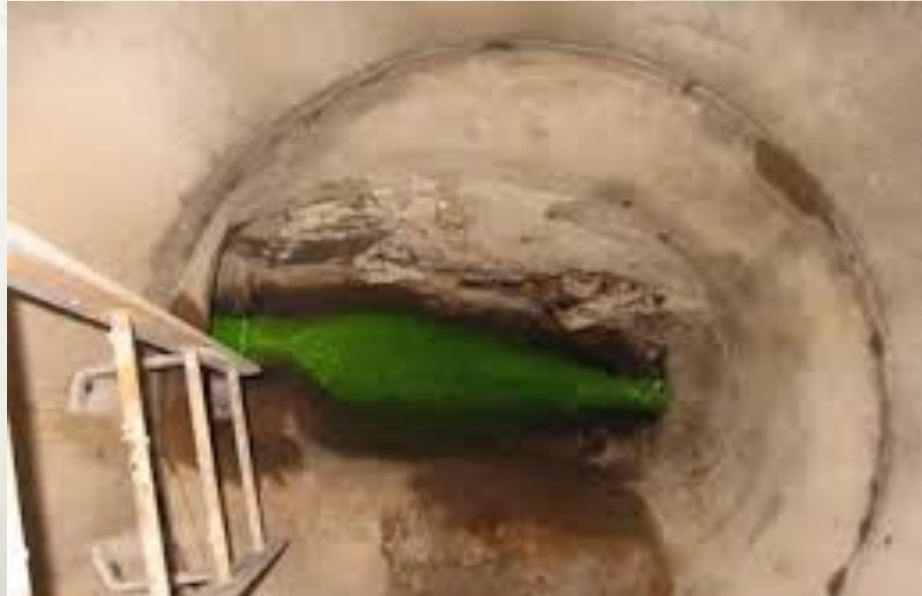
- Focus on roof drain connections for large flat roofs on public and commercial buildings
- Roof Dye Program
