# Collaborative Ingenuity and Careful Operations Brings a Unique Fixed Film Process to BNR

**Paul Dombrowski, PE, BCEE – Woodard & Curran**

**Roger Ignazio, Jr, Superintendent – Canton, CT WPCF**

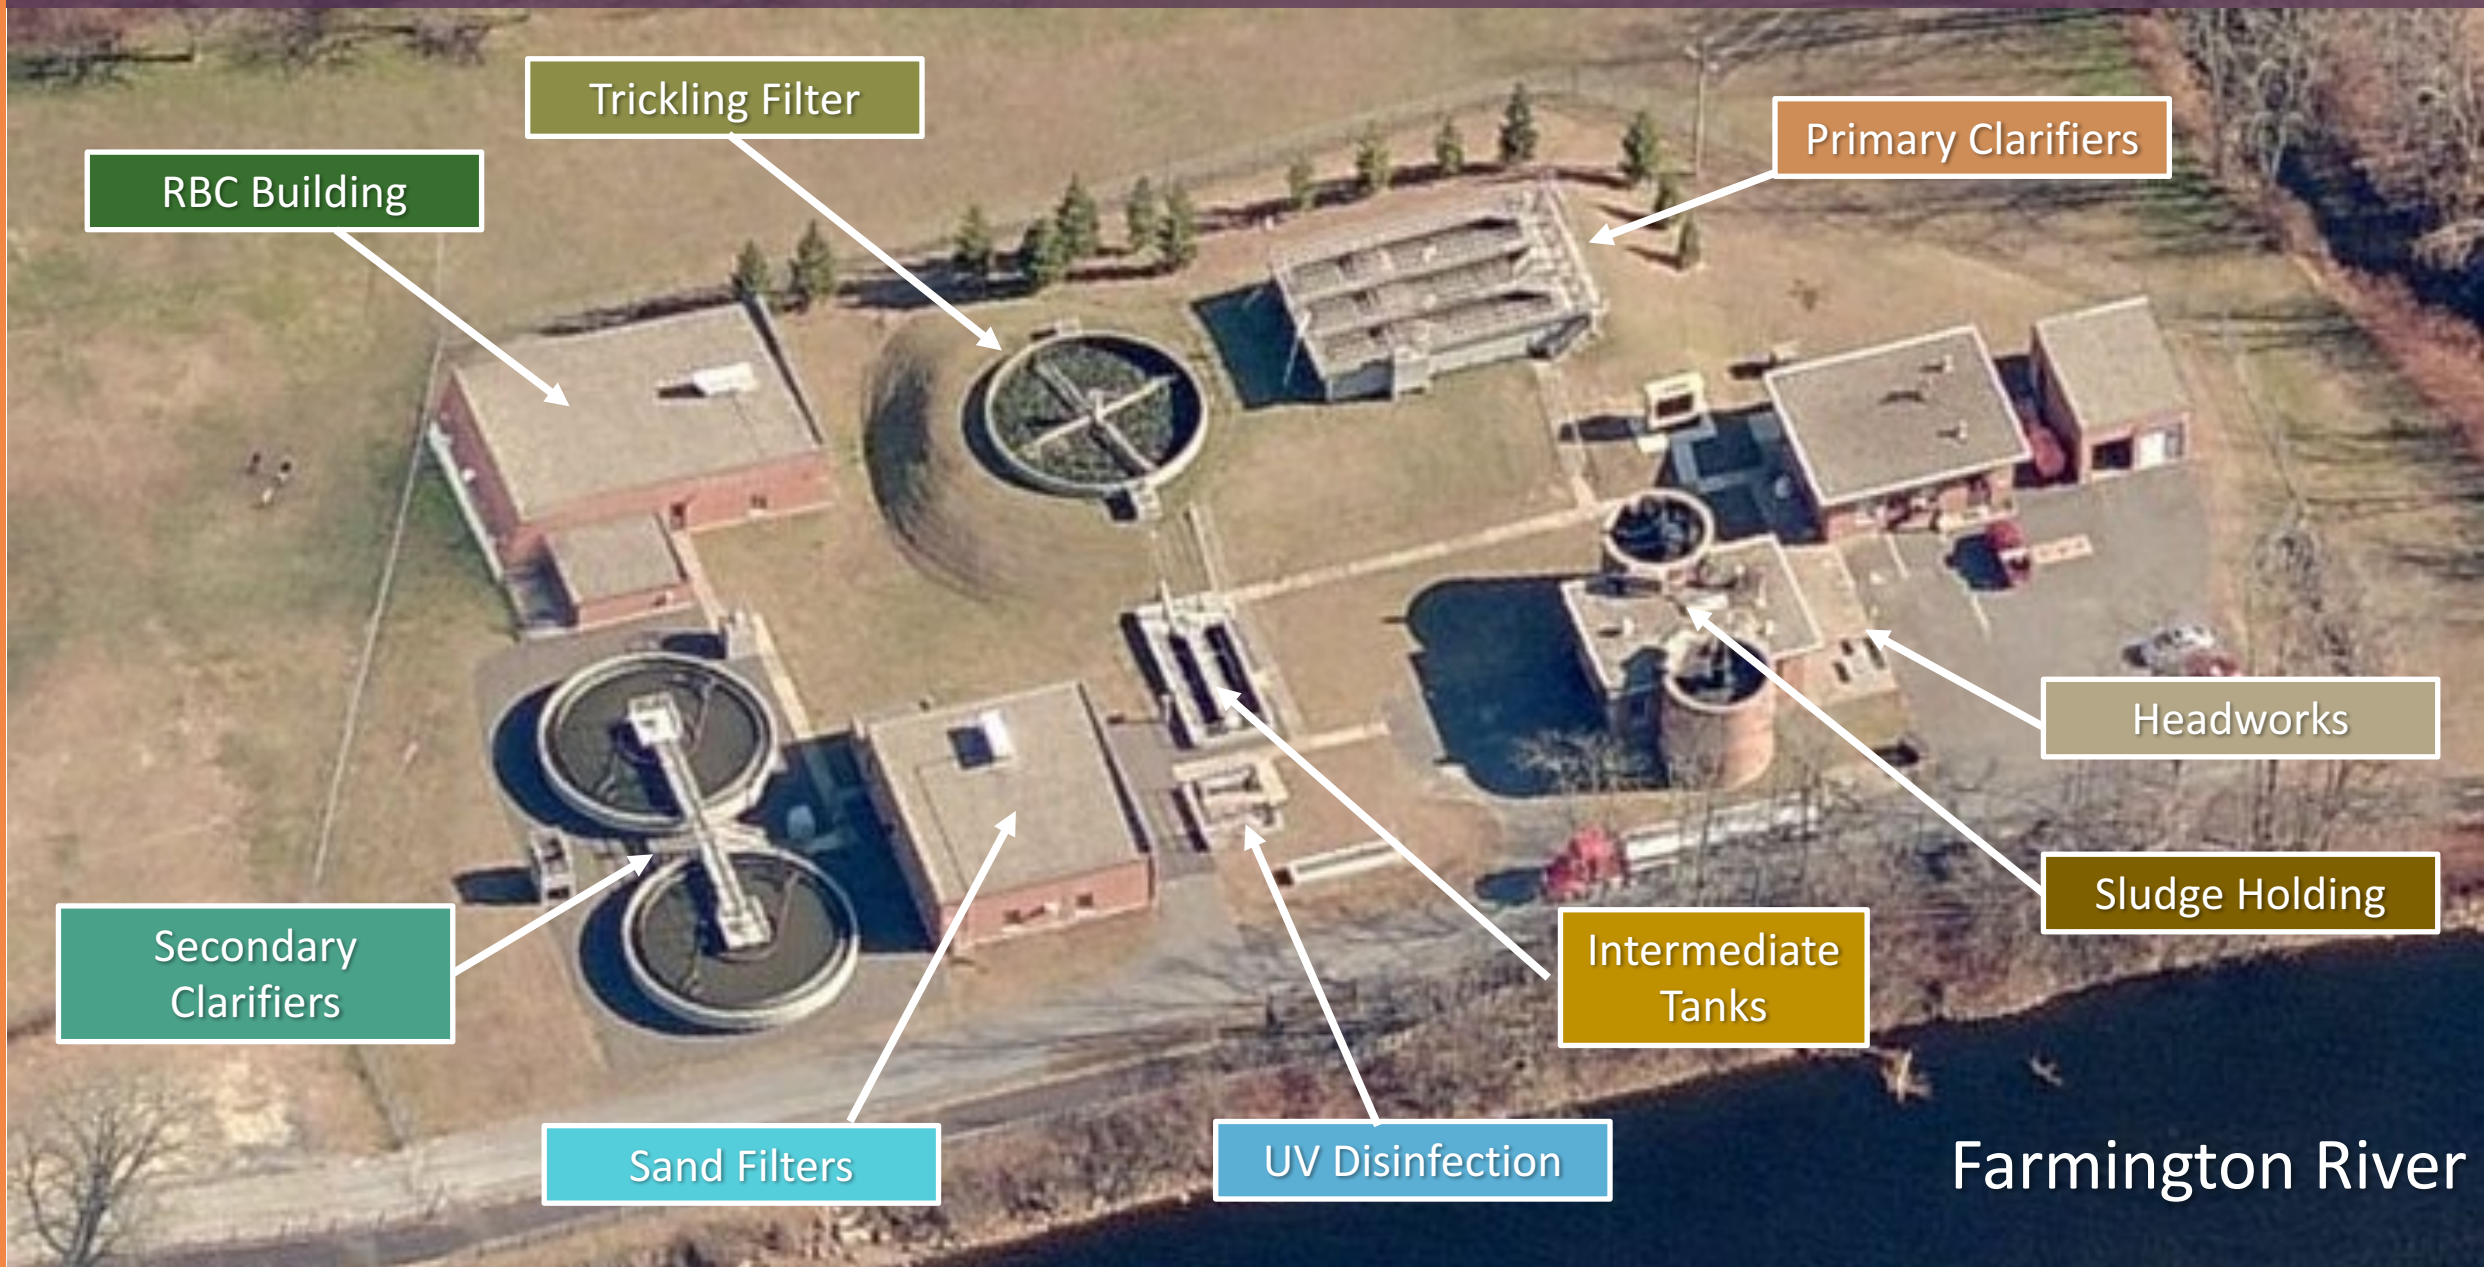
# Canton WPCF – Major Unit Processes

RBC Building

Trickling Filter

Primary Clarifiers

Secondary Clarifiers

Headworks

Sludge Holding

Sand Filters

UV Disinfection

Intermediate Tanks

Farmington River

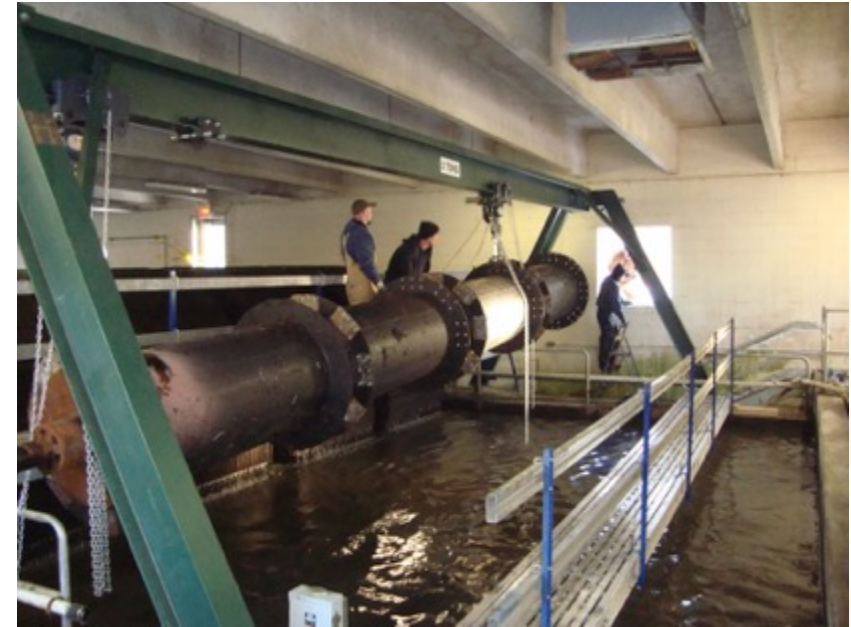
# WPCF Process Flow Diagram

- Equipment:
  - RBC #1 shaft breakage and
  - Trickling Filter (TF) bearing failure within a couple month period
- WPCF limitations
  - Not designed to nitrify or remove TN
  - Undersized anaerobic digester volume
  - Pumping of RBC effluent (prior to sec. clarifiers)

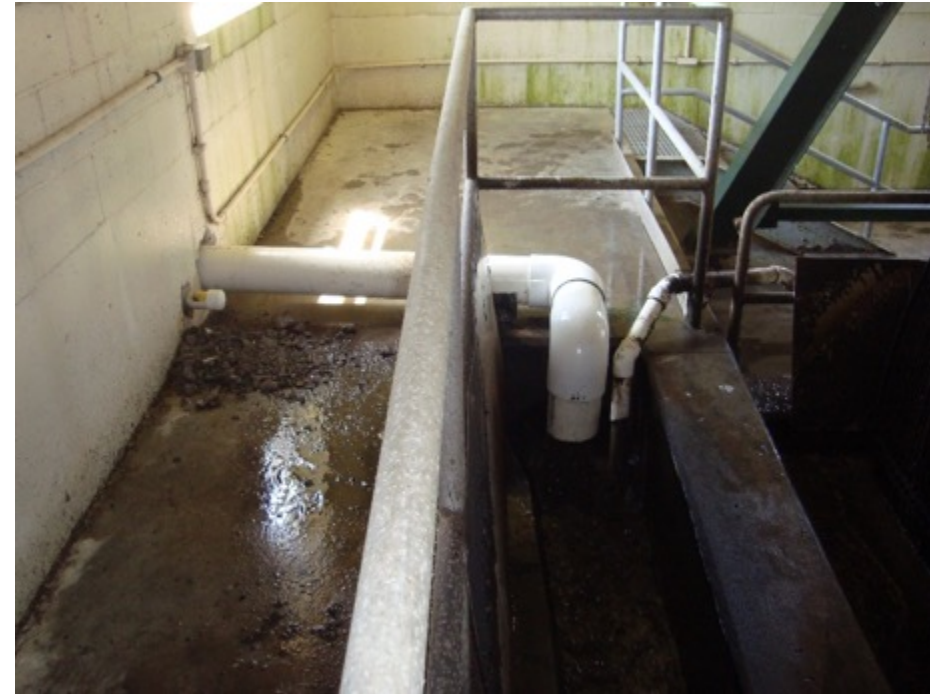
# RBC #3 with empty RBC Bay #4 with aeration

- Added solids recycle (RAS) to RBC's converting it to a hybrid system
- Adding aeration to RBC tanks
- Converted digester to sludge holding tank
- Adding WAS pump
- Convert one old TF (intermediate) clarifier to anoxic tank
- Adding multiple recycle systems
