From Wine to Vine Water Reuse at Ridge Vineyards

Session 32 – Water Reuse: Growing Sustainable and Resilient Businesses and Communities with Water Reuse

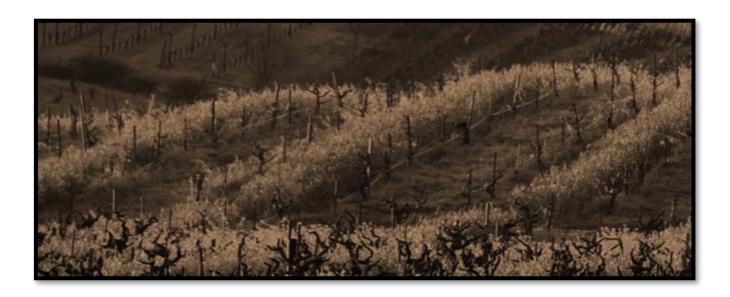
- **▼** Location Site Isolated on Ridge
- No existing building space available for treatment system
- Significantly varying flows and loads

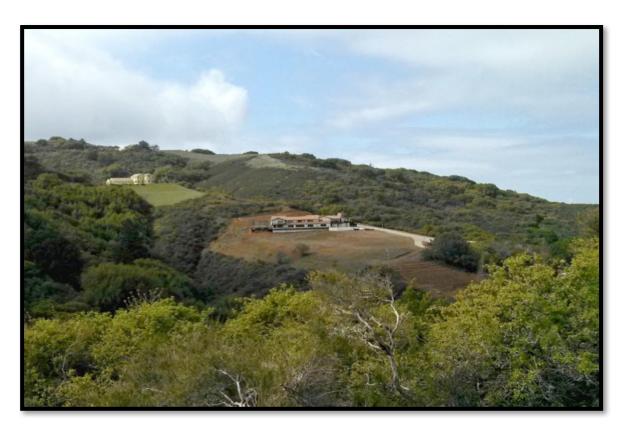
System Design Criteria

Wine Production = 40,000 - 70,000 +cases/year

Wastewater Flow = 0 (no flow) - 7,200 GPD

COD Range = 0 (no flow) - 13,000 mg/L

BOD5 Range = 0 (no flow) - 8,000 mg/L

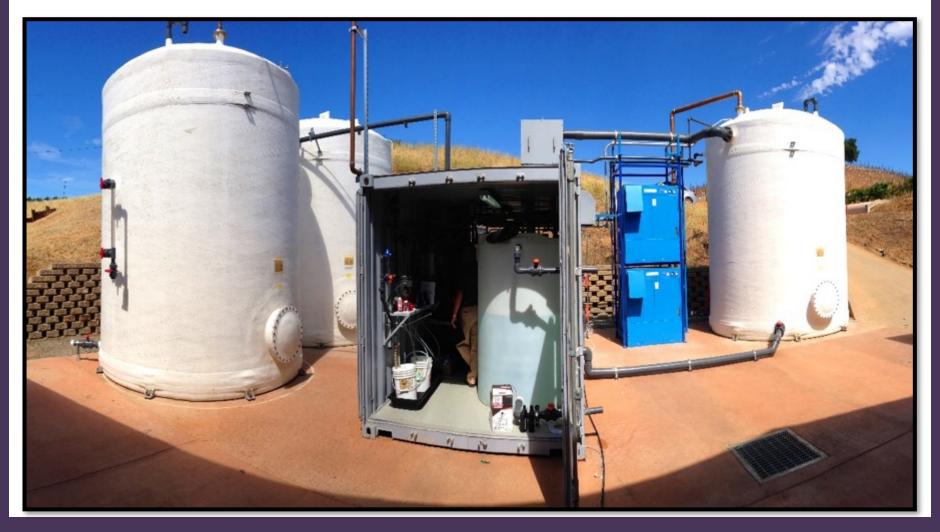
Solution - bioPULSE™ MBR

- * Energy efficient MBR process using Airlift assisted external tubular membranes
- Containerized equipment skid conforms to site constraints
- Use of existing tankage and process equipment

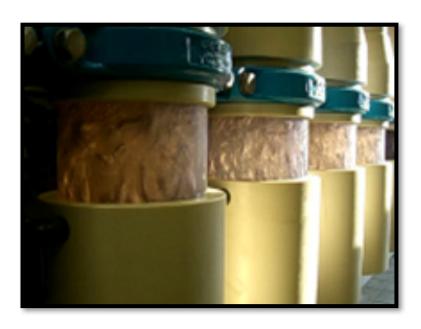
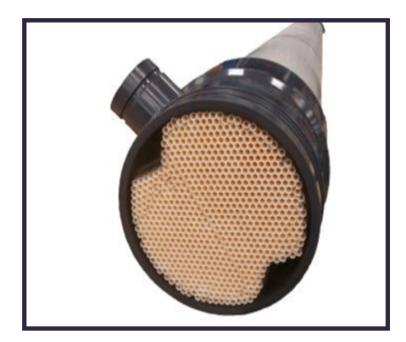
bioPULSE™ Membranes

- Airlift provides for low energy consumption and high flux rates
- Back-pulsed to enhance and sustain flux
- Inside-out filtration (0.03 um pore size)
- Effective drain and flush sequence for removal of fibrous material
- CA Title 22 certified

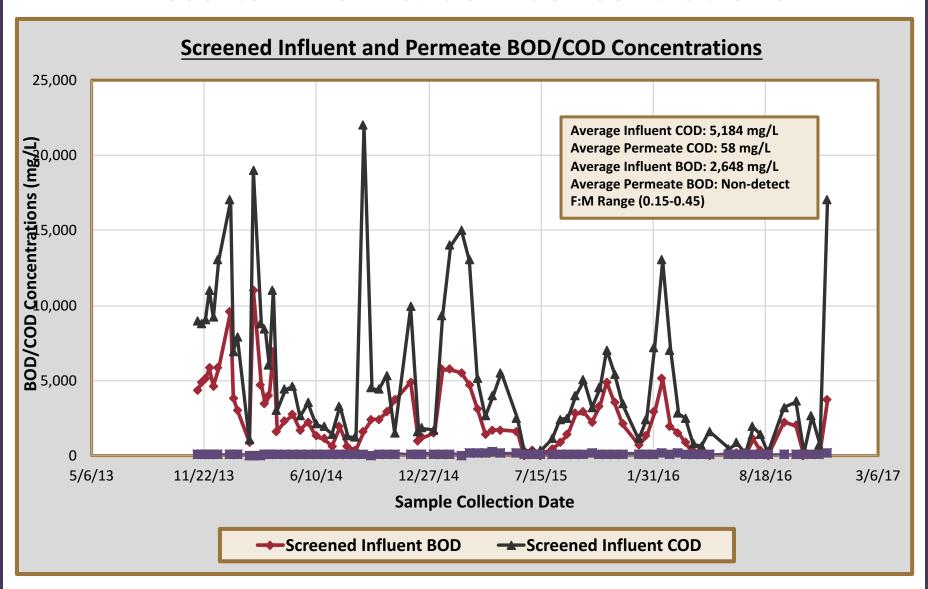
Results – BOD & COD Concentrations

- * bioPULSE MBR System provides a long term reliable and sustainable water treatment and reuse for the Ridge Vineyards.
- System consistently removes >99% BOD5 and COD through extended periods of no flow and peak loading conditions.
- Reuse of system permeate has been critical for vine irrigation during the recent drought conditions, and has resulted in in healthy vines and excellent grape quality.
- * Efficient and well running treatment system has simplified overall winery operations for management.
