ROCKLAND COUNTY INTERCEPTOR SEWER REHABILITATION

MIC AND SEVERE DETERIORATION

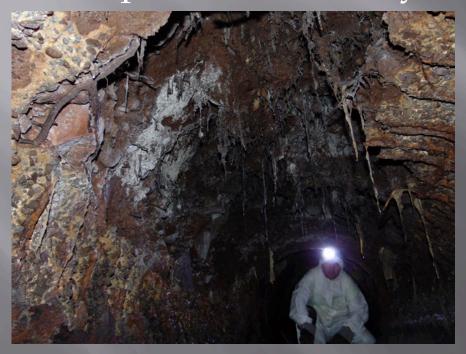
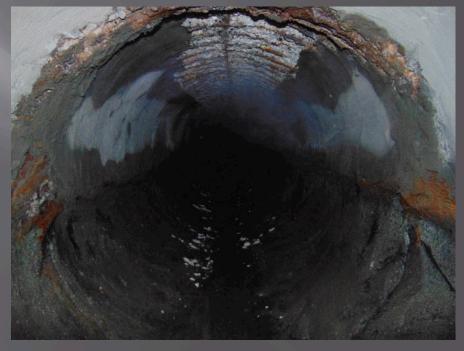
- Routine 5-year CCTV inspection revealed severe deterioration of 36" RCP interceptor
- Exposed soil held by root masses

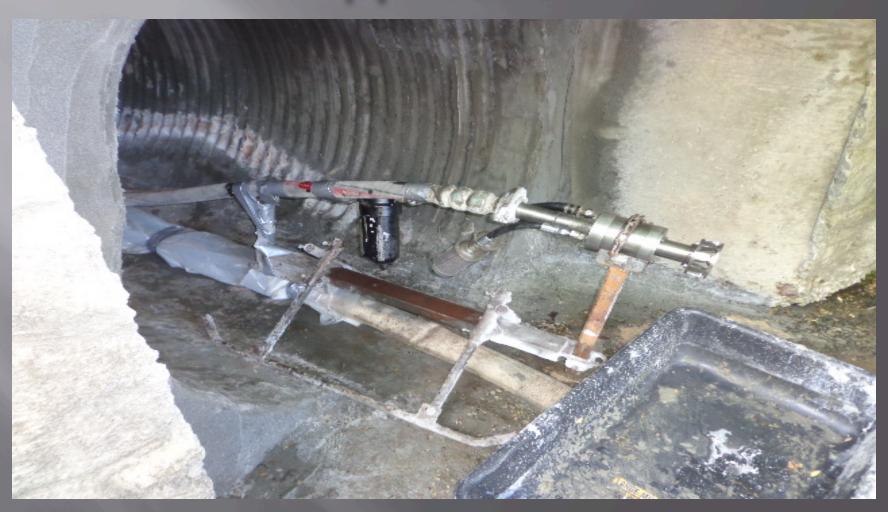
Equipment for Spin Cast Application

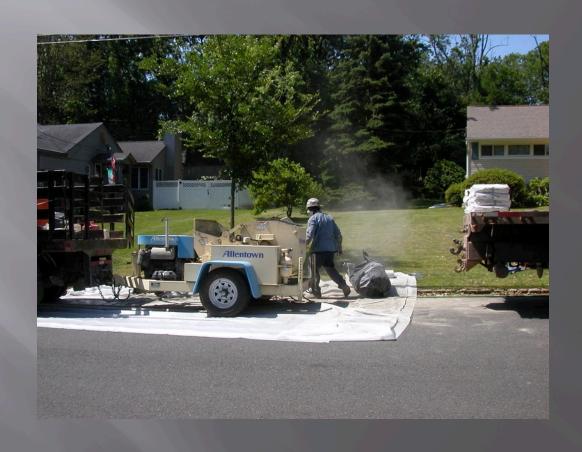
Equipment Parked On Shoulder

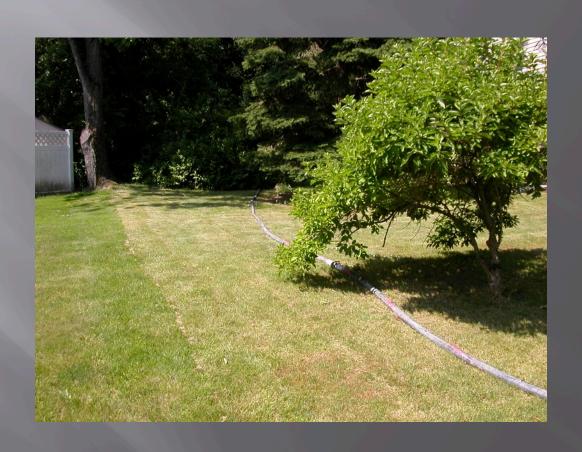
Hose Laid Across Lawn

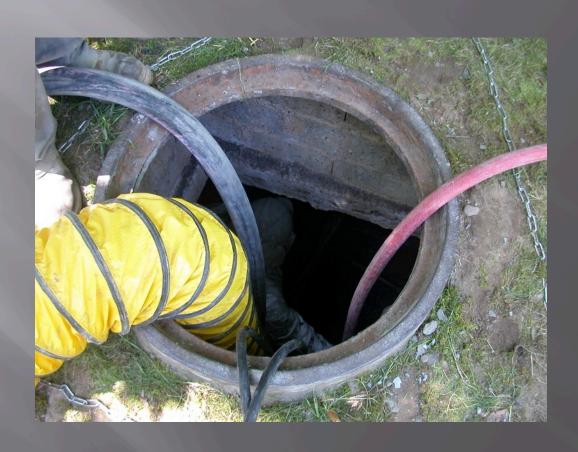
Lining Equipment Inserted Through Manhole

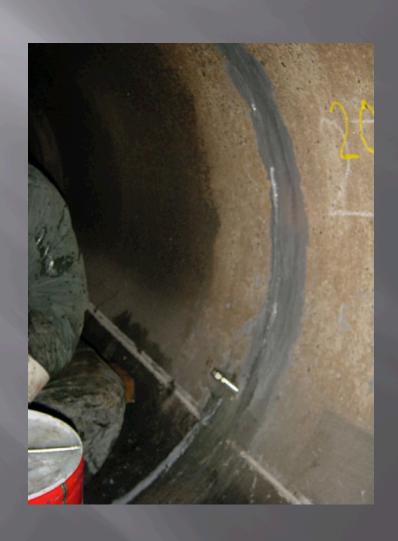
Injection Port

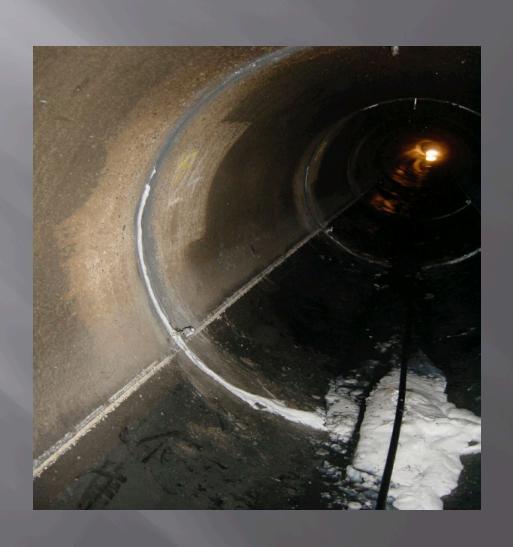
Infiltration Stopped

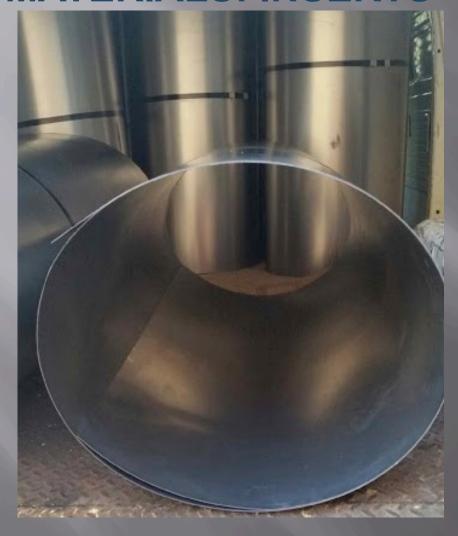
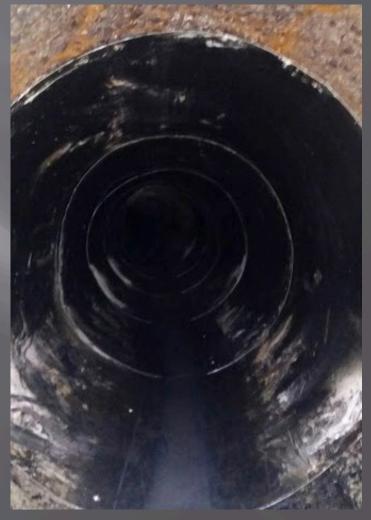
MATERIALS: INSERTS

- Custom-fabricated sheet steel inserts
- Calculated lining thickness
 - Third party engineer provided recommended design
 - Level of loading
 - In-place performance of surrounding soils
 - Existing pipe's current condition
 - Maintain tensile bending stress at the crown and invert less than the flexural stress strength (modulus of rupture), and incorporating a factor of safety of 2.0
 - Calculated design thickness: 1.0"
 - RECOMMENDED design thickness: 1.5" to include additional factor of safety during the void grouting process
 - Rehabilitated pipe designed to accept:
 - Surface live loading
 - External hydrostatic pressure from groundwater
 - Temporary loading exerted by placement of grout fill
- Design plan specified filling cavernous voids with grout replacement following pipe re-lining

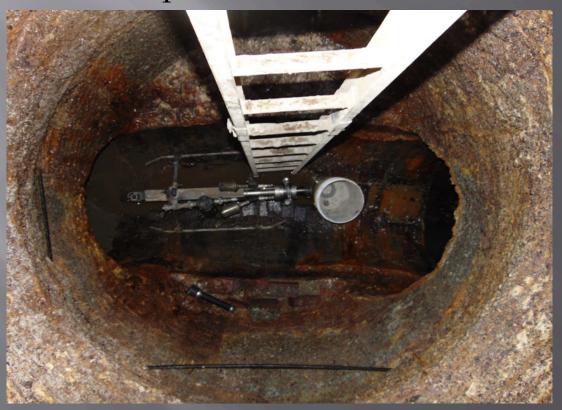
- Inserts installed
- Dewatered via temporary diversion to parallel sewer
- Inserted CCCP spincaster via manhole

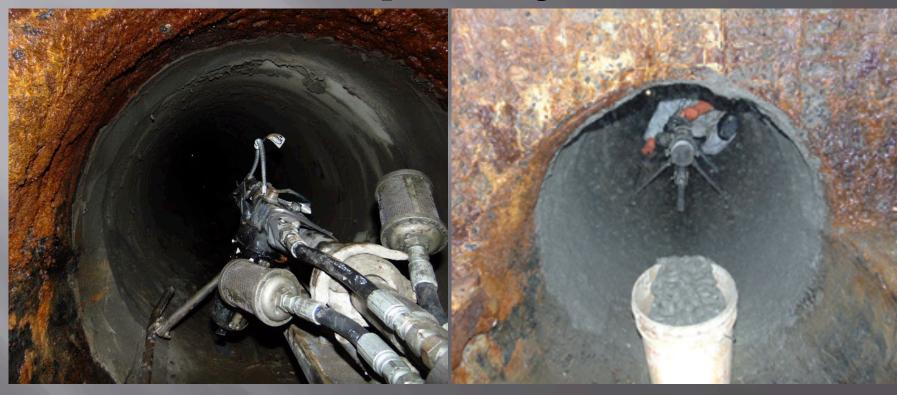
Spincasting
