Warwick Sewer Authority

Flood Response, Recovery & Mitigation

**Presentation to the New England Water
Environment Association
September 26, 2017**

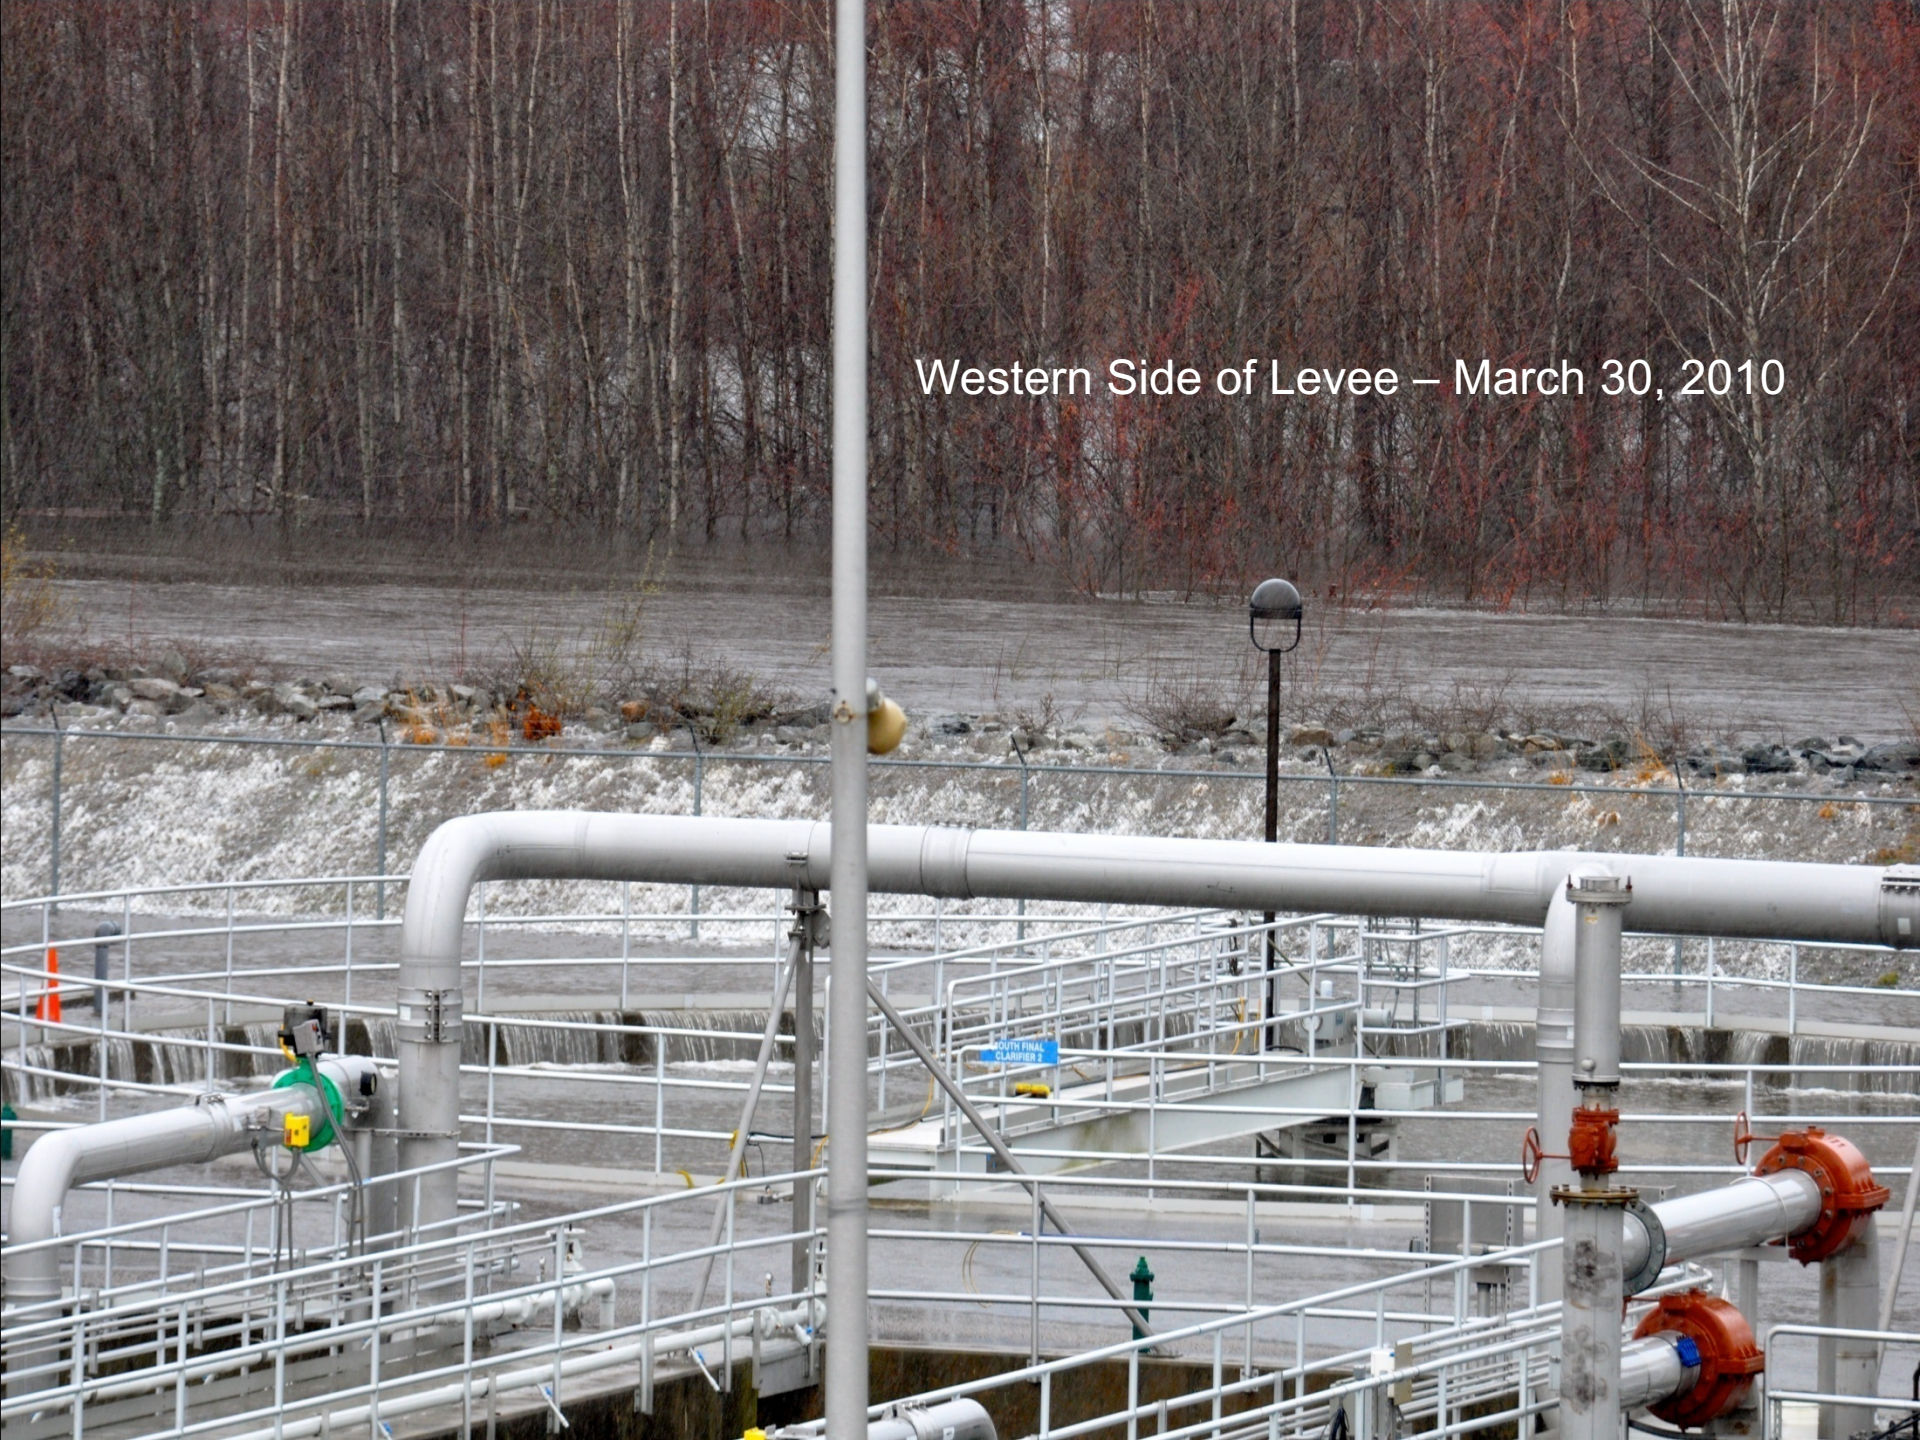
Western Side of Levee – March 30, 2010

An aerial photograph showing a multi-lane highway, Route 95 N, running diagonally from the bottom left towards the top right. The highway is partially submerged in floodwater, which is a murky brown color. To the left of the highway, there is a flooded area with bare trees and a small structure. To the right, there is a large, flooded wooded area. In the background, there is a commercial area with various buildings, parking lots, and a large, empty lot. A light blue arrow points from the text 'Wastewater Treatment Facility' to a specific location in the background. Another black arrow points from the text 'Route 95 N' to the highway.
