Starting from the Bottom

Capisic Pond Enhancement & The Importance of Collaboration & Public Input in Restoration

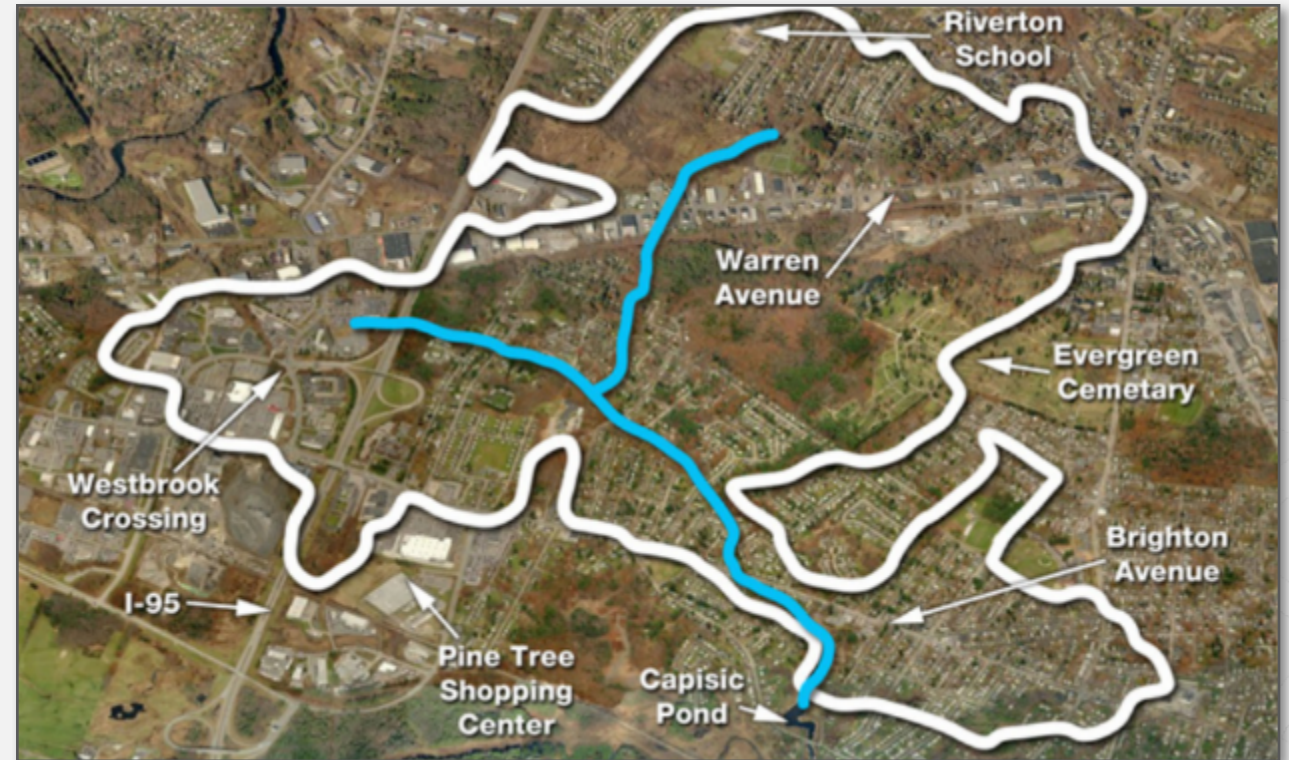
Capisic Brook

- 2.5 miles
- 1,500 acres
- 31% impervious
- Ch 502 Urban Impaired Stream
- Combined Sewer Overflows

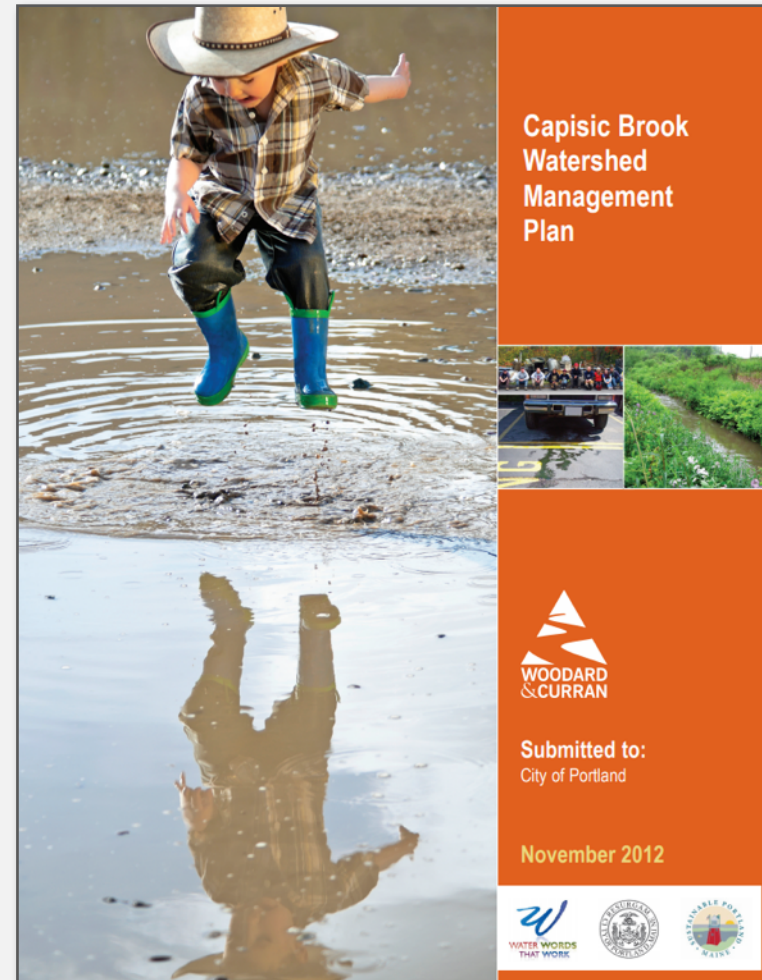
Capisic Brook

- 2.5 miles
- 1,500 acres
- 31% impervious
- Ch 502 Urban Impaired Stream
- Combined Sewer Overflows
- Watershed Management Plan

- Existing Conditions
- Existing Regulatory Restrictions
- Recommended Improvements
- Restoration Monitoring

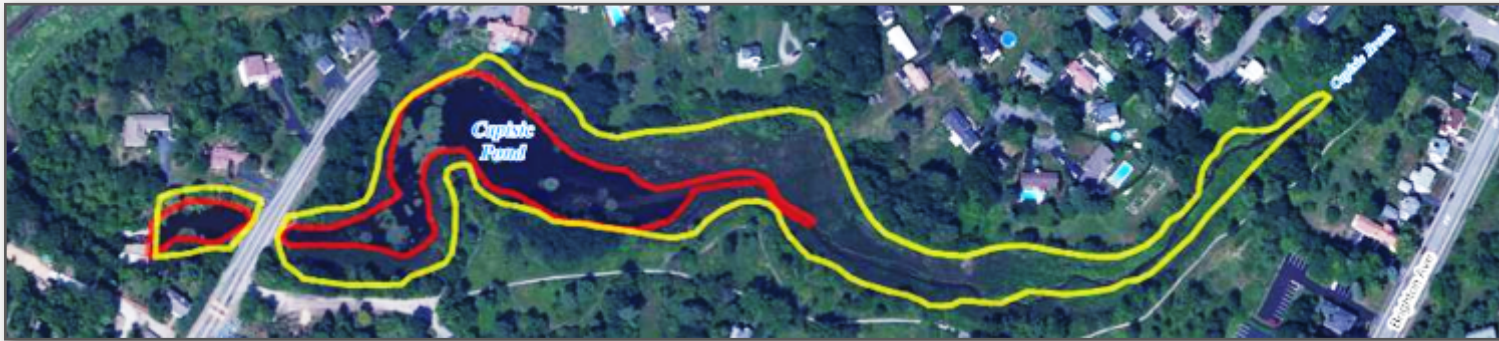
- 1950s – 8 acres open water
- 2010s – 2 acres open water

- Significant Wildlife Habitat (IWWH) rating jeopardized by reduction of open water and lack of diversity
- Upstream sediment & changes in dam weir elevations reduced water depth – monoculture of cattails

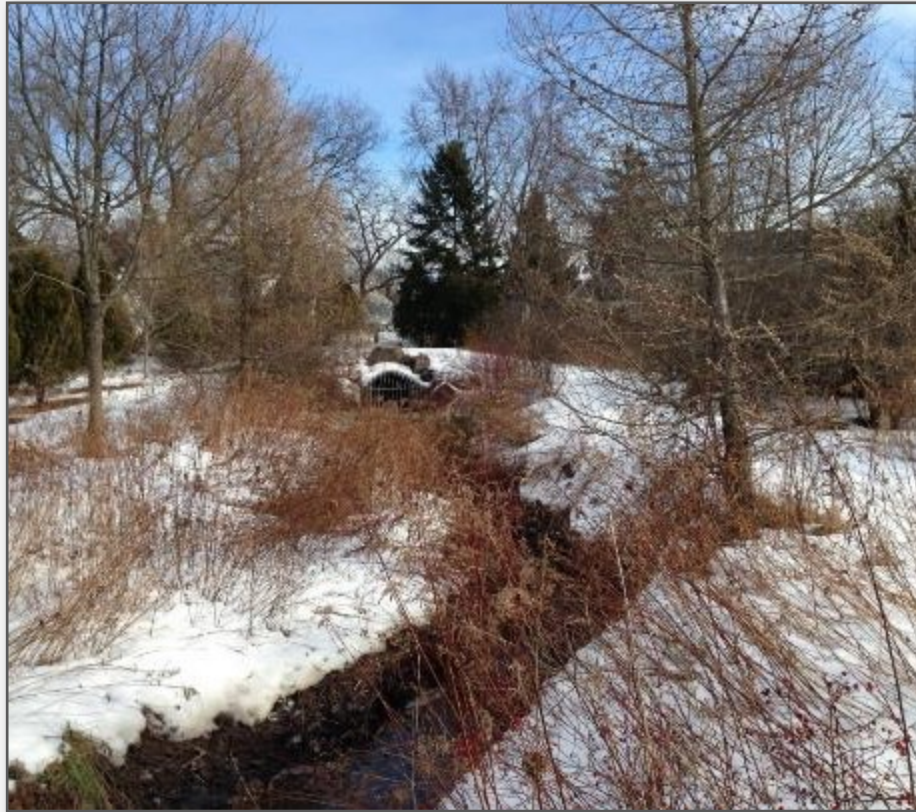
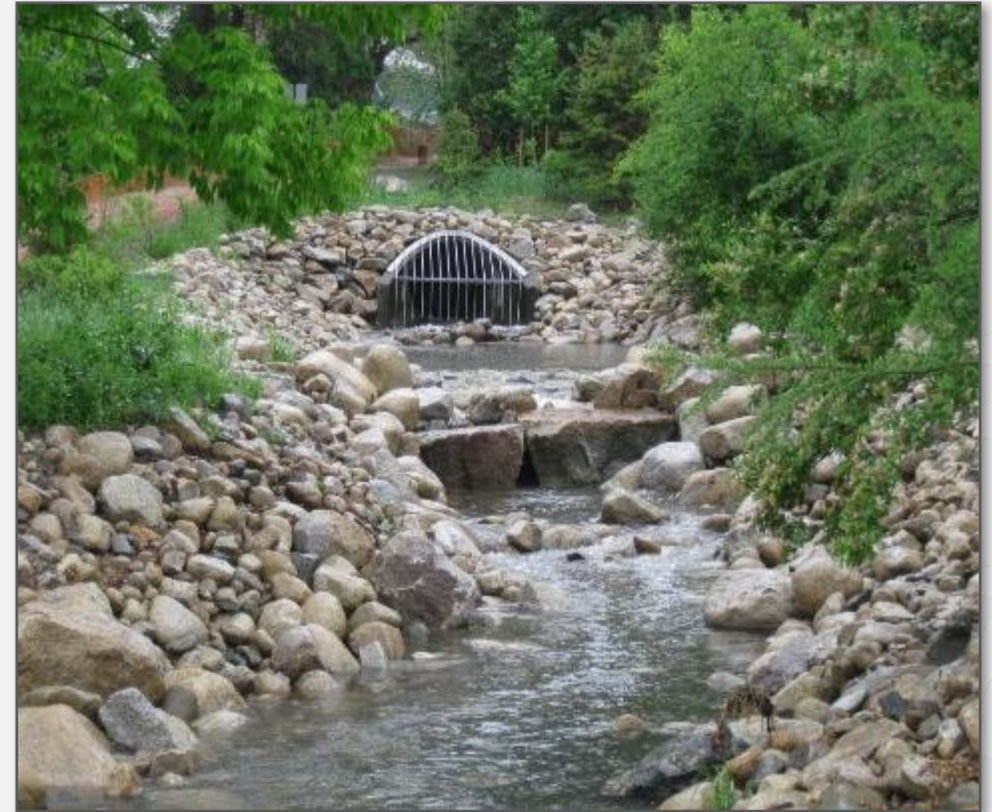
Rockland Avenue Outfall Construction 2014

Outfall Reconstruction &
Permanent Erosion Control

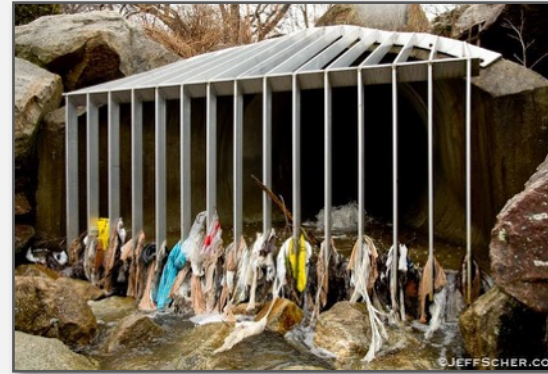
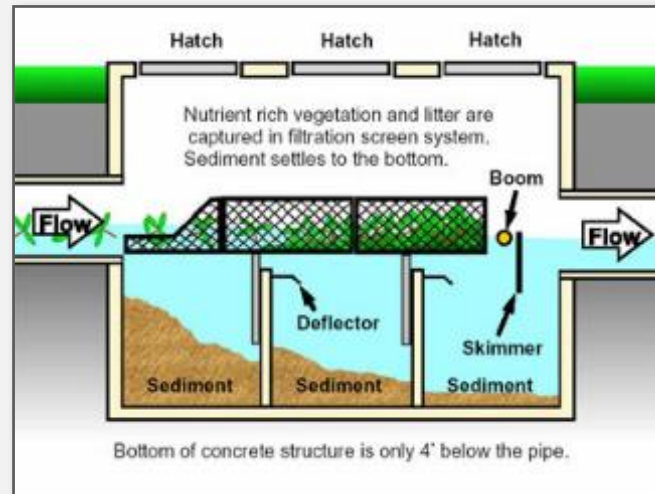
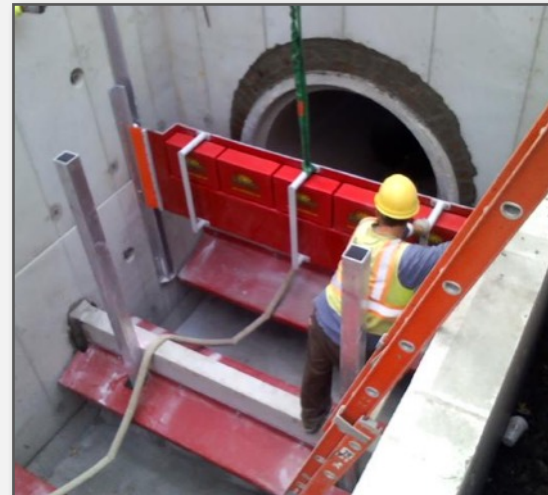
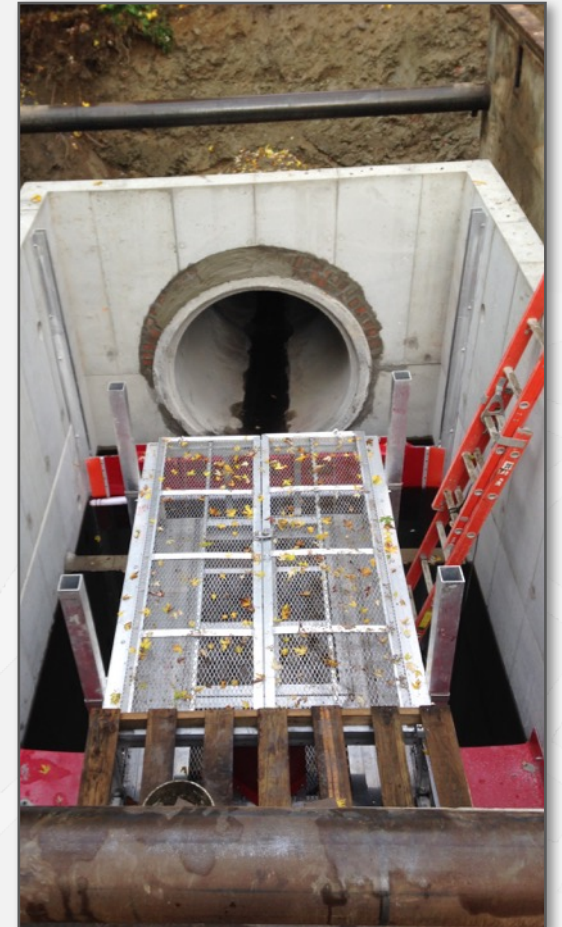
Rockland Avenue Outfall Construction 2014

- Trash Collection with Nutrient Separating Baffle Box (NSBB) by Suntree Technologies
