Post-Storm Infrastructure Improvements and Stream Restoration: Three Case Studies

NEWEA Stormwater Conference May 7, 2018

Today's Session: Three Case Study Examples

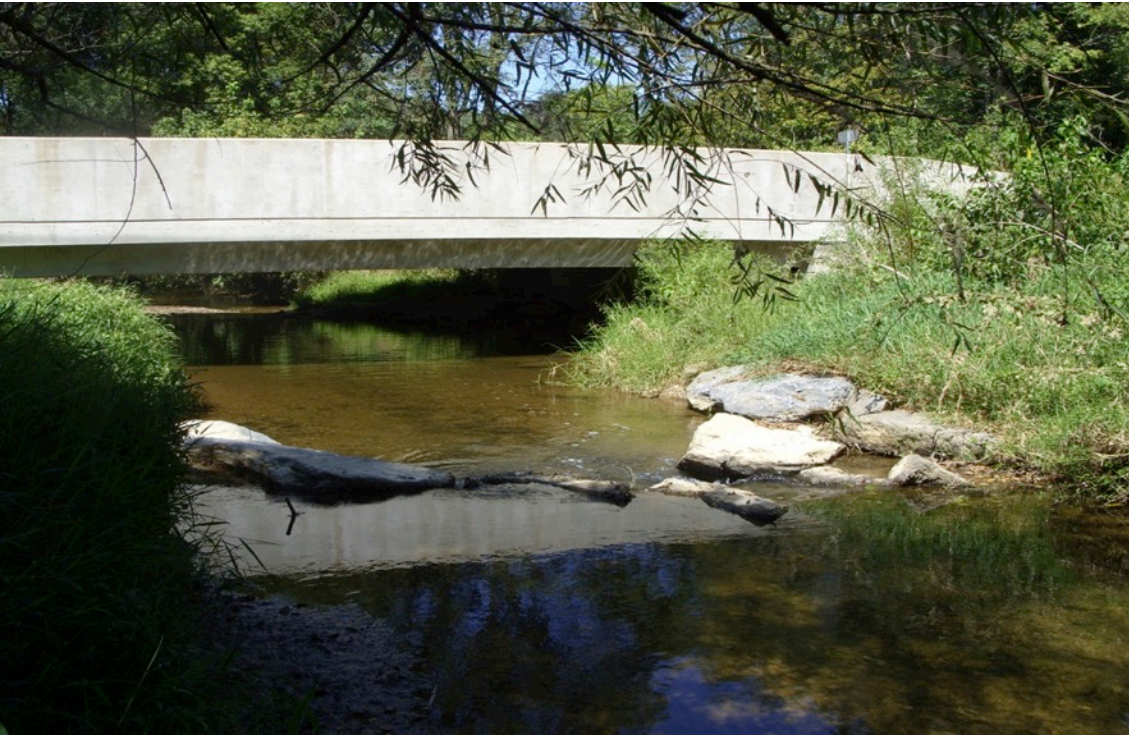
Geomorphic Assessment- Vulnerability/Risk

- Natural channel design stream restoration as a means of improving water quality and resiliency during bridge replacement and highway reconstruction

Scour undermines bridges and may cause bridge failures due to structural instability. **In the last 30 years, more than 1,000 bridges collapsed in the US and about 60% of the failures were related to the scour of bridge foundations.**

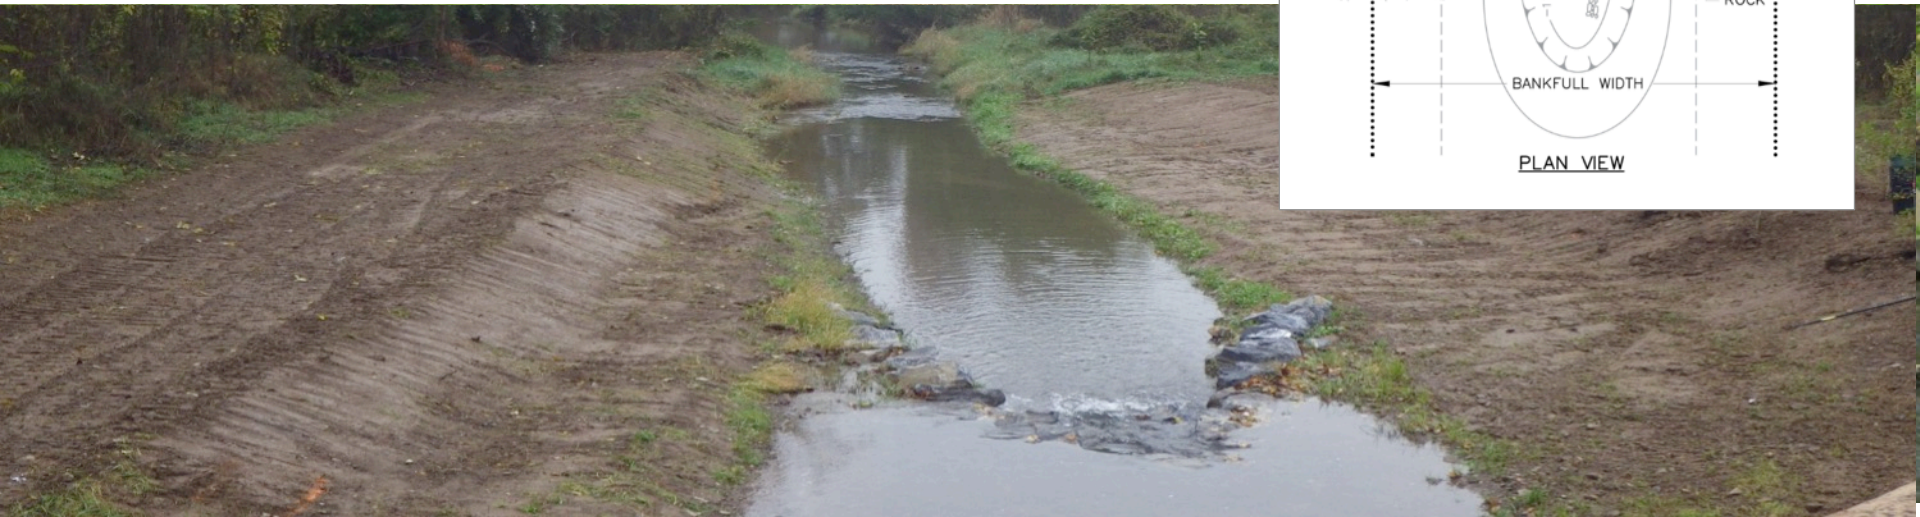
Natural Stream Channel Design for Scour & Flood Hazard Mitigation

- Floodplain Reconnection
- Streambank stabilization
- Channel stability- lowered shear stress
- Bankfull bench flood prone area
- Improved Floodplain Resiliency
- Increased Capacity for Extreme Events

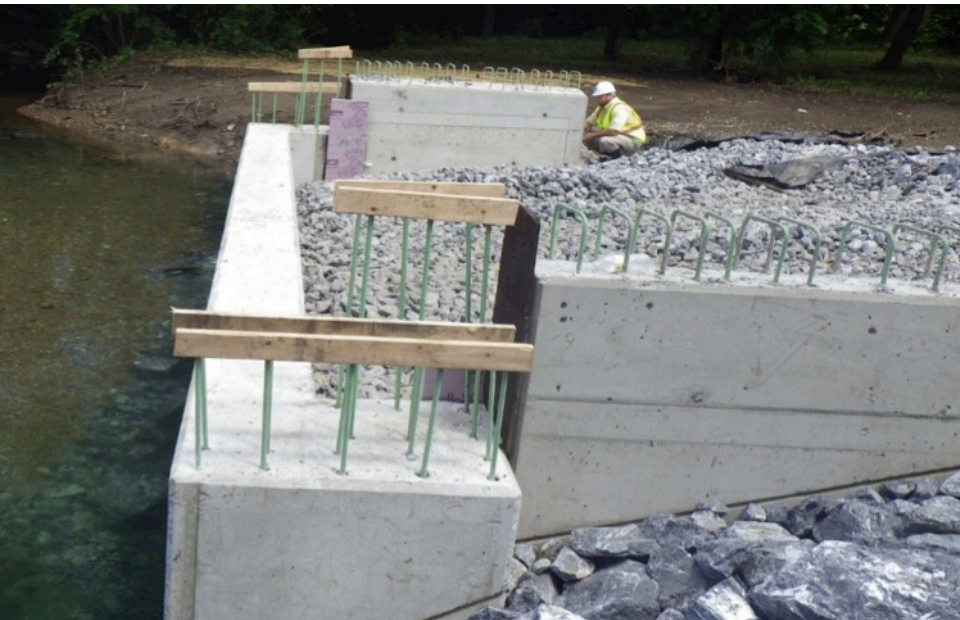
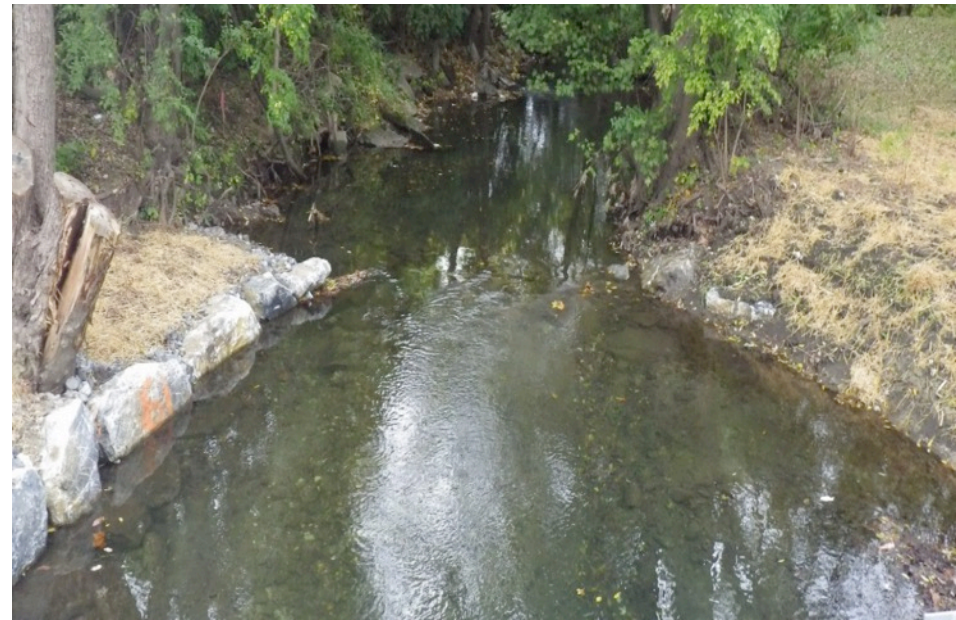
Pollutant Reduction through Natural Stream Channel Design Restoration (TMDLs)

- Stream restoration documented for future pollutant load reduction credit: **248 #/LF/YR Sediment Reduction**
- Floodplain reconstruction documented for sediment/nutrient pollutant load reduction credit

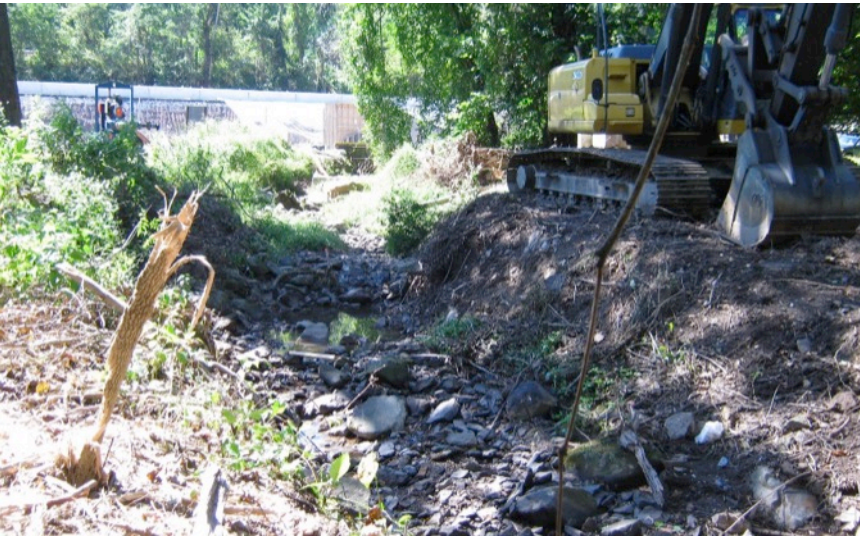
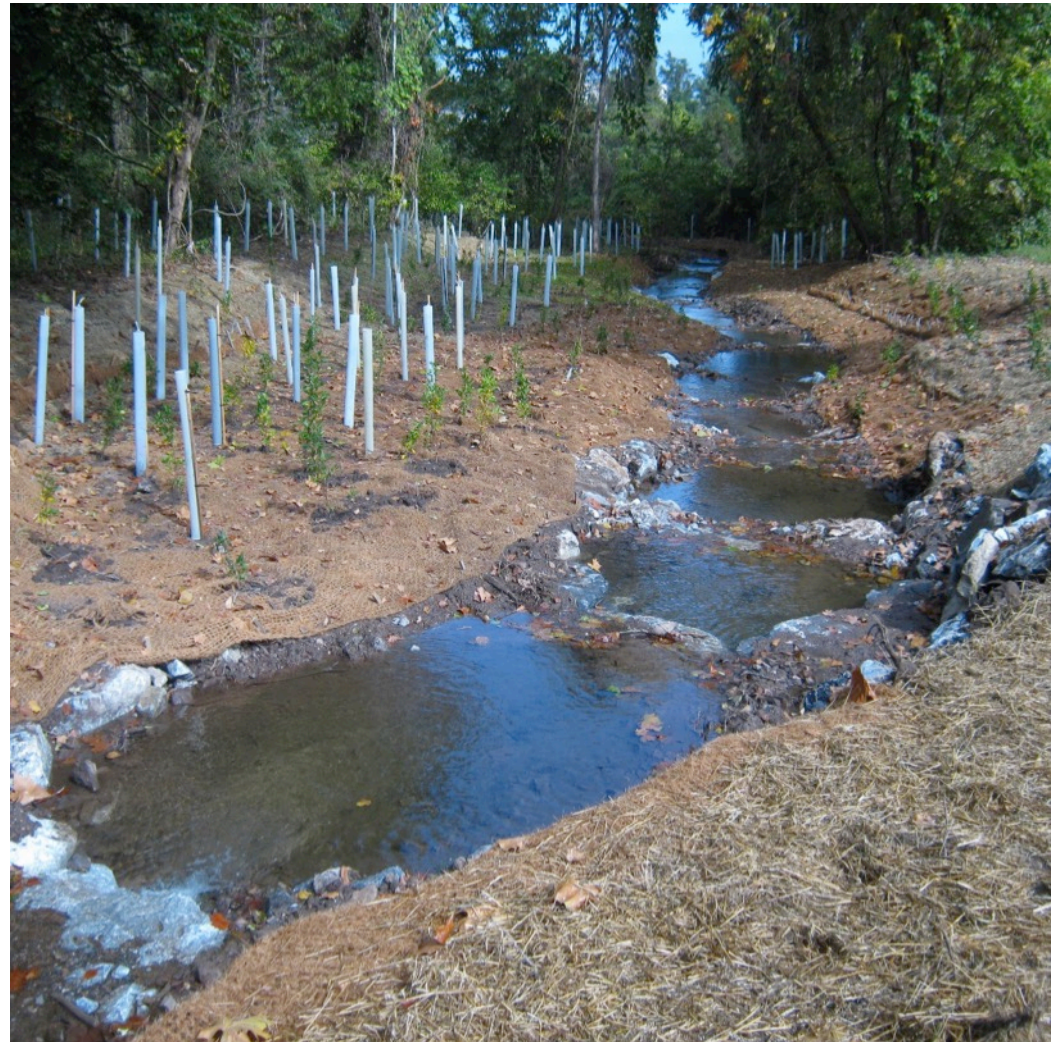
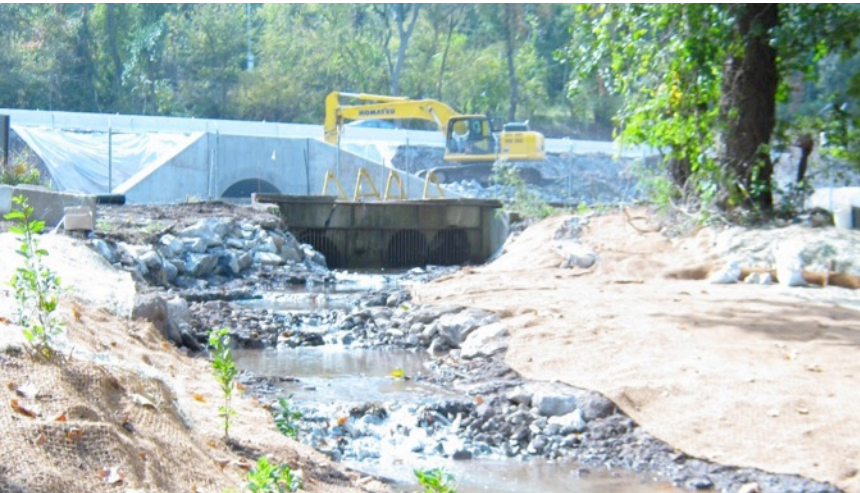
Stream Restoration- Floodplain Reconnection

Headwater Step-Pool Conveyance System

Flood Hazard Mitigation

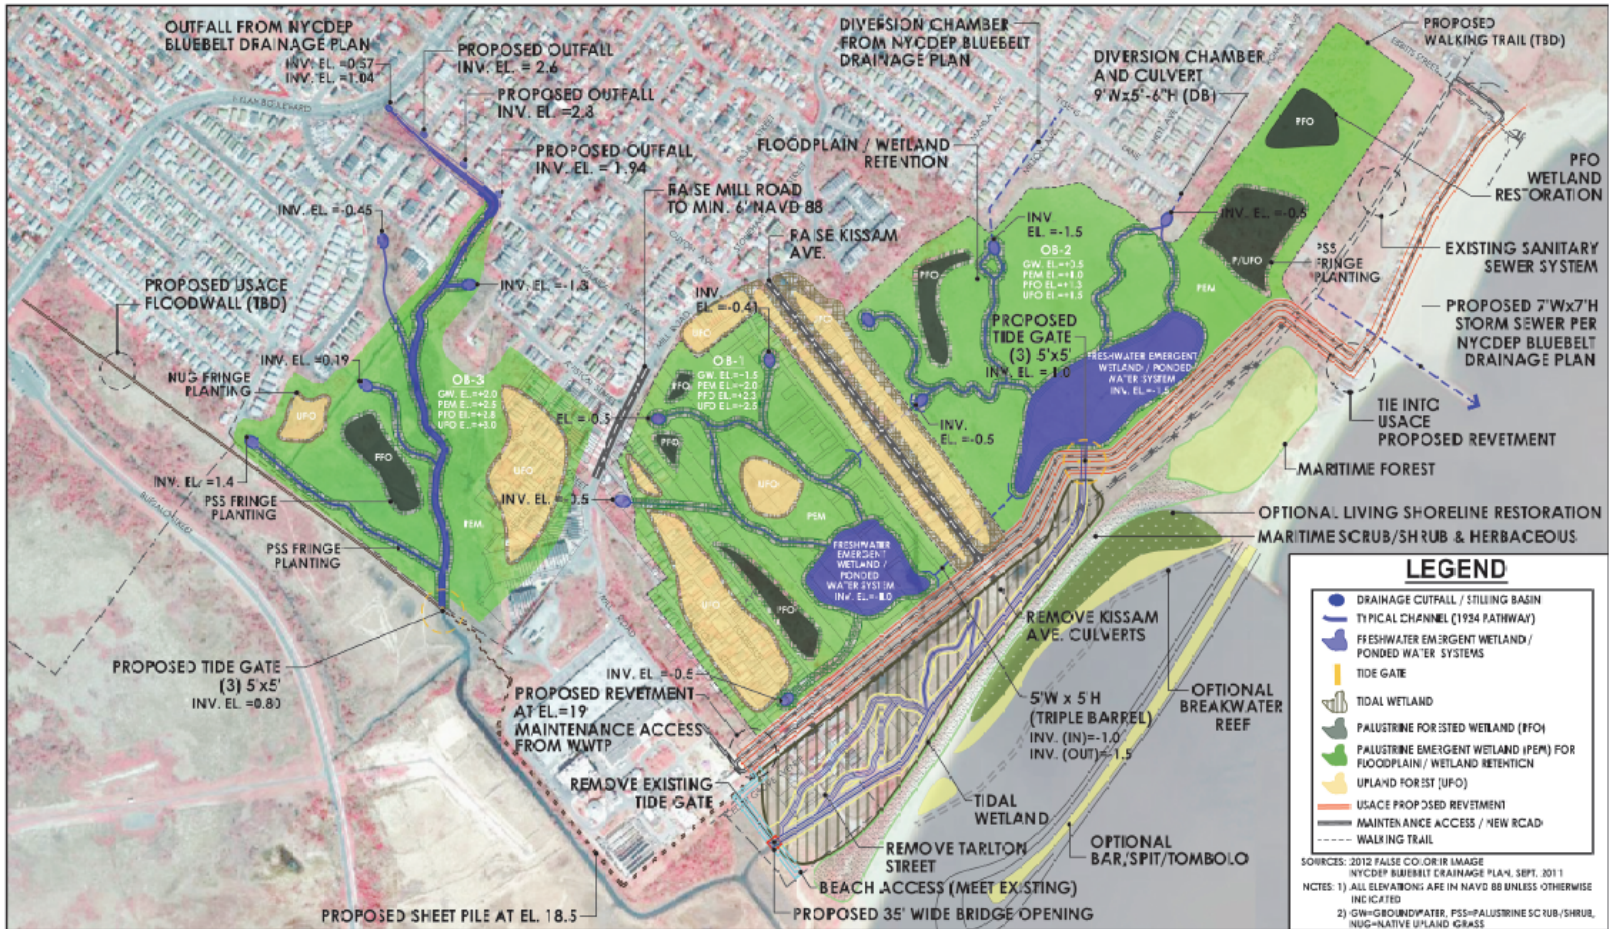
Figure 47 - Final Conceptual Alternative	
					Project Name: Oakwood Beach Flood Attenuation Feasibility Study, New York	Contract: OGS Project - SA319
					Date: January 31, 2014

Summary of Final Alternative

Benefits of Final Conceptual Alternative	
Items	Final Conceptual Alternative
Number of Houses Protected from Coastal Storm Surge	1,843
Nature Based/Natural Areas Restoration	Approx. 193 Acres
Level of Protection	0.2%-annual-chance (500-yr) for Coastal Storm Surge Storage capacity for 1%-annual-chance (100-yr)
Public Access and Trail Components	Public open space - 193 acres 2 miles of trails around restored natural areas 1 mile trail on revetment maintenance access
Stormwater detention storage areas (acres)	OB-1: 45.6 OB-2: 42.4 OB-2 Extended: 10.7 OB-3: 42.2
Volume of Stormwater contained in Restored Storage Areas	OB-1: 35.3 million gallons (108.4 acre-ft) OB-2: 61.5 million gallons (188.8 acre-ft) OB-2 Extended: 8.8 million gallons (27.2 acre-ft) OB-3: 61.8 million gallons (189.9 acre-ft)
Approximate Preliminary Cost	\$173 million

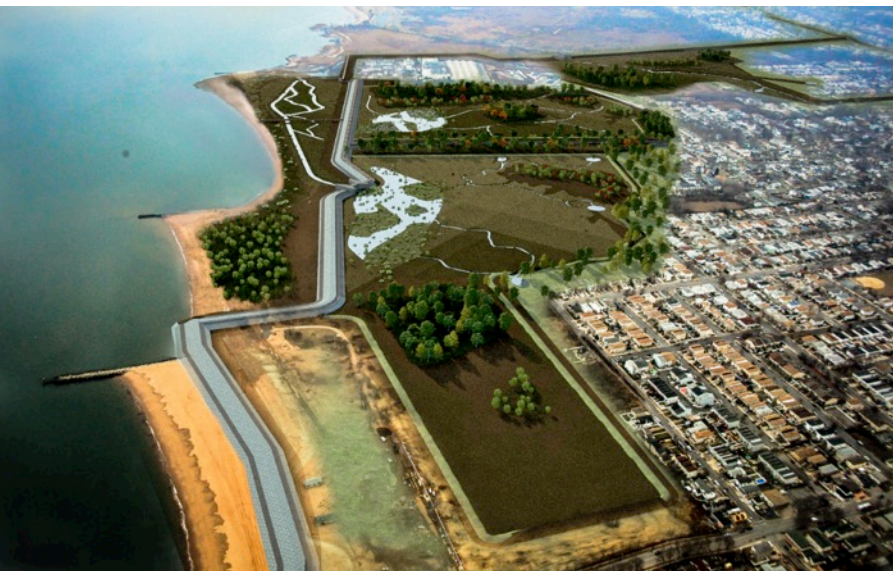
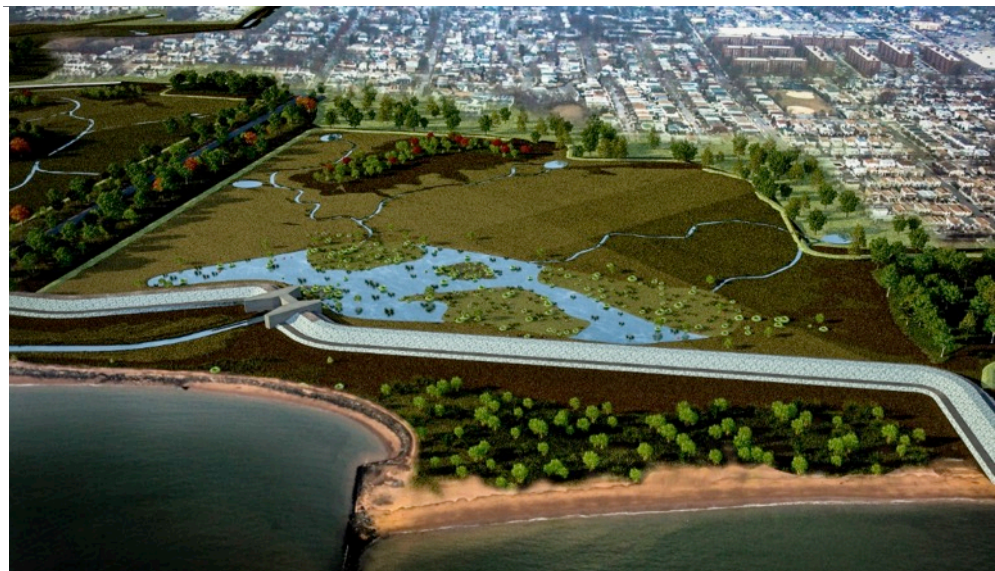
Floodplain Restoration – Stormwater, Wetland

- Stormwater Conveyance/Retention for 100Year Rainfall
- Tidal/Freshwater wetlands: 80+ acres for Water Quality
- NSCD Restoration 1200+ LF/Riparian Buffer Enhancements
- Coastal Revetment Restoration-Living Shoreline Options
- Green/Nature Based infrastructure Improvements

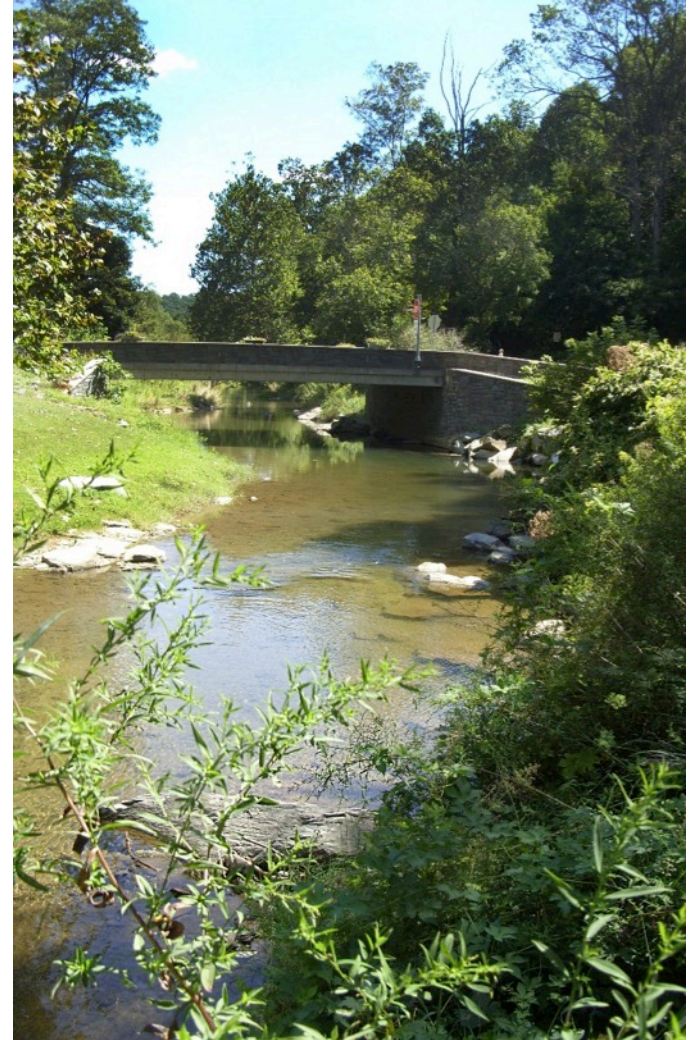
Natural Stream Stabilization at Structure Crossings

- Creates a win-win for all by providing:
 - Reduced sediment discharge
 - Stable channels and streams
 - Scour protected bridge structures & streambanks
 - Stream habitat and fisheries improvements
 - Improved Resiliency

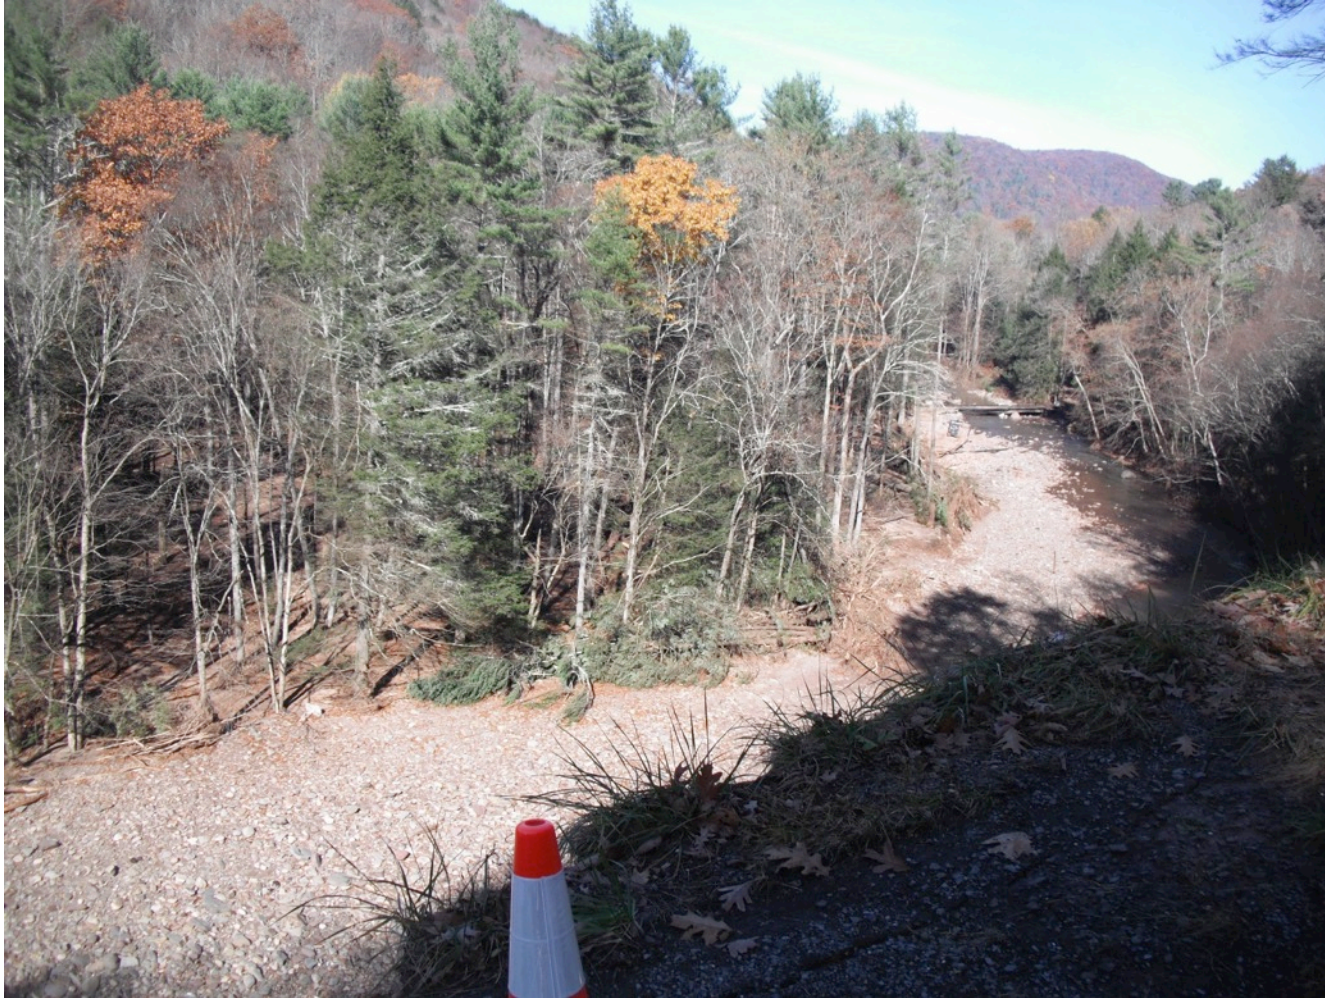
Stream Channel, Embankment and Bridge Storm Damage

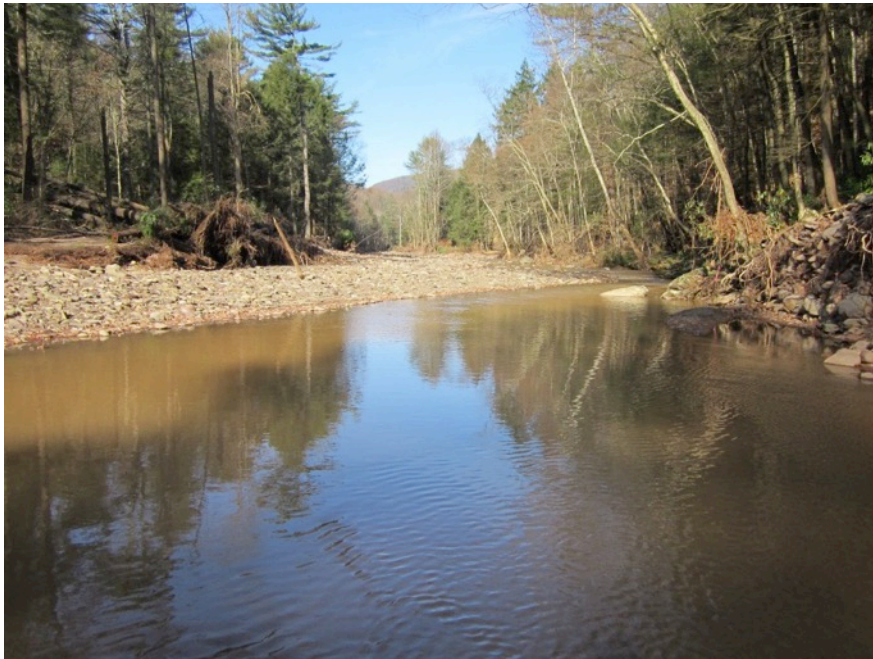
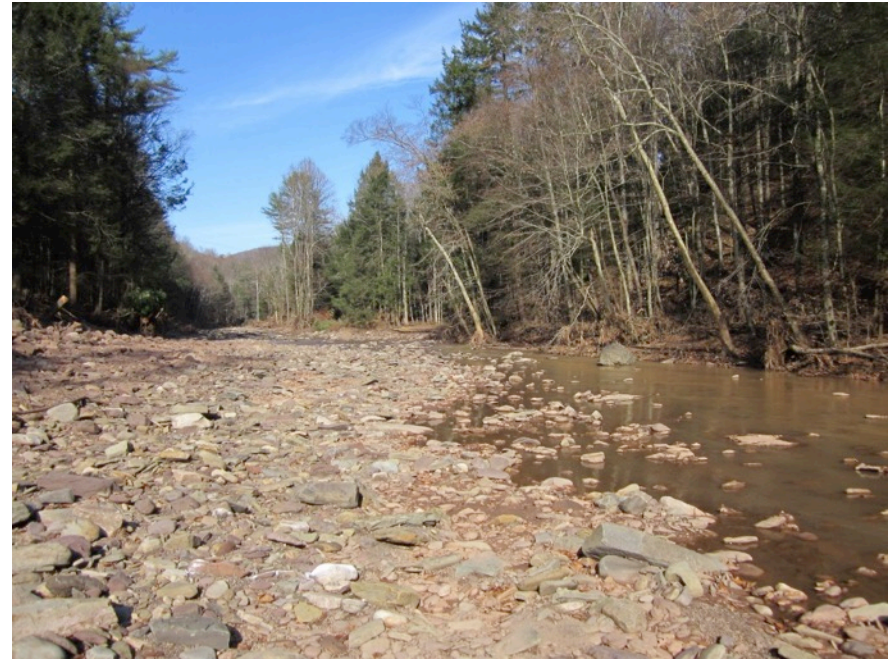
Stream Channel, Embankment and Bridge Storm Damage

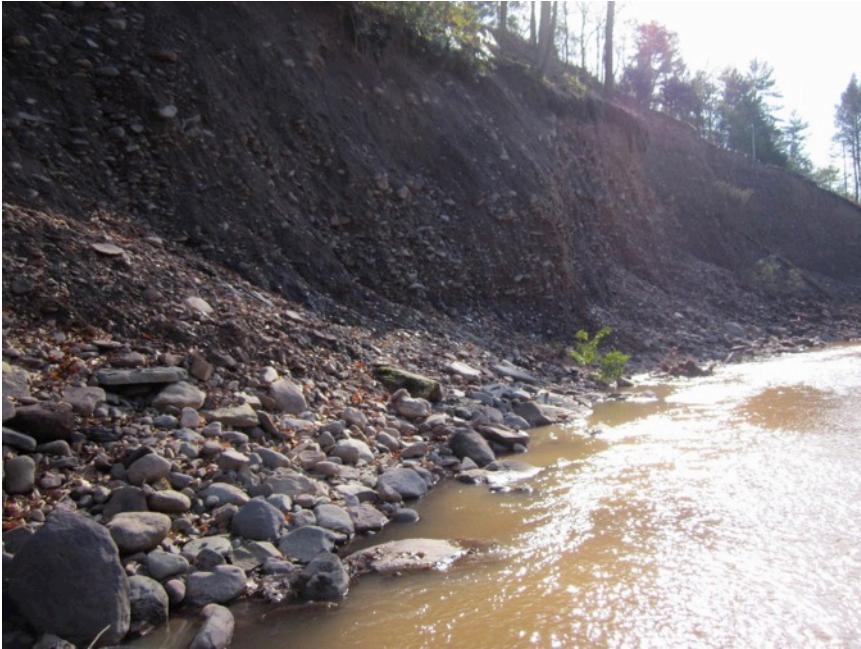
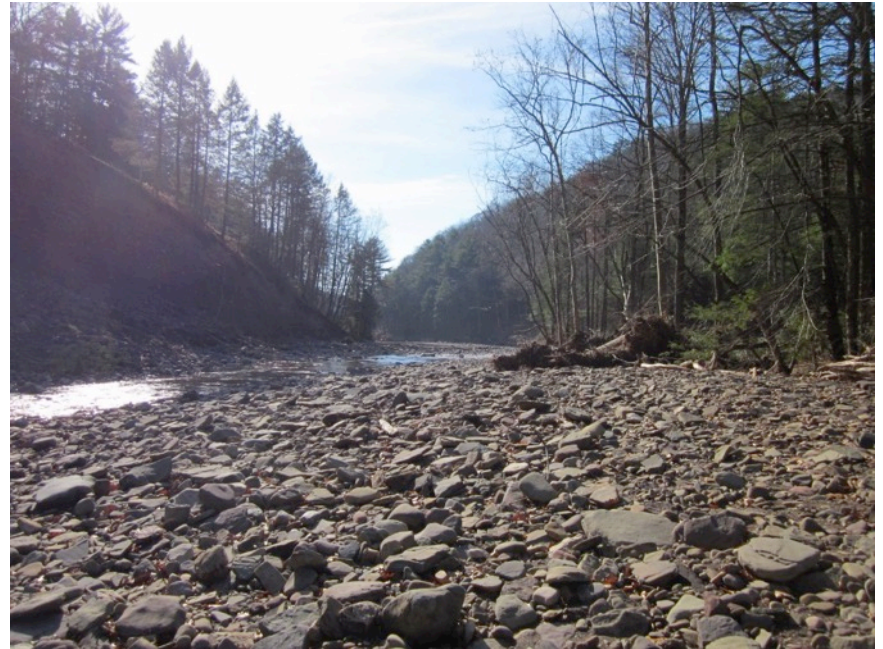
Stream Channel, Embankment and Bridge Storm Damage

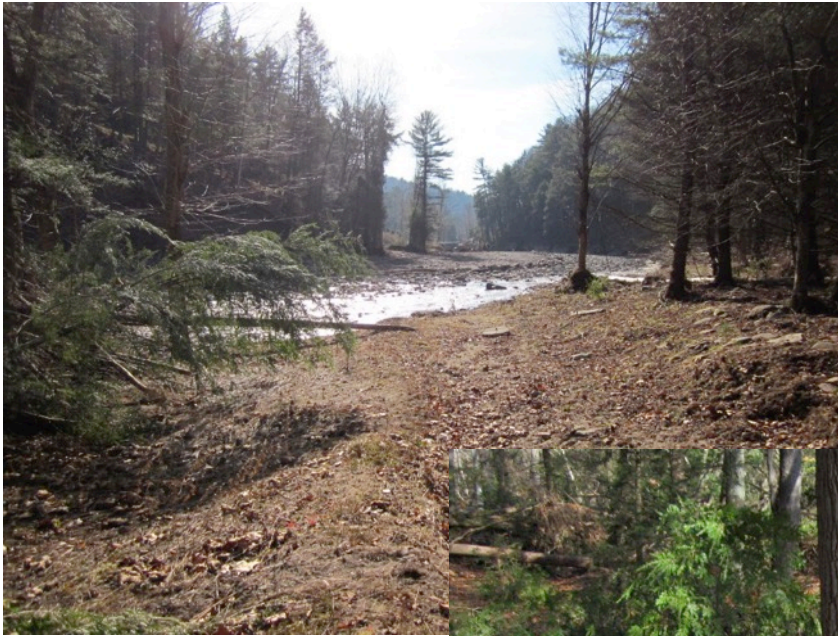
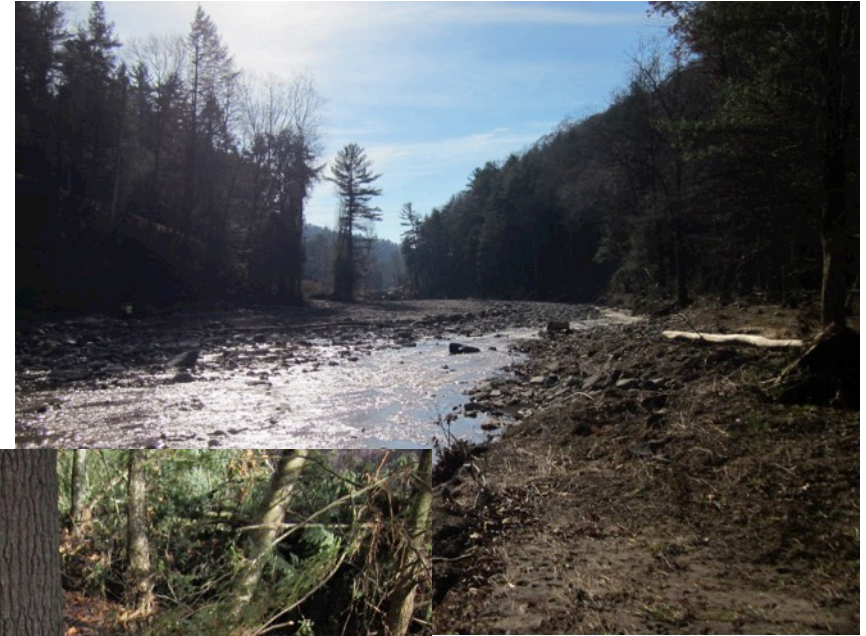
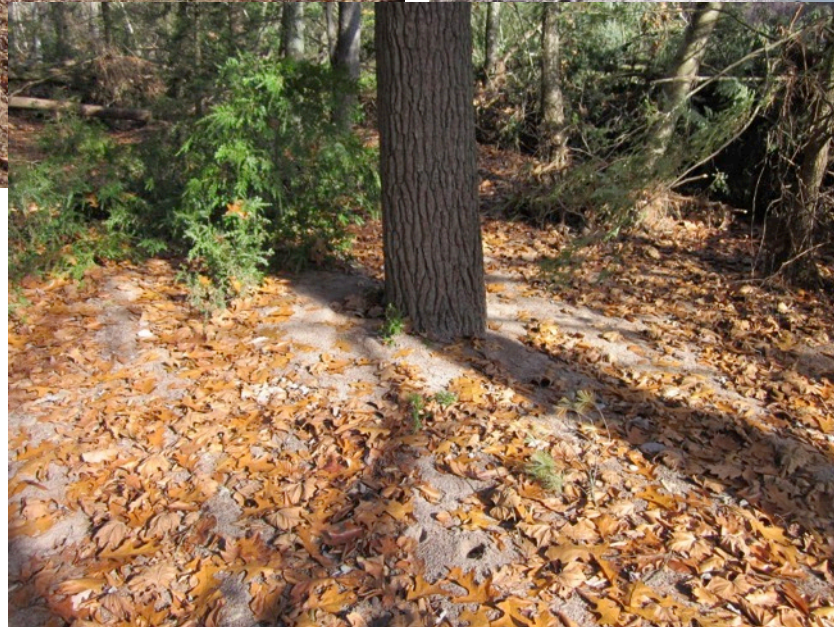
Stream Channel, Embankment and Bridge Storm Damage

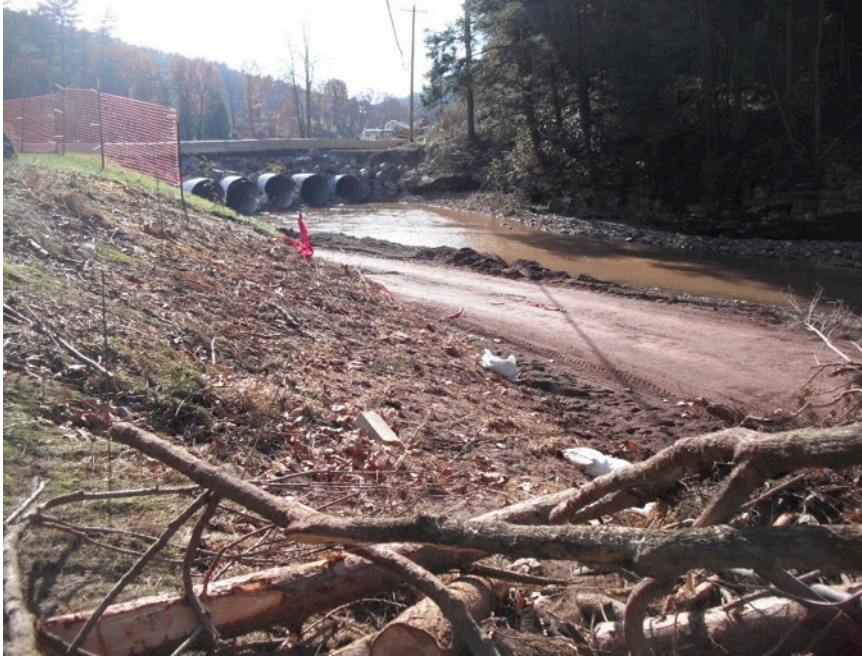
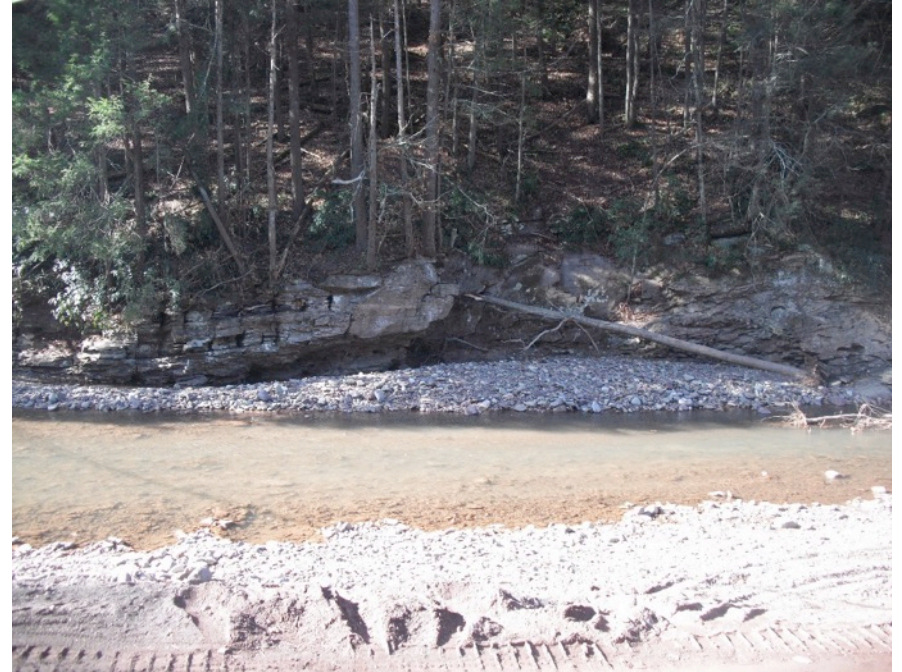
Stream Channel, Embankment and Bridge Storm Damage

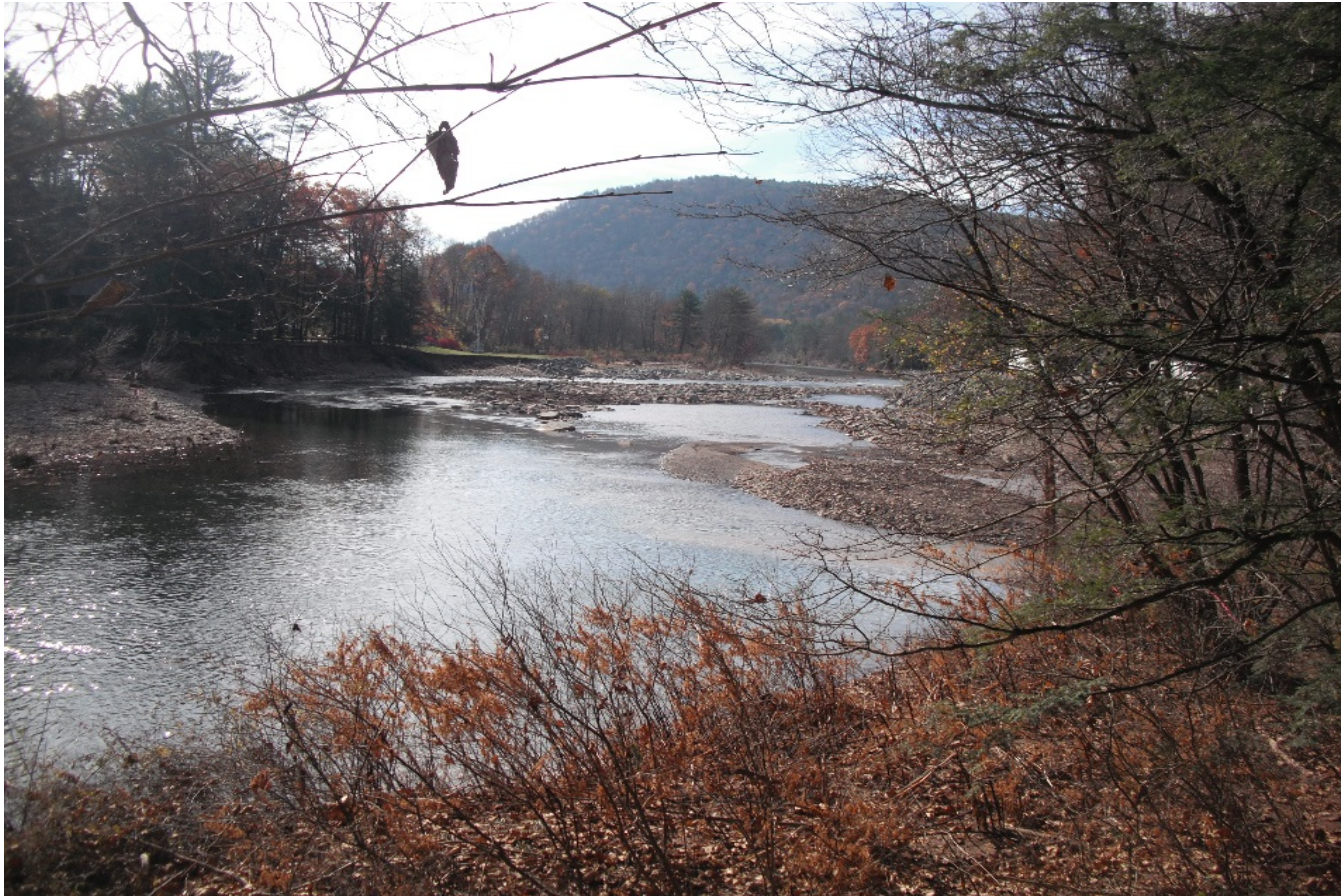
Stream Channel, Embankment and Bridge Storm Damage-Loyalsock Creek

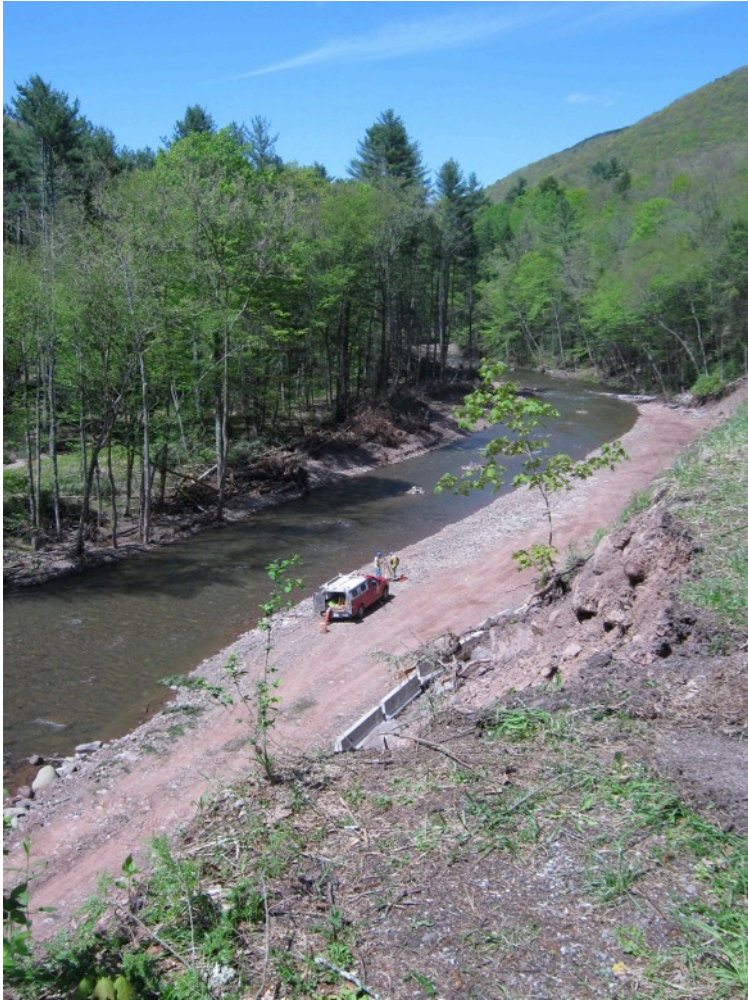
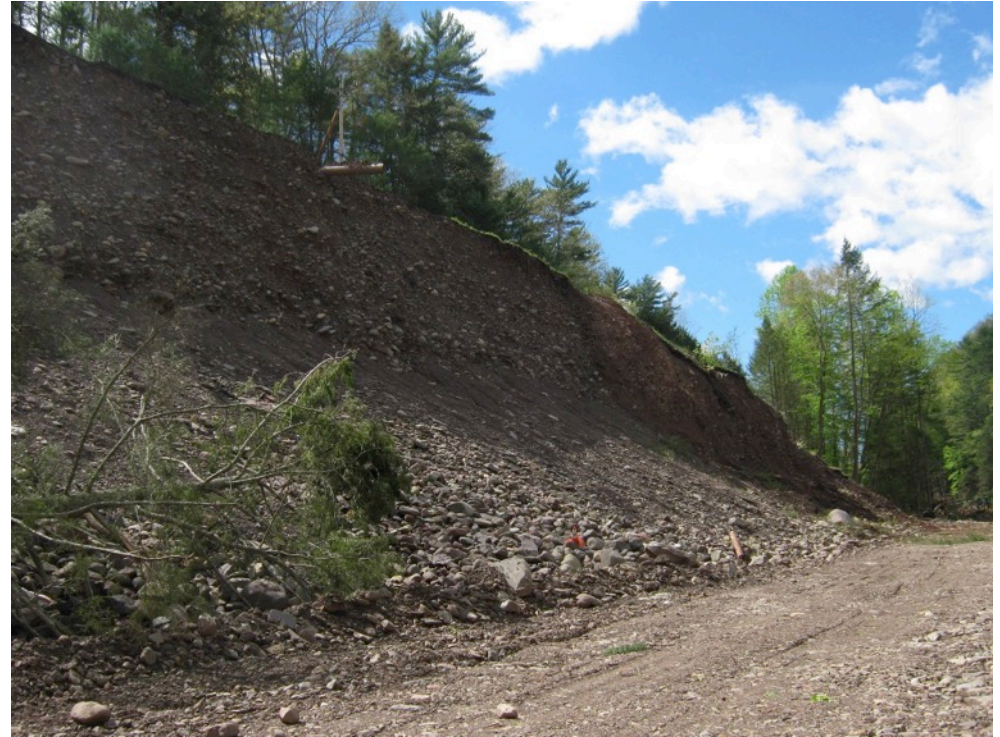
Channel Restoration, Rock J-Vane Construction and Embankment Reconstruction

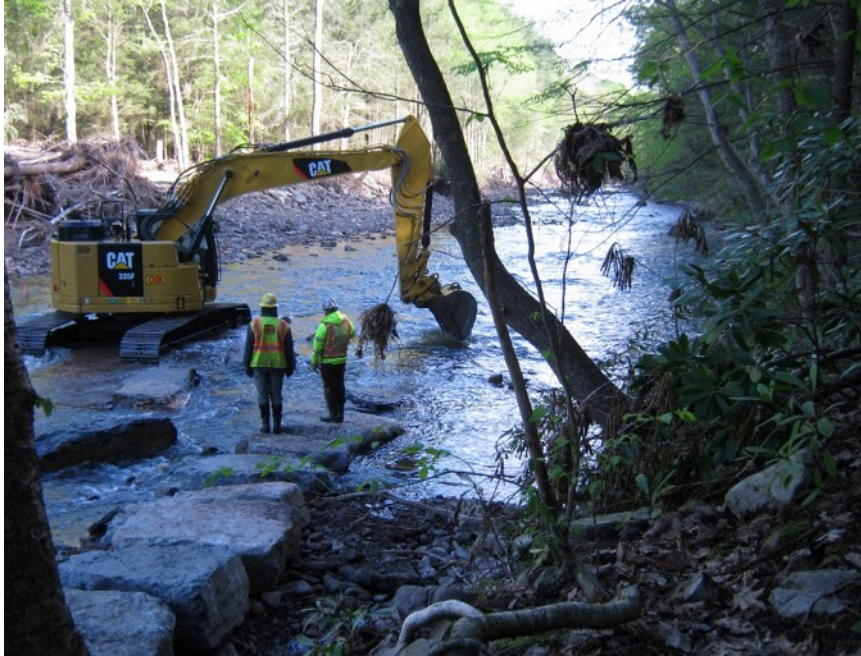
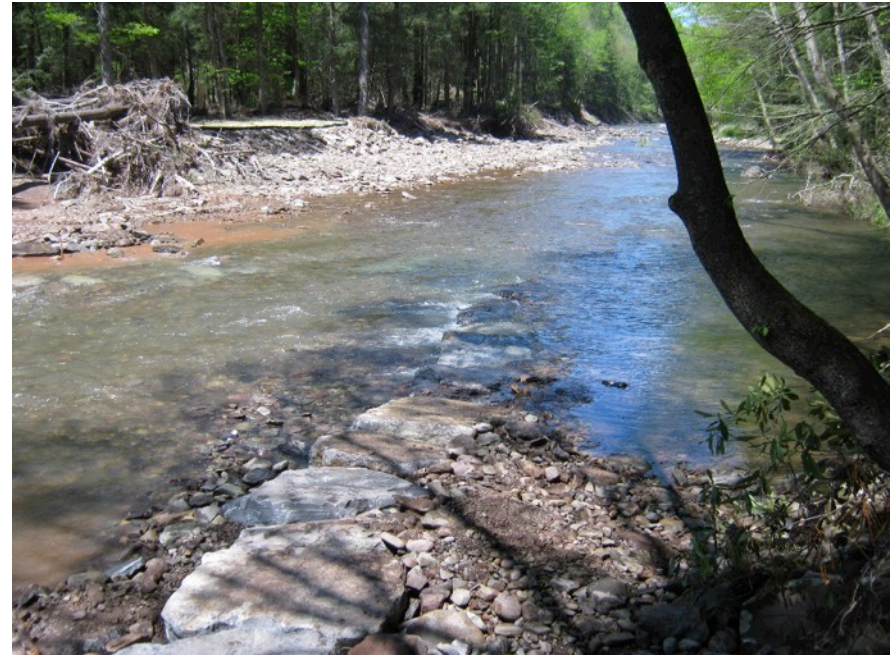
Channel Restoration and Rock J-Vane Construction

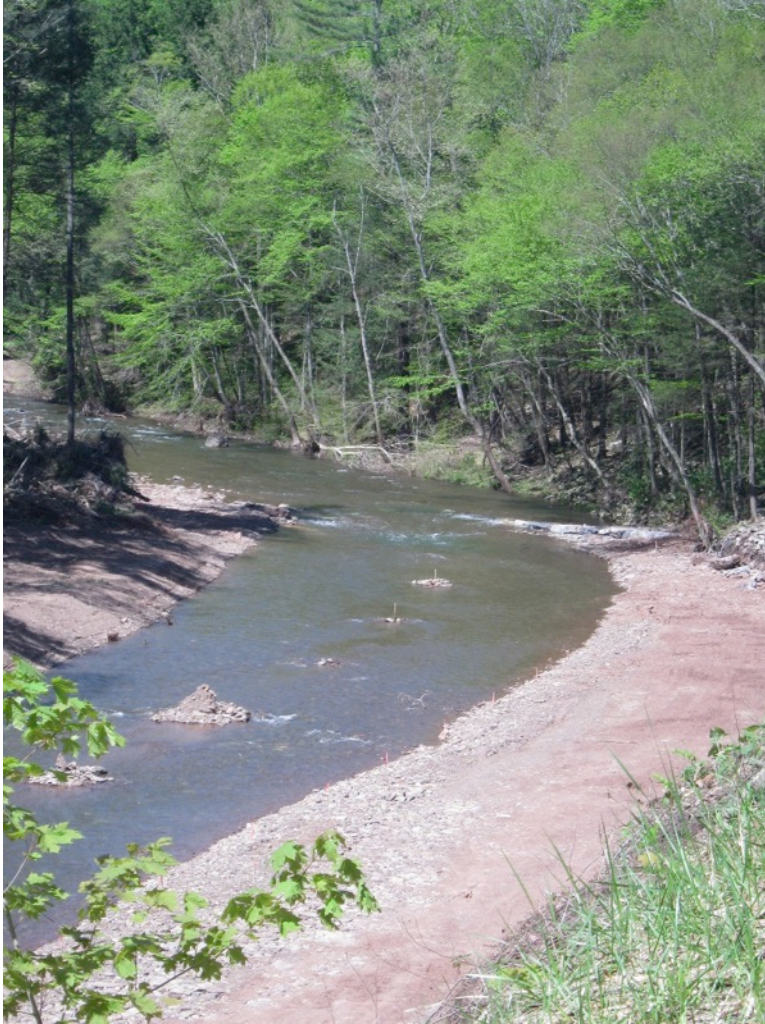
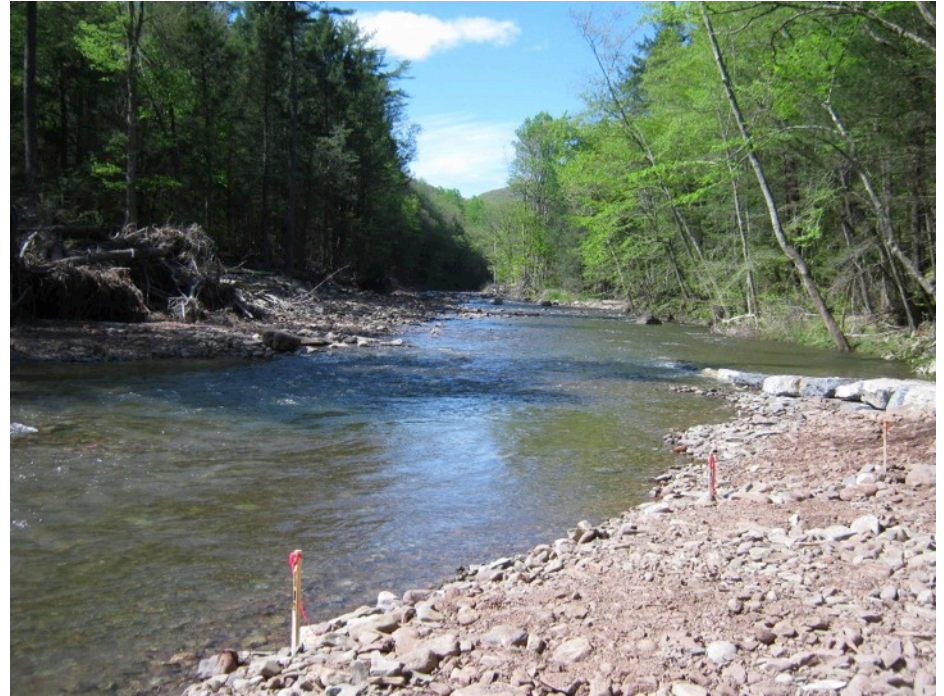
Channel Restoration and Rock J-Vane Construction

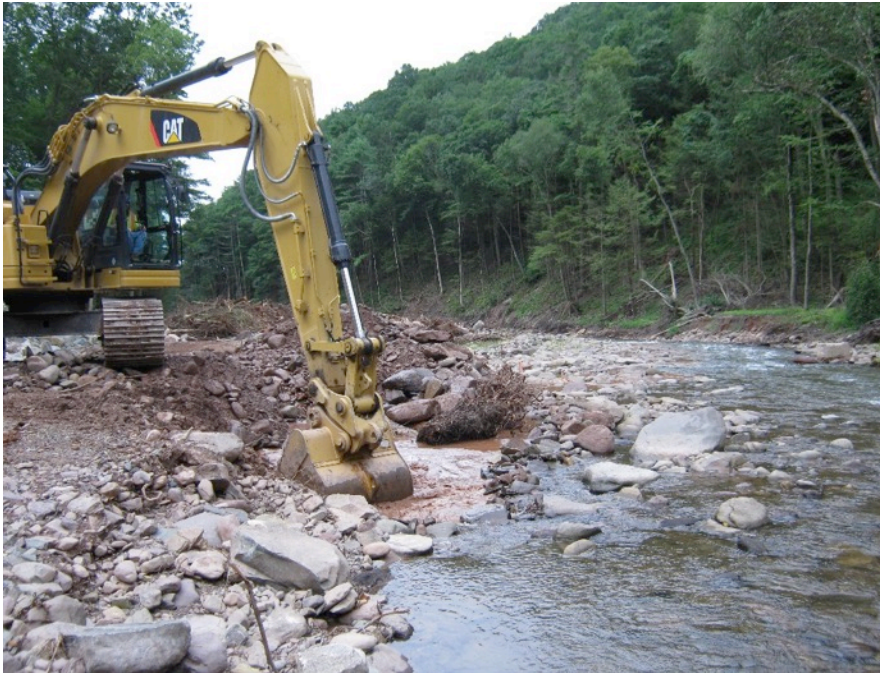
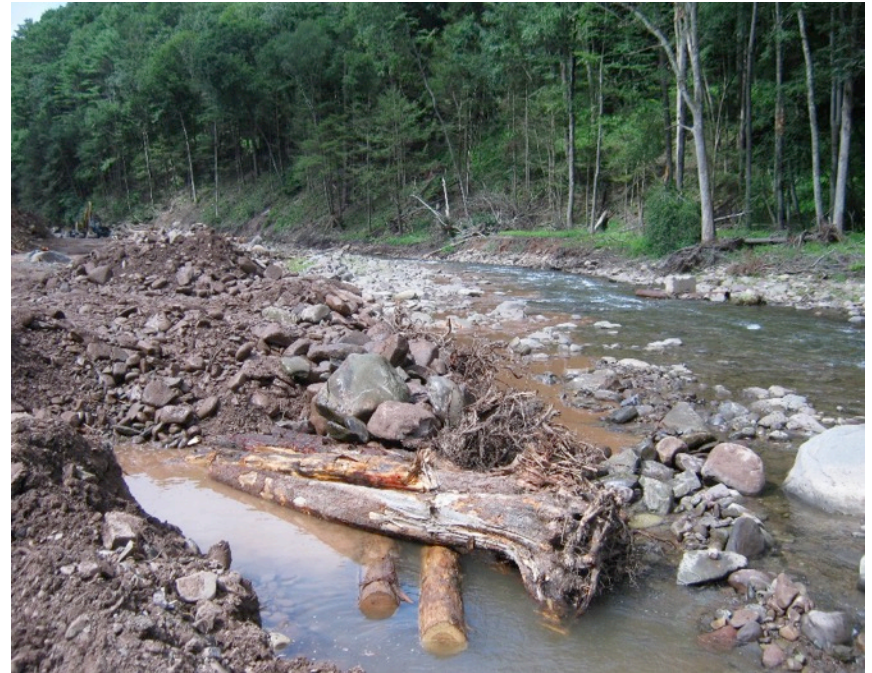
Rootwad Construction Channel and Embankment Completion

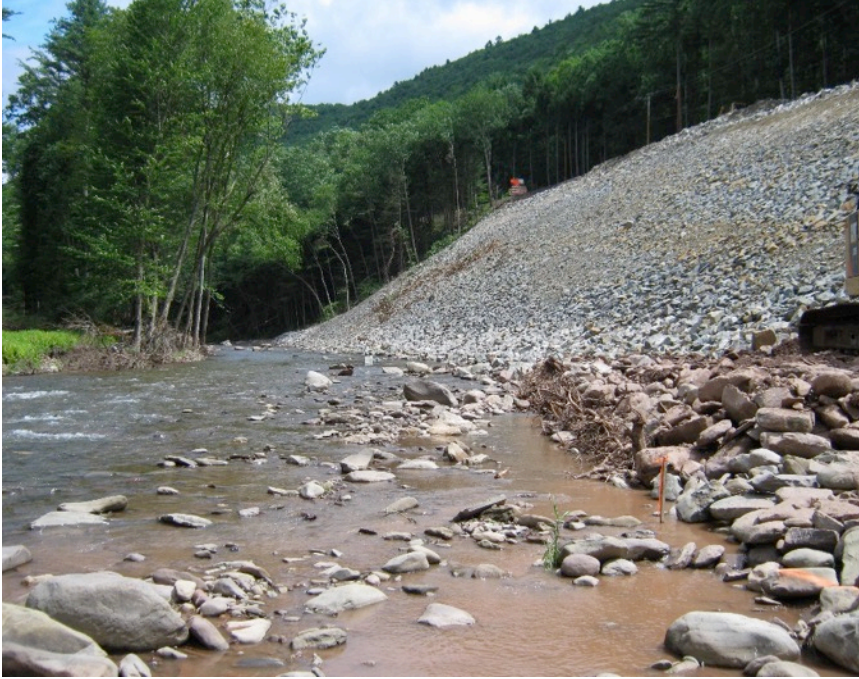
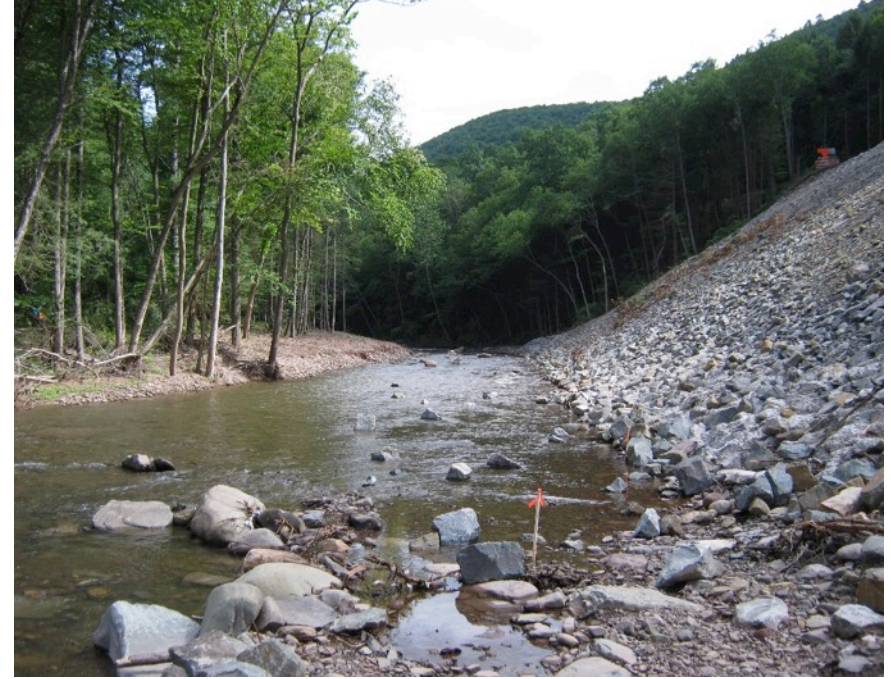
Rootwad Construction Channel and Embankment Completion
