Post-Storm Infrastructure Improvements and Stream Restoration: Three Case Studies

NEWEA Stormwater Conference May 7, 2018

Today's Session: Three Case Study Examples

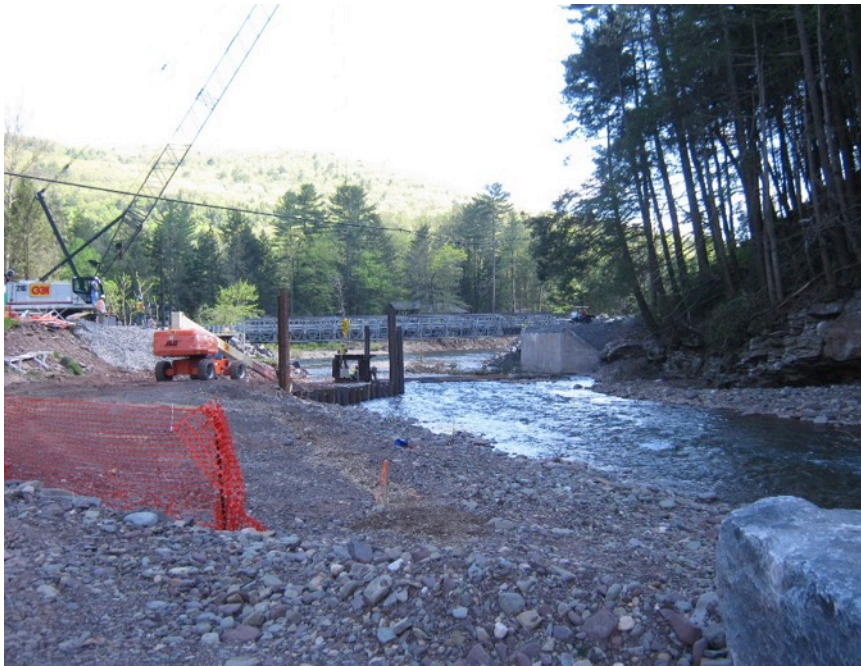
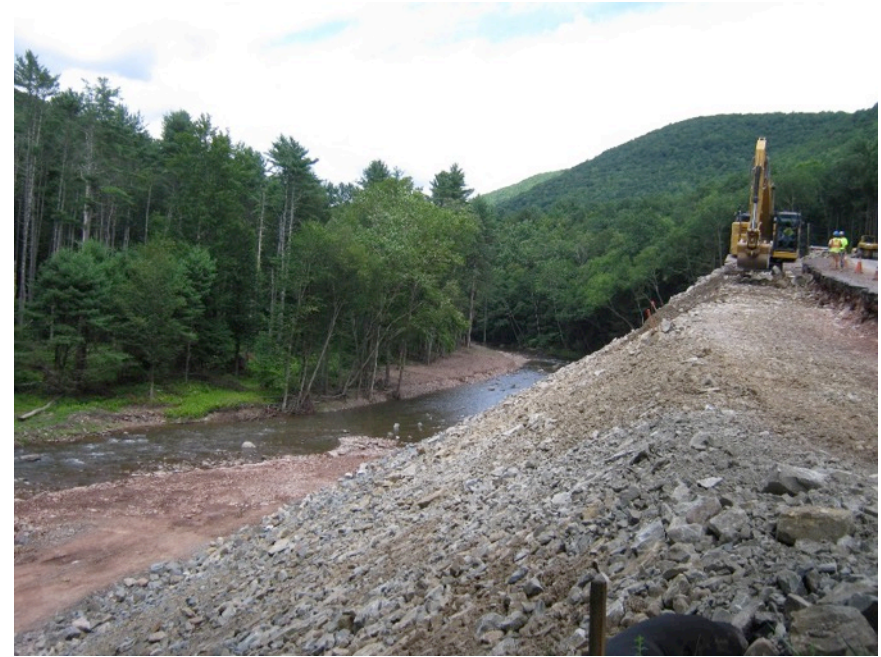
Channel/Embankment Construction and Bridge Replacement

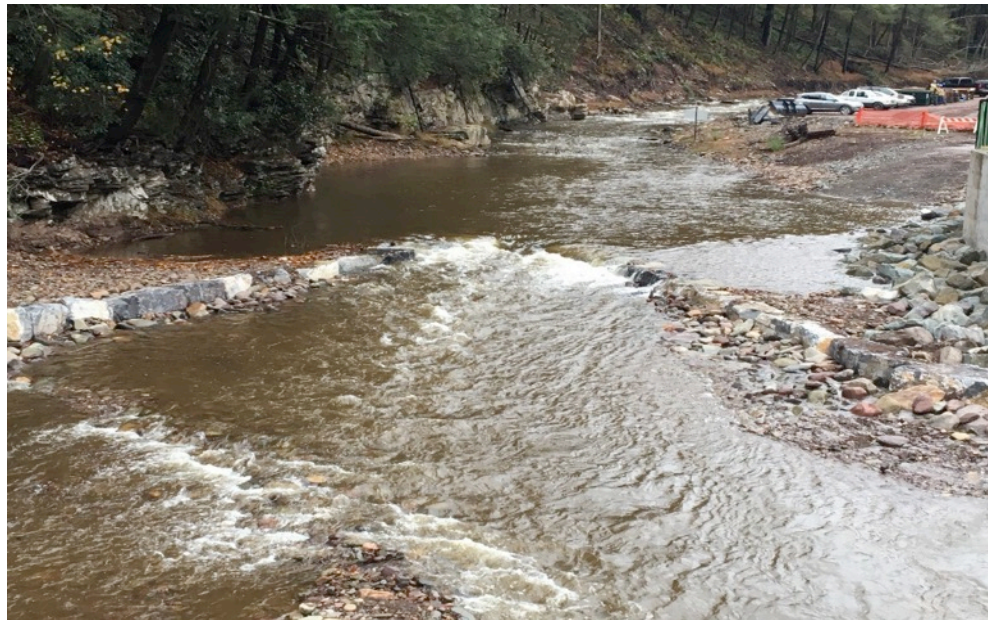
Bridge Cross Vane & Embankment Completion
