Stacey's Brook Phase 1 Sewer Rehabilitation Project

A Phased Approach to Reduce Collection System Exfiltration
and Improve Surface Water Quality

Swampscott, MA

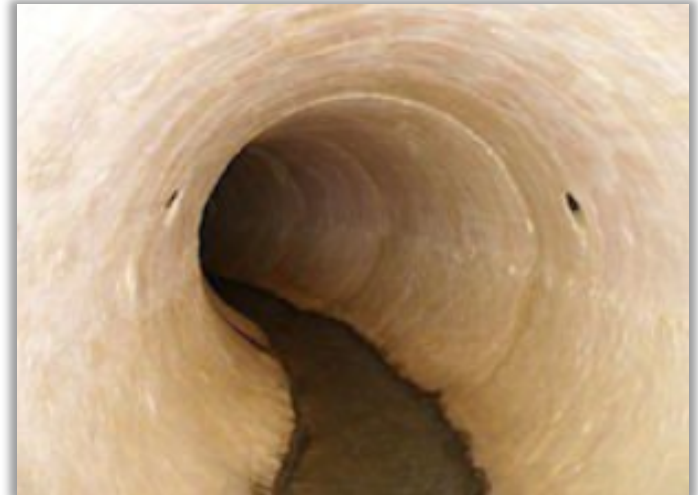
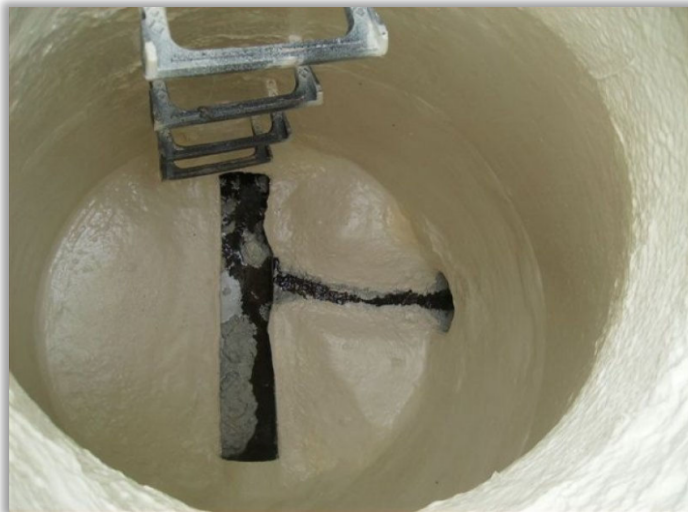
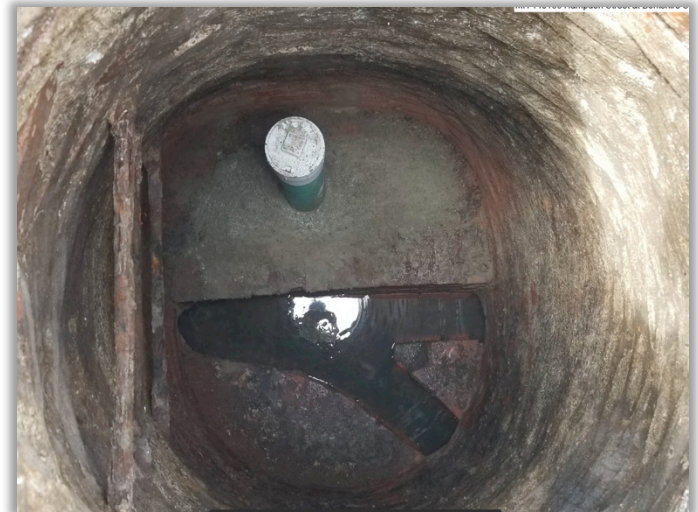
- CIPP Sewer Mainlines
- Lining Manholes
- Replacing Laterals
- Capping Underdrains

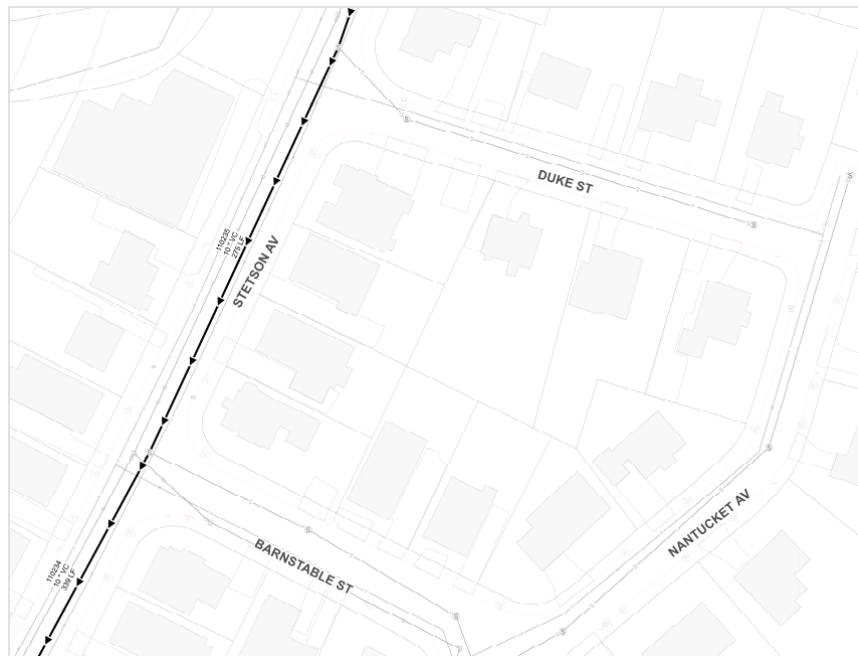
Existing Drawing

Changes would have to be manually performed in CAD

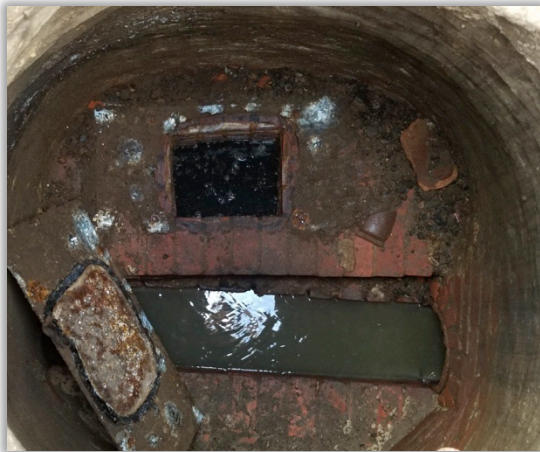
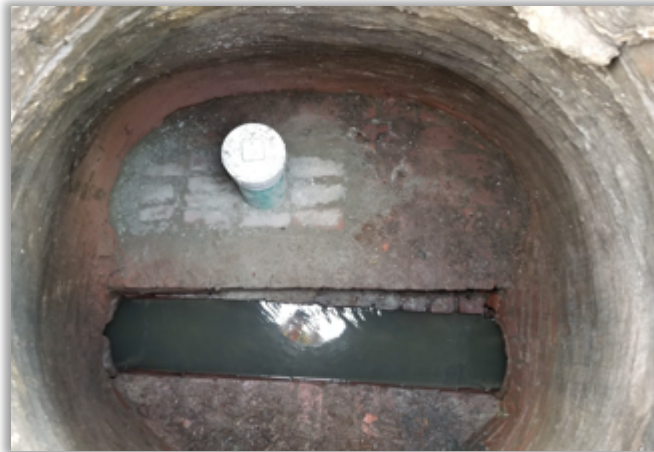
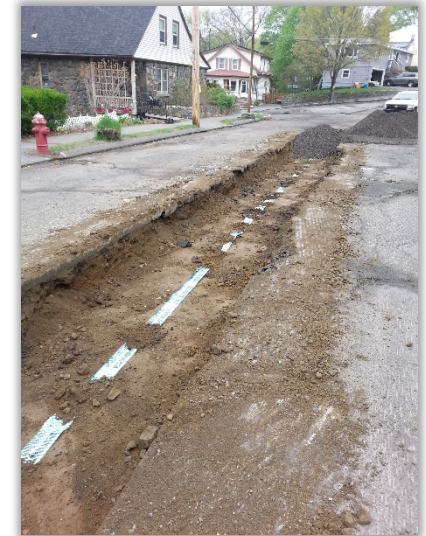
- Construction cost of \$908K
- Installation of 5,900 LF of 8" PVC, 2 manholes and repair of 25 underdrain manholes
- Completed over \$14k underbudget despite the removal of **590 CY of ledge**
- Town reporting lower I/I
