Targeting O&M through Model Calibration

The Metropolitan District Commission, Hartford, CT

The Metropolitan District Commission (MDC)

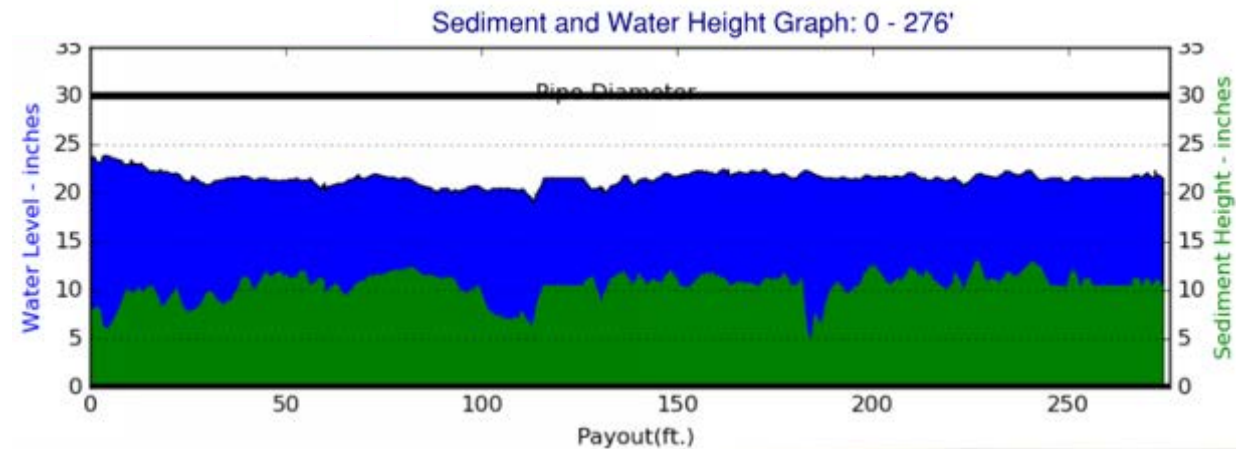
Heavy sediment buildup in OSBI multi-sensor inspection

- Model underpredicted water level and overflow frequency
 - Required up to 15" of sediment in the 30" interceptor and high losses to match data
- Interceptor prioritized in system-wide multi-sensor inspections
 - Heavy sediment discovered
 - Blockage discovered in siphon barrel
 - Prioritized for interceptor cleaning

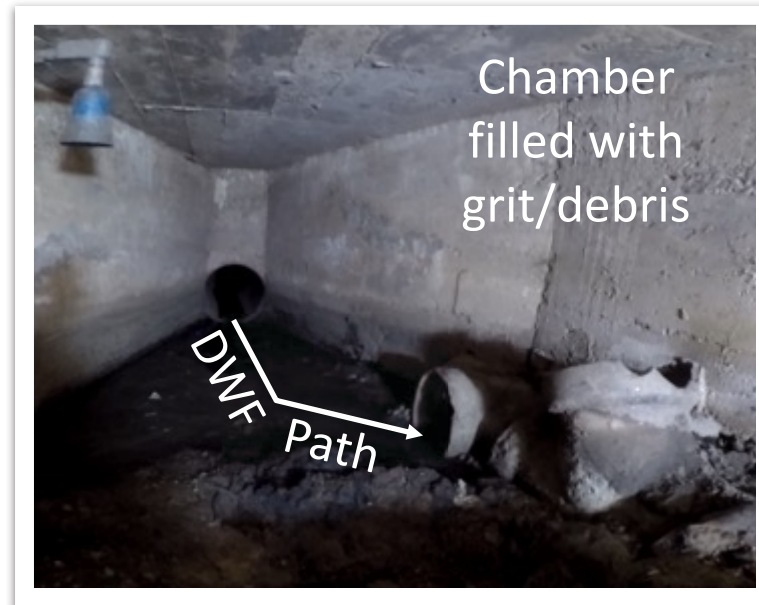
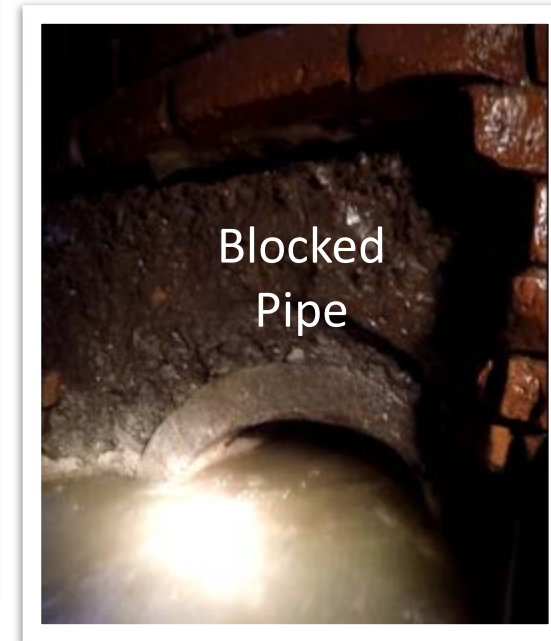
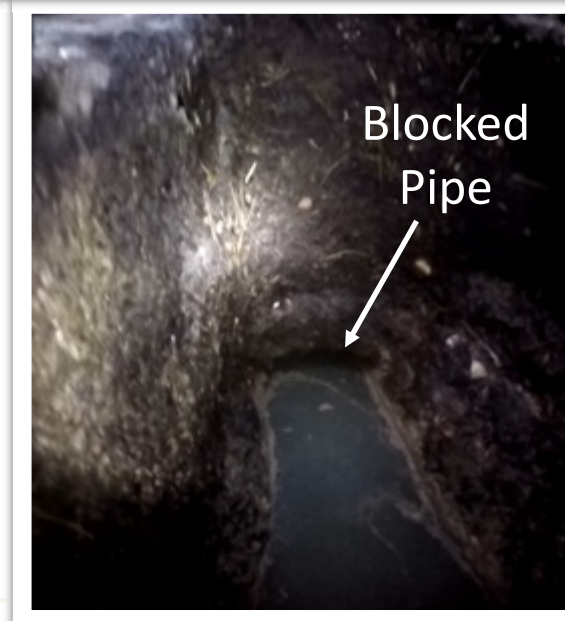
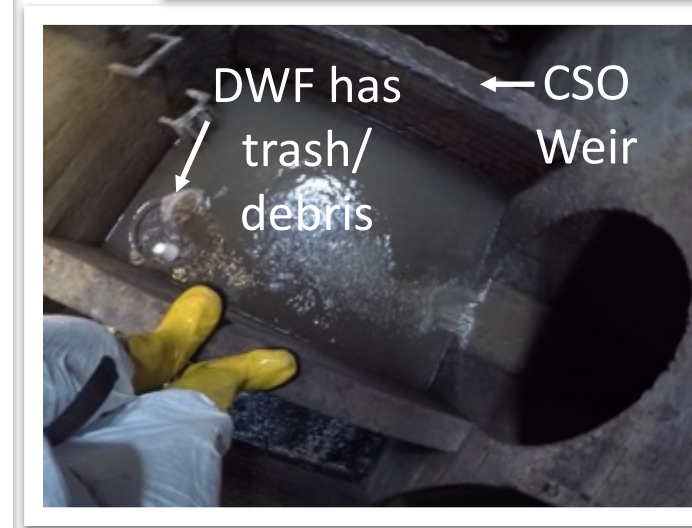
- Model underpredicted overflow frequency and duration
 - Excessive losses required to achieve match
- Locations prioritized during system-wide inspections
 - Grease and debris blockages were found in over 20 CSO regulators
 - Multiple siphon blockages discovered
 - Prioritized for cleaning

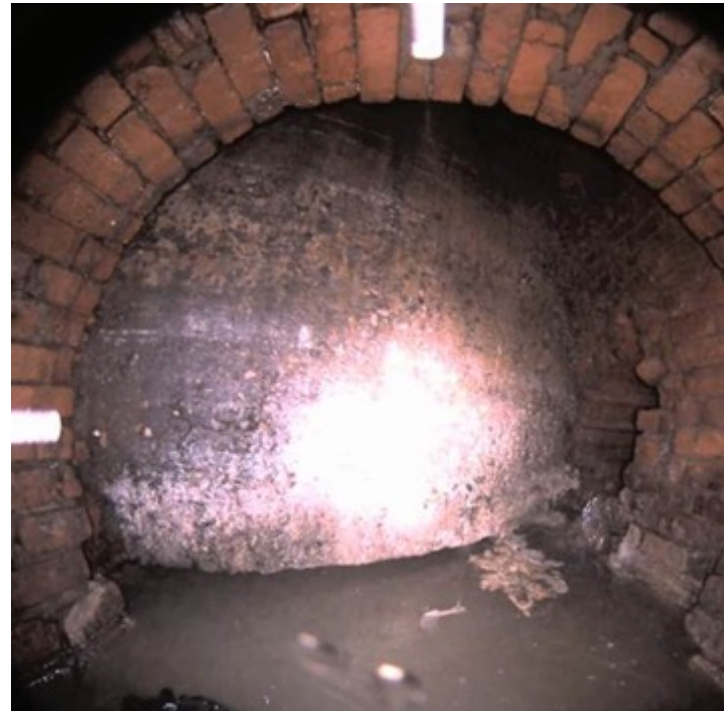
View from CCTV

- Model unable to simulate frequent interceptor surcharge
- Partial wall discovered during field inspection
- Added weir and orifice to the model
- Calibrated opening dimensions to reproduce meter data

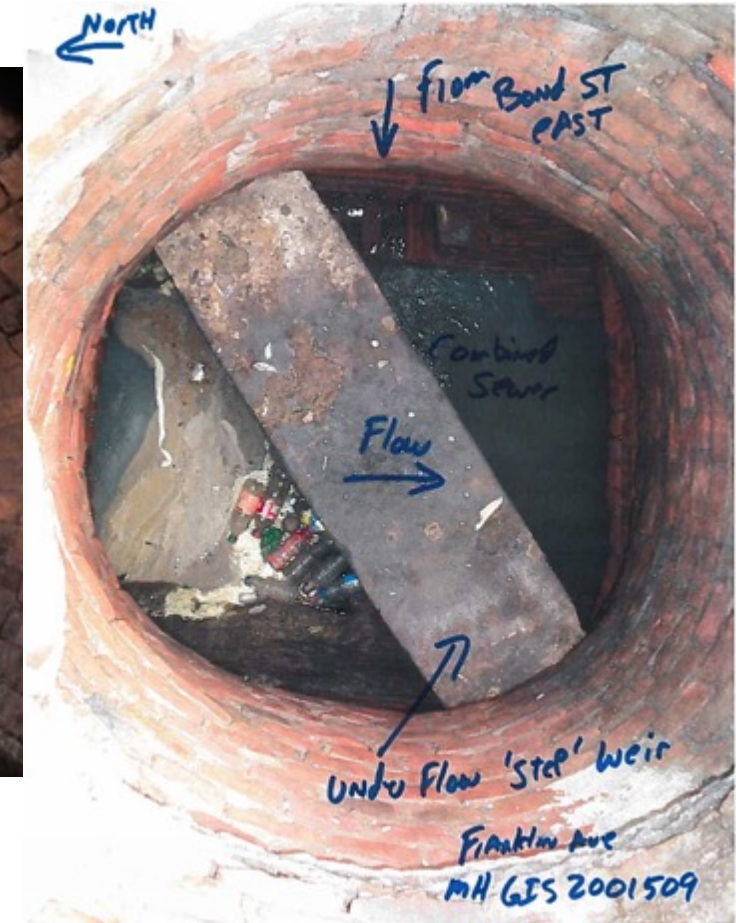
View from manhole
