Assessing the Long-Term Financial Sustainability of Water Mains

Using Monte-Carlo Simulation

Cris Perez

January 27, 2019

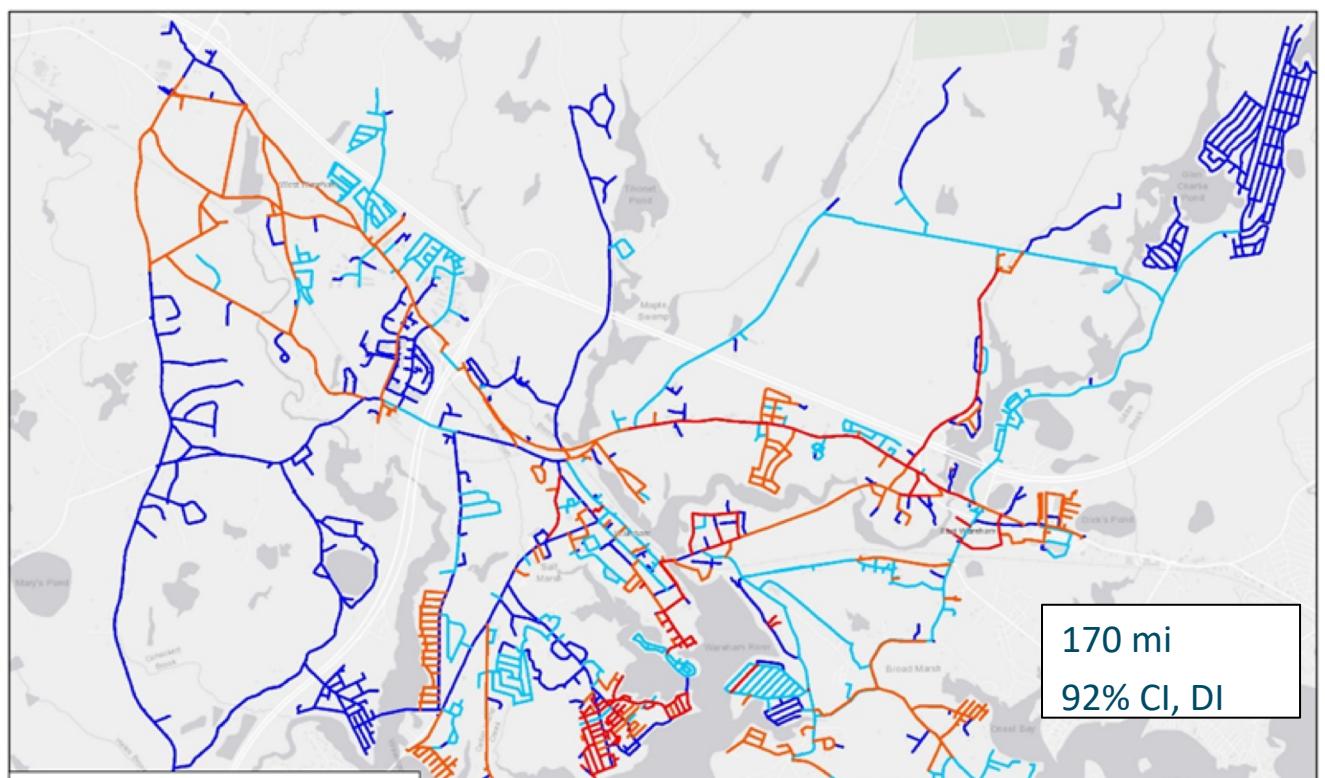
Installation Year

- 1924 - 1943 (>75 yrs old) - 5%
- 1944 - 1968 (50-75 yrs old) - 24%
- 1969 - 1993 (25-50 yrs old) - 28%
- 1994 - 2017 (< 25 yrs old) - 43%

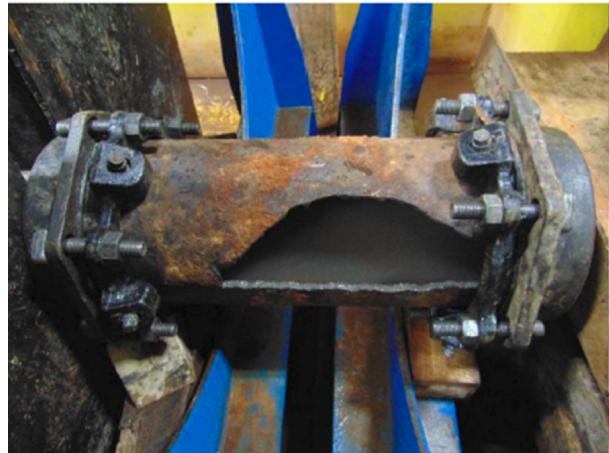
When to Consider Replacing Pipe – Field Results

Estimated Minimum Pipe

Thickness Before Break – 12 inch
pipe → Bending stress controls

Stress	Required Thickness, in.
Ductile Iron	
Int. Press. Hoop Stress	0.05
Bending	0.19
Cast Iron	
Int. Press. Hoop Stress	0.08
Bending (20 ft span)	0.51
Bending (15 ft span)	0.30
Bending (10 ft span)	0.13

Specimen	Manufacture Thickness	Minimum Bending Thickness	% of Original Thickness
Ductile – Class 52	0.37 inch	0.19 inch	51% (49% corroded)
Cast Iron – 15 ft Span	0.65 inch	0.30 inch	46% (53% corroded)

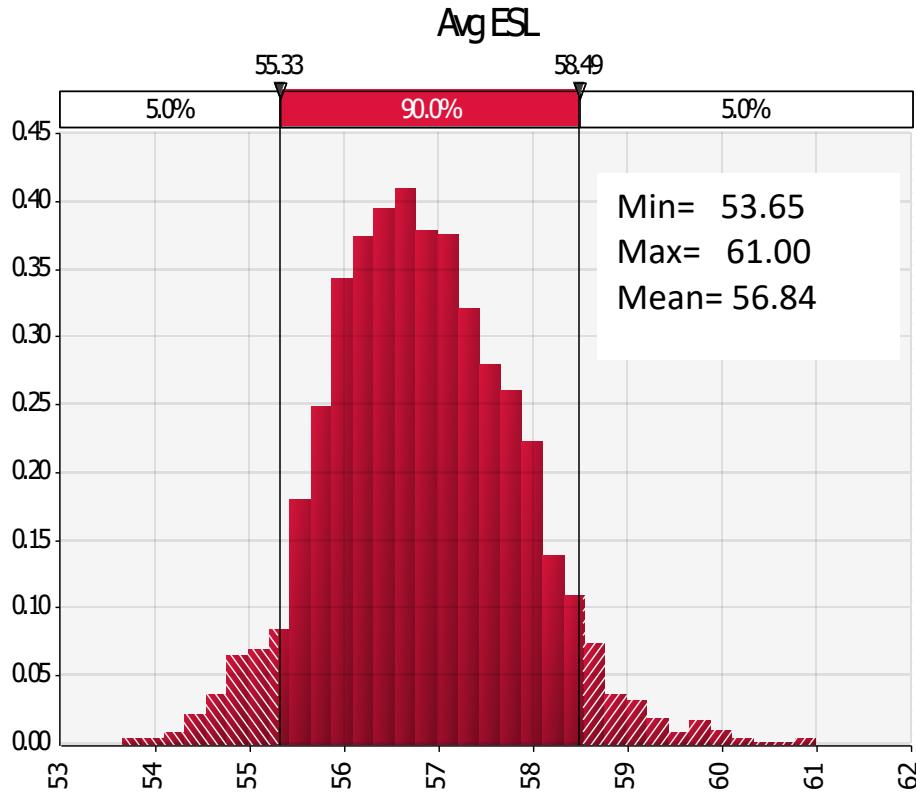
Estimated Service Life

How long does it take
to lose 50% of the
thickness?

- The corrosion rates derived from the Echologic's data result in estimated service life values shorter than what's been traditionally accounted for.
 - Soil corrosivity in Wareham could be a concern.
 - More corrosivity data should be collected for a more accurate assessment.
 - Other failure modes should also be considered.
 - This analysis indicates that at least \$1.5M per year is needed to maintain the system overtime.
