NEWEA 2019 Annual Conference

MANCHESTER, NH WWTP

Primary Clarifier/Thickener Upgrade

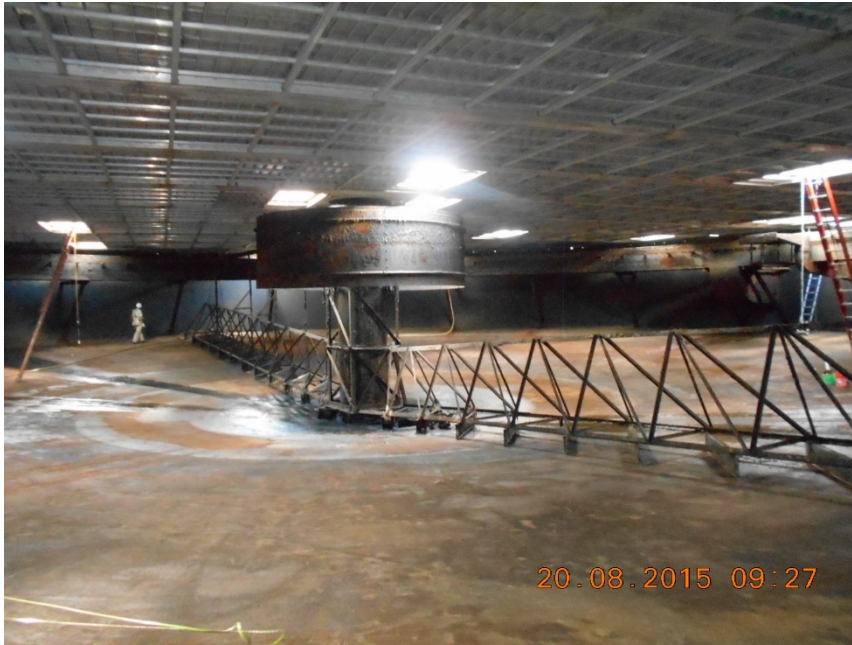
Primary Clarifiers

- Three 130-ft dia. concrete tanks w/ painted steel mechanisms
 - Two built in 1975
 - One built in 1993
- Center feed w/ double sided internal launder
- Conventional segmented plow blade sludge removal
- Covers added in 1998

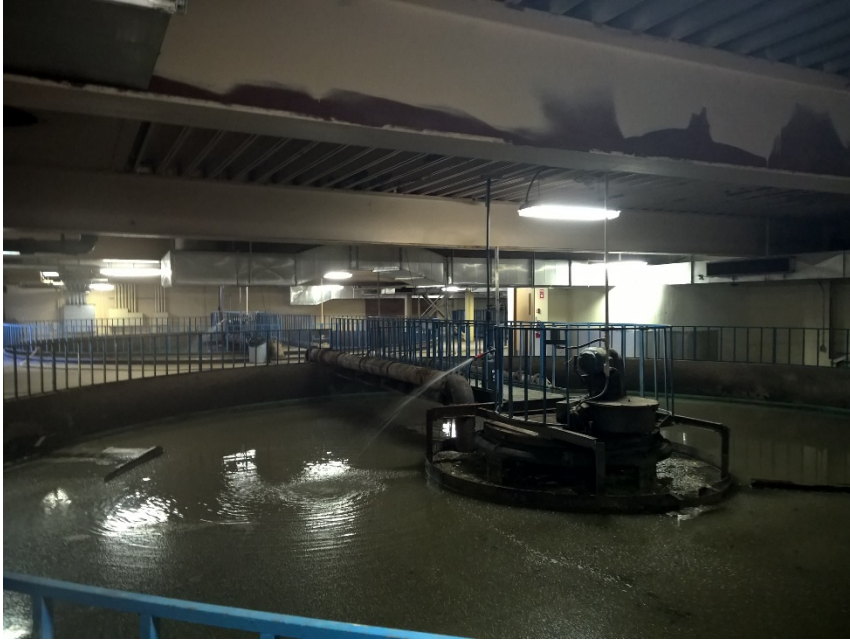
Gravity Thickeners

- Three 50-ft dia. painted steel tanks w/ painted steel mechanisms
 - Two built in 1975
 - One built in 1993
- Center feed w/ single sided perimeter launder
- Conventional segmented plow blade sludge removal
- Open top tanks located in Ops Building

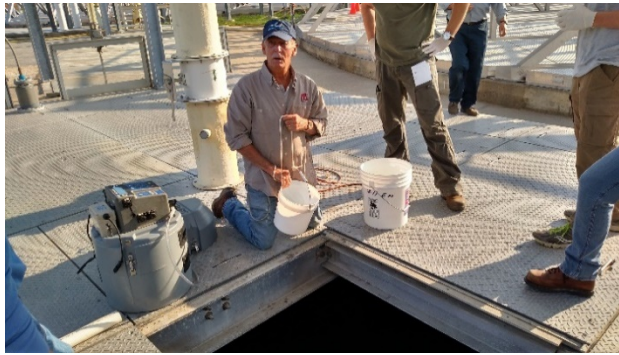
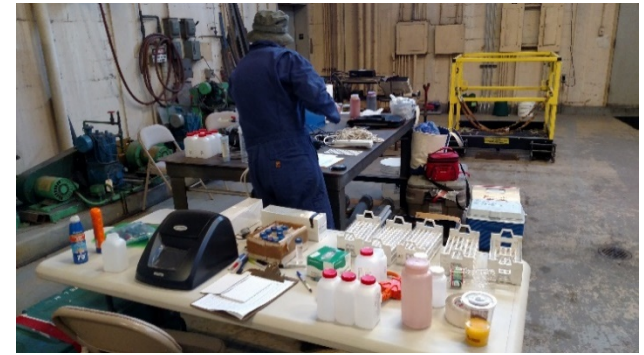
Hydraulics

- Stress Testing:
 - Performed in conjunction with Clarifier Performance Evaluations, Inc. (CPE)
 - Tested Primary Clarifiers for
 - Hydraulic balance/performance/capacity
 - Tested units at average flows and storm flows
 - Collected visual, dye test and TSS data

- Stress Testing Results:
 - Existing units/design still performed well after 40 years
 - Internal launder inboard vs outboard weir results similar
 - Short circuiting a concern at storm flows
- Stress Testing Recommendations:
 - A larger and deeper center well was recommended
 - Stick with internal double sided launder
 - No need to add EDI or DCB at this time

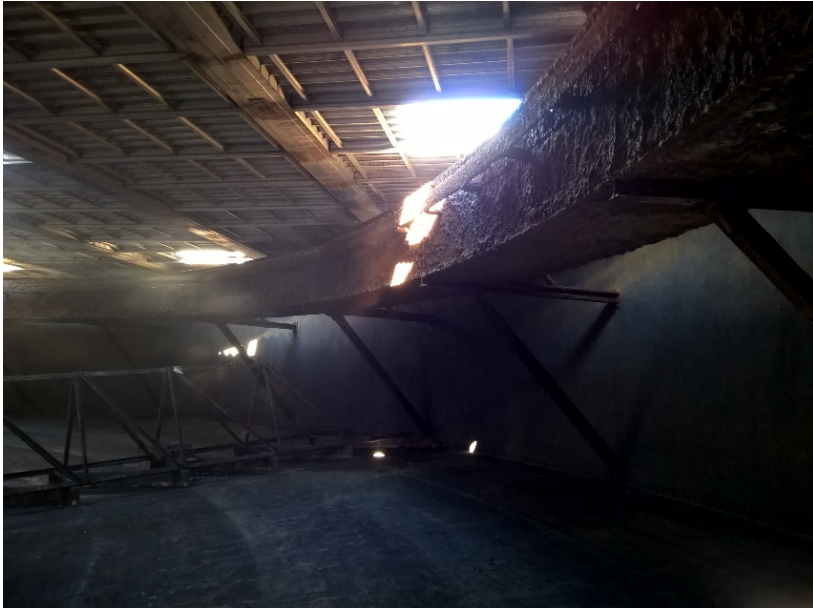
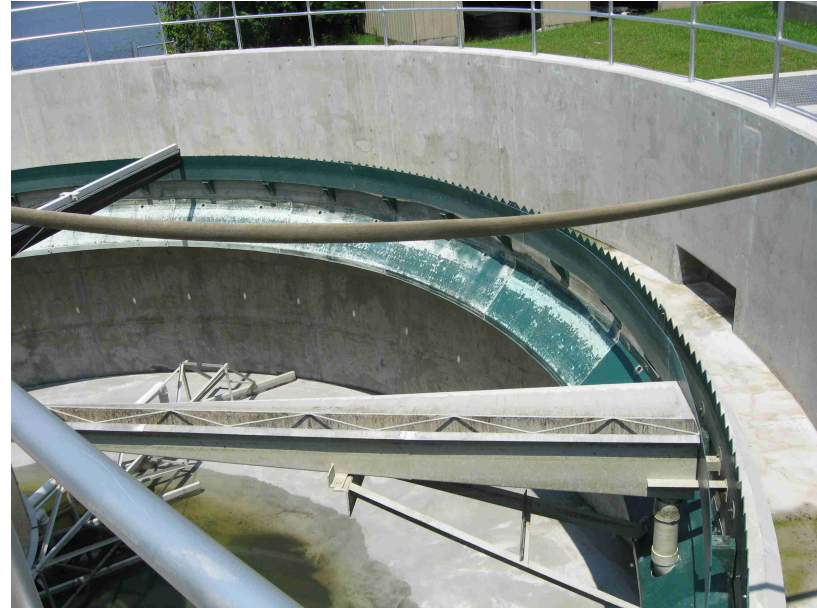
PC Effluent Launderers

- Internal double sided vs conventional perimeter

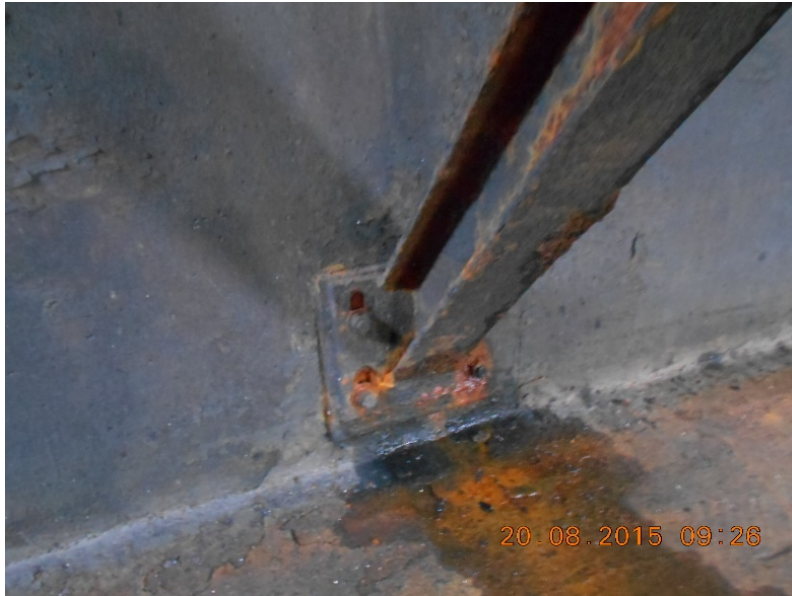
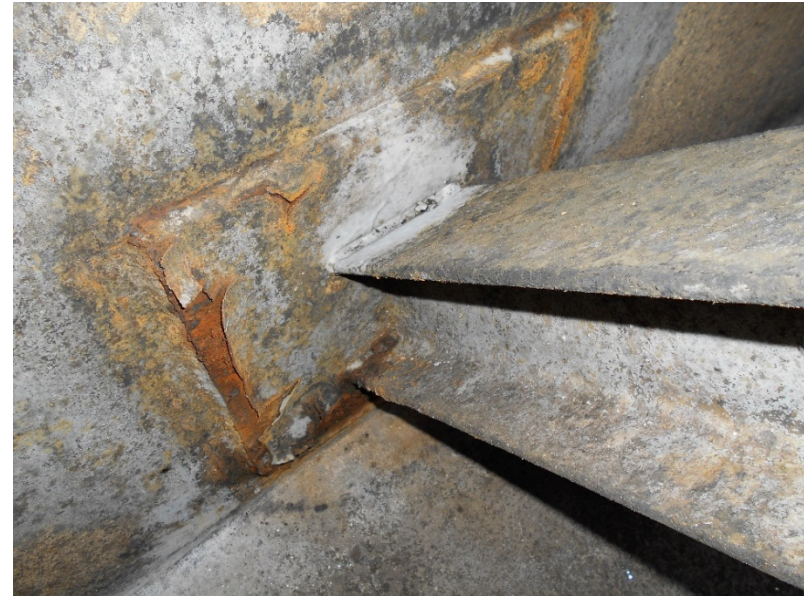
PC Effluent Launderers

- Provide all new supports vs reuse existing anchor points

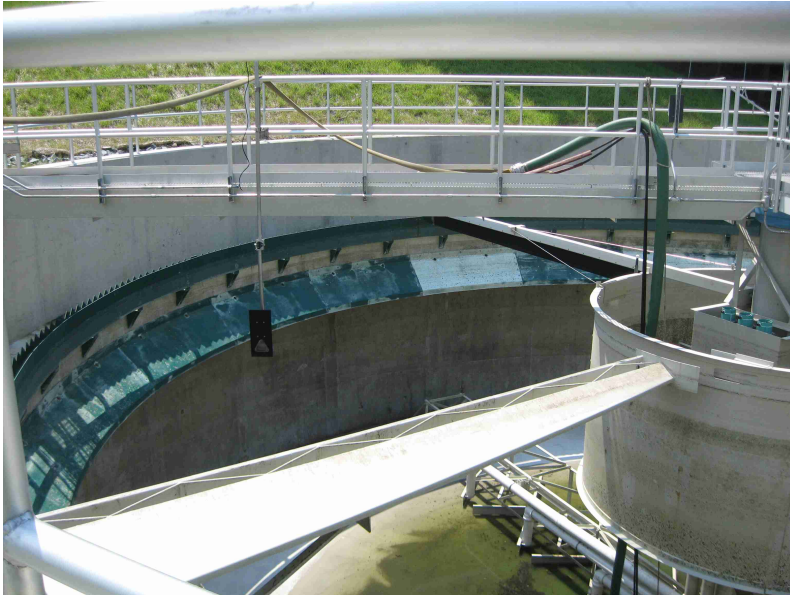
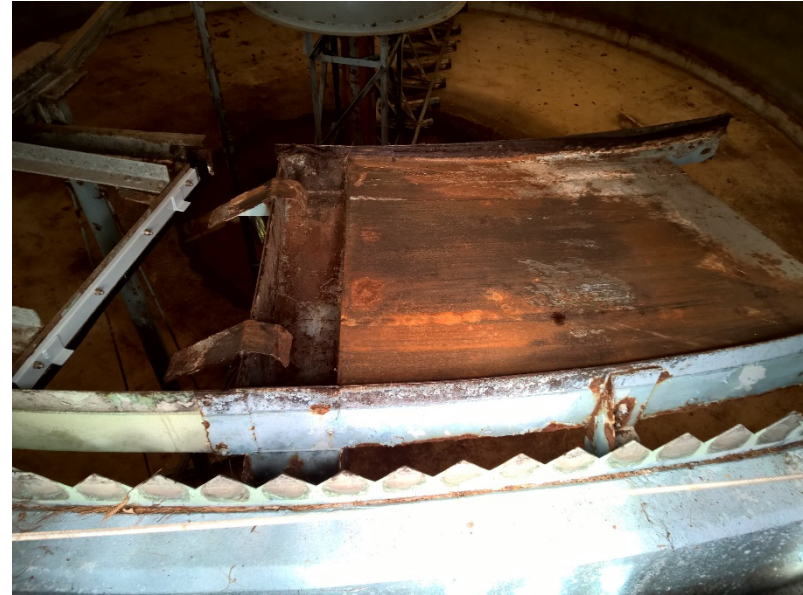
PC Scum Collection

- Multiple skimmer arms
- Full surface skimming vs perimeter skimming
- Water flushing at scum trough

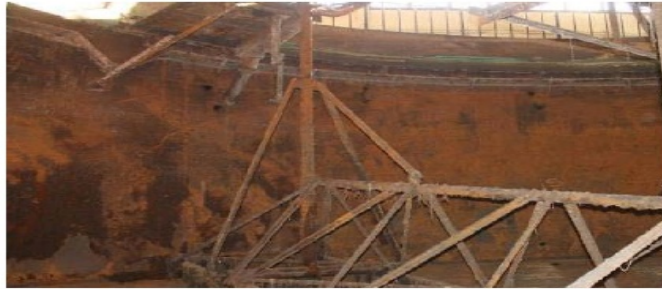
Photo No. 4 Wall of Thickener No. 1, under Skimmer Scum box, thin wall plate detected.

- Thickness Testing (Corrosion Probe, Inc.)
- Repair Methods

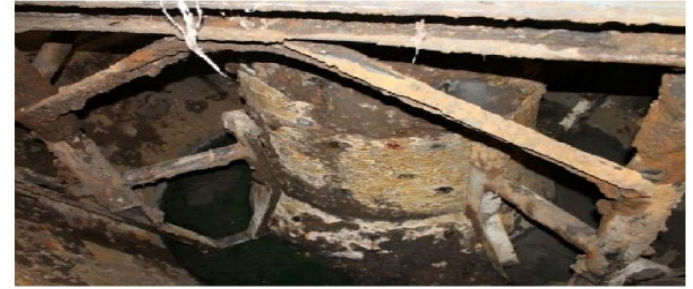
Photo No. 5 Center Column of Thickener No. 1, looking North at locations 10 thru 13.

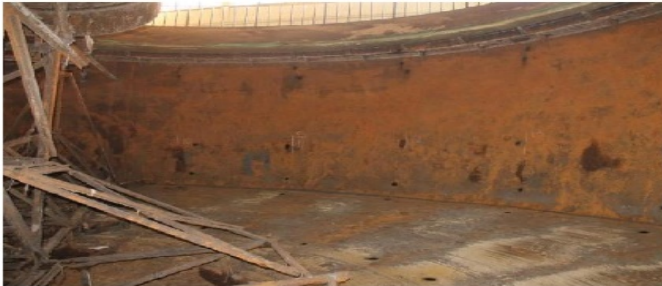
Photo No. 6 Wall and floor of Thickener No. 1, looking Southwest at locations 10 thru 14.

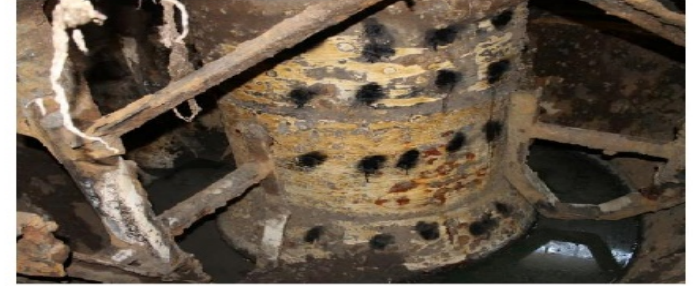
Photo No. 7 Center Column of Thickener No. 1, looking South at locations 1 and 16 thru 20.

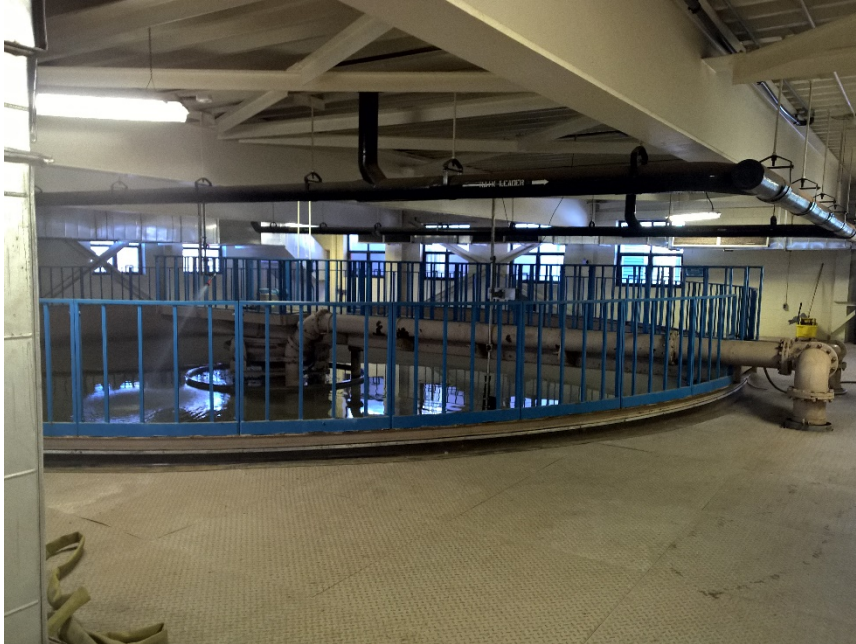
GT Covers

- Custom low profile design
- Odor control intake and discharge ports
- New blowers to existing scrubber

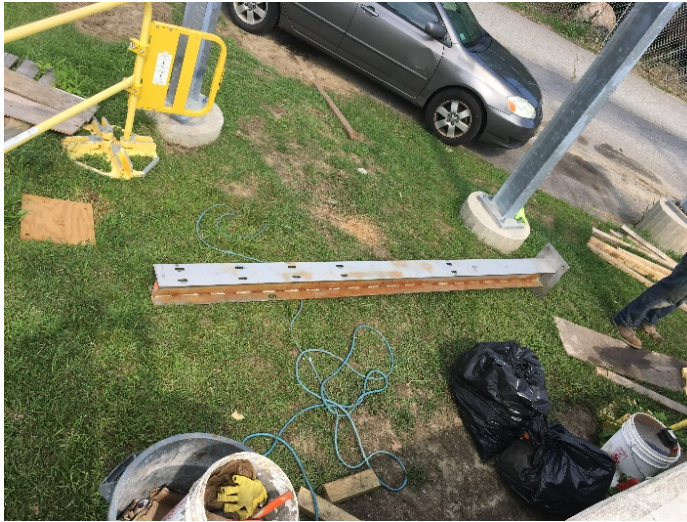
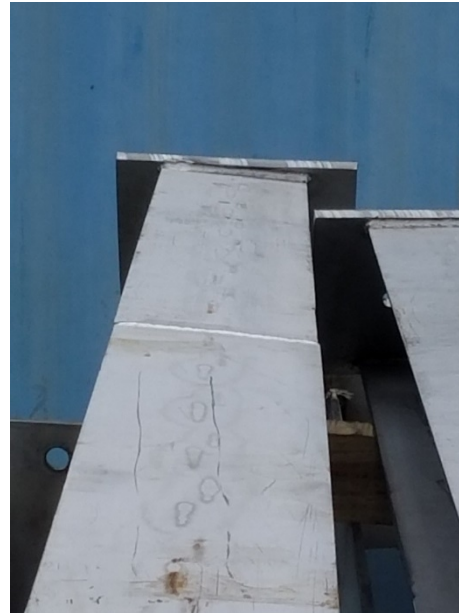
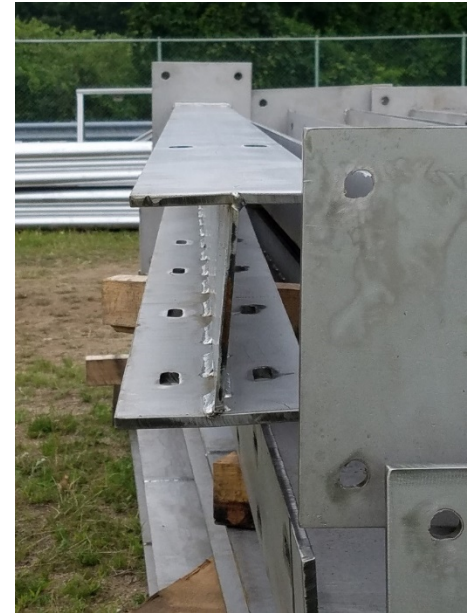
PC SS components

- Red residue/staining
- Twisted members

- Key PC Construction Challenges
 - SS components (red residue/staining; twisted members)
 - Launder support attachment to wall
- Key GT Construction Challenges
 - Sand blasting showed new repair areas
 - Not all new welds water tight
 - Custom covers

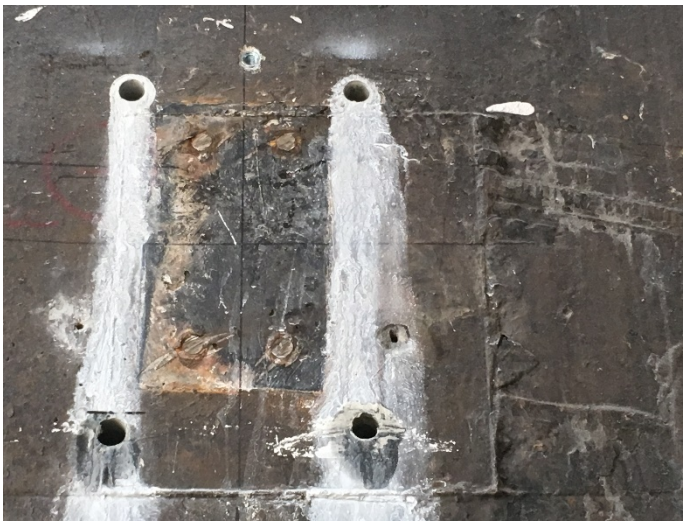
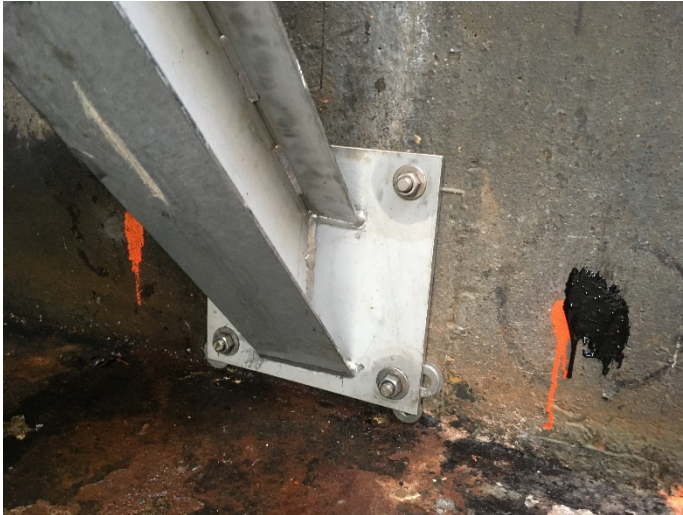
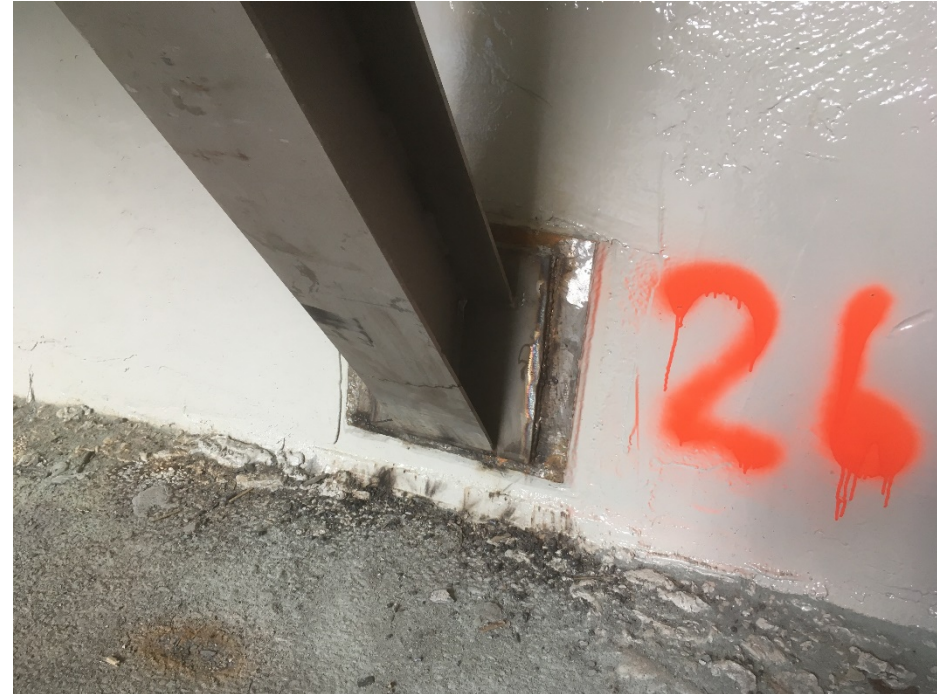
PC Launder Supports

- Bolted attachment
- Welded attachment

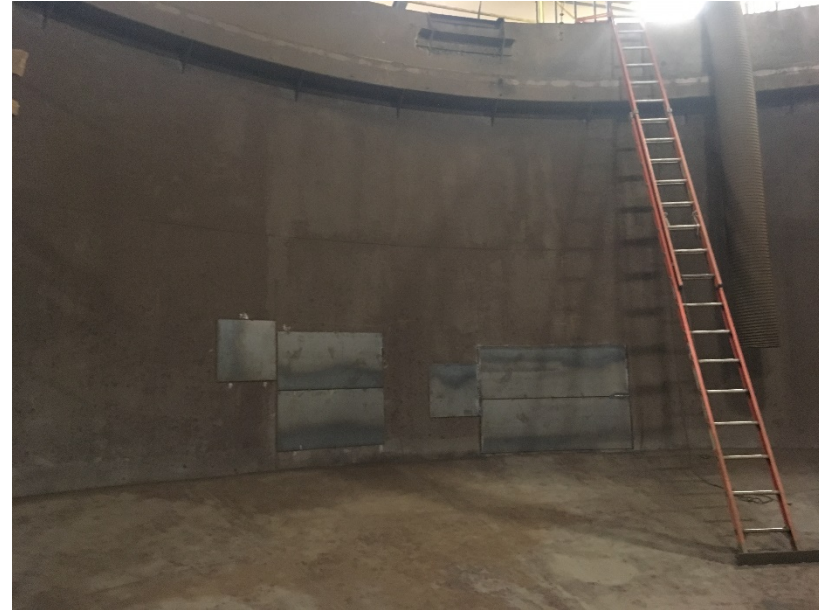
GT Sandblasting/Welding

- Sand blasting showed new repair areas
- Not all new welds water tight

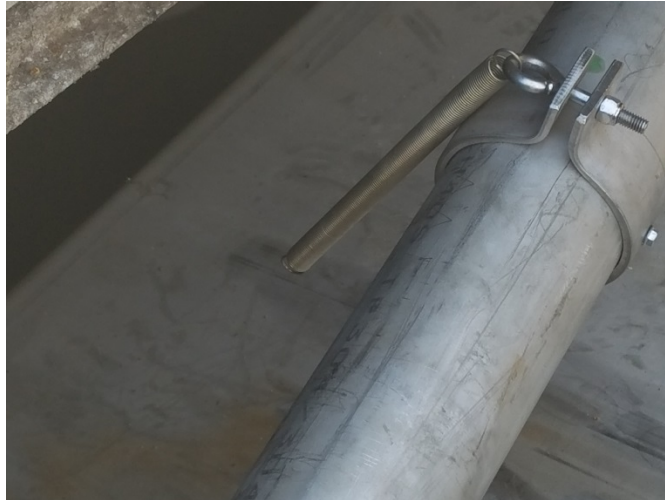
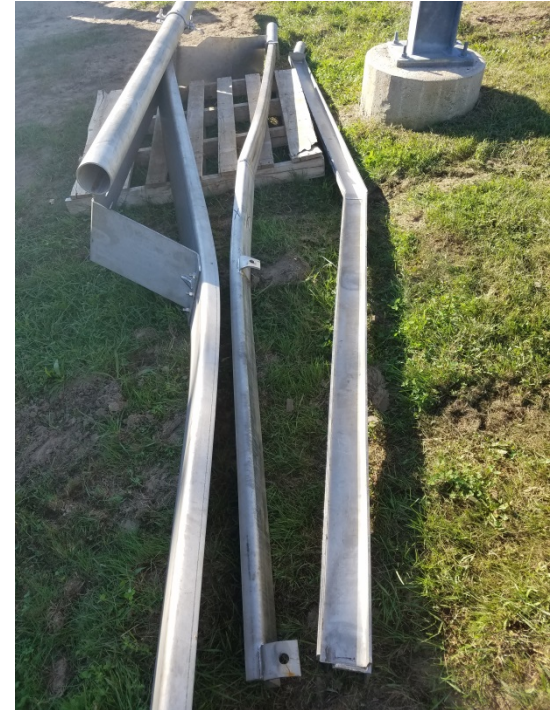
- Expect the Unexpected
 - PC skimmer arm scraper blade tension spring lets go.....

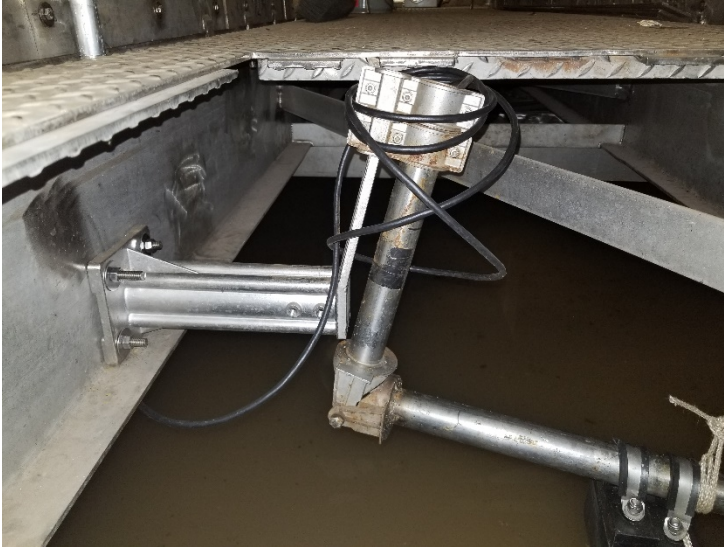
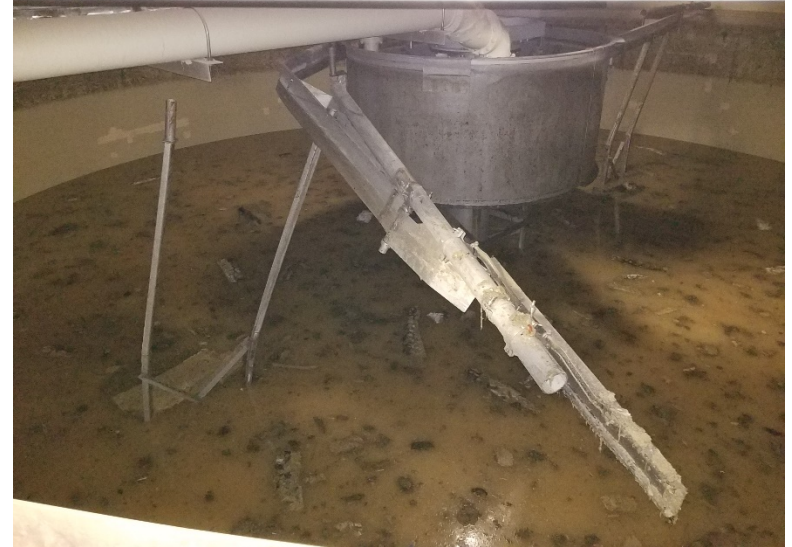
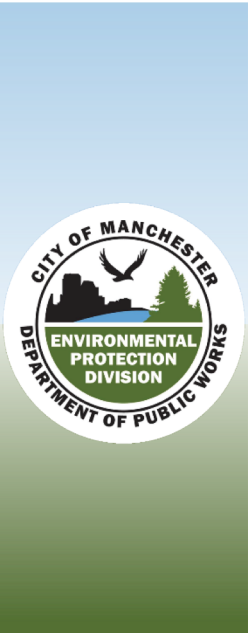
- Expect the Unexpected
 - GT SBD loosens and contacts skimmer arm.....

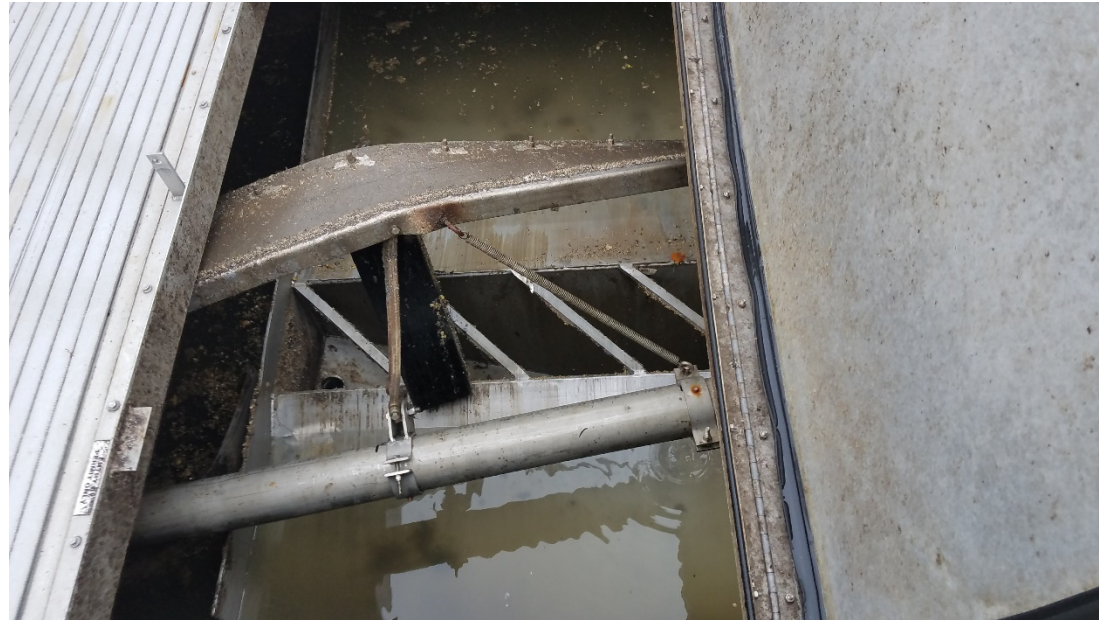
- Expect the Unexpected
 - 6"x6"x2' PT block vs PC skimmer arm.....

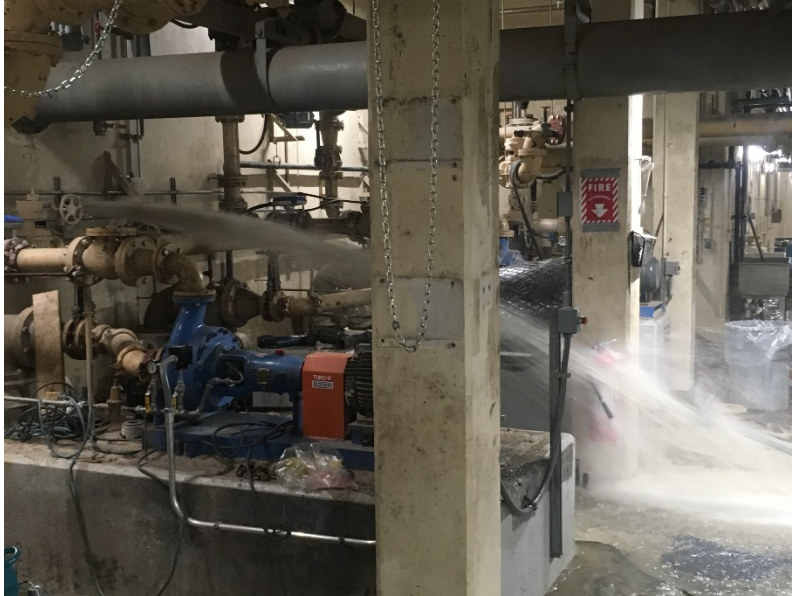
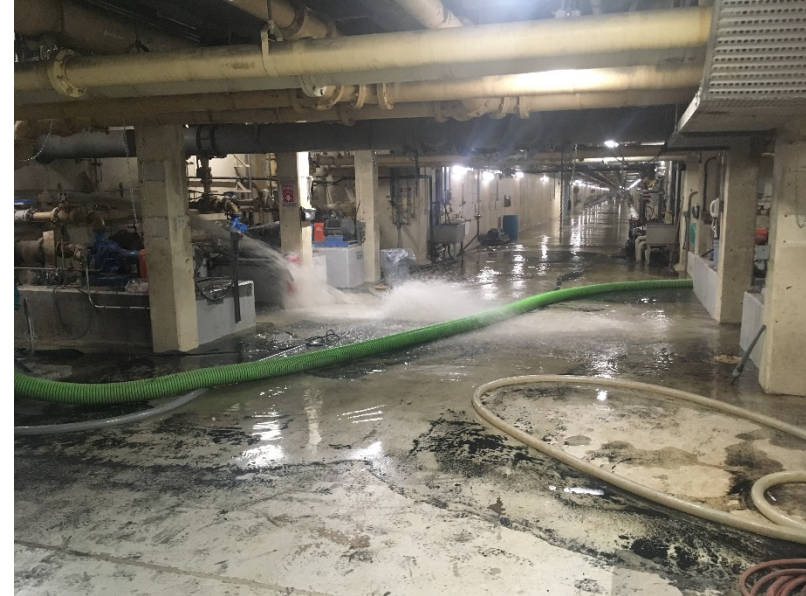
- Expect the Unexpected
 - 20' deep PC influent sample line plug lets go.....
