CITY OF QUINCY COASTAL INFRASTRUCTURE MITIGATION AND CLIMATE RESILIENCY STRATEGIES

**NEWEA Spring Meeting & Exhibit
June 5, 2019**

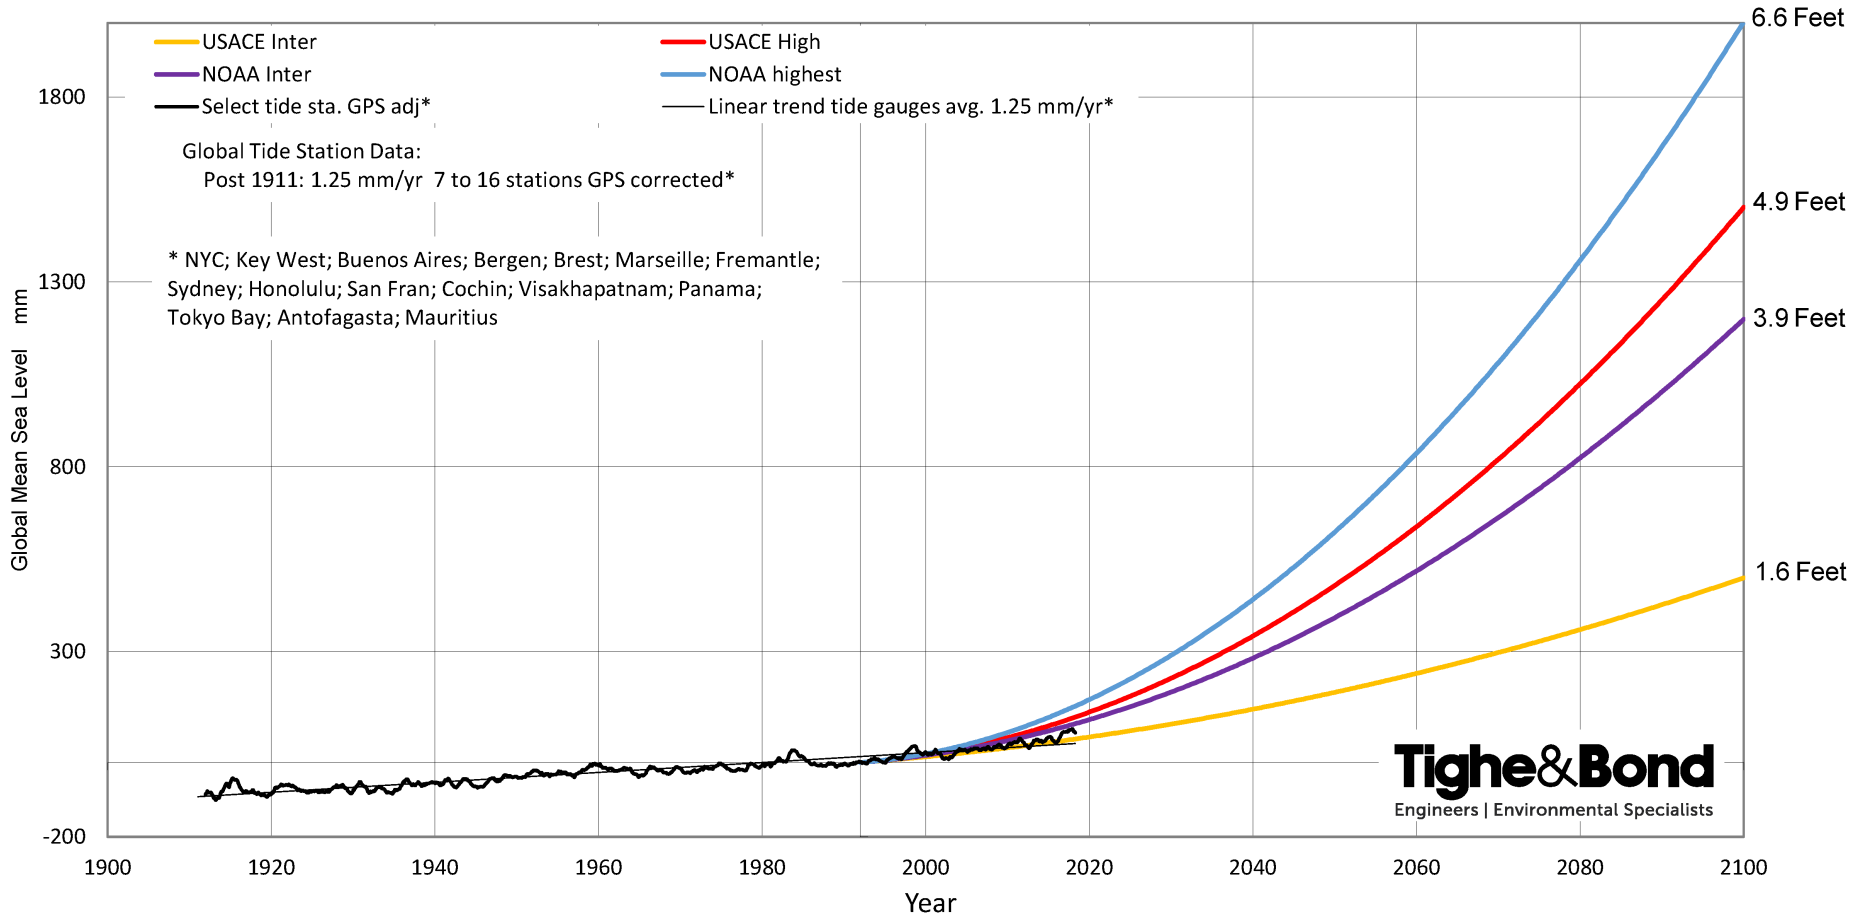
Sea Level Observations versus Projections

Projections: Global SLR Scenarios For the US National Climate Assessment, 2012

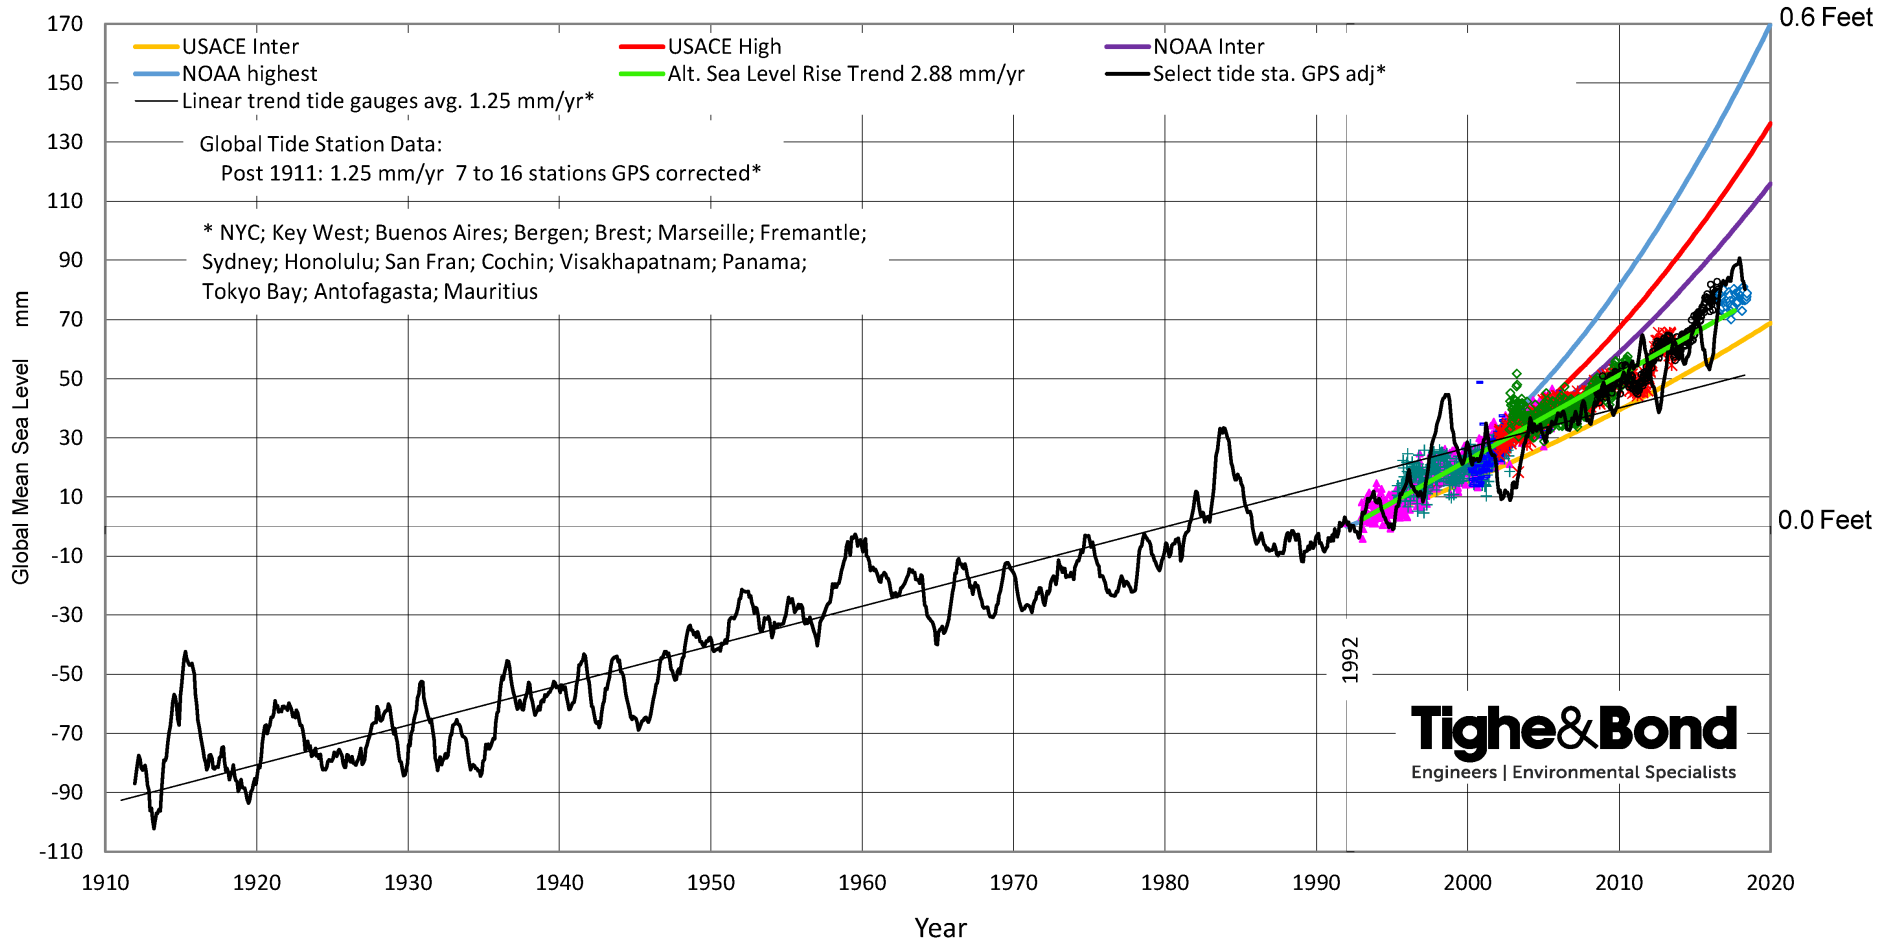
Sea Level Observations versus Projections

SEA LEVELS ARE RISING, BUT MINIMAL ACCELERATION SO FAR – REASONABLE FOR DESIGN

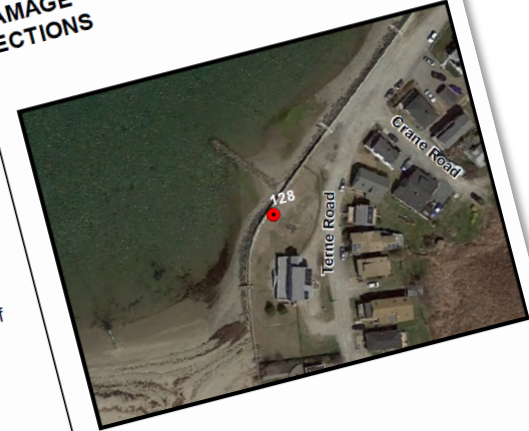
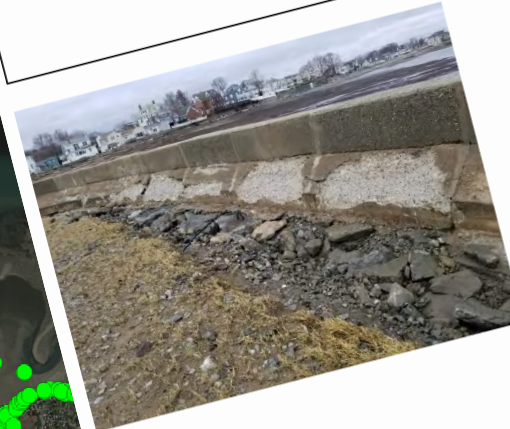
Location ID: 128

Observation:
Significant spalling on 7 units along landside of seawall

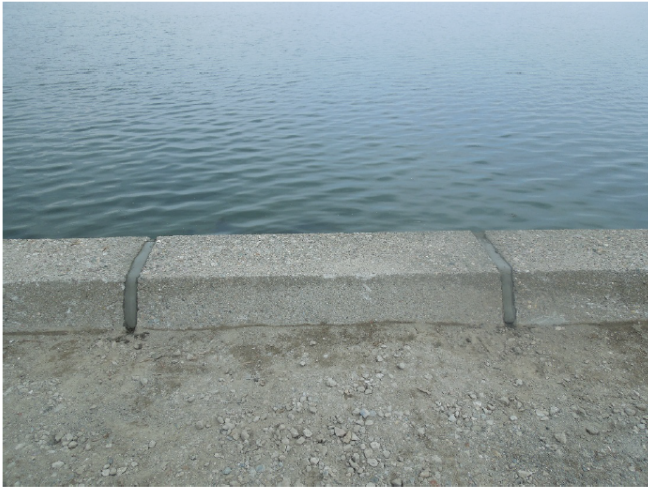
Roadside view of grouted joints along Dorchester Ave.

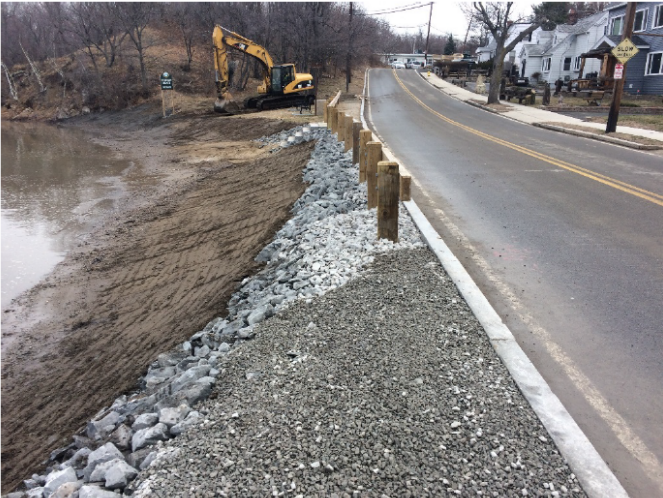
Revetment repair and curb reset at Nickerson Beach.

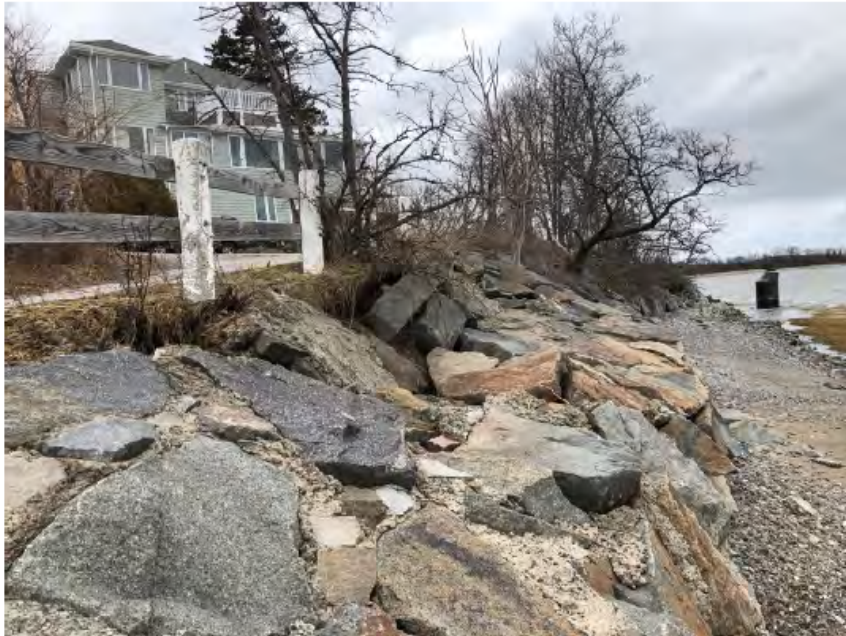
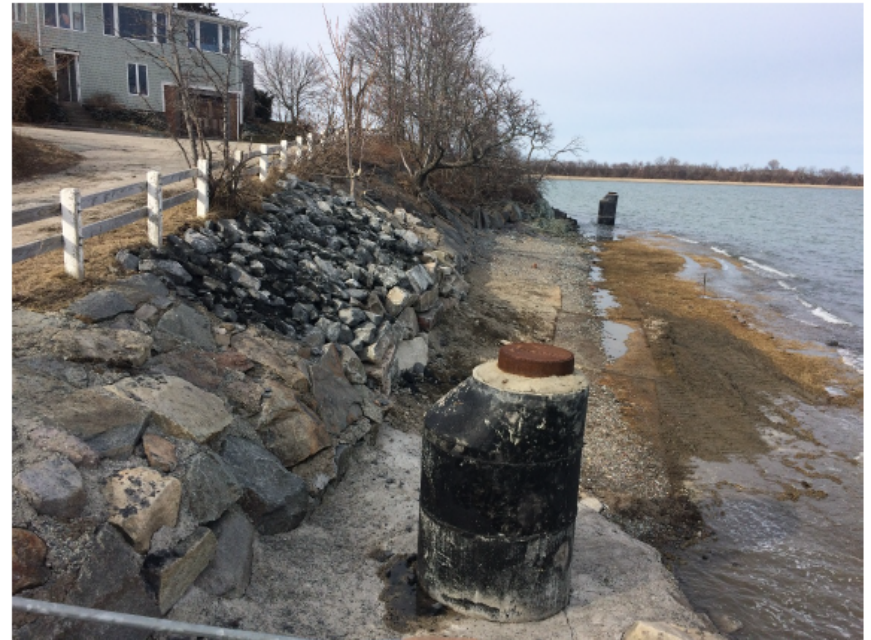
LOCATION 2 – BAYSIDE ROAD

Revetment repair along Bayside Road.

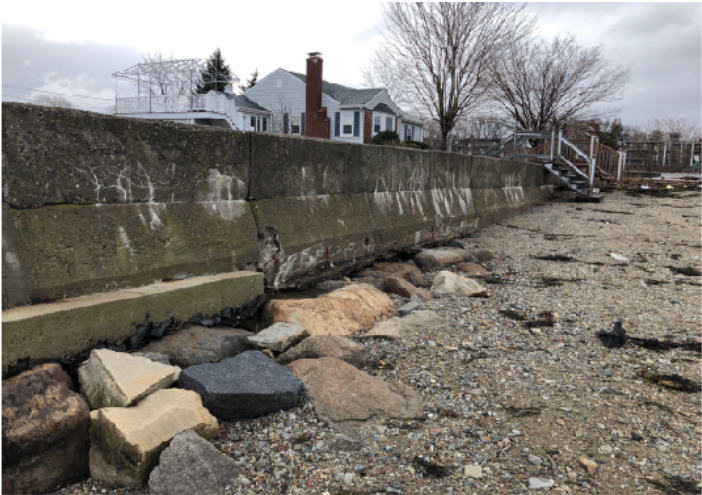
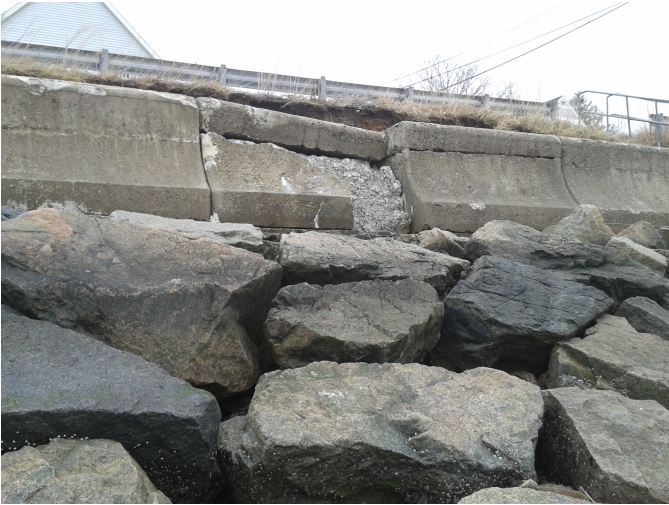
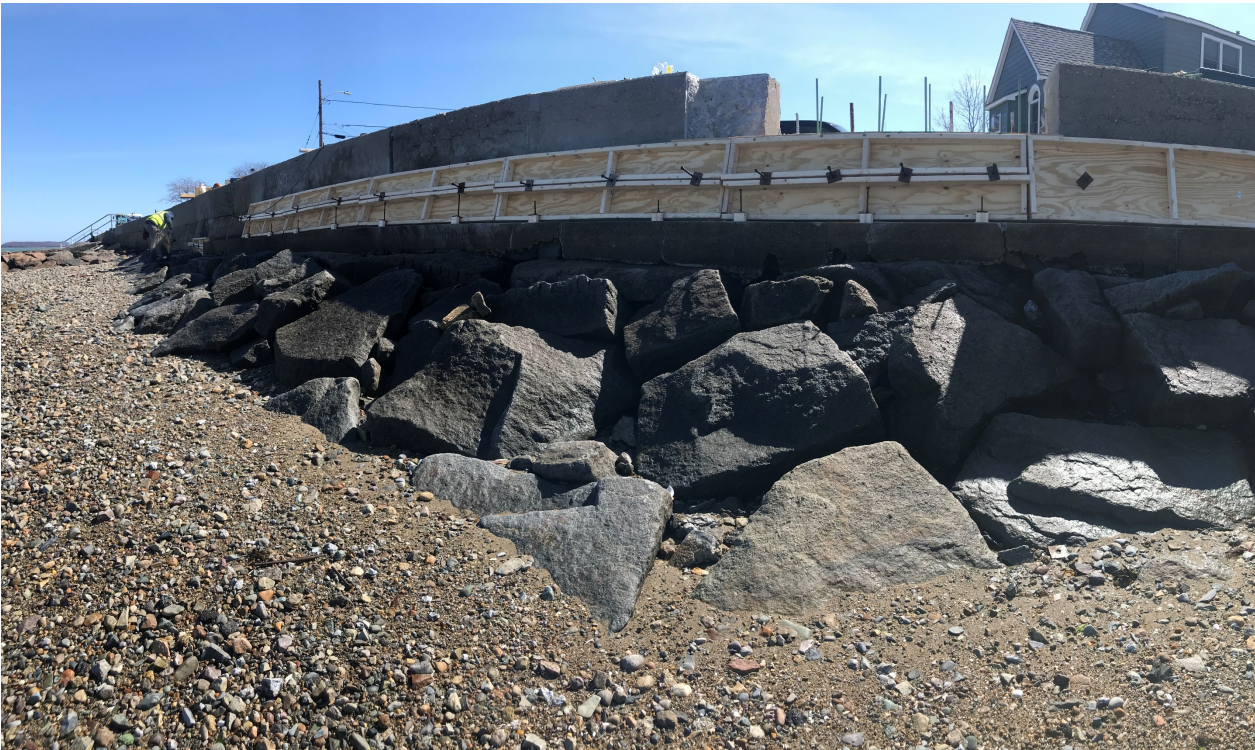
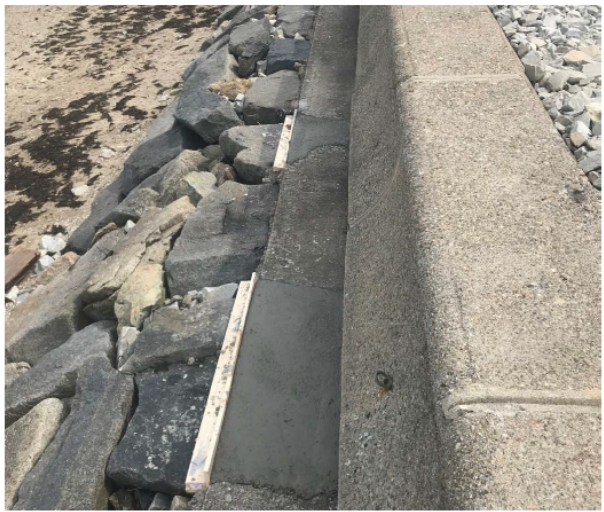
LOCATION 4 – TERNE RD. / SHELTON RD.

Leveling slab repaired at seawall along Shelton Rd.
