Prioritizing Green Infrastructure for Phosphorus Reduction within Boston's MS4

Lower Stony Brook Green Infrastructure
First Baptist Church Bioretention

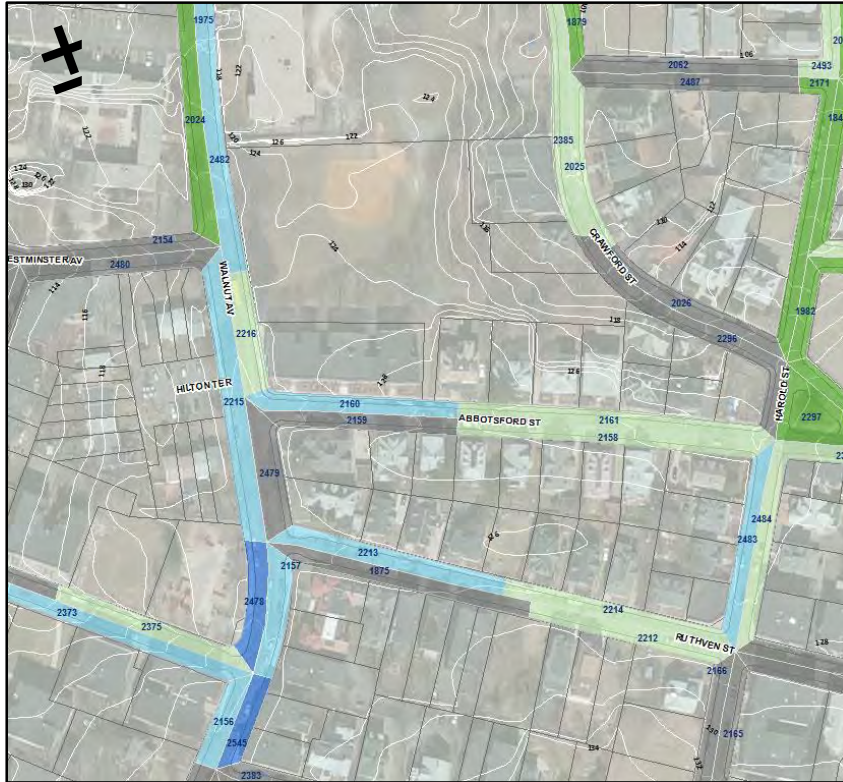
Drainage Area Analysis

Drainage areas characterized as:

- **High** – Minimal constraint impacts
- **Off-site High** – DA can be easily managed by an adjacent parcel
- **Medium** – Some constraints however drainage area could still be managed with additional coordination
- **Off-site Medium** – Drainage area may need to cross a street or need further investigation
- **Low** – Drainage area is not suitable for GI nor can it be managed by another location

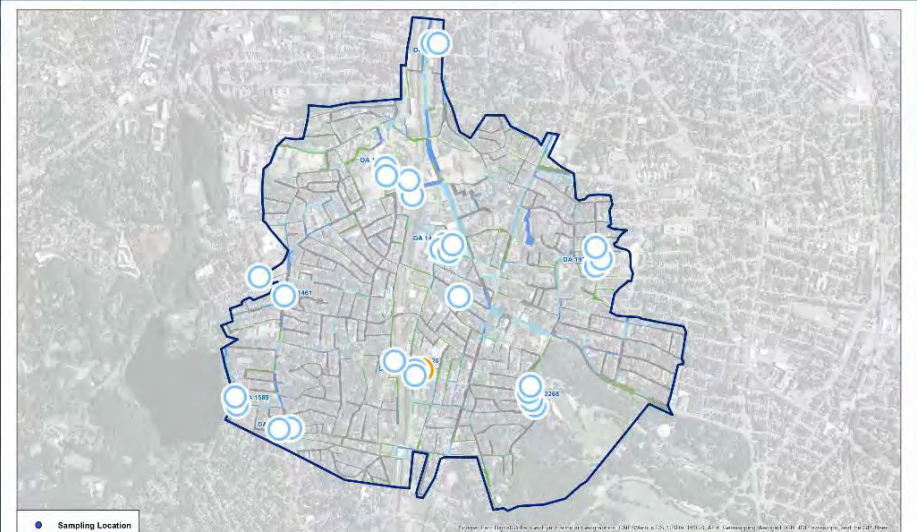
Lower Stony Brook Green Infrastructure Sampling Locations
*Priority Drainage Area Labels

● Sampling Location

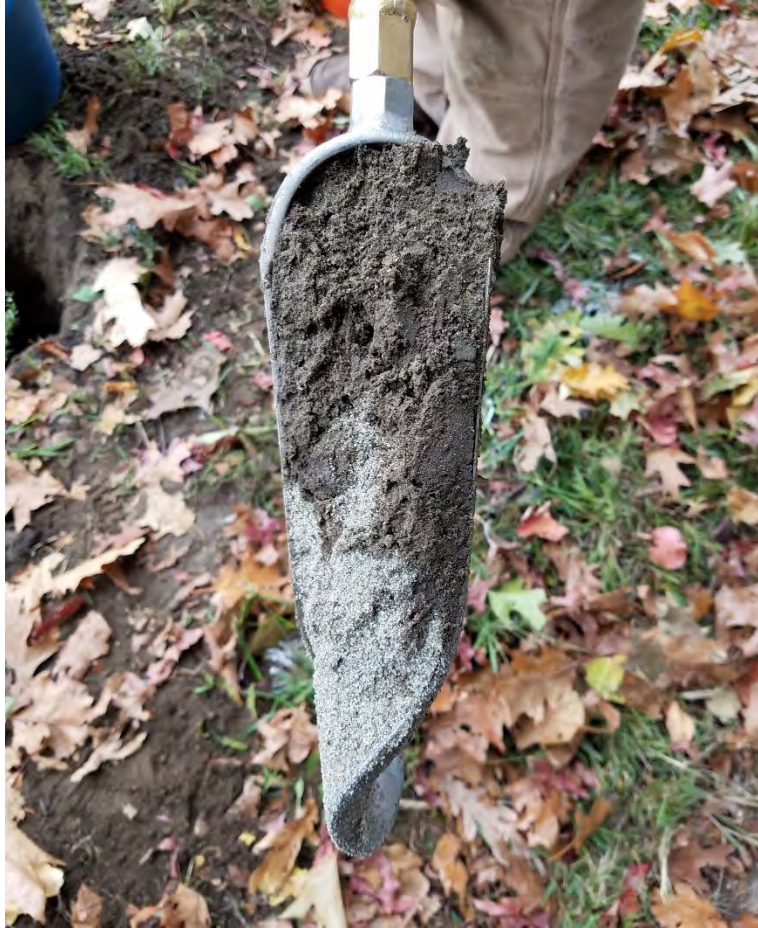
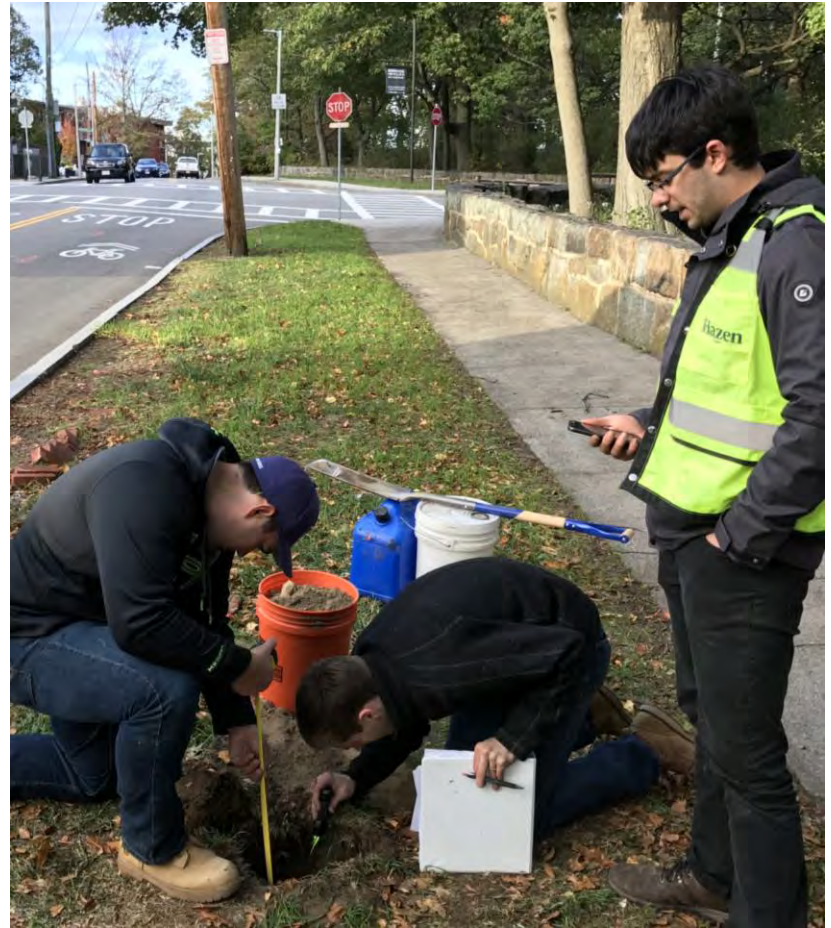
Hand Auger Characterization and Infiltration Testing

Site	Raw Drawdown (in/hr)	Design Infiltration Rate (in/hr)
1447	5	0.6
1431	11	1.2
1589	13	0.8
1933	9	2.0
2144	30	4.3
1240	6	1.7
1022	0	0
2313	7	1.0
1820	3.6	0.5

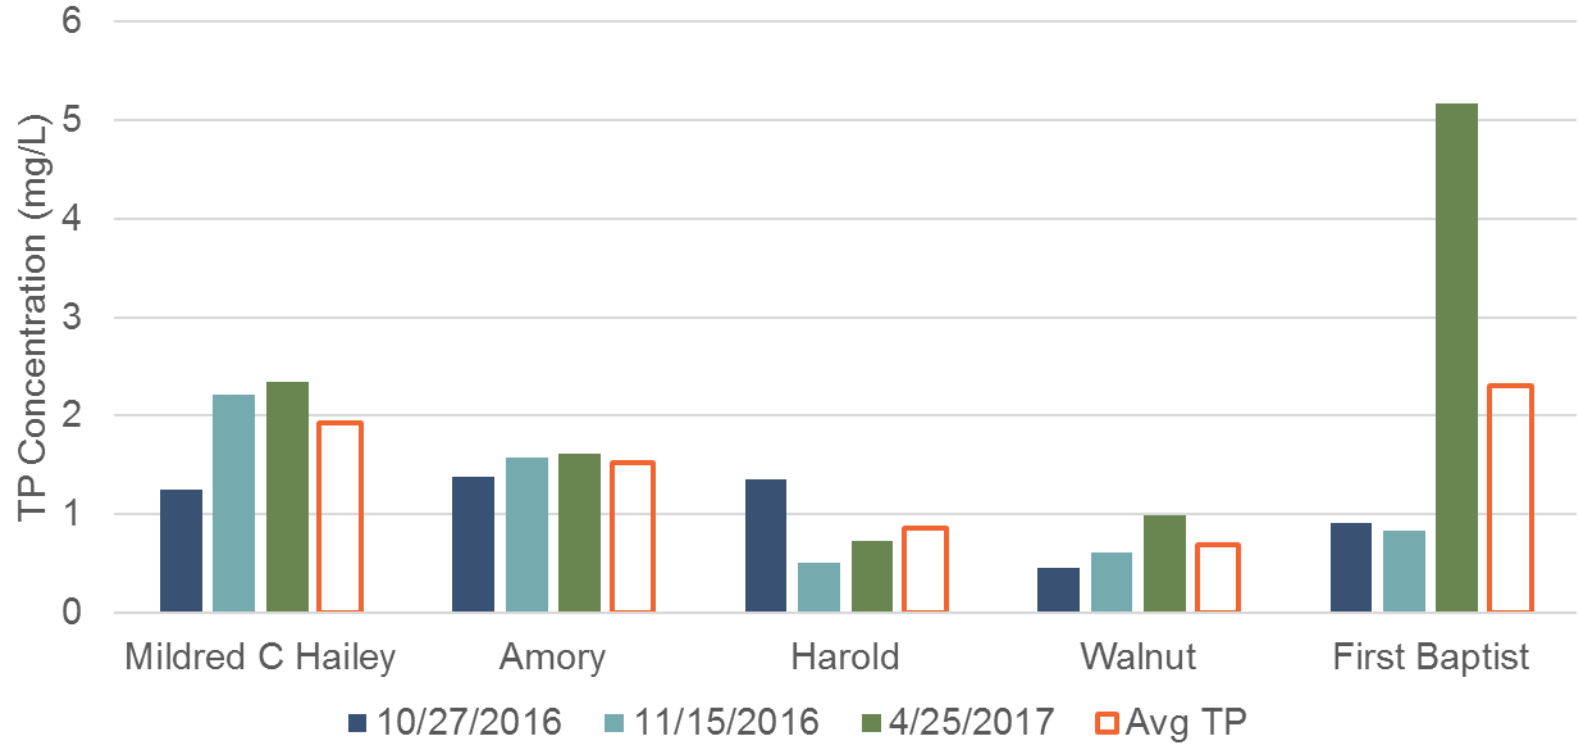
Total Phosphorus

Storm Sampling Results

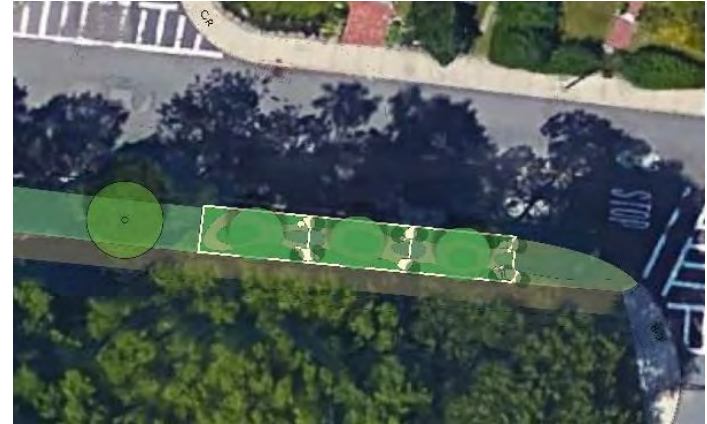
Example: Walnut Ave.

Right-of-Way Bioretention

- Linear bioretention implemented within the ROW
- Treatment of adjacent ROW runoff through curb cuts and other diversions

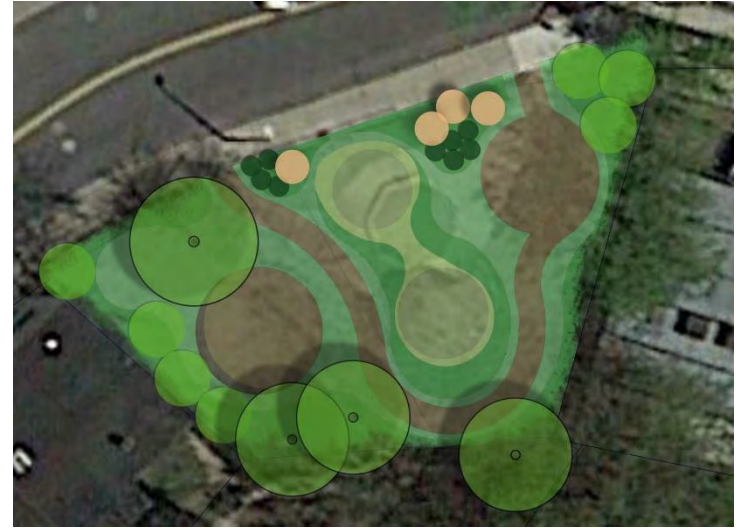
Example: Amory St. & Dimock St.

Small Catchment Bioretention

- Bioretention on a public or private property
- Treatment of adjacent areas < 1 ac
- Often sited in grassed areas, small parks, or other open spaces

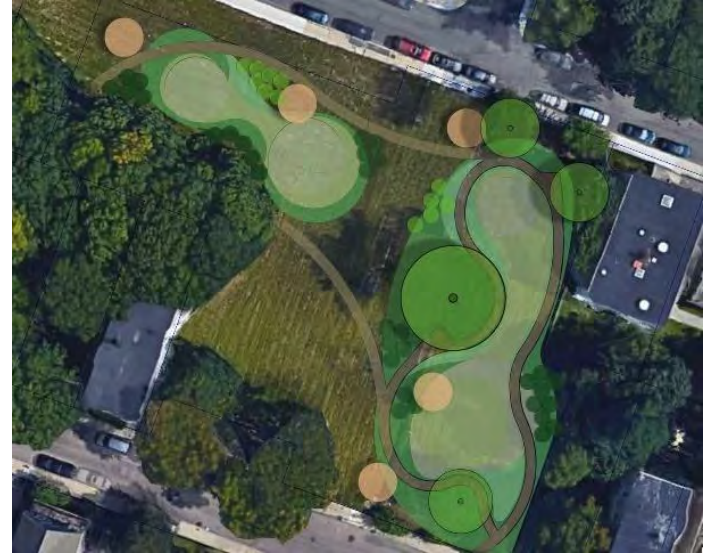
Example: Harold St. & Hollander St.

Large Catchment Bioretention

- Bioretention on a public or private property
- Treatment of adjacent areas > 1 ac
- Multiple drainage diversions, disconnections, and street crossings typical
- Often sited in vacant lots or other large open spaces

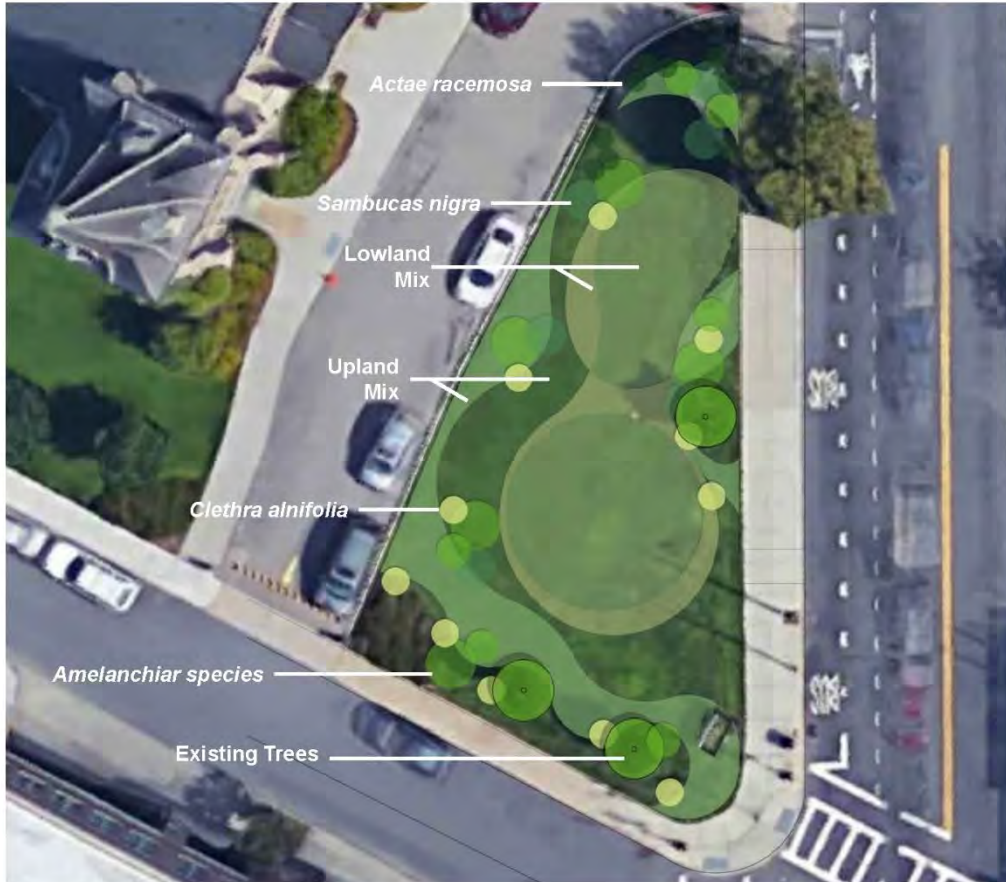
First Baptist Church Bioretention Planting Plan

Genus and Species	Common Name
Lowland Mix	<i>Andropogon gerardii</i>	Big Blue Stem
	<i>Carex formosa</i>	Handsome Sedge
	<i>Panicum virgatum</i>	Switchgrass
	<i>Polygonum hydropiper</i>	Marsh Pepper Knotweed
Upland Mix	<i>Asclepias tuberosa</i>	Butterfly Milkweed
	<i>Eupatorium fistulosum</i>	Joe Pye Weed
	<i>Hypericum ascyron</i>	Great St. John's-wort
	<i>Monarda fistulosa</i>	Wild Bergamot
Shrubs & Tree	<i>Actaea racemose</i>	Bugbane
	<i>Amelanchiar species</i>	Serviceberry
	<i>Clethra alnifolia</i>	Sweet Pepperbush
	<i>Sambucas nigra</i> 'Eva ppaf'	Black lace Elderberry
