A PHOENIX FROM THE ASHES

THE FALL AND RISE OF THE GREENFIELDS WWTP

NEWEA Annual Conference
January 2022

Erin K. Moore, PE, Tighe & Bond
David Seche, Tighe & Bond

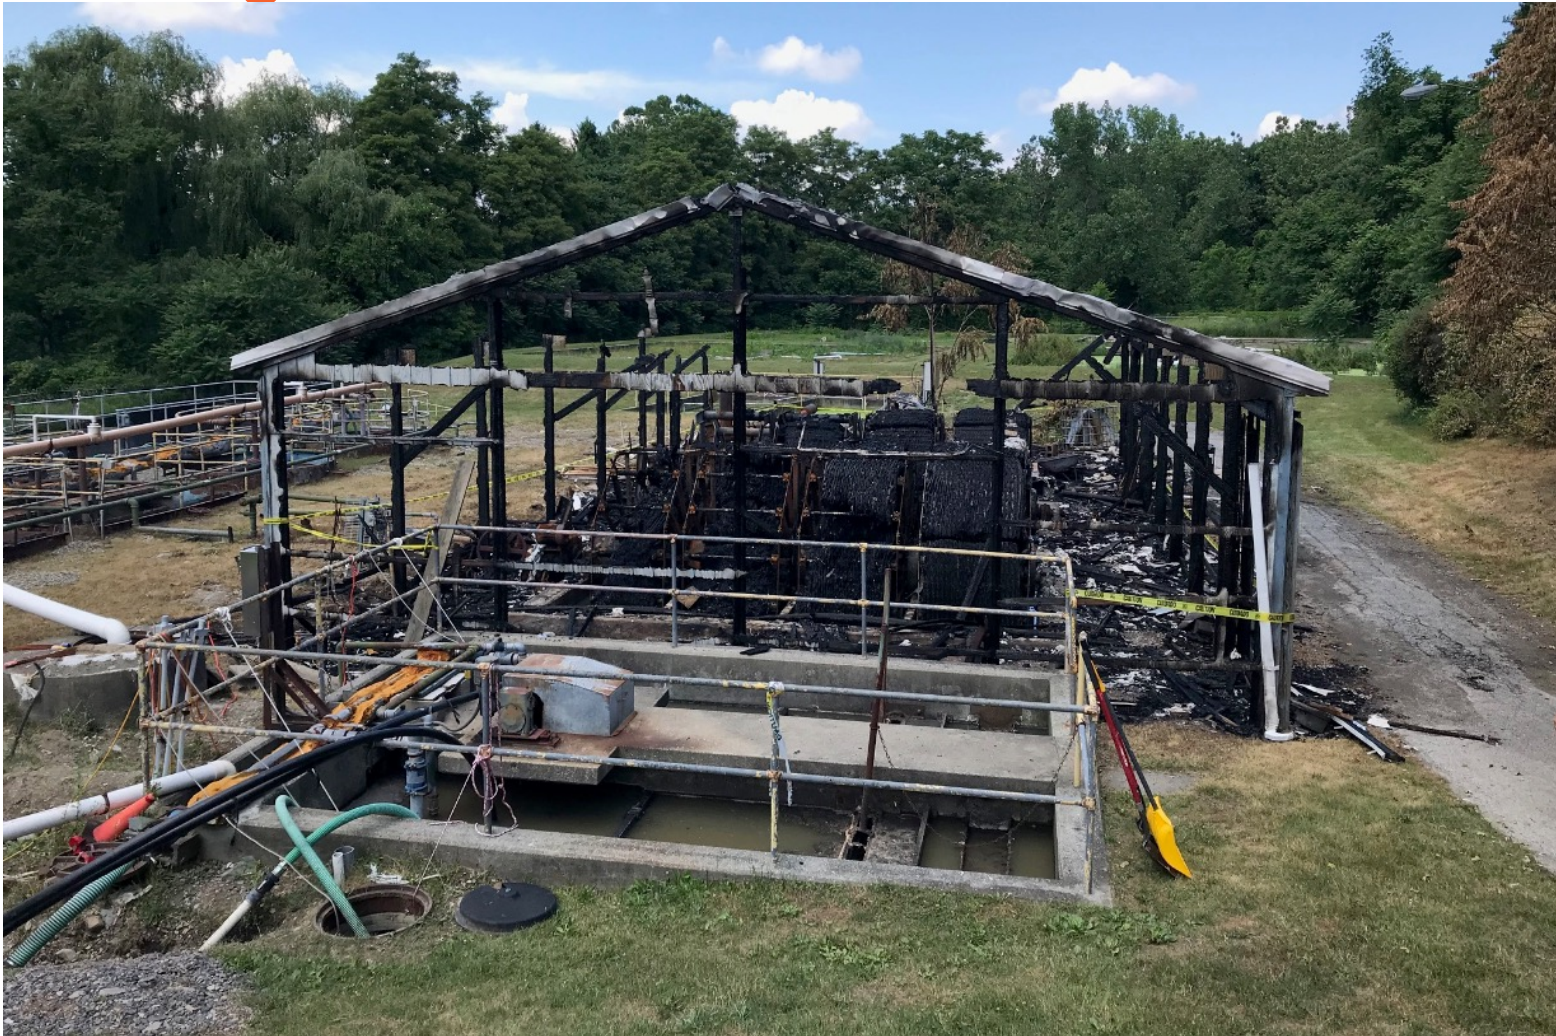
- **Primary Clarifier – OK!**
- **Sludge Air Lift - Gone**

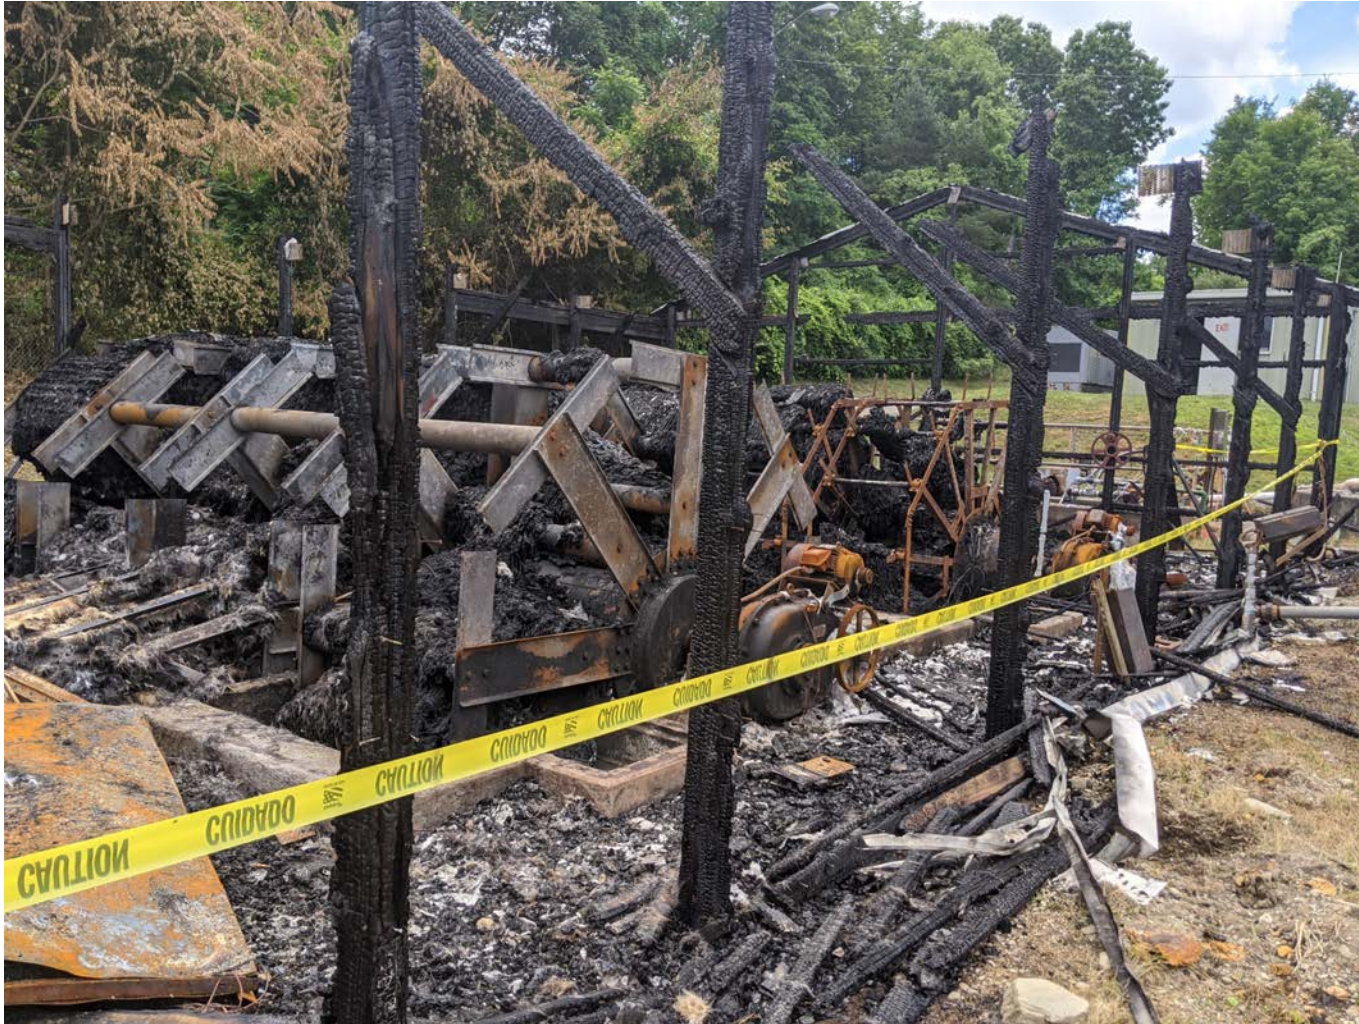
- RBCs – Gone

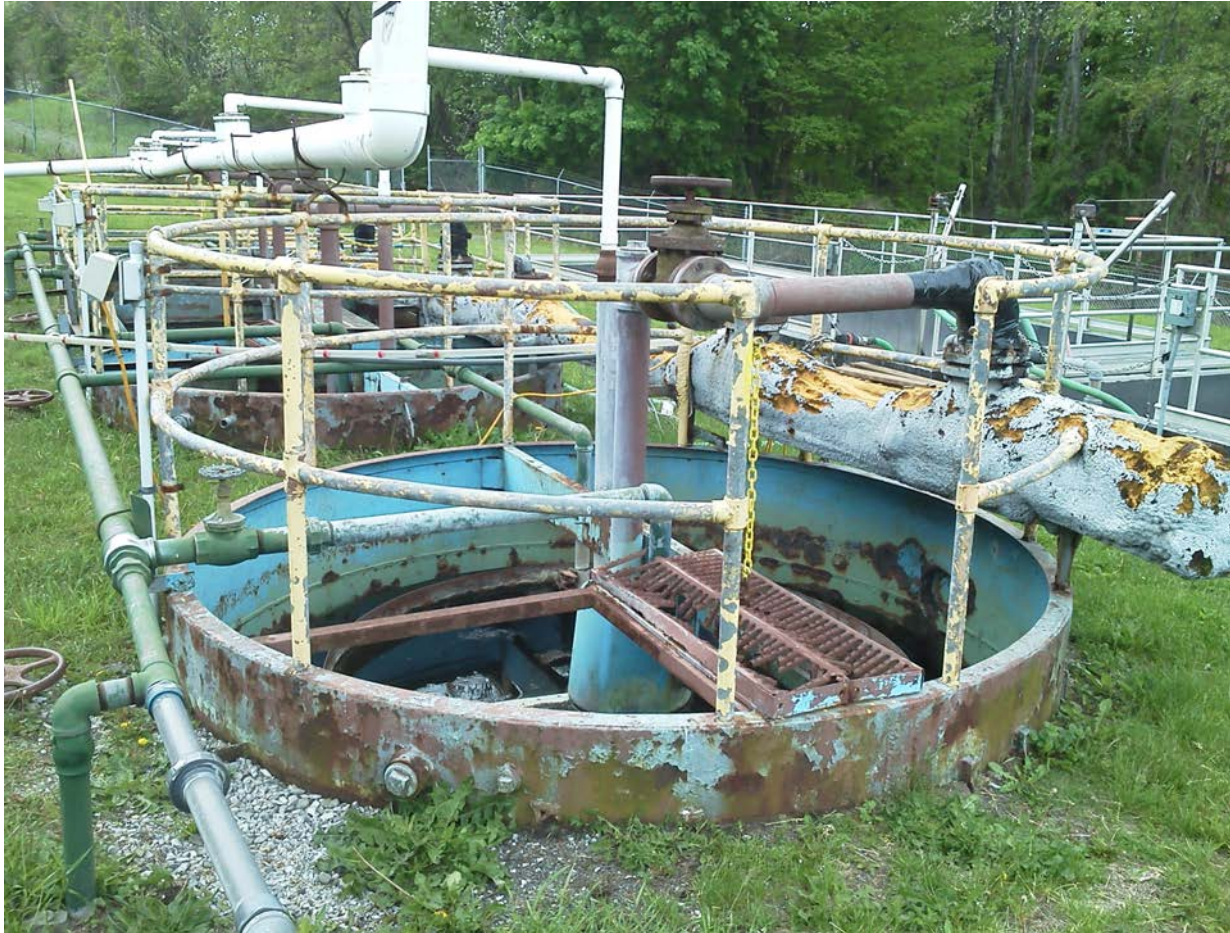
- **Secondary Clarifiers – OK?**
- **Sludge Air Lift - Gone**

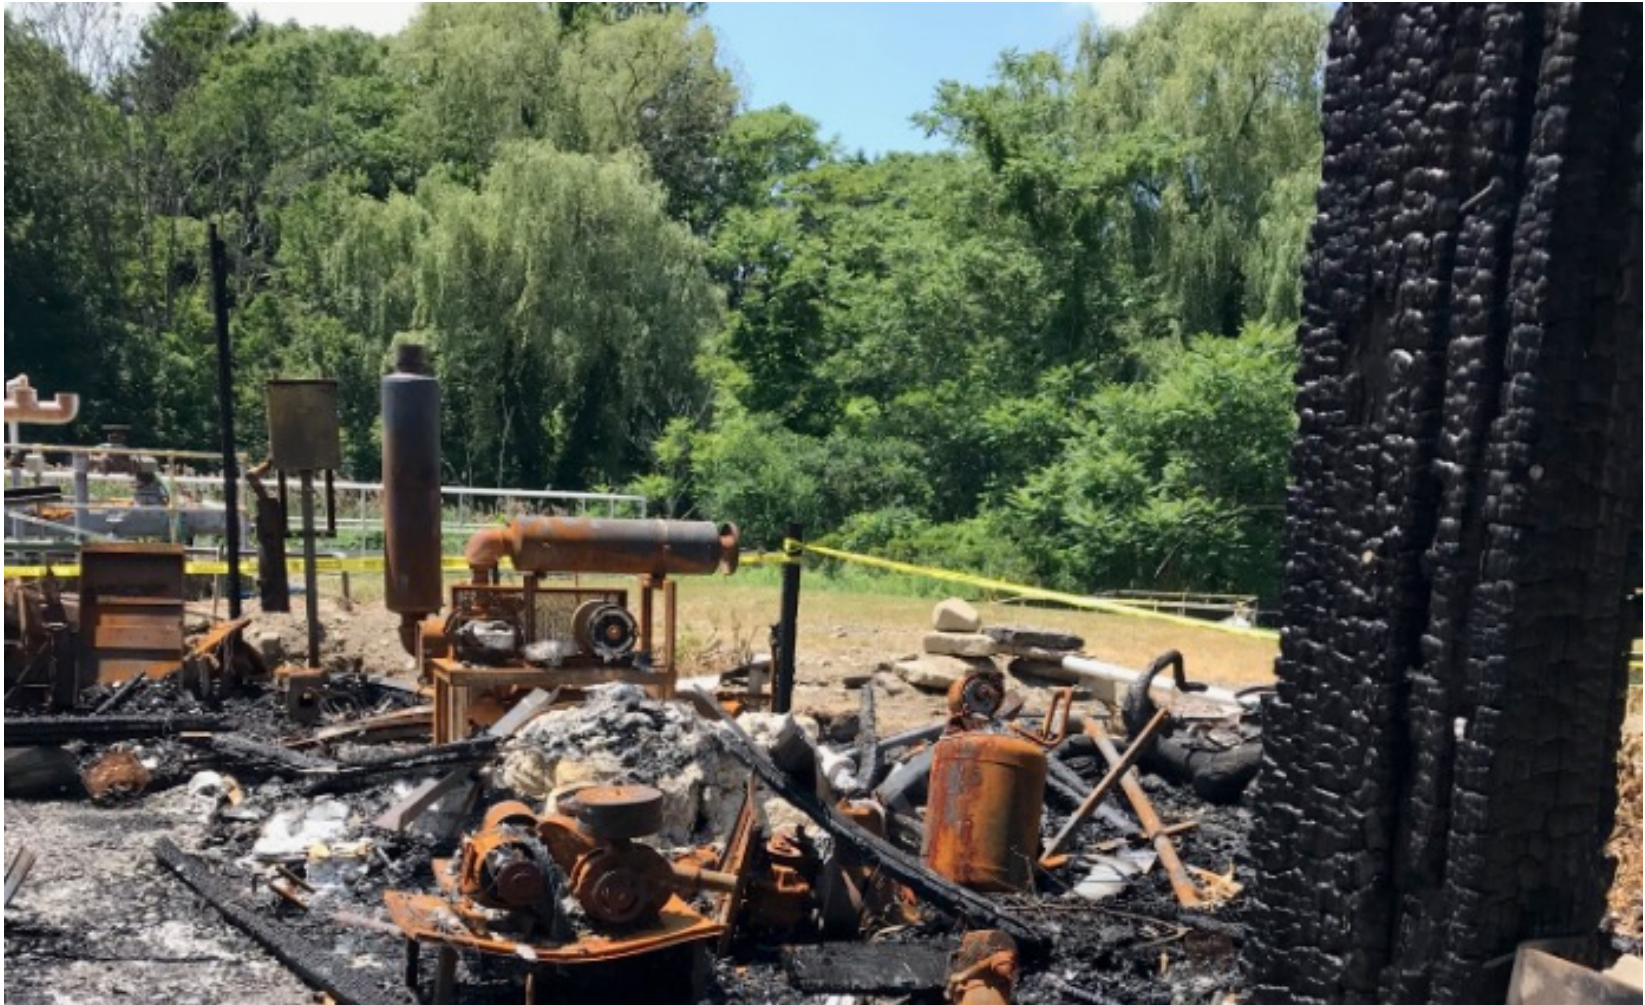
- **Blowers – Gone**
- **Disinfection Chemical Feed – Gone**

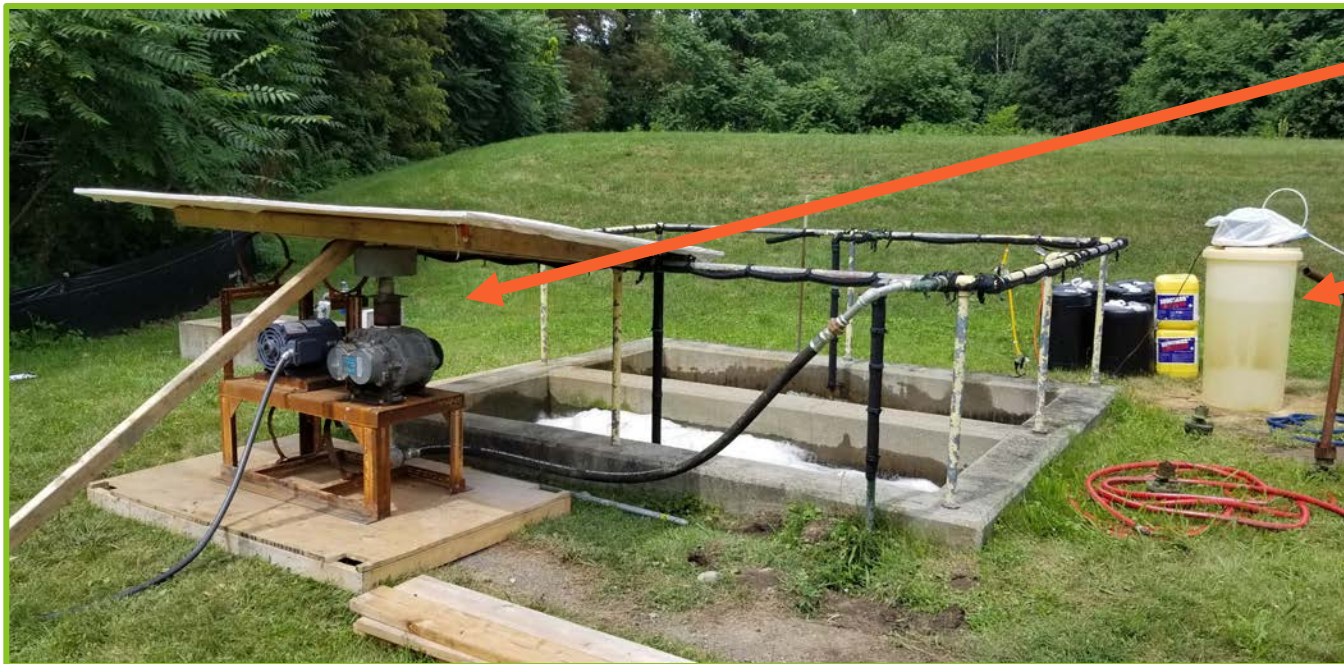
Temporary blower

Disinfection

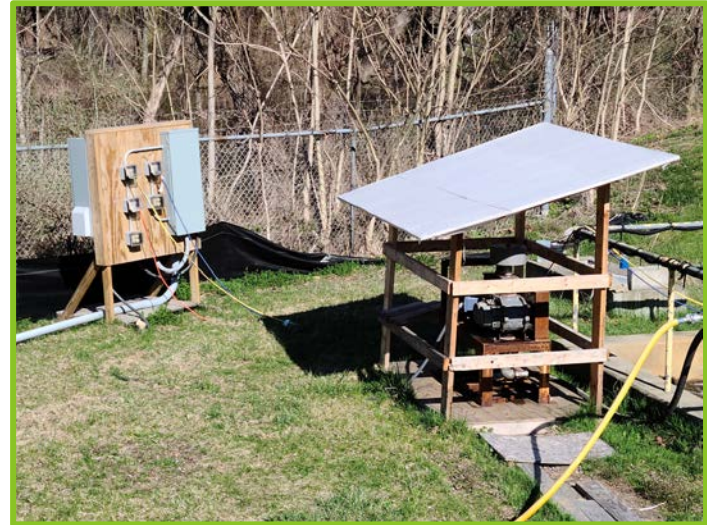
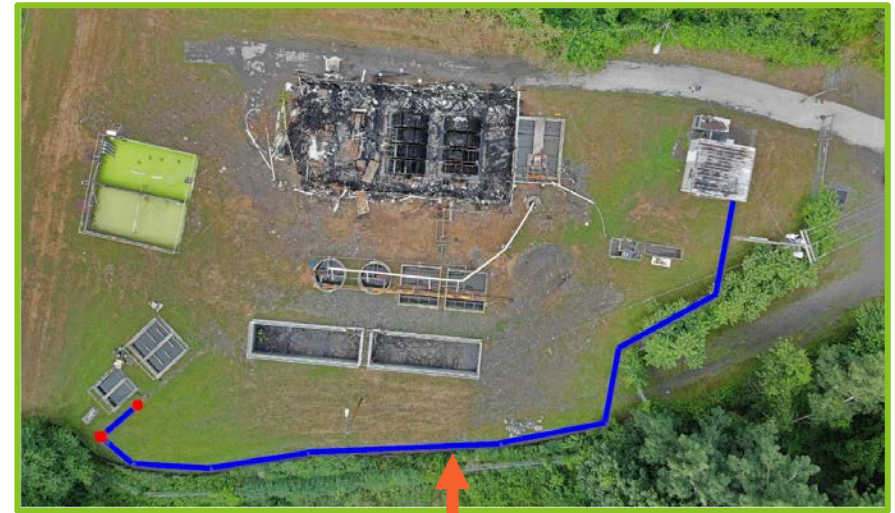
- **Restoration of post aeration was the second priority.**
 - Tighe & Bond sized the replacement blower and located a local supplier to provide a blower quickly.
 - Temporary power for the blower was coordinated through the Electrical Contractor. This required extending power to the far end of the site and procurement of a compatible VFD, which delayed restoration of the post aeration.
 - Post aeration was restored 28 days after the fire.

Routing of temporary electric service

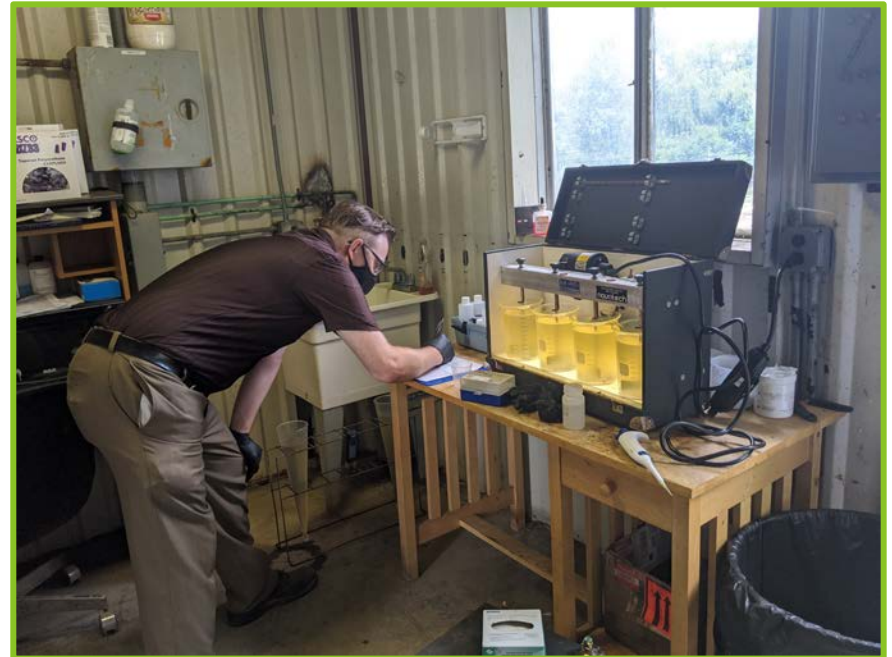
COAGULANT JAR TEST RESULTS

- Coagulant vendor representative visited site to test different coagulants. Jar testing was conducted, and a coagulant type and dose selected.
- Recommended coagulant and dose:
25 uL/L of Surfloc C-3000
- Enhanced coagulation was begun 21 days after the fire.

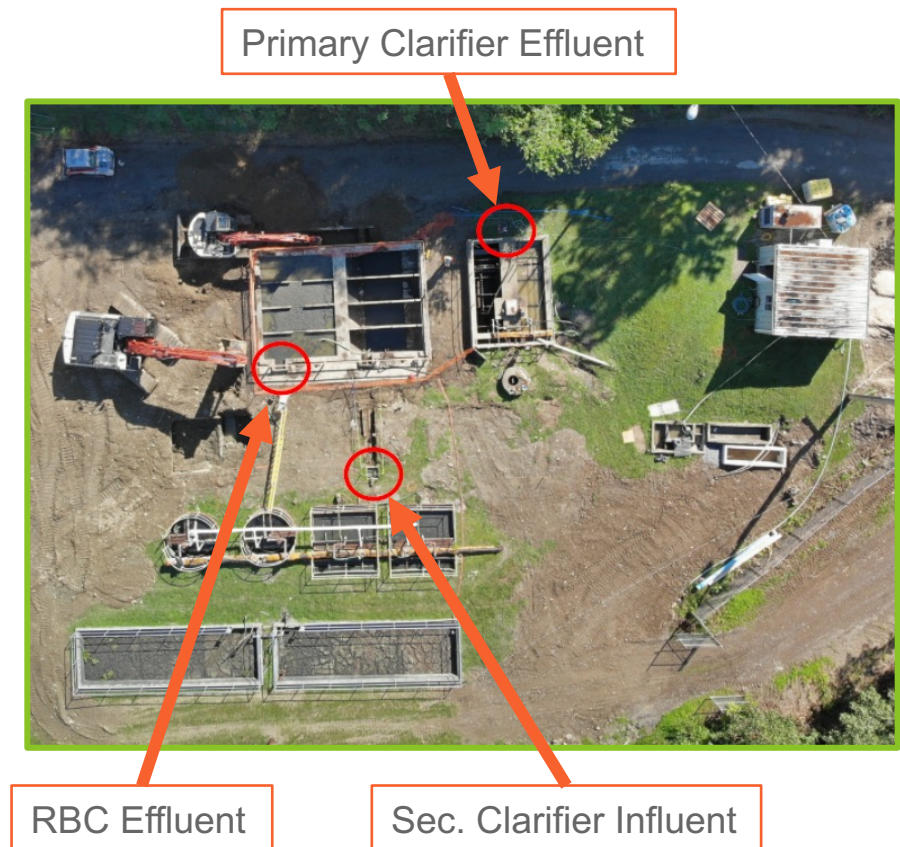
- **Major decision: At what point in the treatment process to dose the coagulant?**

- Locations discussed included Primary Clarifier effluent, RBC effluent, and Secondary Clarifier influent.
- Primary clarifier dosing would result in settling in the RBC tanks, which are not design for efficient solids removal.
- Dosing was done at the RBC effluent and Secondary Clarifier influent, depending on what construction activities were occurring.

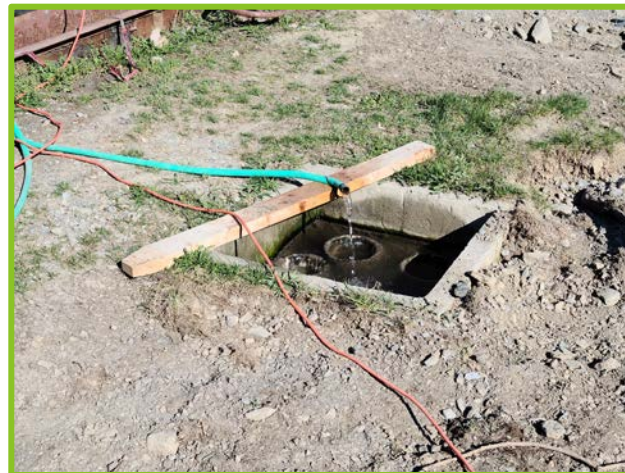
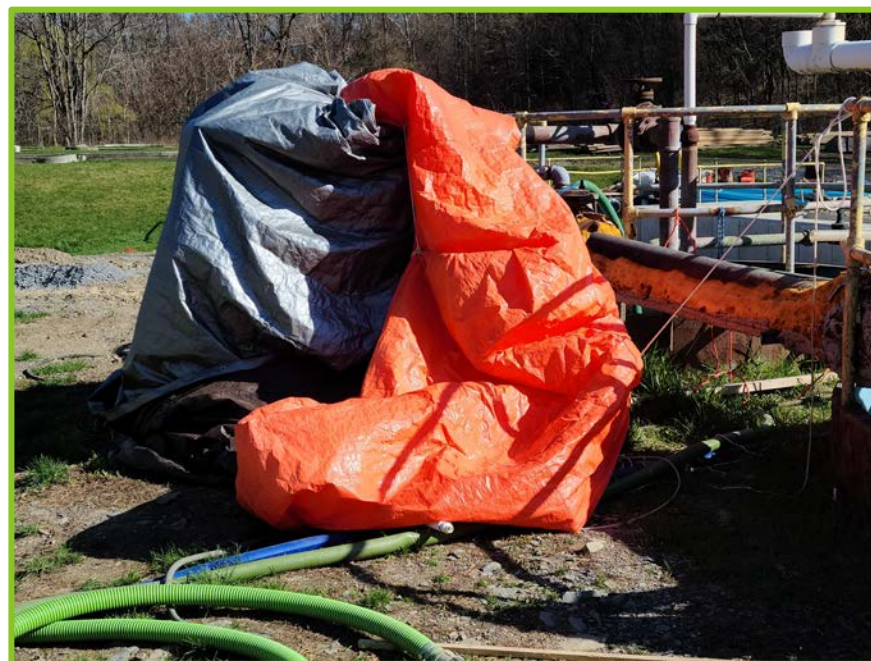
- Coagulant needs to be maintained above 10°F
- No space to store inside
- Many layers of coverings and heater

- Added later to ensure dosed coagulant entered each clarifier
- Ensured coagulant did not freeze in tubing

- Tubing pinched or cut
- Tubing pulled out of dose location
- Extension cords for dose pump and heater unplugged

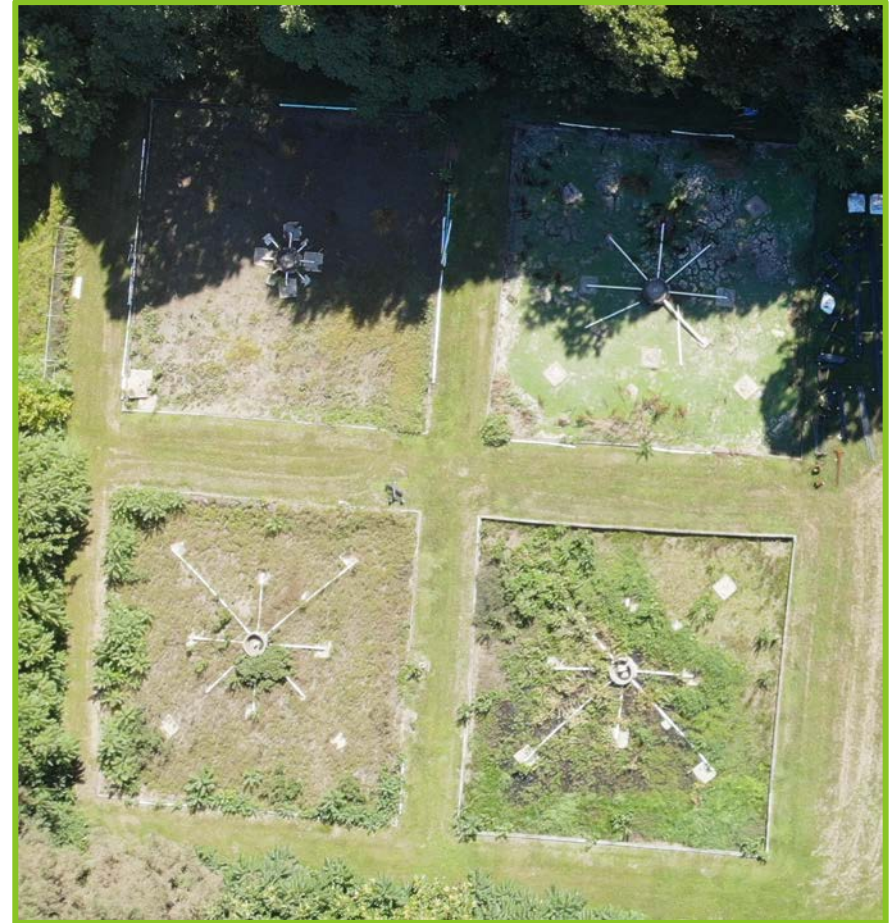
- **Prior to fire used as polishing filters**
- **Able to provide some physical filtration**
- **Biologic growth within sand media provides additional treatment**
- **Increased maintenance and decreased time each filter can be in service**

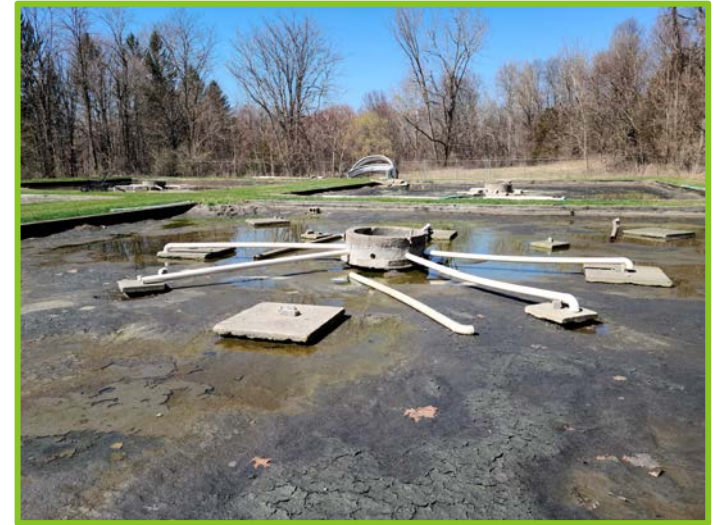
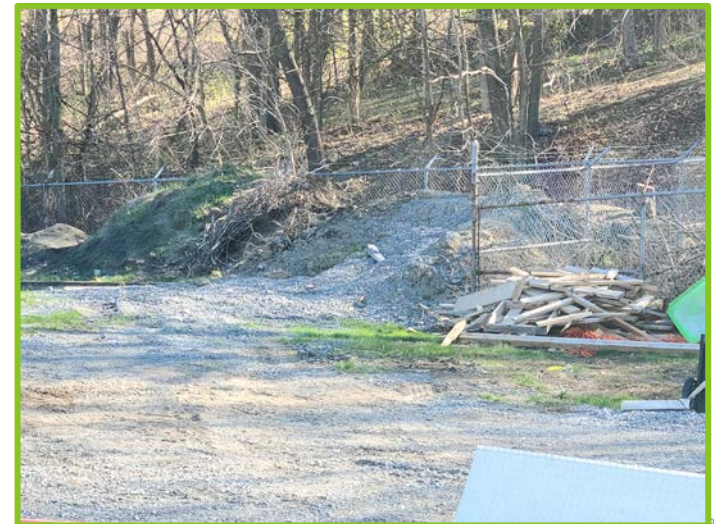
- Lack of upstream secondary treatment resulted in increased solids in sand filter influent.
- Solids captured have clogged sand media.

- Once clogged, sand filters do not pass flow quickly enough to avoid overtopping.
- Sand filters in service from 2-6 weeks.
- Prior to fire in service for up to 6 months.

- Prior maintenance was removal of plant growth from surface during extended down time.
- New maintenance is removal of solids accumulating on sand surface.
- Solids removal also removes sand media and has reduced the depth of sand layer.

- Due to fouling, the sand filters are again part of the project, with a reduced rehab scope.

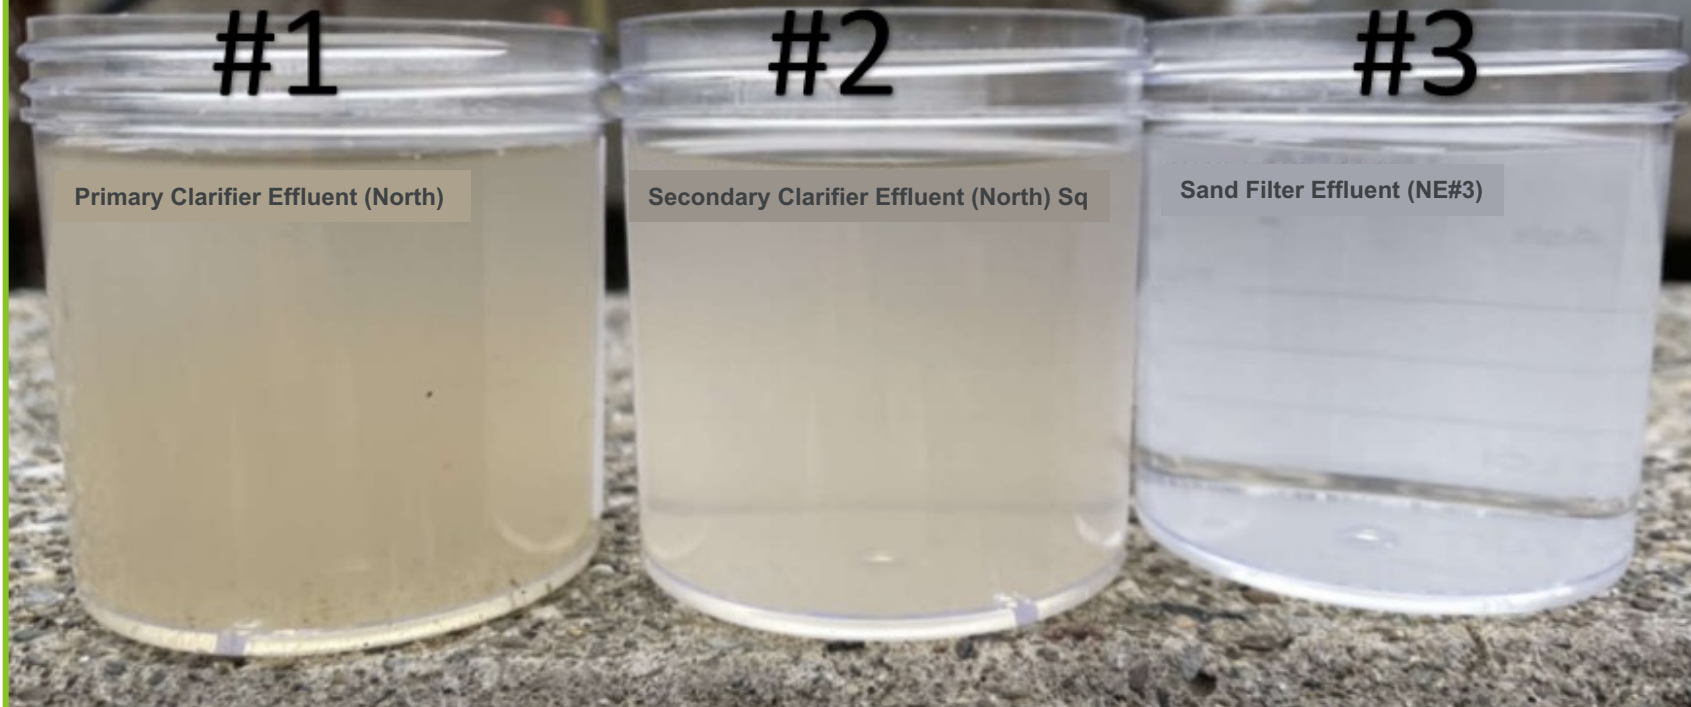
but ammonia was still high.

GFS WWTP 2020-12-16
Weather – cloudy, dry 20F
Effluent Flow Meter
30gpm/43,200gpd

Treatment Status:
Grit – Normal
Grinder – Broken scheduled for repair
Pri Clarifier – South out of service / North operational
RBC – Out of service – Replacement scheduled for install Jan-Feb 2021
Sec Clarifier – Two Square operational – Two Round out of service
Sand Filters – SW#2 & NE#3 Active – SE#1 & NW#4 Cleaned and ready for service
Disinfection – Cl2 online
Post Aeration – Temporary Air online

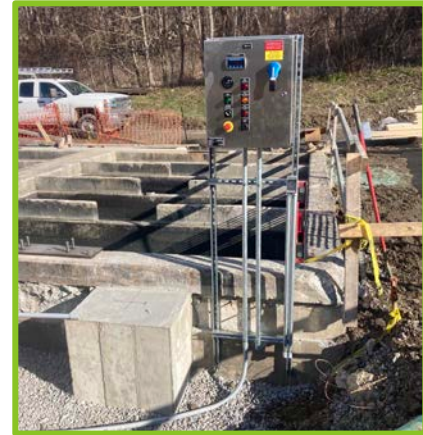
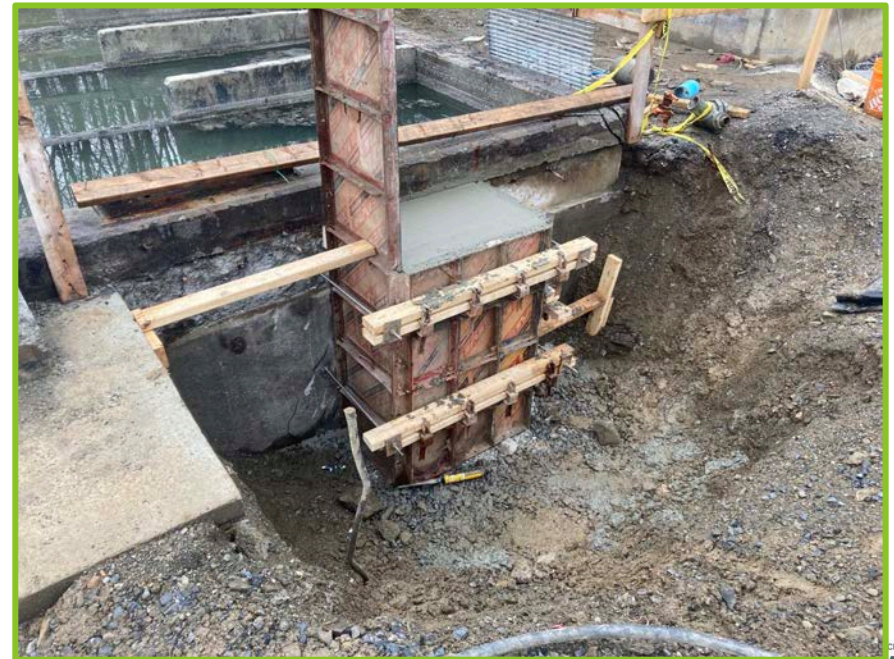
All
cured
and
with
the
control
panel,
too!

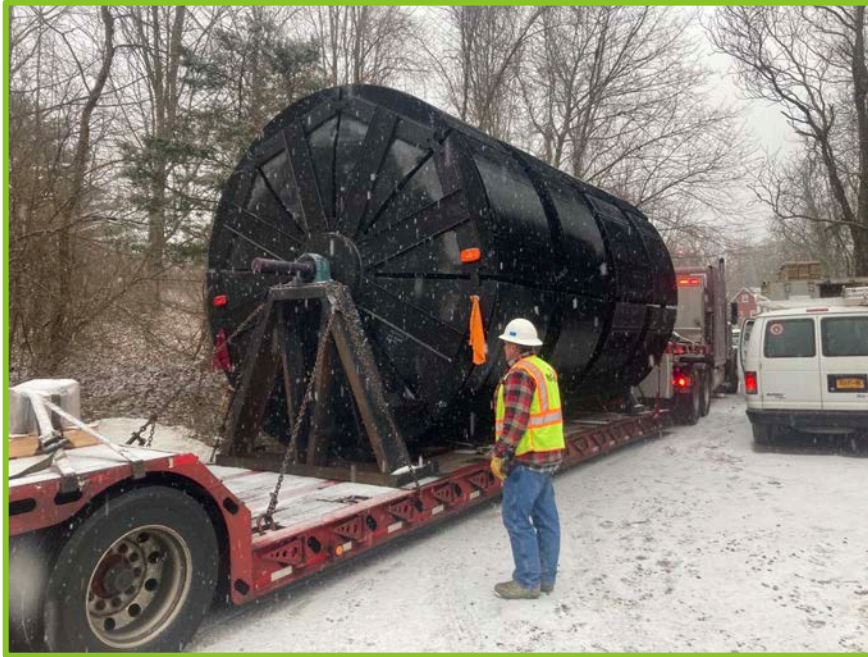
DELIVERY AND SETTING OF NEW RBCs

First on the truck...

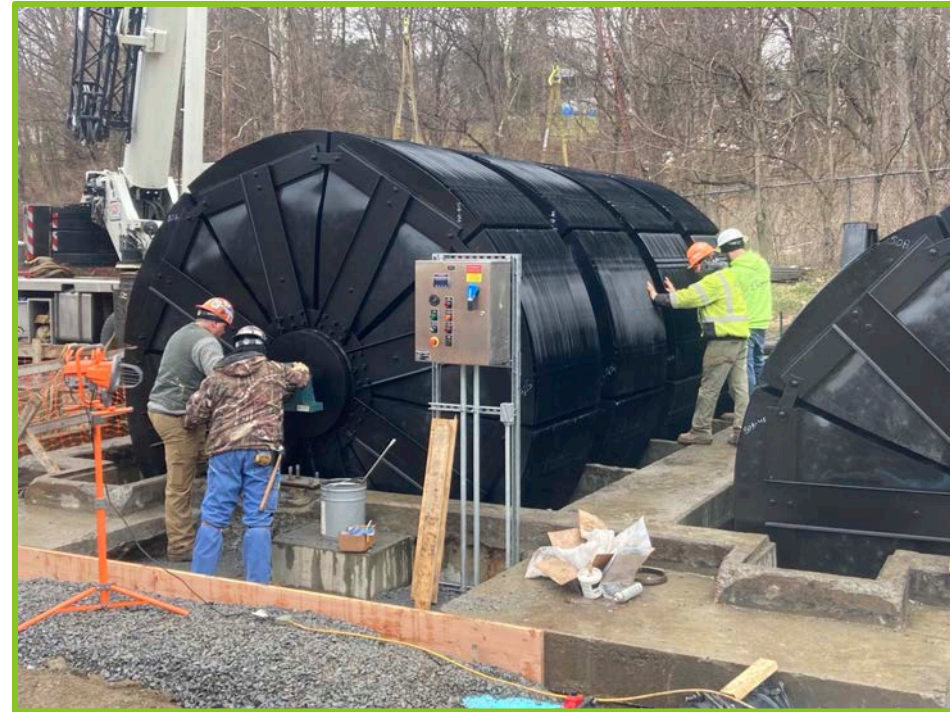
... and then there were two

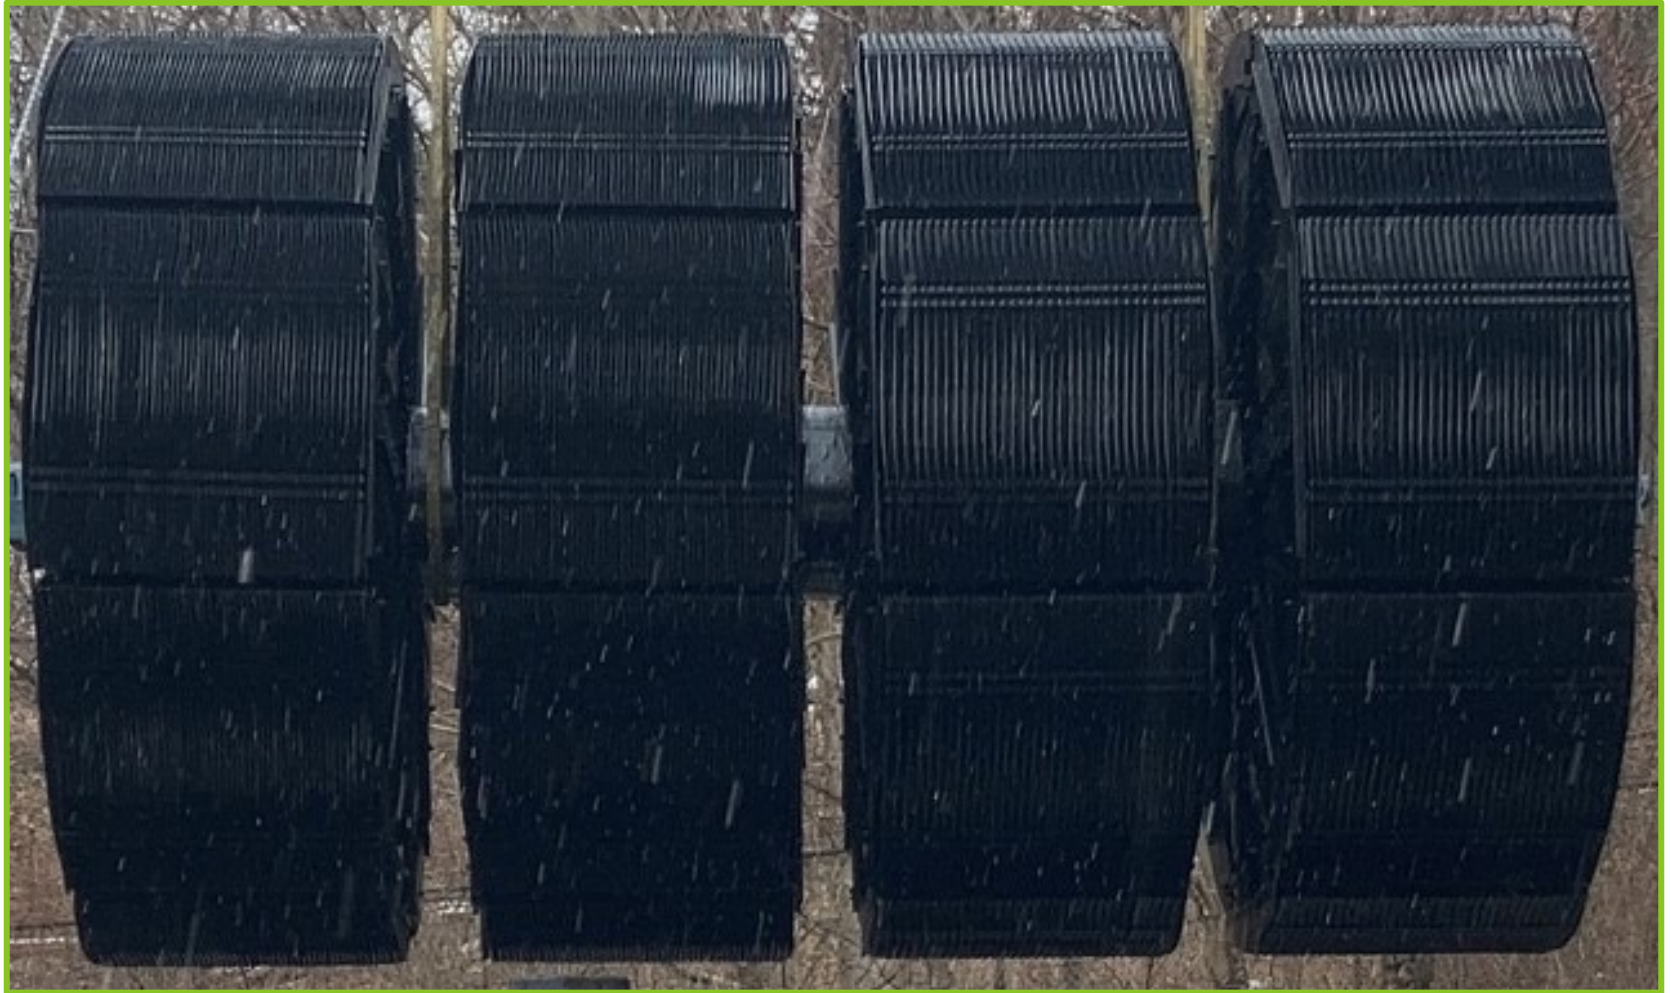
CAN YOU SPOT THE DIFFERENT MEDIA DENSITIES?

High

Standard

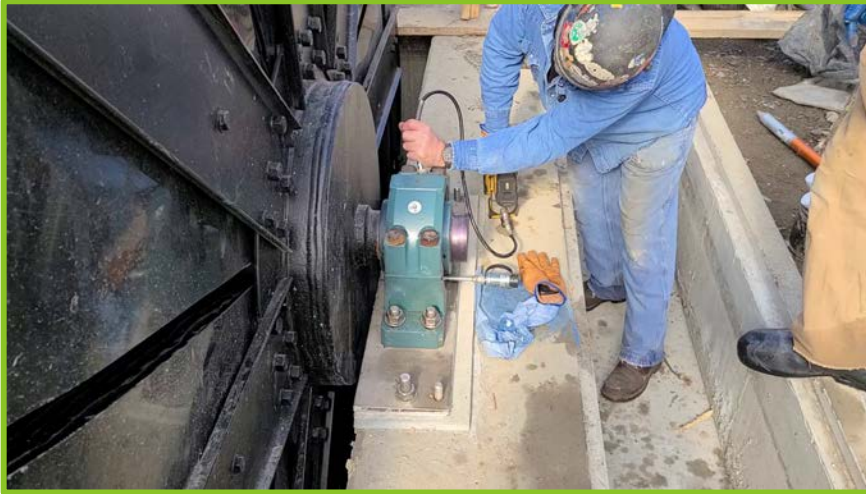
Grease your RBCs first...

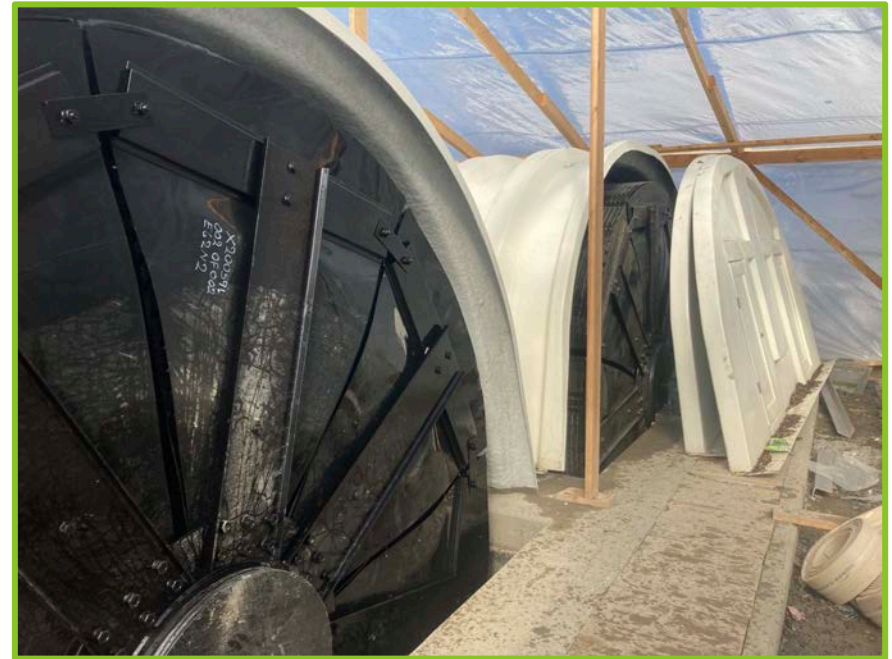
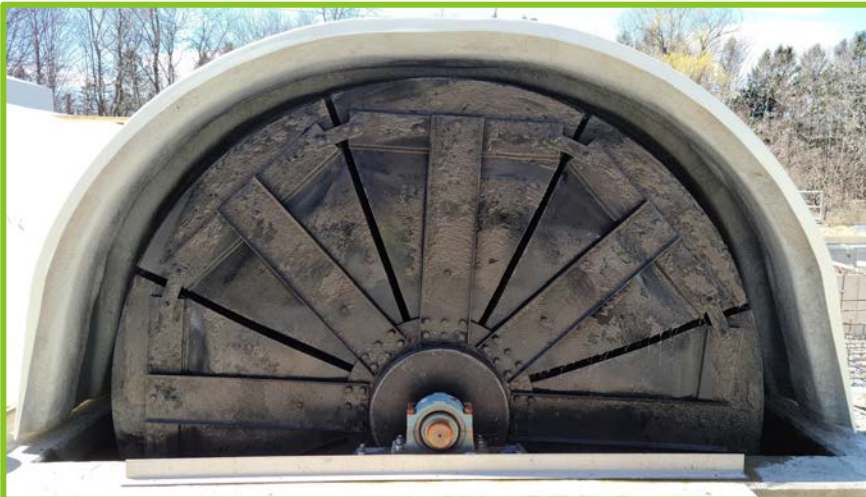
...then tuck them under the covers...

... and in 6 to 8 weeks they will be all grown up!
