# CSO Reduction and → Green Infrastructure

A Happy Marriage

Presented by: Kevin Trainor, P.E. & Justin Pellerin, P.E.

**Fore Street/Eastern Promenade Sewer Separation Project**

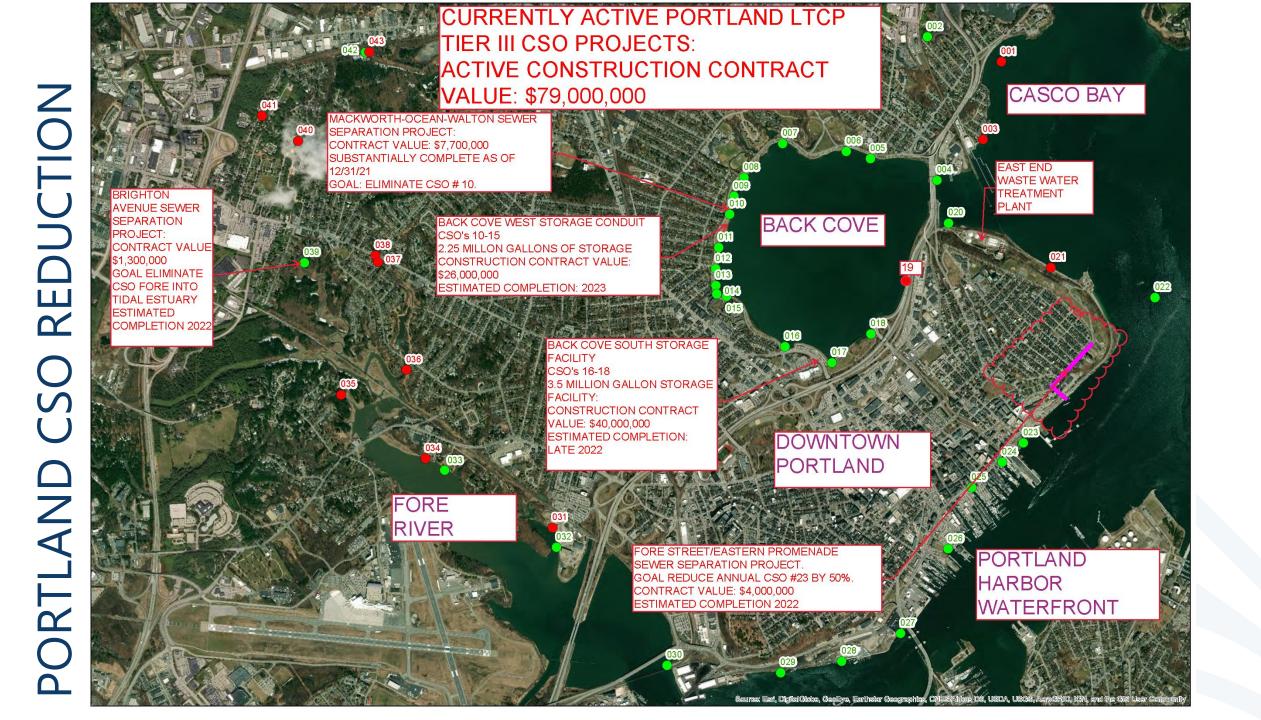
**Brighton Avenue Sewer Separation** Manhole Installation Summer of 2021 Back Cove South 3.5 MG Storage Facility Construction Summer of 2021

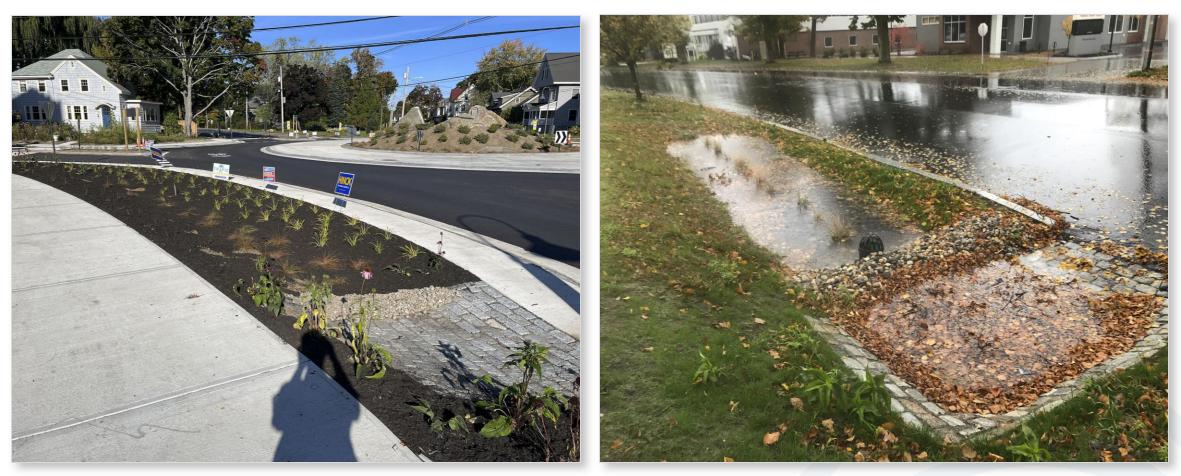
### Portland Green Infrastructure Examples

Deering Corner Roundabout Bio Retention Cells

Baxter Blvd Bio Retention Cells

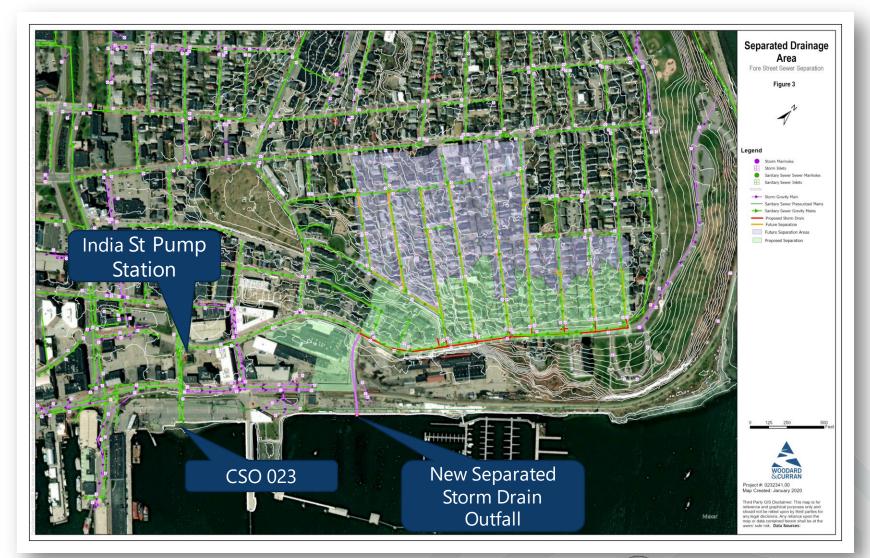
### **CSO Reduction-Sewer Separation**

Installation of 1,800 LF of separated storm drain

- This phase separates 21 acres, 31 catch basins
- Opportunity for separation of additional 28 acres
- Reduce CSO's at location #23 into Portland Harbor.
- Recent Modeling Indicates project will reduce Annual CSO Discharge Volume by 50% (2010-2020 Average Annual Discharge CSO # 23= 12 MG)

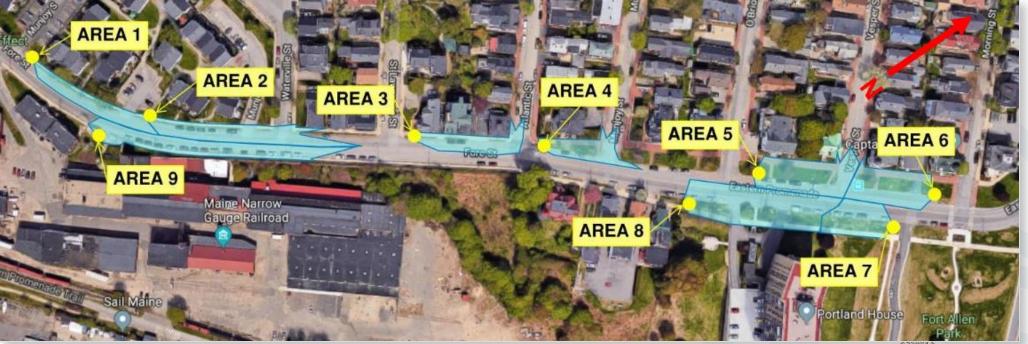
- 9 locations for GI Identified
  - Focusing on impervious area in ROW
  - Heavily used street parking area
  - Objective is to maximize treatment value

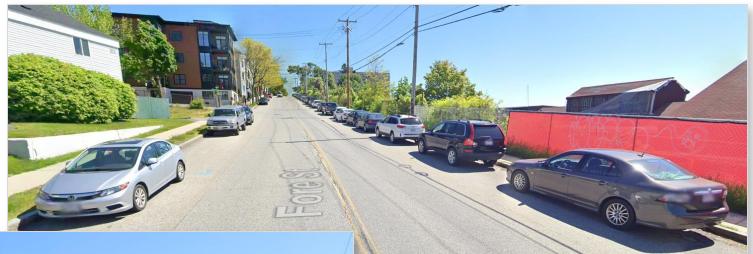
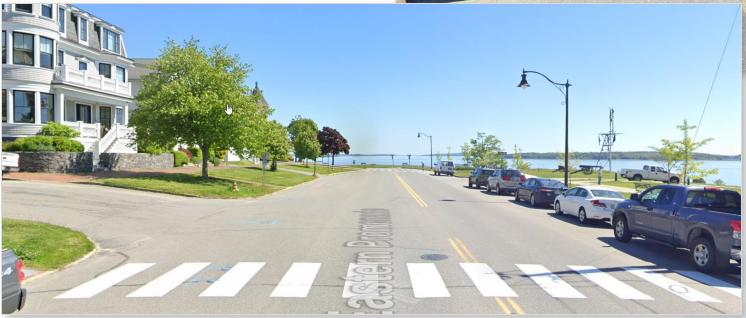
- Narrow ROW
- Steep slopes
- Historic neighborhood
- Esplanade grading

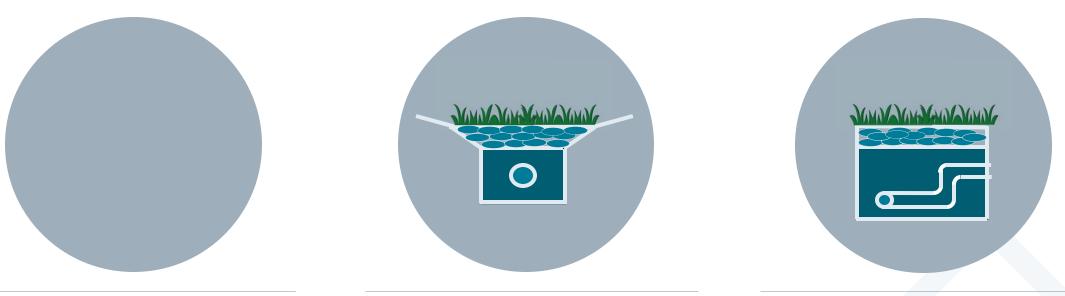
# Treatment Alternatives

Prefabricated Tree/Box Filters Traditional Underdrained Surface/Subsurface Soil Filters Upflow Soil Filtration Media

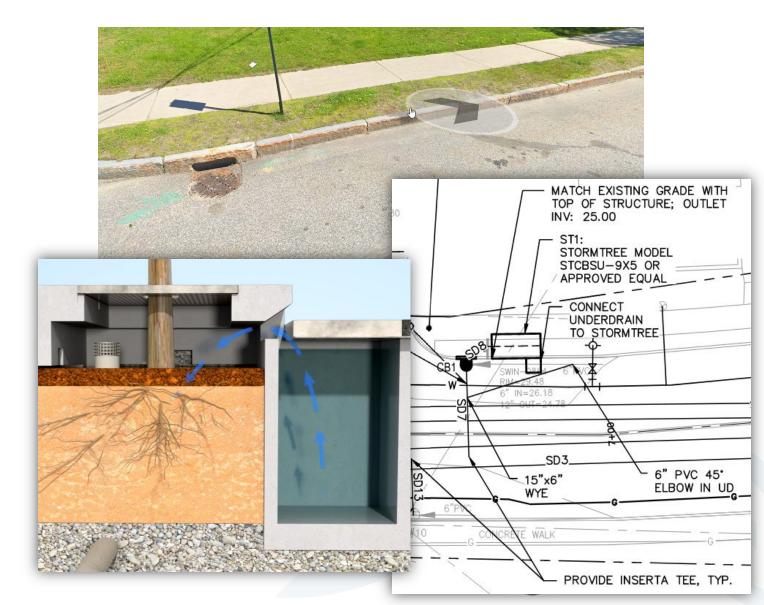
# **Treebox Filters**

StormTree<sup>®</sup> units

- Located in esplanade
- Upstream sump/catch basin with overflow weir
- Open-bottom & sides
- High-flow filtration media
- Overflow piped connection to storm drain
- Treatment performance
  - 85% TSS removal
  - 85% Oil & grease removal
  - 48% TN removal
  - 48% TP removal
  - 60% Total metals removal

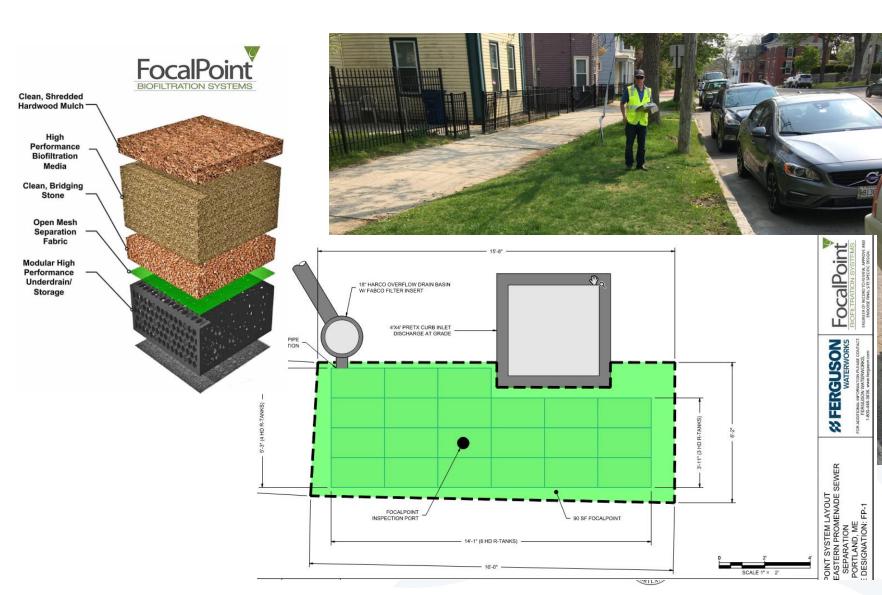
# **Biofiltration System**

### FocalPoint<sup>®</sup> unit

- Located in esplanade
- Upstream PreTx<sup>™</sup> unit with overflow weir
- Vegetated
- High-flow filtration media
- Treatment performance
  - 80% TSS removal
  - 48% TN removal
  - 60% TP removal
  - 50% Indicator bacteria

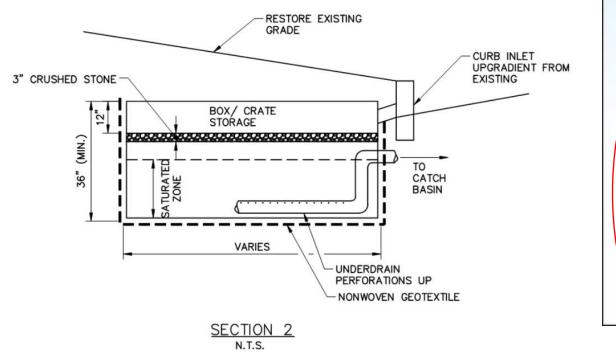
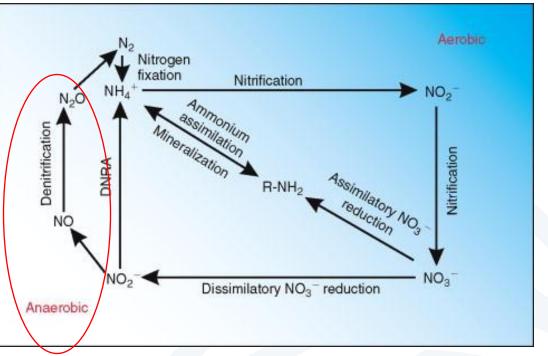
# **Upflow Filtration – Brief Explanation**

Increased Nitrogen Removal:

- Saturated zone promotes denitrification
- Particulate removal through filtration

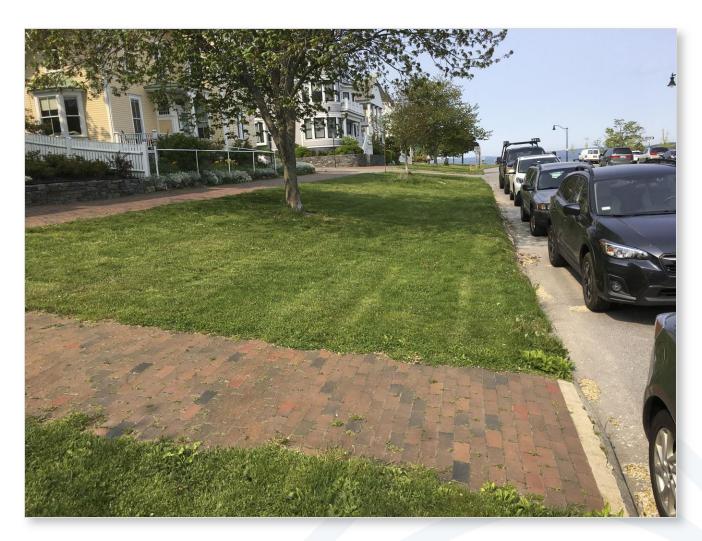
# Bold & Gold ® Upflow Filtration

### Bold & Gold® unit

- Located in esplanade
- Upstream PreTx<sup>™</sup> unit with overflow weir
- No vegetation (except existing grass)
- Cleanout ports only at surface
- High-flow filtration media

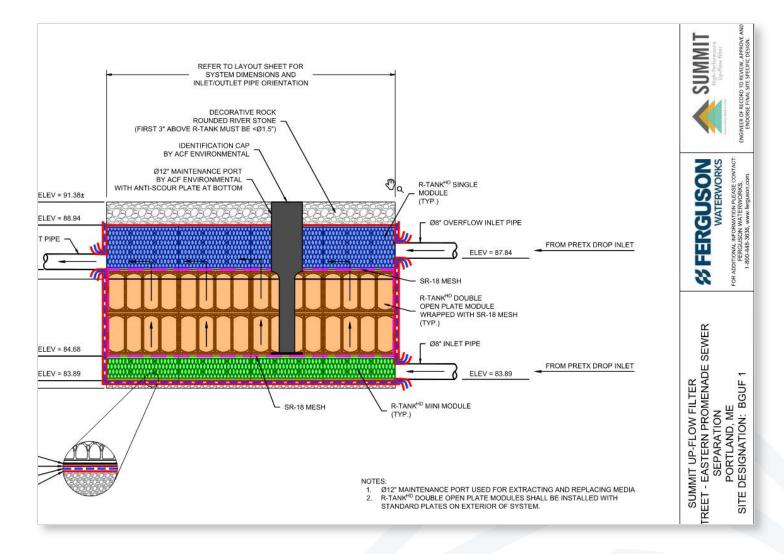
### Bold & Gold ® Upflow Filtration

### Bold & Gold® unit

- Requires 3-6" of driving head for upflow
- Maintenance ports for media replacement/ regeneration
- Treatment performance
  - 70-95% TSS removal
  - 55-75% TN removal
  - 65-95% TP removal

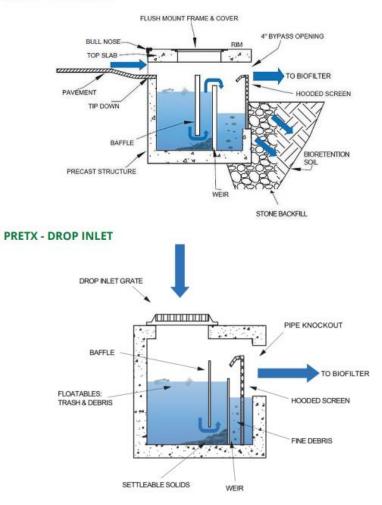
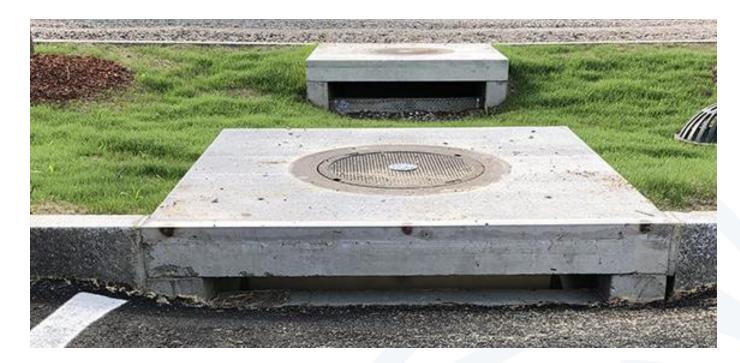
#### PRETX - CURB INLET

#### PreTx<sup>®</sup> Unit (multiple configurations)

- Provides settling, screening, and floatable removal
- Protects BMP and downstream infrastructure
- Easily accessible cleanout
