Performance Evaluation of the Narragansett Bay Commission's CSO Tunnel Odor Control System and Ancillary Facilities

February 2022

Robert Baglini, PE
Derick Hopkins, PE

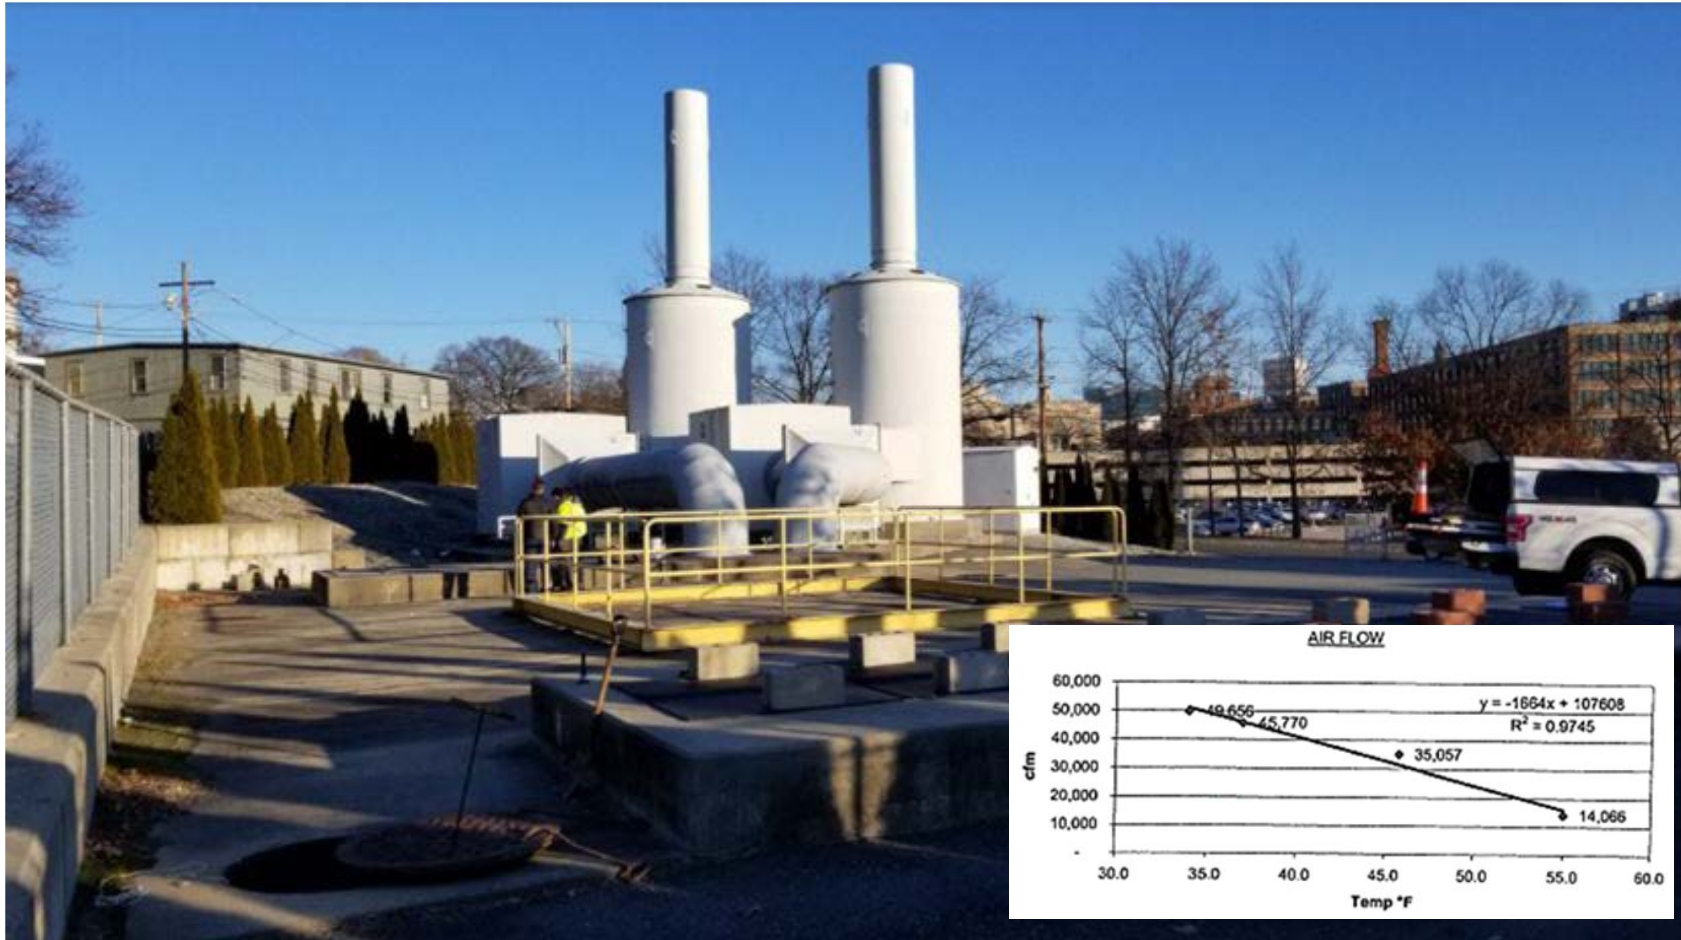
Odor Control – Round 1

- Phase I completed in 2008
- The NBC began receiving odor control complaints associated with the Foundry Shaft shortly after it was placed into operation
- 2009: NBC procures Design-Build Services to construct the Odor Control System at Receiving Shaft (Calvary Street) site
- Two 30,000 cfm radial flow activated carbon units

Existing Odor Control System - Receiving Shaft Site (Upstream)

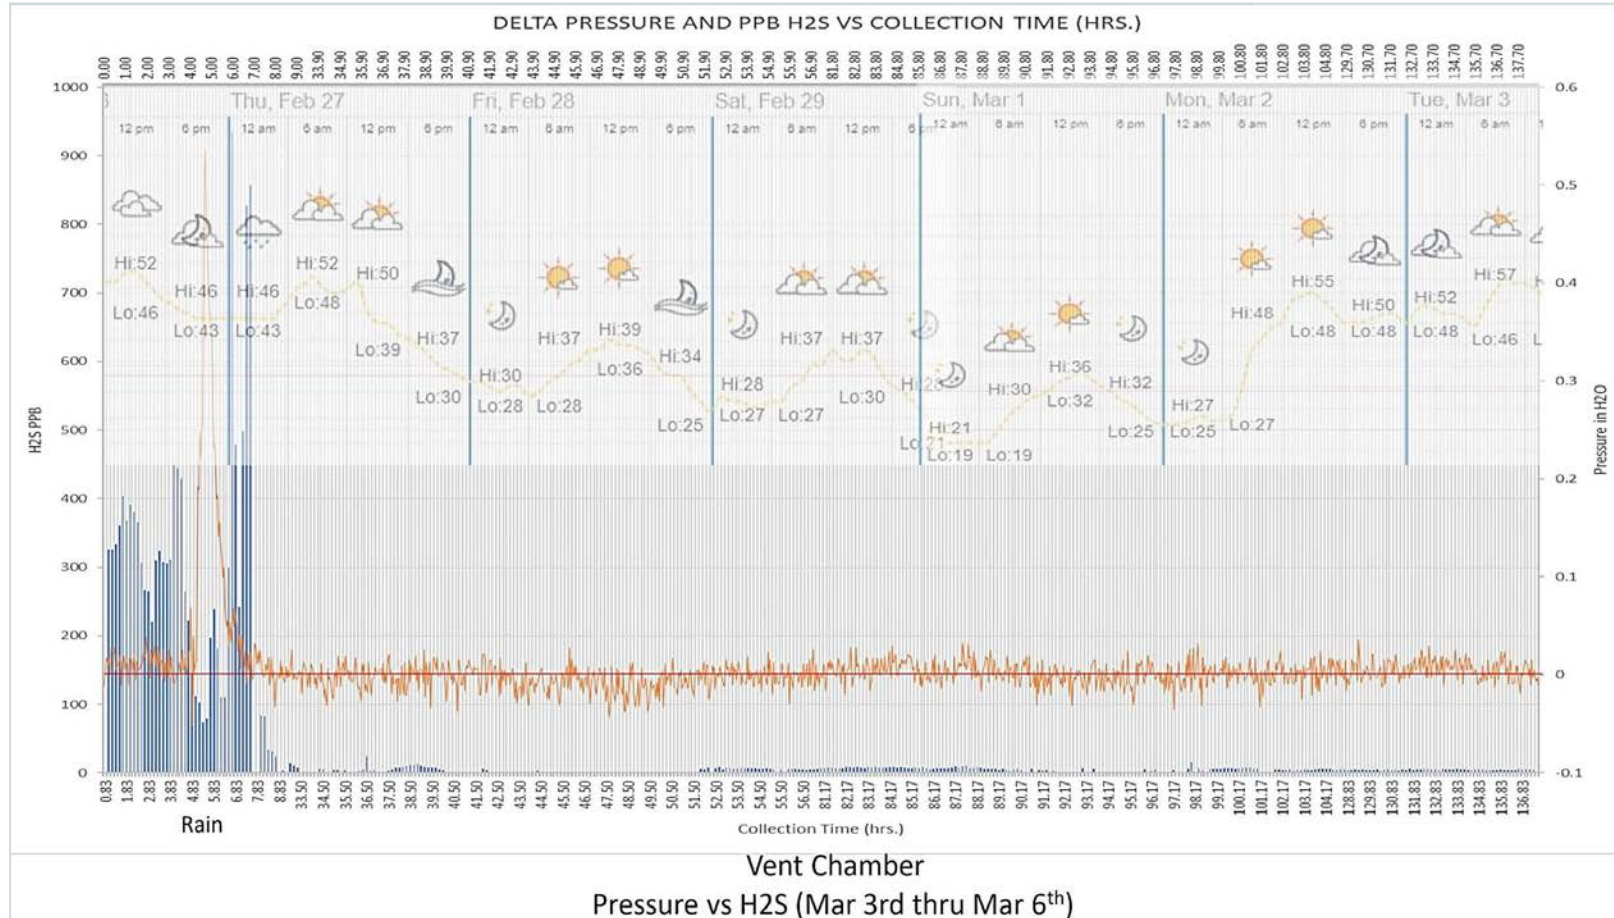
Continuous H2S and pressure monitoring result

- H2S ppb and differential pressure measured continuous at Foundry Shaft from February to March
 - H2S emission found to be detectable at the receiving shaft
 - H2S correlated well to rainfall (i.e., pressurizing events) and tunnel mucking operations
 - Steam constantly escaping from the louvered side of the Foundry Shaft

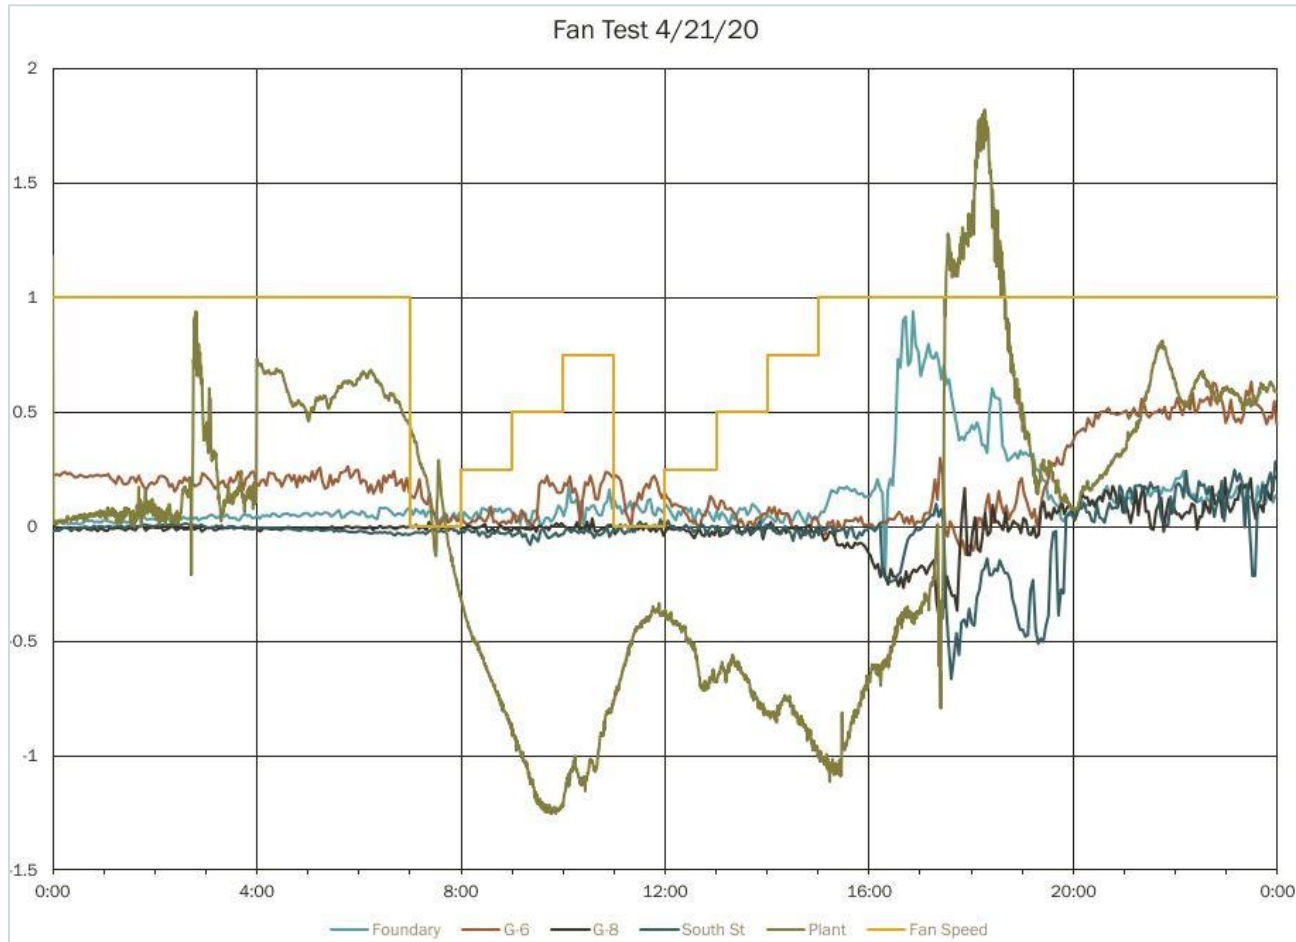
System wide multi speed fan test with continuous differential monitoring

- Existing odor control fans were varied from 0% to 100% while continuously monitoring pressure at:
 - Foundry Shaft
 - G-6 and G-8
 - South Street
 - Fields Point
- Test conducted on multiple days with varying ambient temperatures
- No strong correlations between fan speeds and pressures

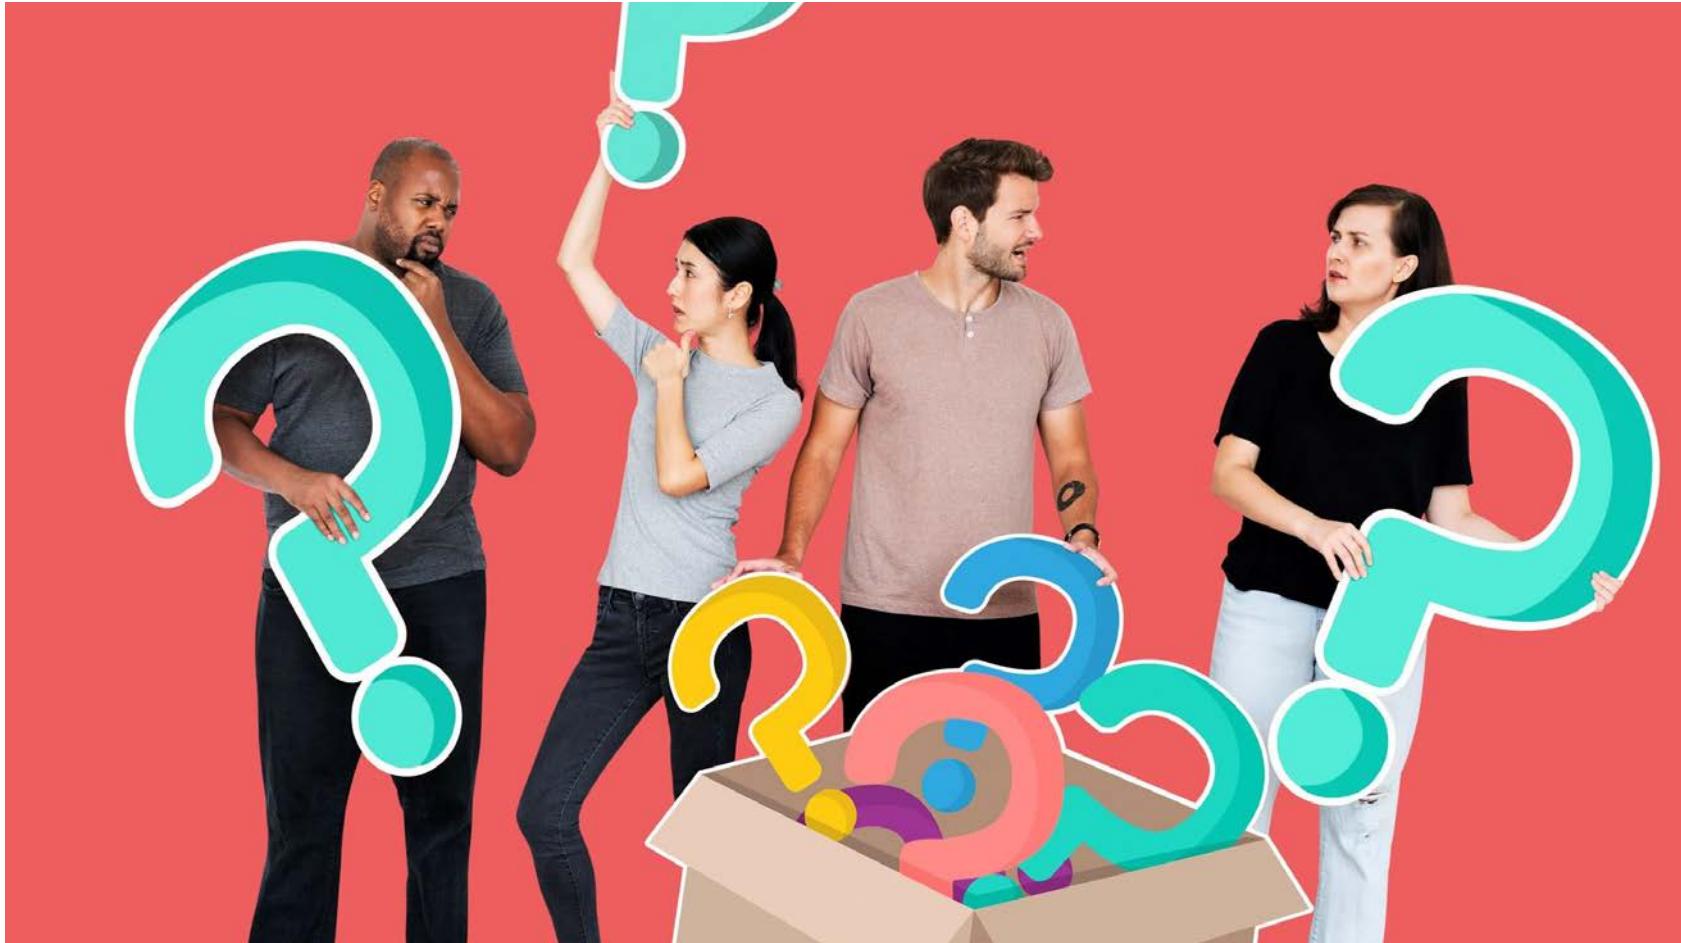
Source of the Odors?

- H₂S is detectable especially following tunnel pressurizing events
- The existing odor control units are operating within their expected parameters
- The WCSOI may influence airflow, but only under a certain set of conditions

- Air may be short circuiting the tunnel via the interceptors and the original Gate and Screening Structures (a materials issue)

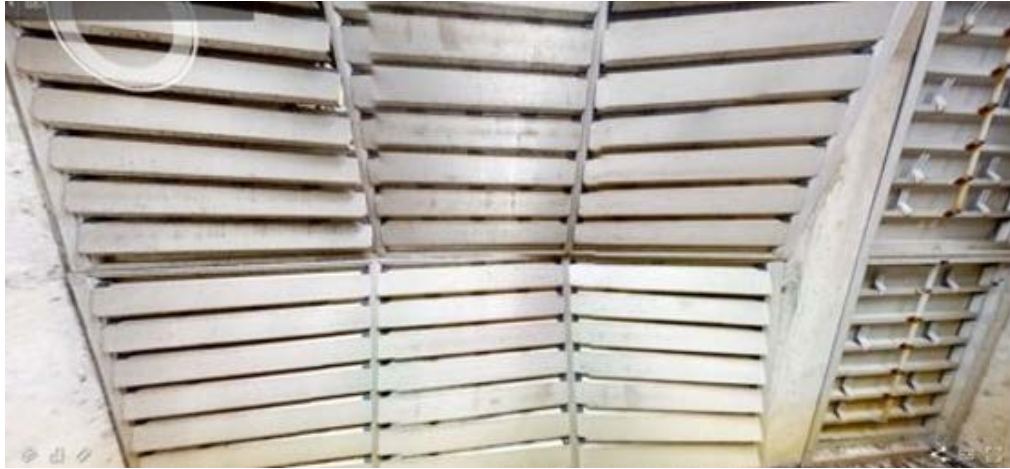
Gate and Screening Structures

- Wright-Pierce conducted a site investigation of each gate and screening structure
- All equipped with intake and exhaust dampers
- If dampers are damaged/corroded, out of balance, air may short circuit

- Damper replacement / miscellaneous maintenance work (construction scheduled for Spring/Summer 2022)
 - Monitor odor complaints if/when received:
- Media replacement / Carbon Vessel Modifications (future construction contract)
- Re-assess dispersion / evaluate discharge stack height
- Expand Capacity of System (most costly option)

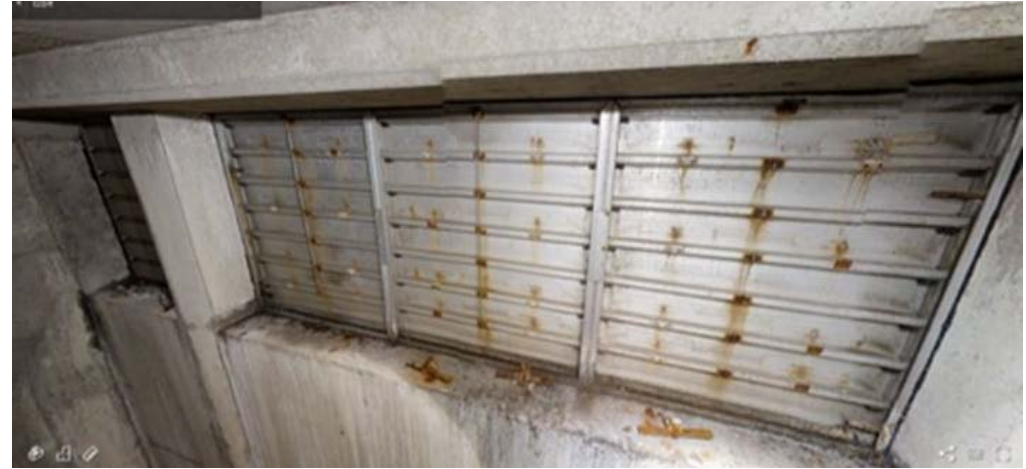
- Resulting H₂S induced corrosion found to hinder damper functionality. For example, the blades get stuck, require higher pressure to open, and do not fully close
- Dampers found to have varying degrees of deterioration, contributes to air short-circuiting, may enhance “chimney effect”

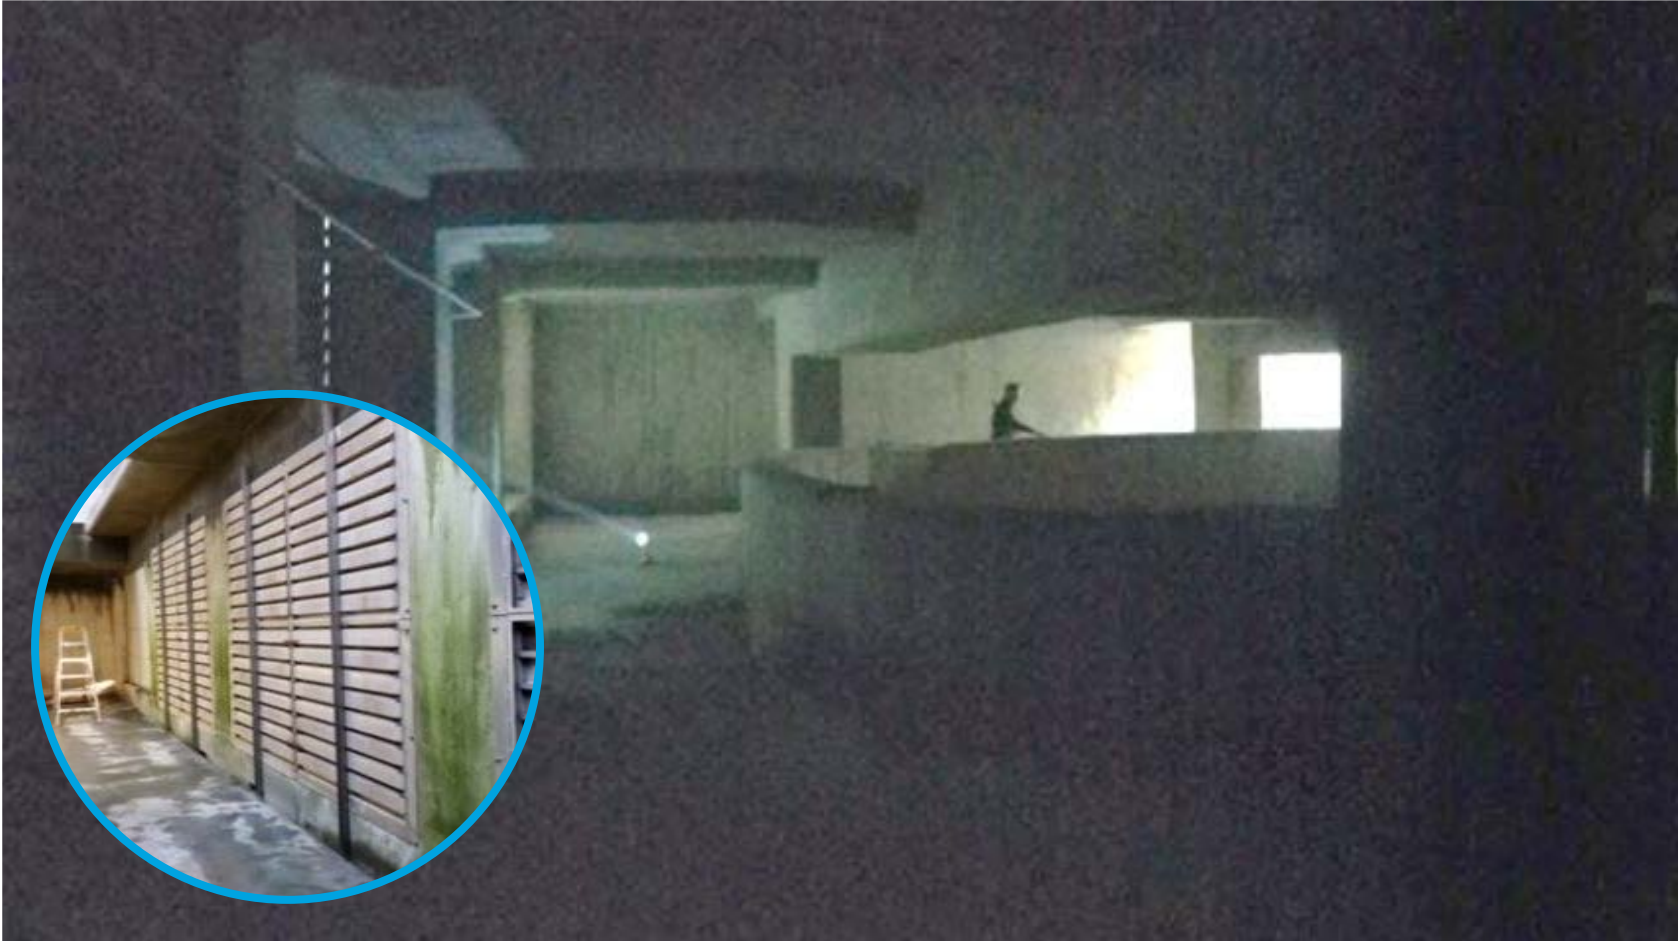
Receiving Shaft

- Fugitive emissions suspected to escape through defects
- Large plenum dynamic air pattern / zone of influence of blower suction
